Tarlton Stream and Wetland Restoration Project

Year 5 (2010) Monitoring Report

RE: Tarlton Wetland and Stream Restoration Project (D05013-1)

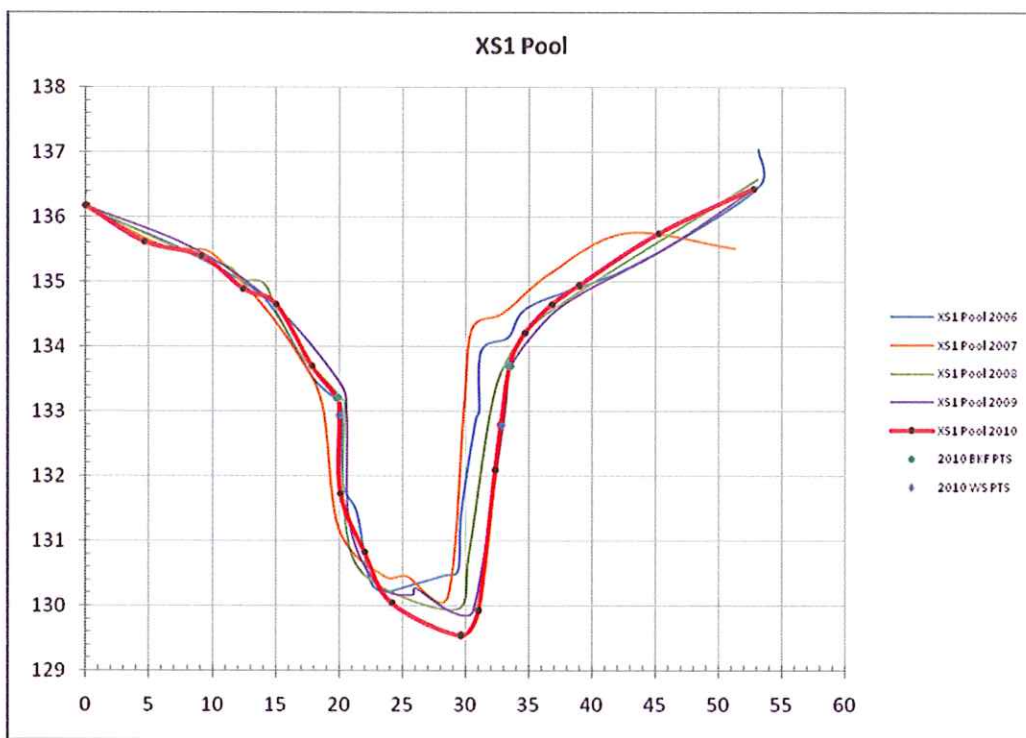
Graph 1: Cross Section 1 Pool

Cross Section 1 Pool – No significant changes, Thalweg right of center.

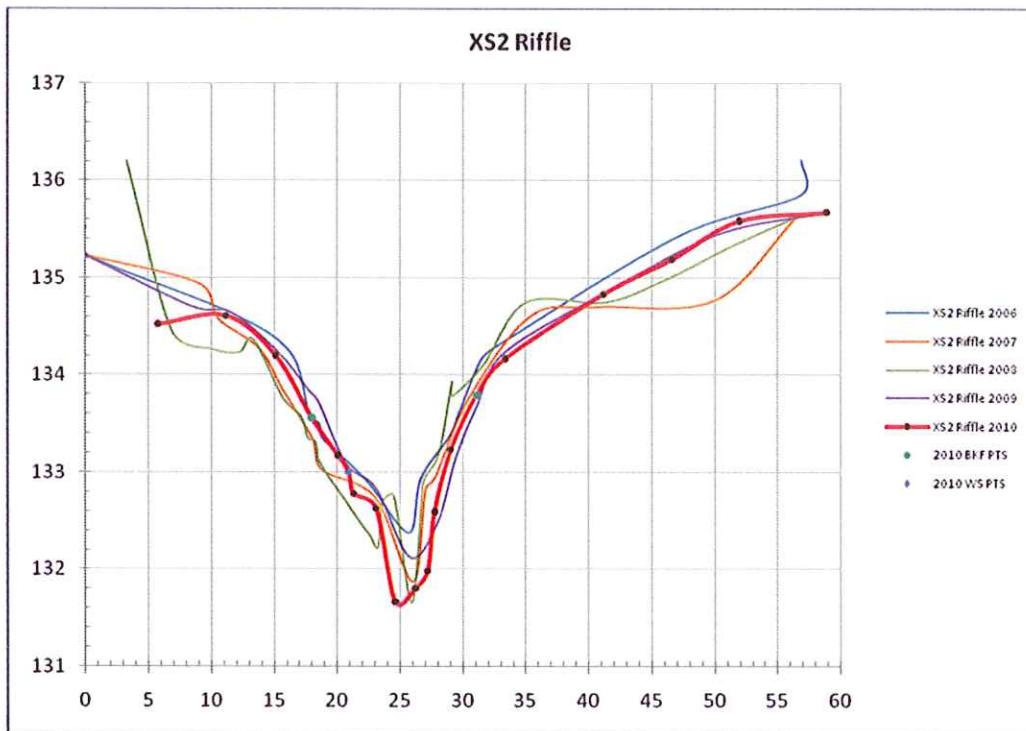
Graph 2: Cross Section 2 Riffle

Cross Section 2 Riffle– Sand deposits from 2006 and 2009 are completely cleared out, thalweg centered.

There is currently only one constructed riffle on the project, which is located at the site of the original dam and corresponds with Cross Section 2. This riffle was constructed with large cobbles and small boulders found on site. A pebble count was done in 2006 which demonstrated the substantial size of the bed material. In 2009, pebble counts were done on two sections of the same riffle, 2009 and 2009a. Sample 2009a was taken in the same area as the 2006 sample. Only a small representative sample was taken in 2006. Samples for 2009 were slightly larger, but low amounts of smaller bed material make a larger count difficult. The site has shown no significant change since as-built documents were submitted. Pebble count graphs are located in Appendix B with Cross Section 2.

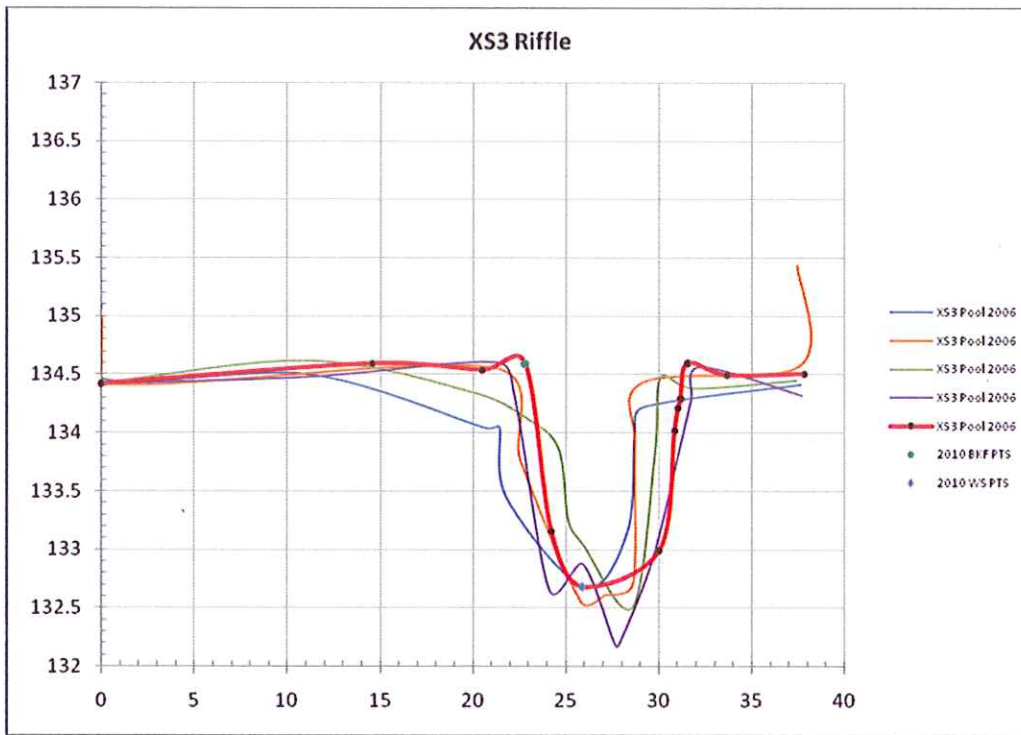
Graph 3: Cross Section 3 Pool

Cross Section 3 Pool – Channel appears shallower due to shifting sand bed nature of the stream, left and right bank seem stable as of 2009, thalweg left of center.

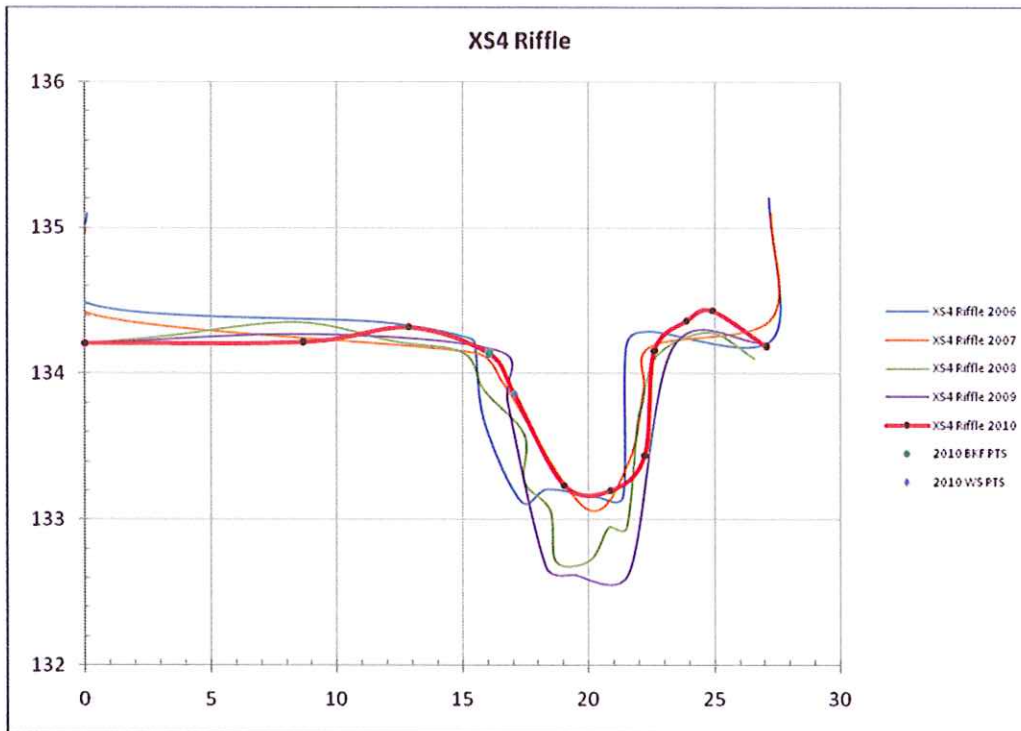
Graph 4: Cross Section 4 Riffle

Cross Section 4 Riffle – Sand deposits similar to those in 2006 and 2007 are present in 2010, thalweg right of center.

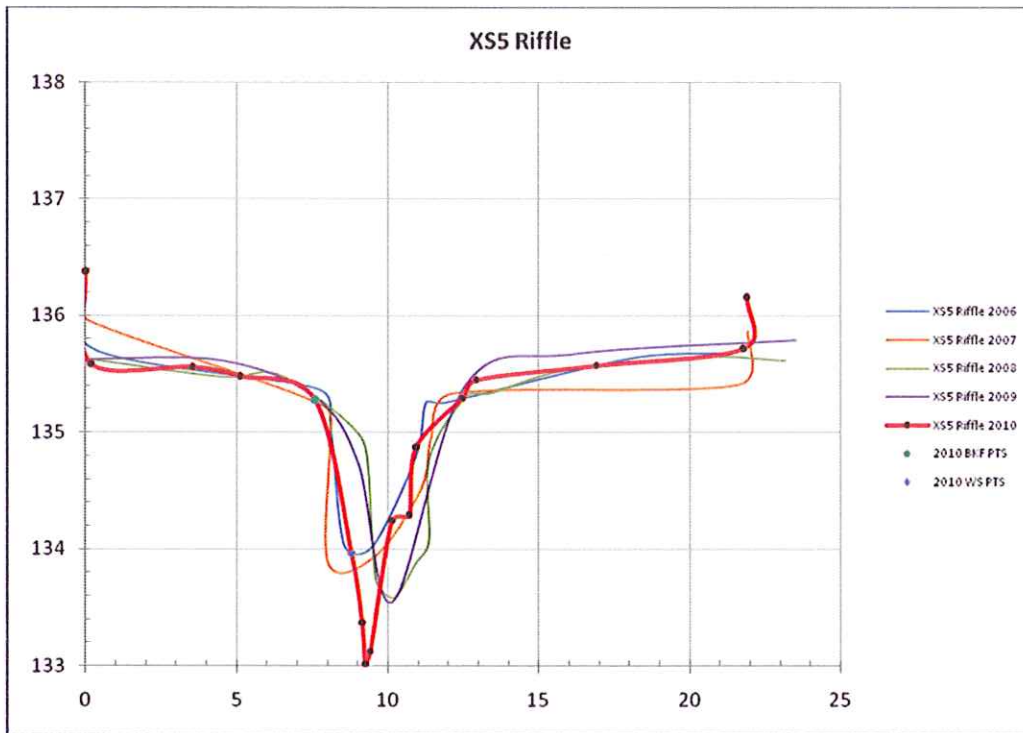
Graph 5: Cross Section 5 Riffle

Cross Section 5 Riffle – Seems to have re-aligned with the 2006 channel but has deepened significantly, thalweg left of center.

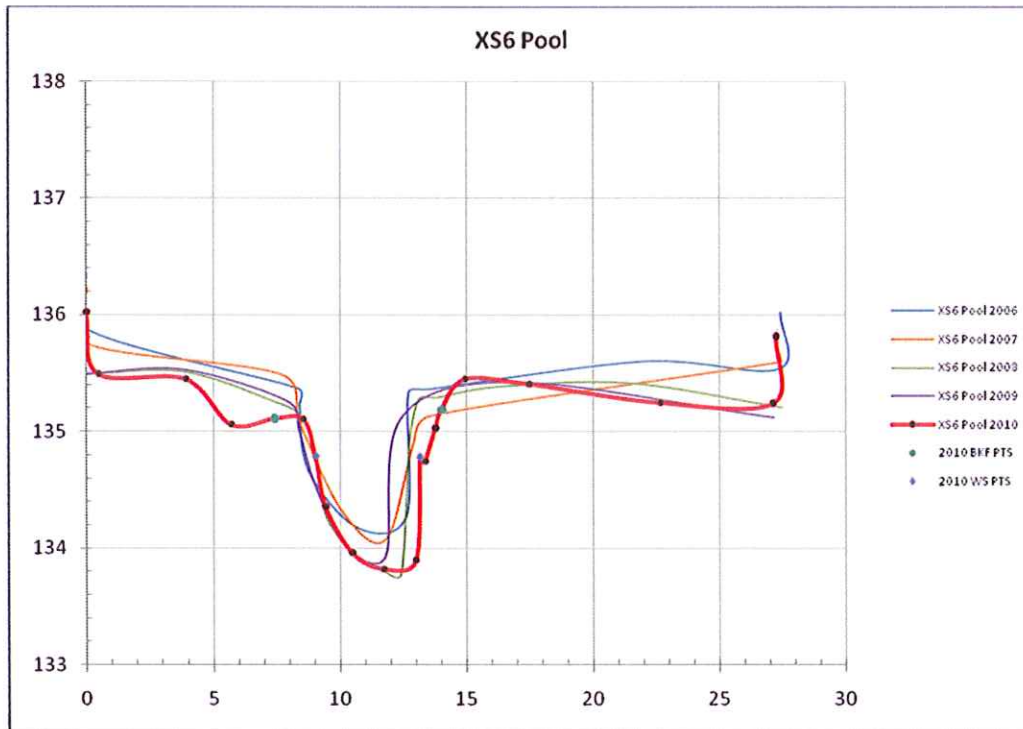
Graph 6: Cross Section 6 Pool

Cross Section 6 Pool – Right bank and overall channel width continues to fluctuate slightly, thalweg right of center.

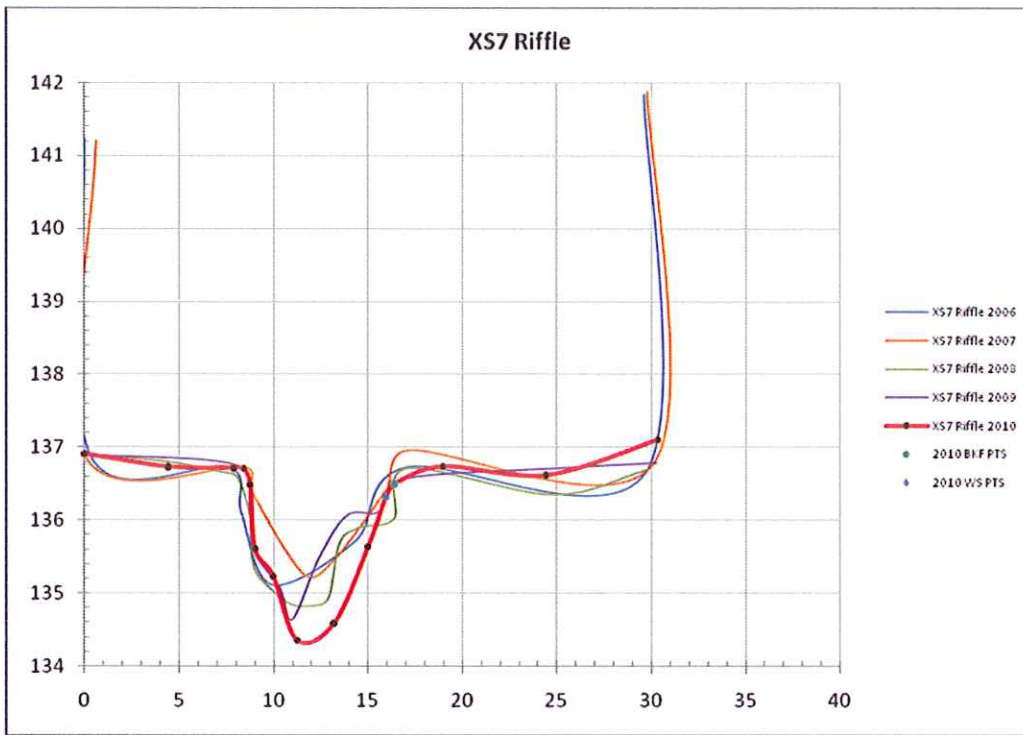
Graph 7: Cross Section 7 Riffle

Cross Section 7 Riffle – Channel continued to deepened slightly in 2010, right bank and overall channel width continues to fluctuate slightly as well, thalweg left of center.

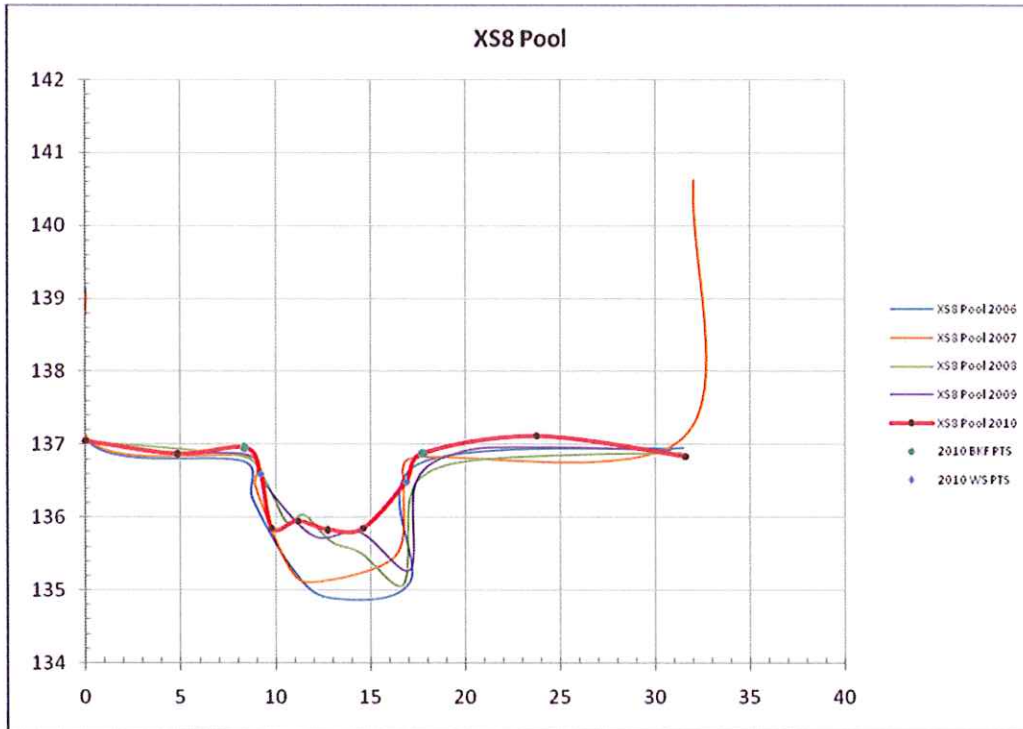
Graph 8: Cross Section 8 Pool

Cross Section 8 Pool – Sand deposition has continued since 2008, left bank seems to be stabilized while deep section to the right has filled in, thalweg left of center.

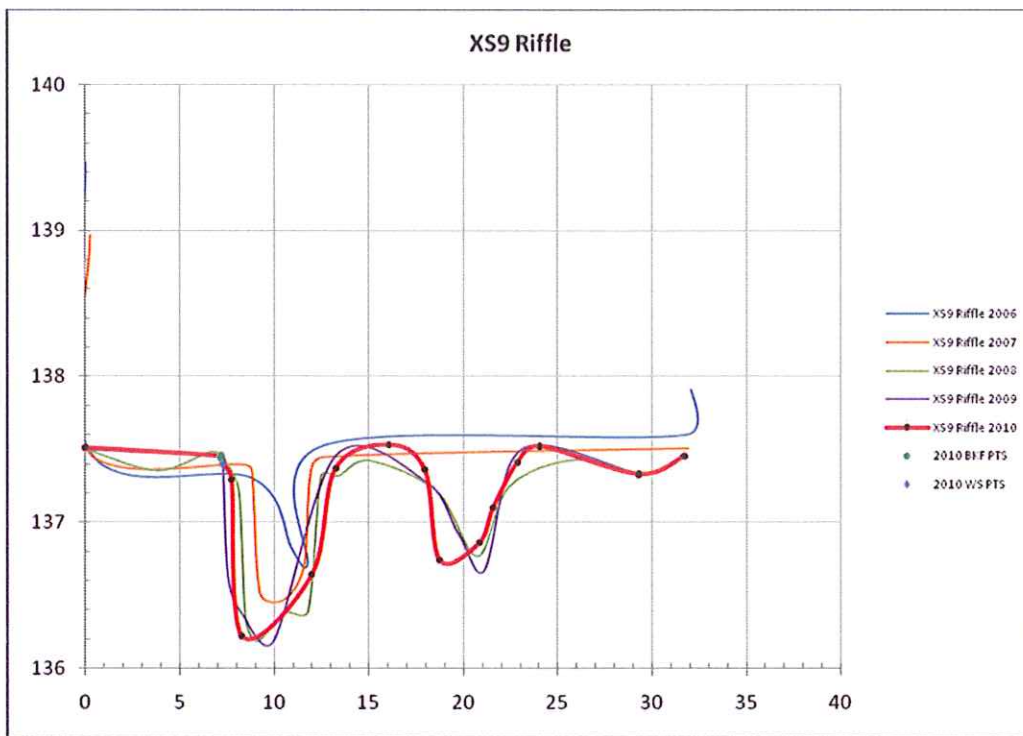
Graph 9: Cross Section 9 Riffle

Cross Section 9 Riffle – Channel depth has been stable as of 2008, scouring or settling of unconsolidated materials may have occurred along right bank in 2008, but has also stabilized, thalweg left of center

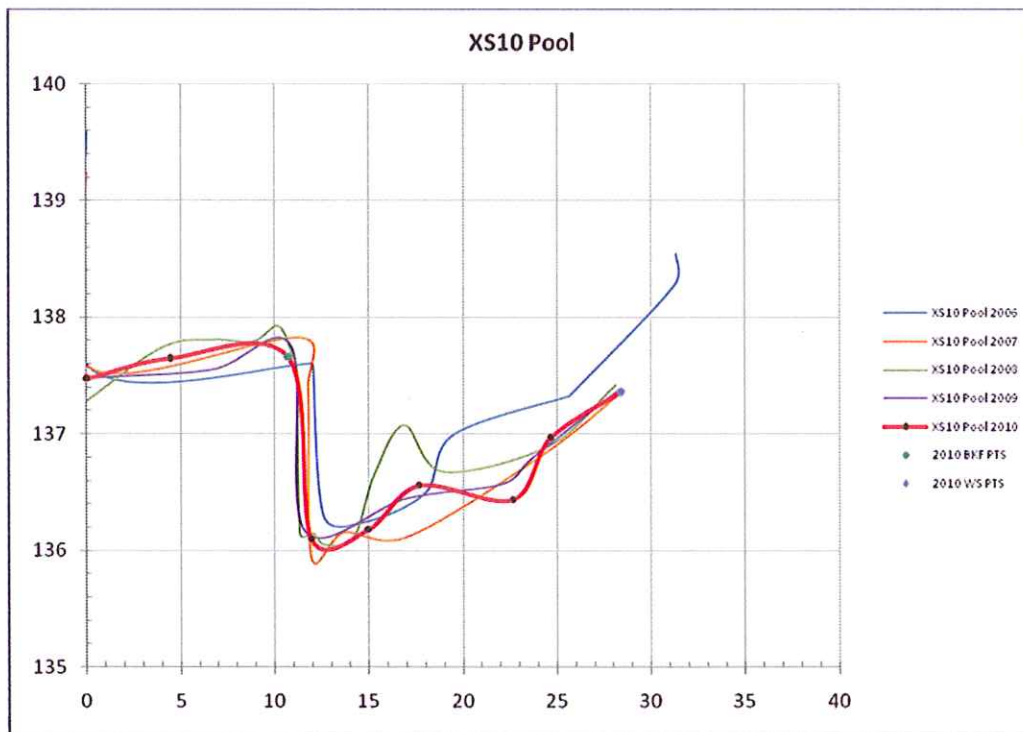
Graph 10: Cross Section 10 Pool

Cross Section 10 Pool – Channel indicates a steep slope on the left bank, but appears stable, depth and sand formations continue to fluctuate slightly but appear relatively stable, thalweg left of center.

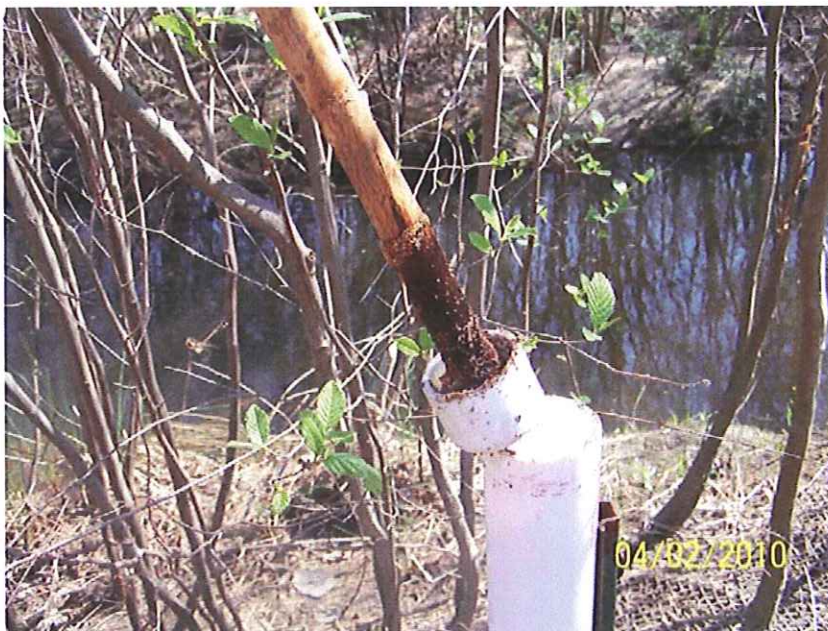
Most likely triggered on 3-29-2010

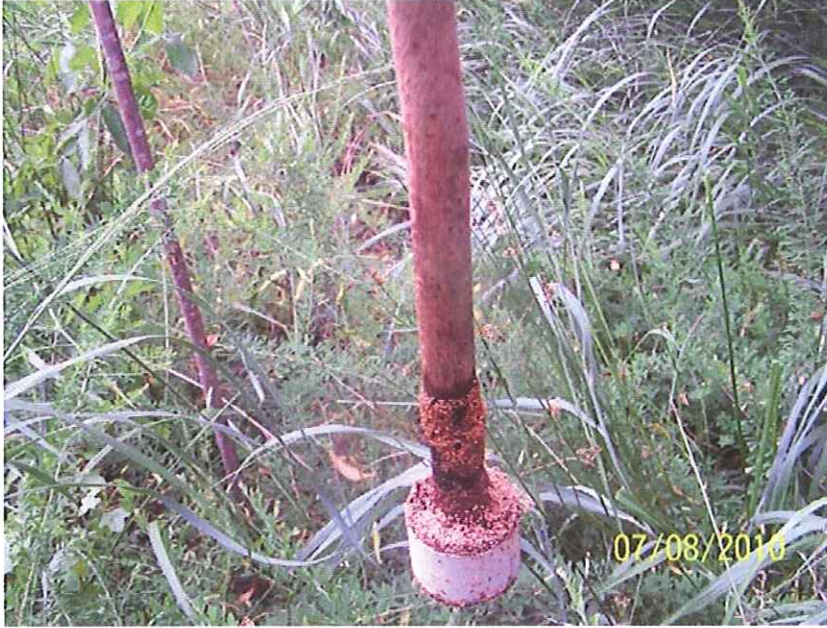
May have been Triggered on June 13th, 2010.
