FINAL
ANNUAL MONITORING REPORT
YEAR 1 (2012)
TATE FARM (RIPSHIN BRANCH)
STREAM/WETLAND RESTORATION SITE
ASHE COUNTY, NORTH CAROLINA
(EEP Project No. 372, Contract No. 004802)
Construction Completed December 2011

January 2013

Prepared by:
Axiom Environmental, Inc.
218 Snow Avenue
Raleigh, North Carolina 27603

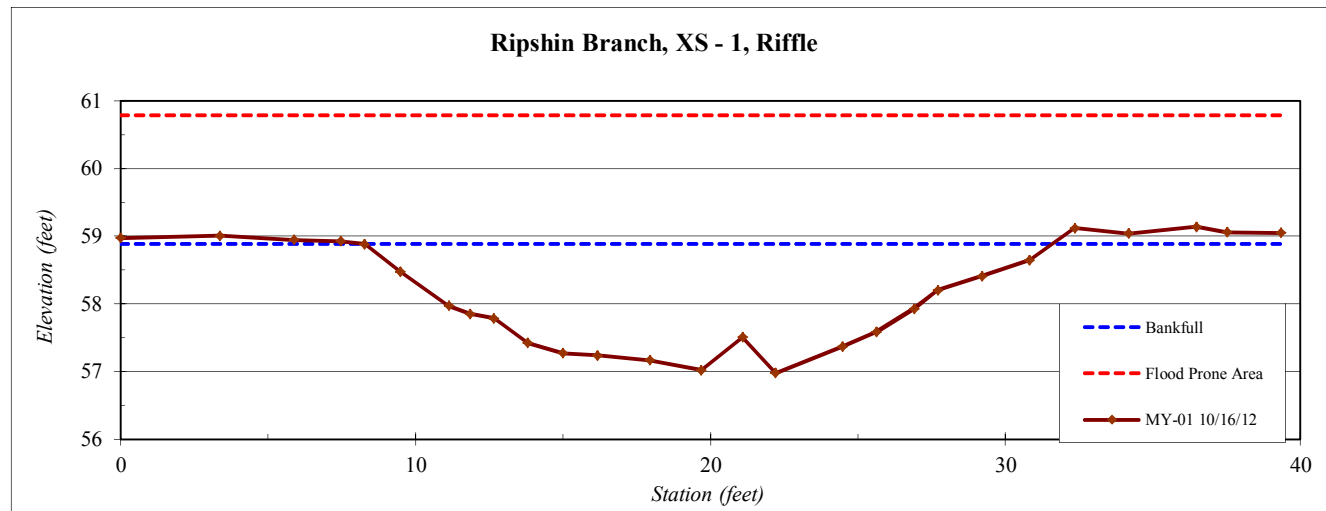
River Basin:	Upper New
Watershed:	Tate Farm
XS ID	XS - 1, Riffle
Drainage Area (sq mi):	1.6
Date:	10/16/2012
Field Crew:	Perkinson, Jernigan

SUMMARY DATA	
Bankfull Elevation:	58.9
Bankfull Cross-Sectional Area:	27.6
Bankfull Width:	23.4
Flood Prone Area Elevation:	60.8
Flood Prone Width:	>80
Max Depth at Bankfull:	1.9
Mean Depth at Bankfull:	1.2
W / D Ratio:	19.8
Entrenchment Ratio:	3.4
Bank Height Ratio:	1.0

Stream Type	B/C
--------------------	-----

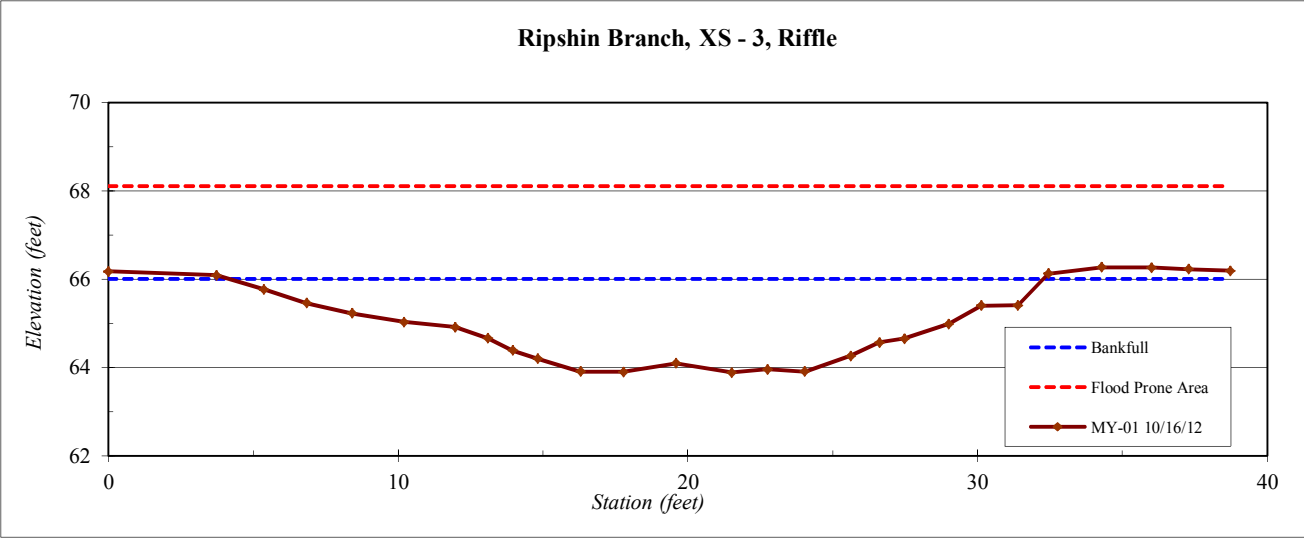
River Basin:	Upper New
Watershed:	Tate Farm
XS ID	XS - 3, Riffle
Drainage Area (sq mi):	1.6
Date:	10/16/2012
Field Crew:	Perkinson, Jernigan

SUMMARY DATA	
Bankfull Elevation:	66.0
Bankfull Cross-Sectional Area:	37.4
Bankfull Width:	28.1
Flood Prone Area Elevation:	68.1
Flood Prone Width:	>80
Max Depth at Bankfull:	2.1
Mean Depth at Bankfull:	1.3
W / D Ratio:	21.1
Entrenchment Ratio:	2.8
Bank Height Ratio:	1.0

Stream Type B/C

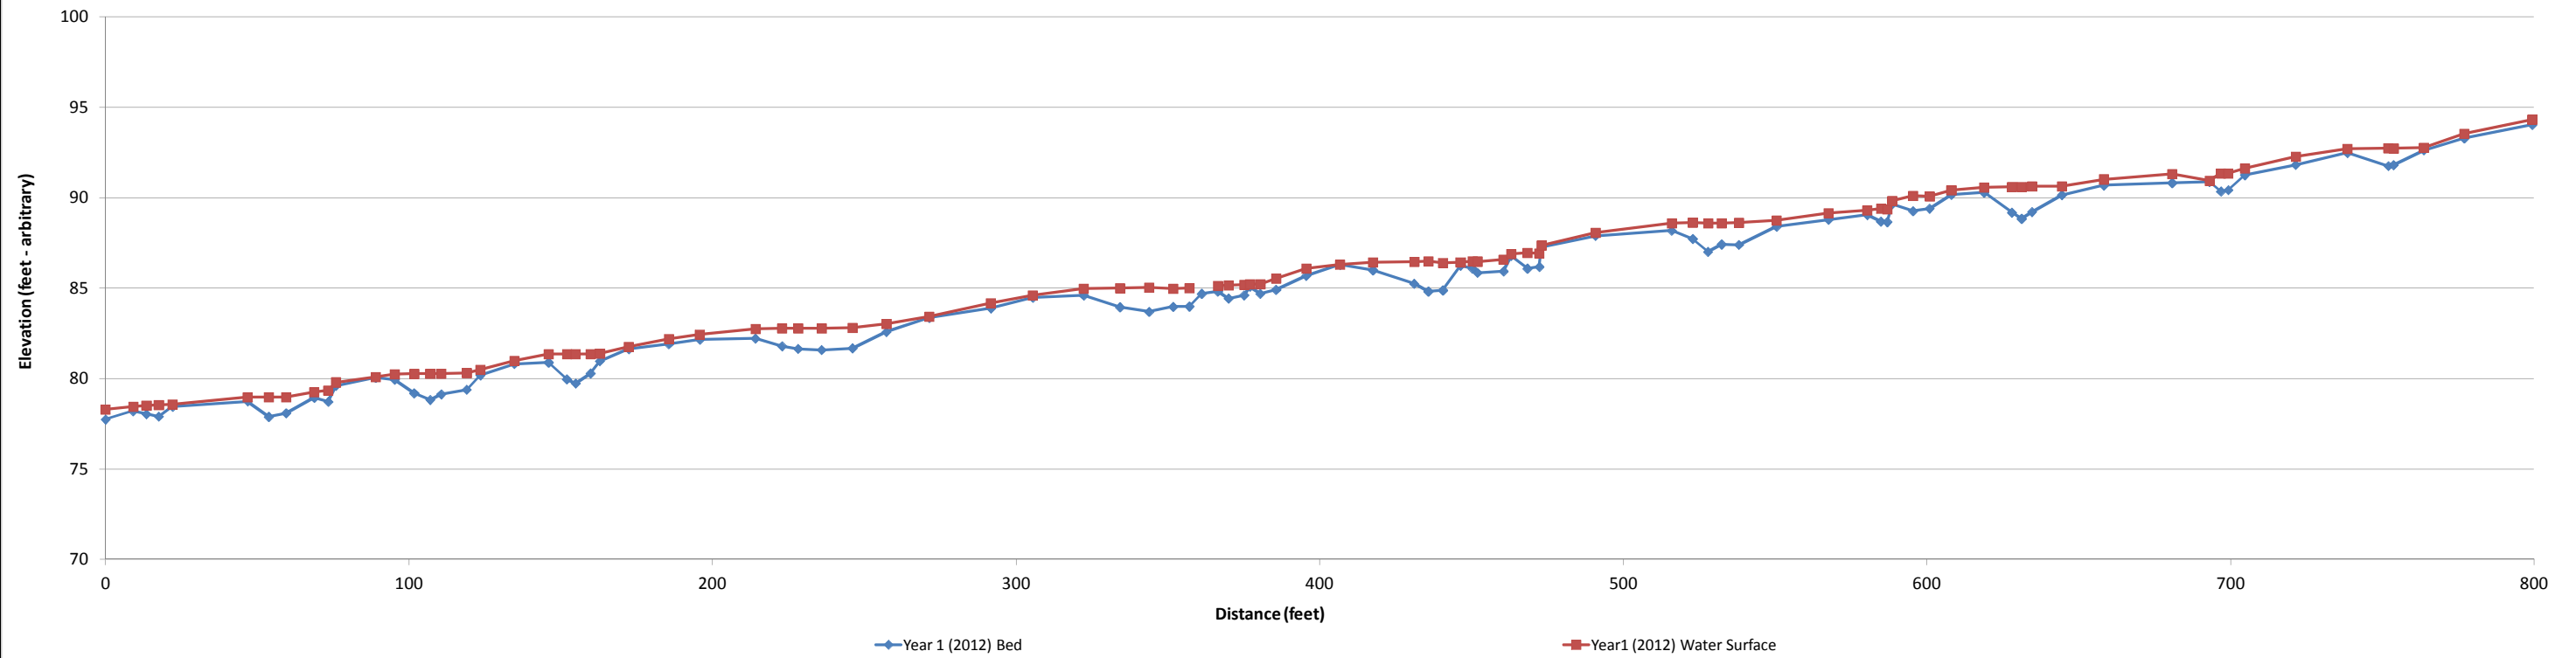
Tate Farm Year 1 (2012) Profile - Unnamed Tributary 00+00 to 08+00

2012	2013	2014	2015	2016
Avg. Water Surface Slope	0.0201				
Riffle Length	30				
Avg. Riffle Slope	0.0235				
Pool Length	21				
Pool to Pool Spacing	44.0

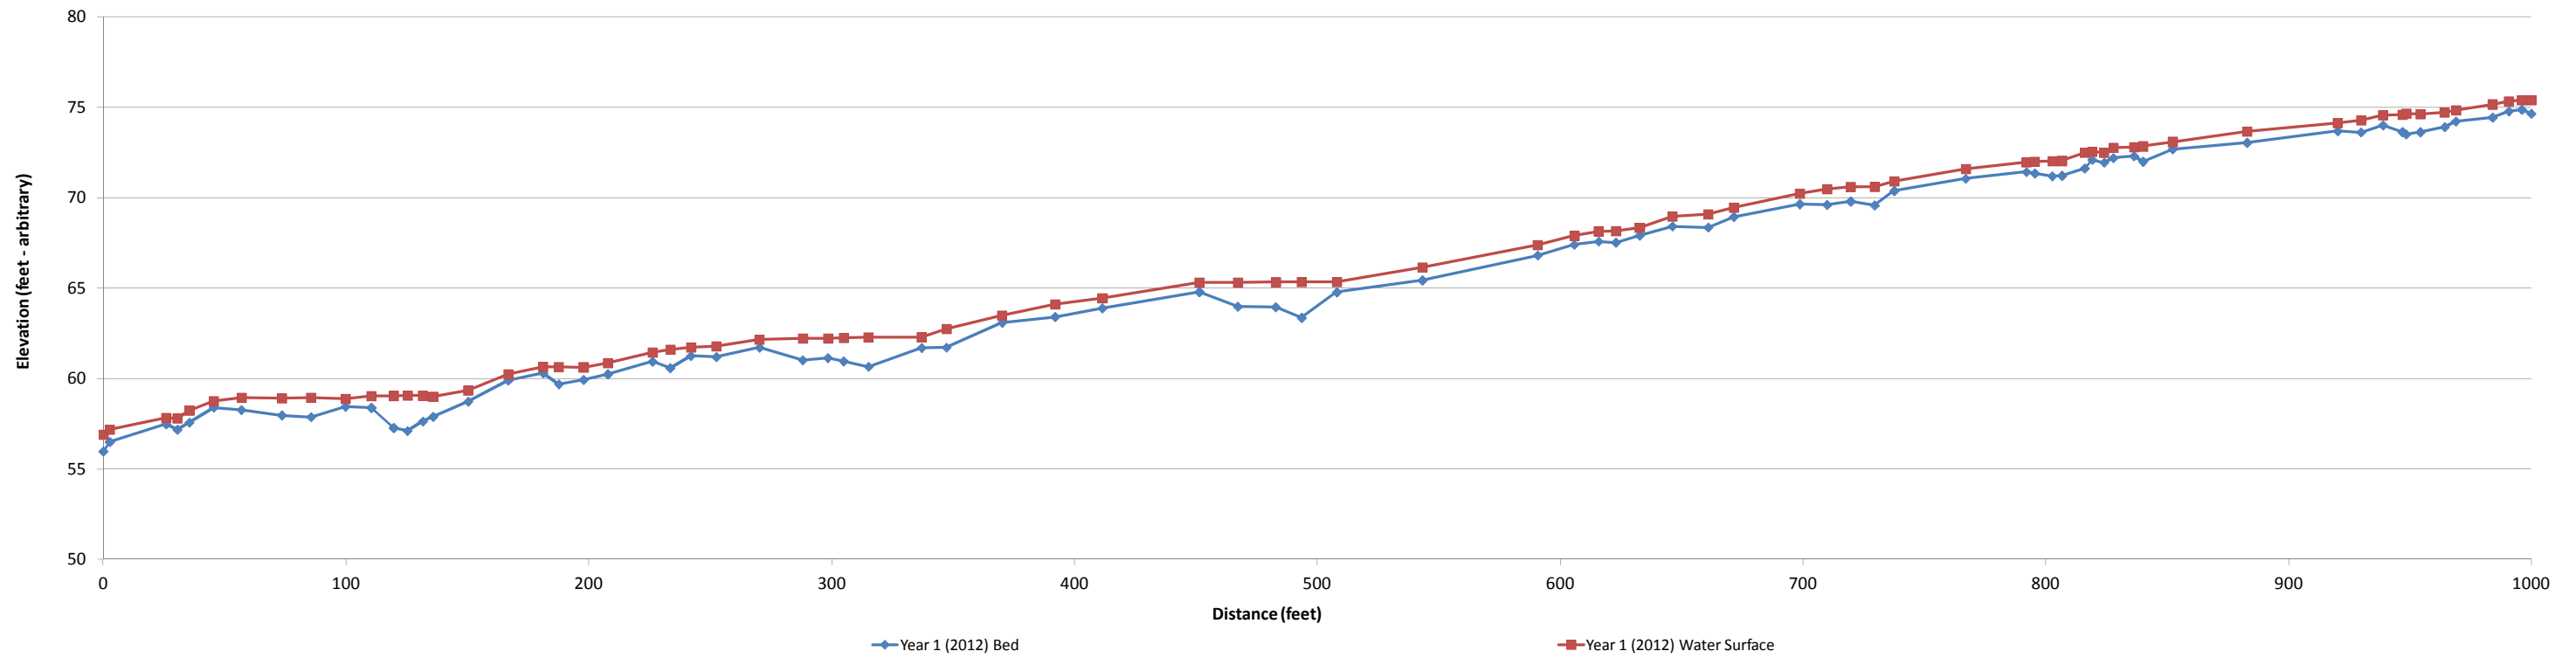
Tate Farm Year 1 (2012) Profile - Ripshin Branch 00+00 to 10+00

2012	2013	2014	2015	2016
Avg. Water Surface Slope	0.0182				
Riffle Length	35				
Avg. Riffle Slope	0.0247				
Pool Length	28				
Pool to Pool Spacing	55.0

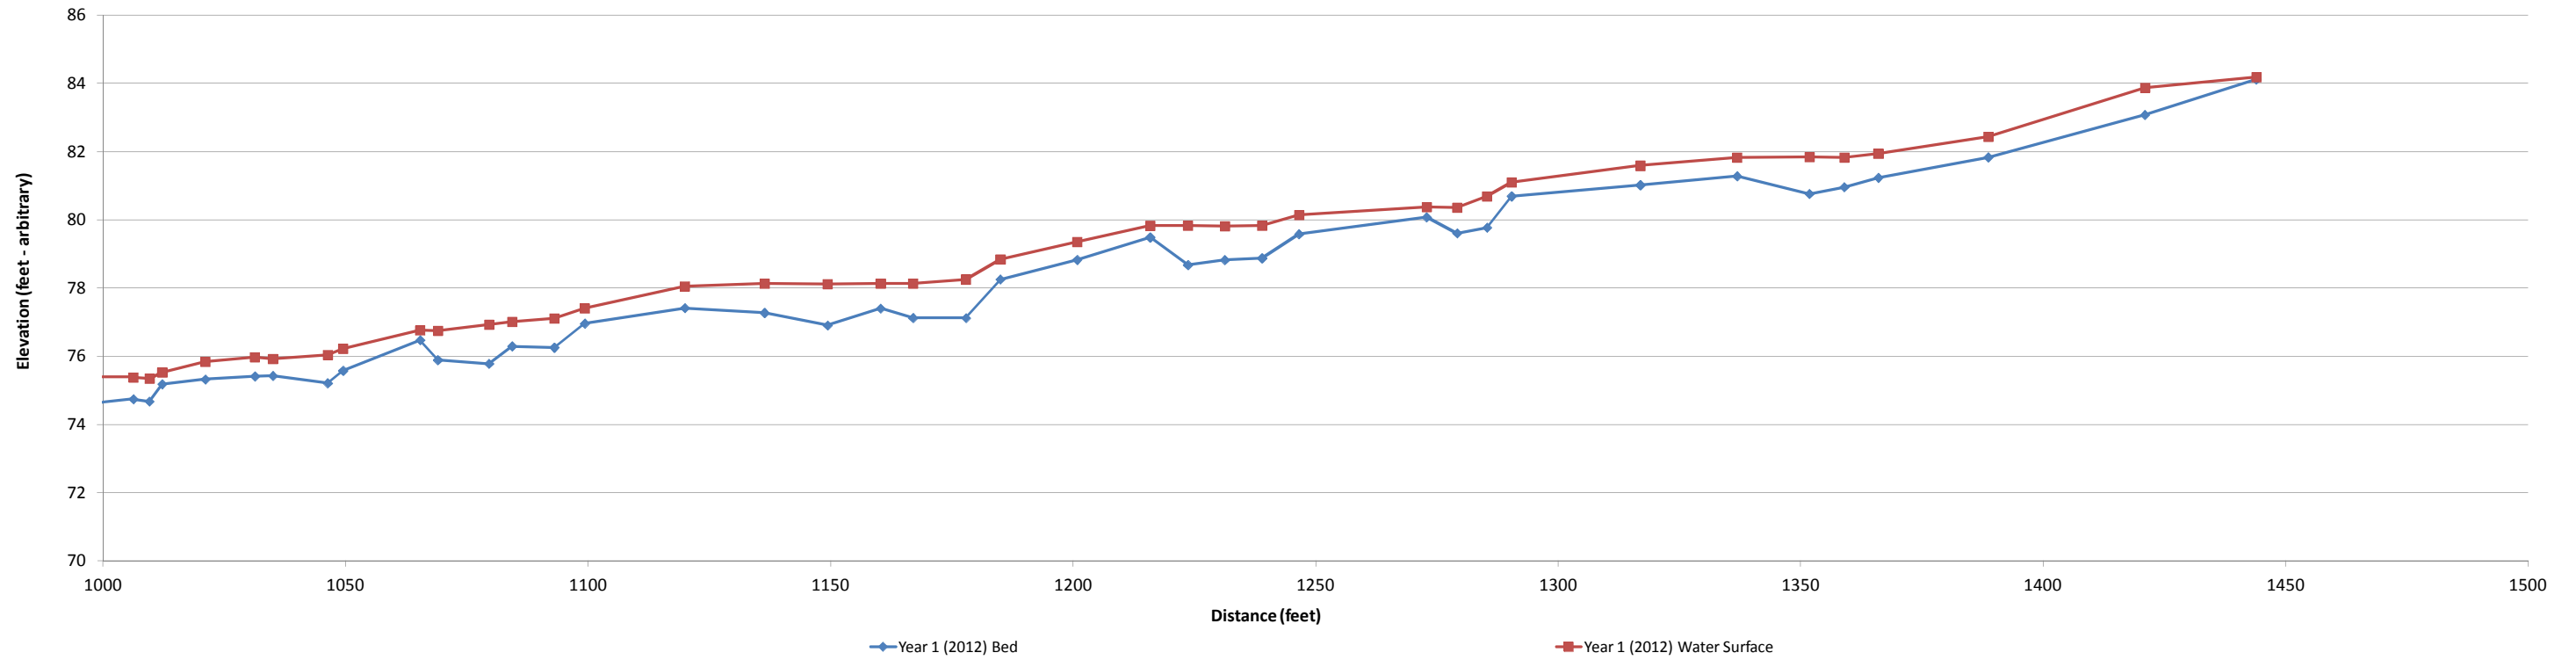
Tate Farm Year 1 (2012) Profile - Ripshin Branch 10+00 to 15+00

2012	2013	2014	2015	2016
Avg. Water Surface Slope	0.0182				
Riffle Length	35				
Avg. Riffle Slope	0.0247				
Pool Length	28				
Pool to Pool Spacing	55.0

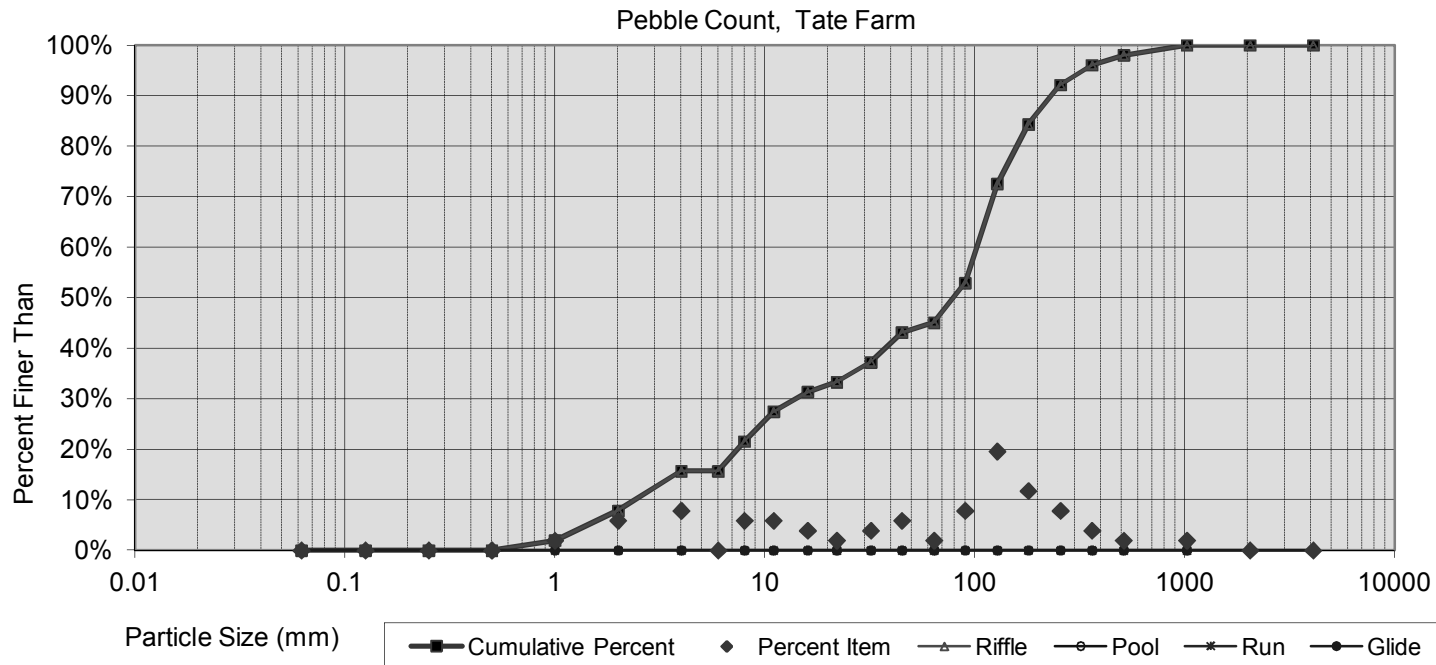
Note: **Cross Section 4 - Ripshin Branch**

Size percent less than (mm)					Percent by substrate type					
D16	D35	D50	D84	D95	silt/clay	sand	gravel	cobble	boulder	bedrock
6.093	25.80	79.2	178	329	0%	8%	37%	47%	8%	0%

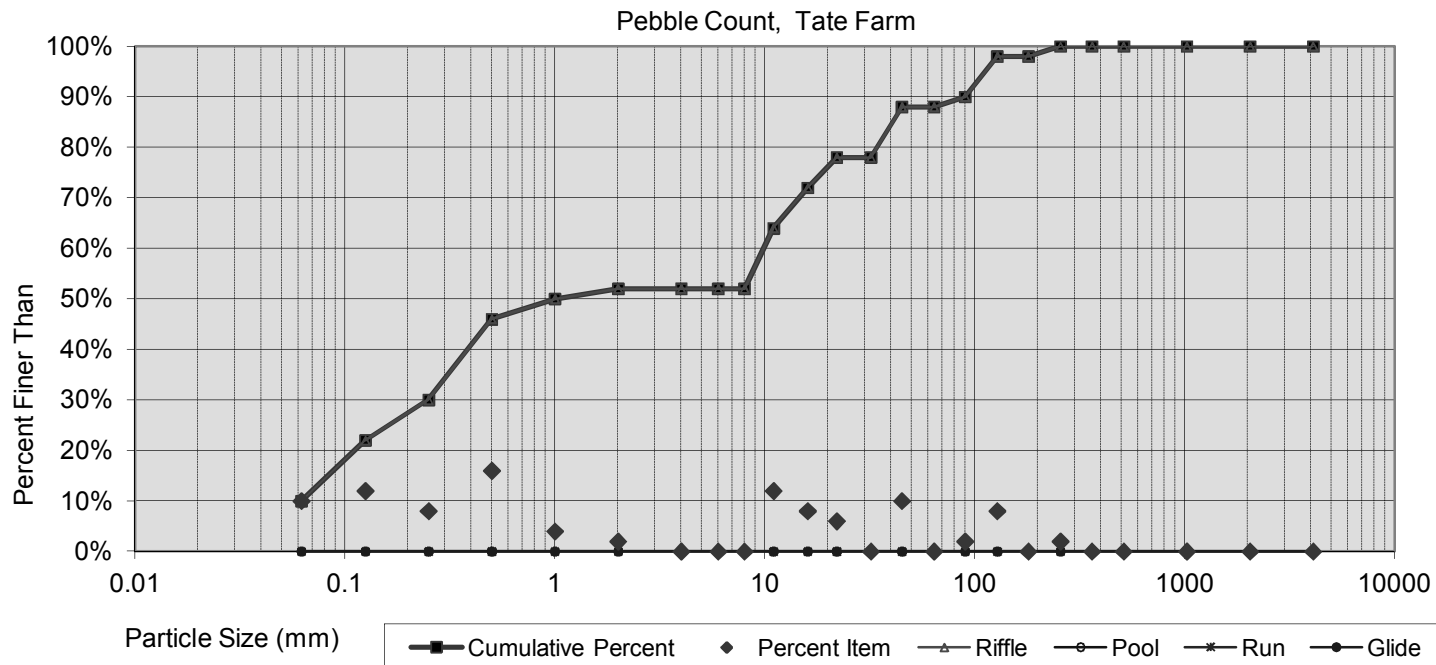
Note: **Cross Section 8 - Unnamed Tributary**

Size percent less than (mm)					Percent by substrate type					
D16	D35	D50	D84	D95	silt/clay	sand	gravel	cobble	boulder	bedrock
0.088	0.31	1.0	39	112	10%	42%	36%	12%	0%	0%
