FINAL
ANNUAL MONITORING REPORT
YEAR 3 (2014)
TATE FARM (RIPSHIN BRANCH)
STREAM/WETLAND RESTORATION SITE
ASHE COUNTY, NORTH CAROLINA
(EEP Project No. 372, Contract No. 004802)
Construction Completed December 2011

Prepared by:
Axiom Environmental, Inc.
218 Snow Avenue
Raleigh, North Carolina 27603

November 2014

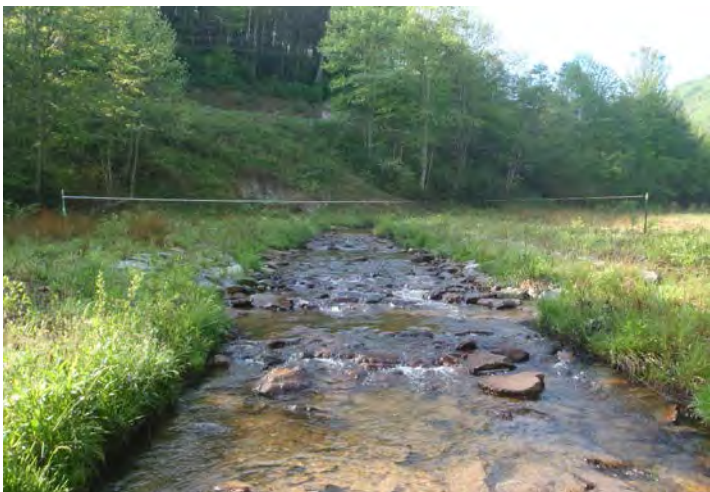
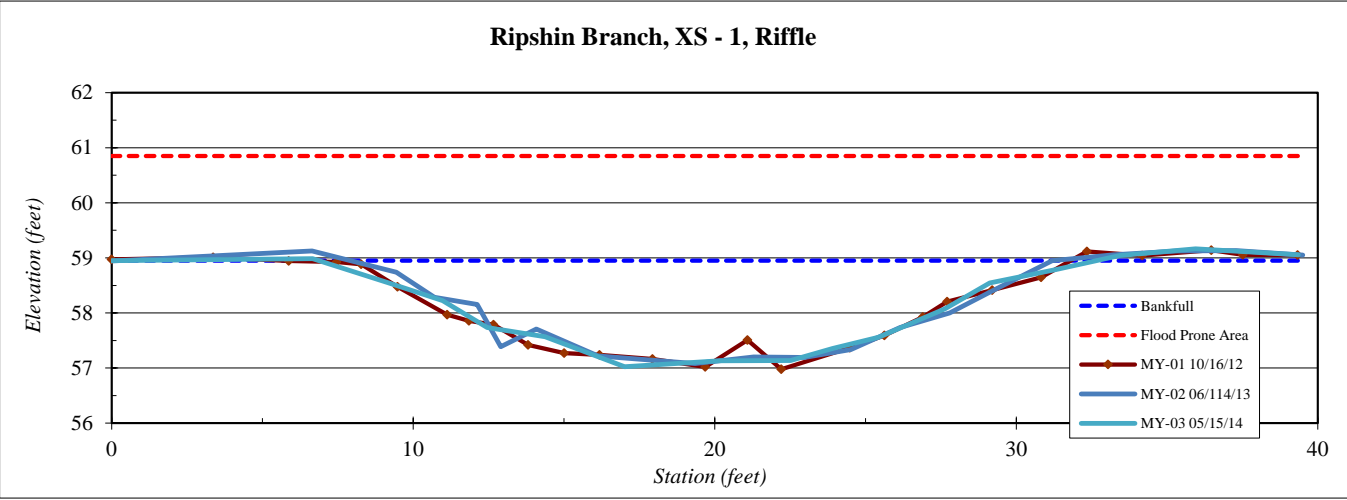
River Basin:	Upper New
Watershed:	Tate Farm
XS ID	XS - 1, Riffle
Drainage Area (sq mi):	1.6
Date:	5/15/2014
Field Crew:	Perkinson, Jernigan

SUMMARY DATA	
Bankfull Elevation:	59.0
Bankfull Cross-Sectional Area:	28.8
Bankfull Width:	25.8
Flood Prone Area Elevation:	60.9
Flood Prone Width:	>80
Max Depth at Bankfull:	1.9
Mean Depth at Bankfull:	1.1
W / D Ratio:	23.1
Entrenchment Ratio:	3.1
Bank Height Ratio:	1.0

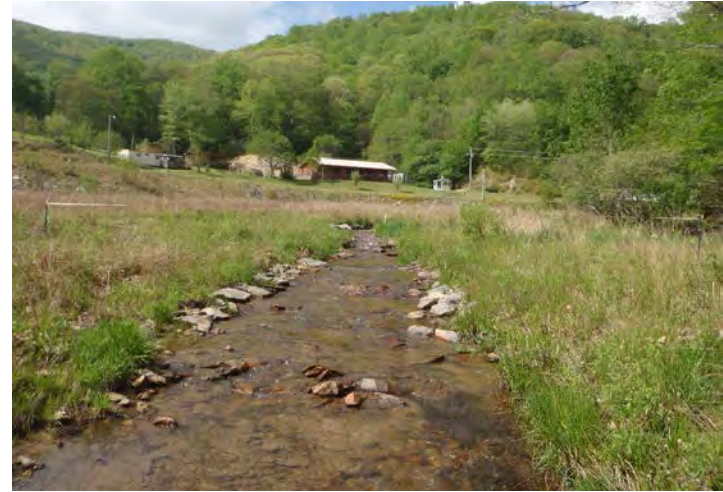
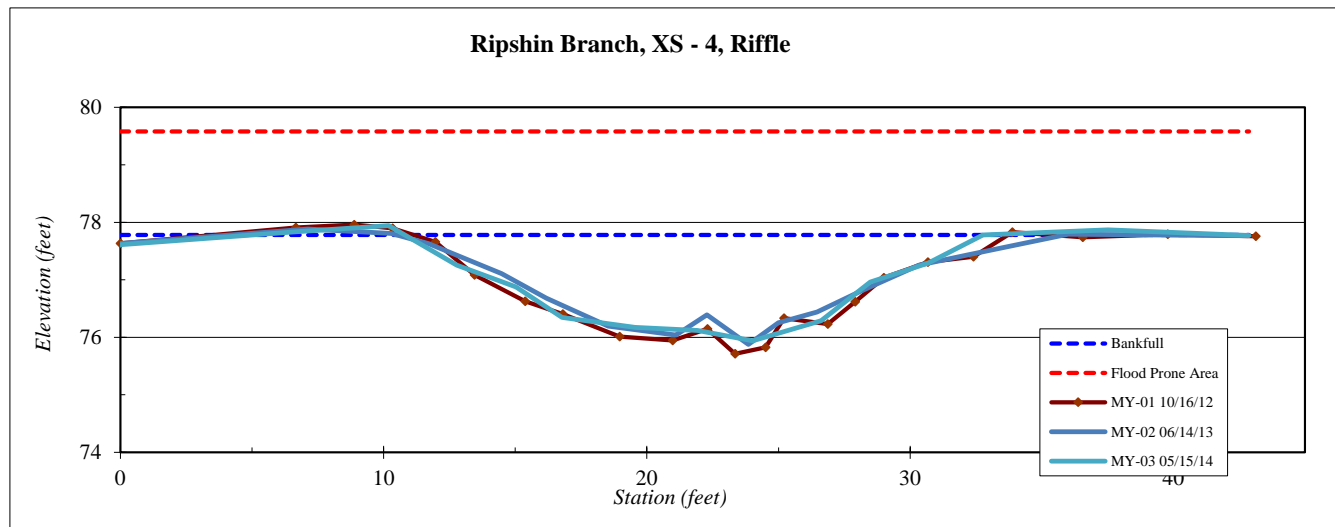
River Basin:	Upper New
Watershed:	Tate Farm
XS ID	XS - 4, Riffle
Drainage Area (sq mi):	1.6
Date:	5/15/2014
Field Crew:	Perkinson, Jernigan

SUMMARY DATA	
Bankfull Elevation:	77.8
Bankfull Cross-Sectional Area:	24.4
Bankfull Width:	22.0
Flood Prone Area Elevation:	79.6
Flood Prone Width:	>80
Max Depth at Bankfull:	1.8
Mean Depth at Bankfull:	1.1
W / D Ratio:	19.8
Entrenchment Ratio:	3.6
Bank Height Ratio:	1.0

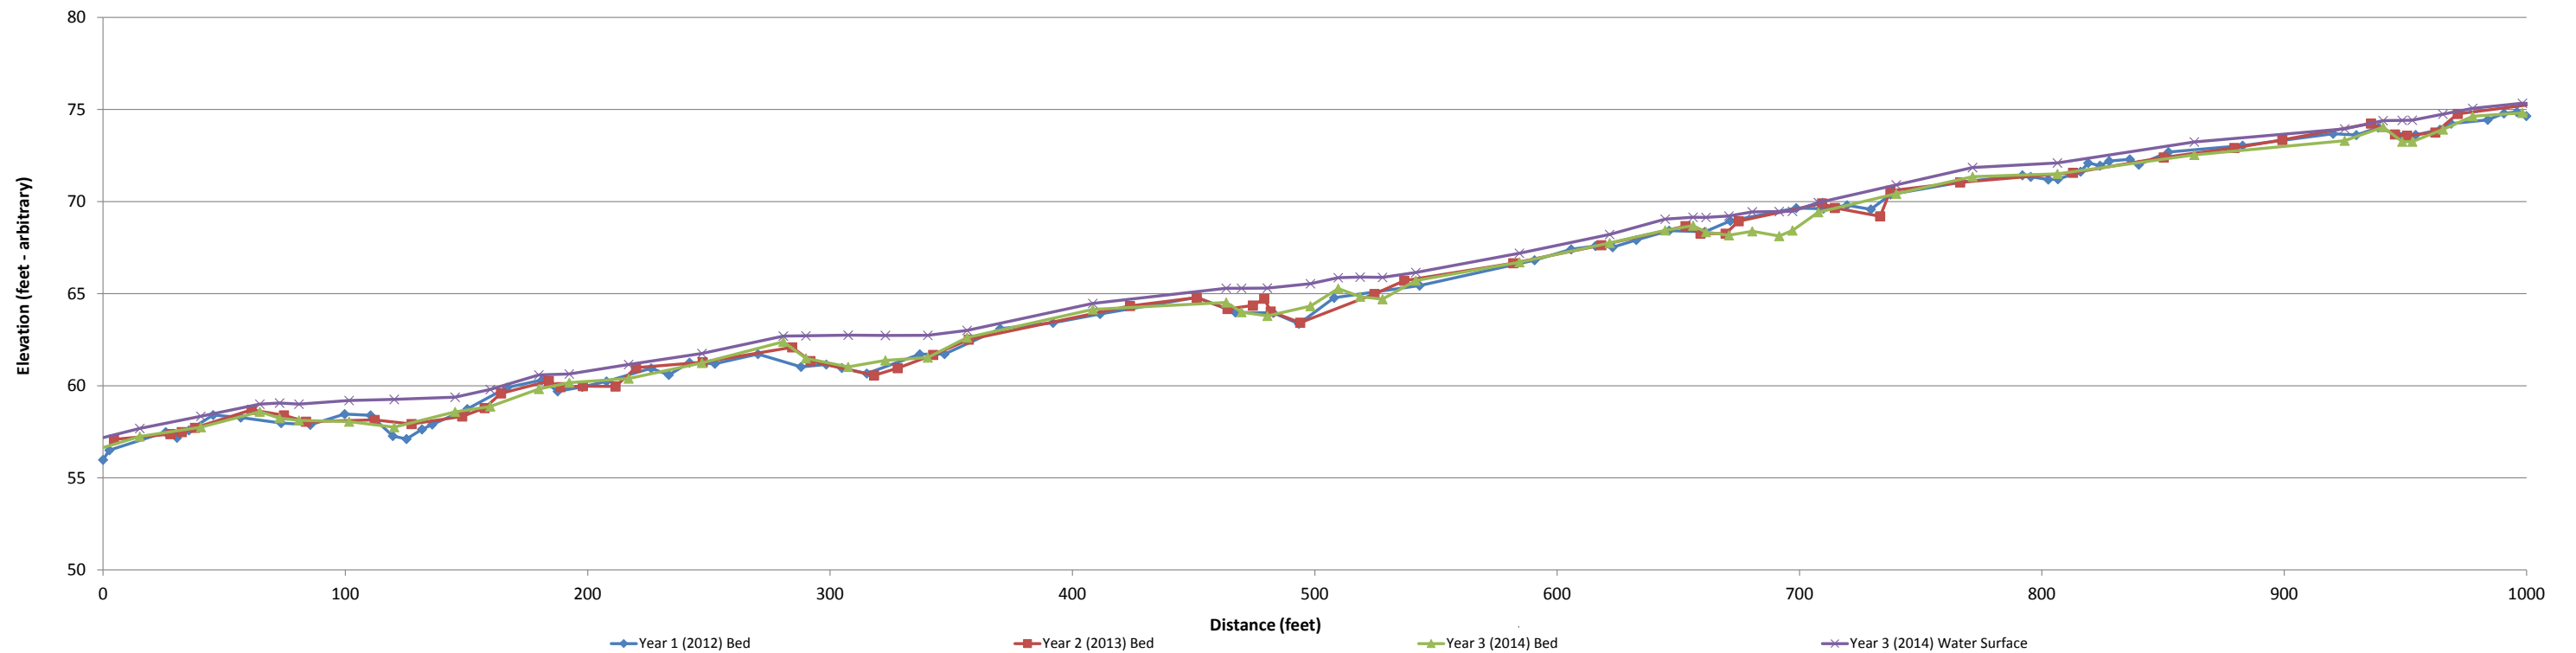
Tate Farm Year 3 (2014) Profile - Ripshin Branch 00+00 to 10+00

2012	2013	2014	2015	2016
Avg. Water Surface Slope	0.0182	0.0189	0.0191		
Riffle Length	35	33	53		
Avg. Riffle Slope	0.0247	0.0228	0.0224		
Pool Length	28	28	43		
Pool to Pool Spacing	55	66	88

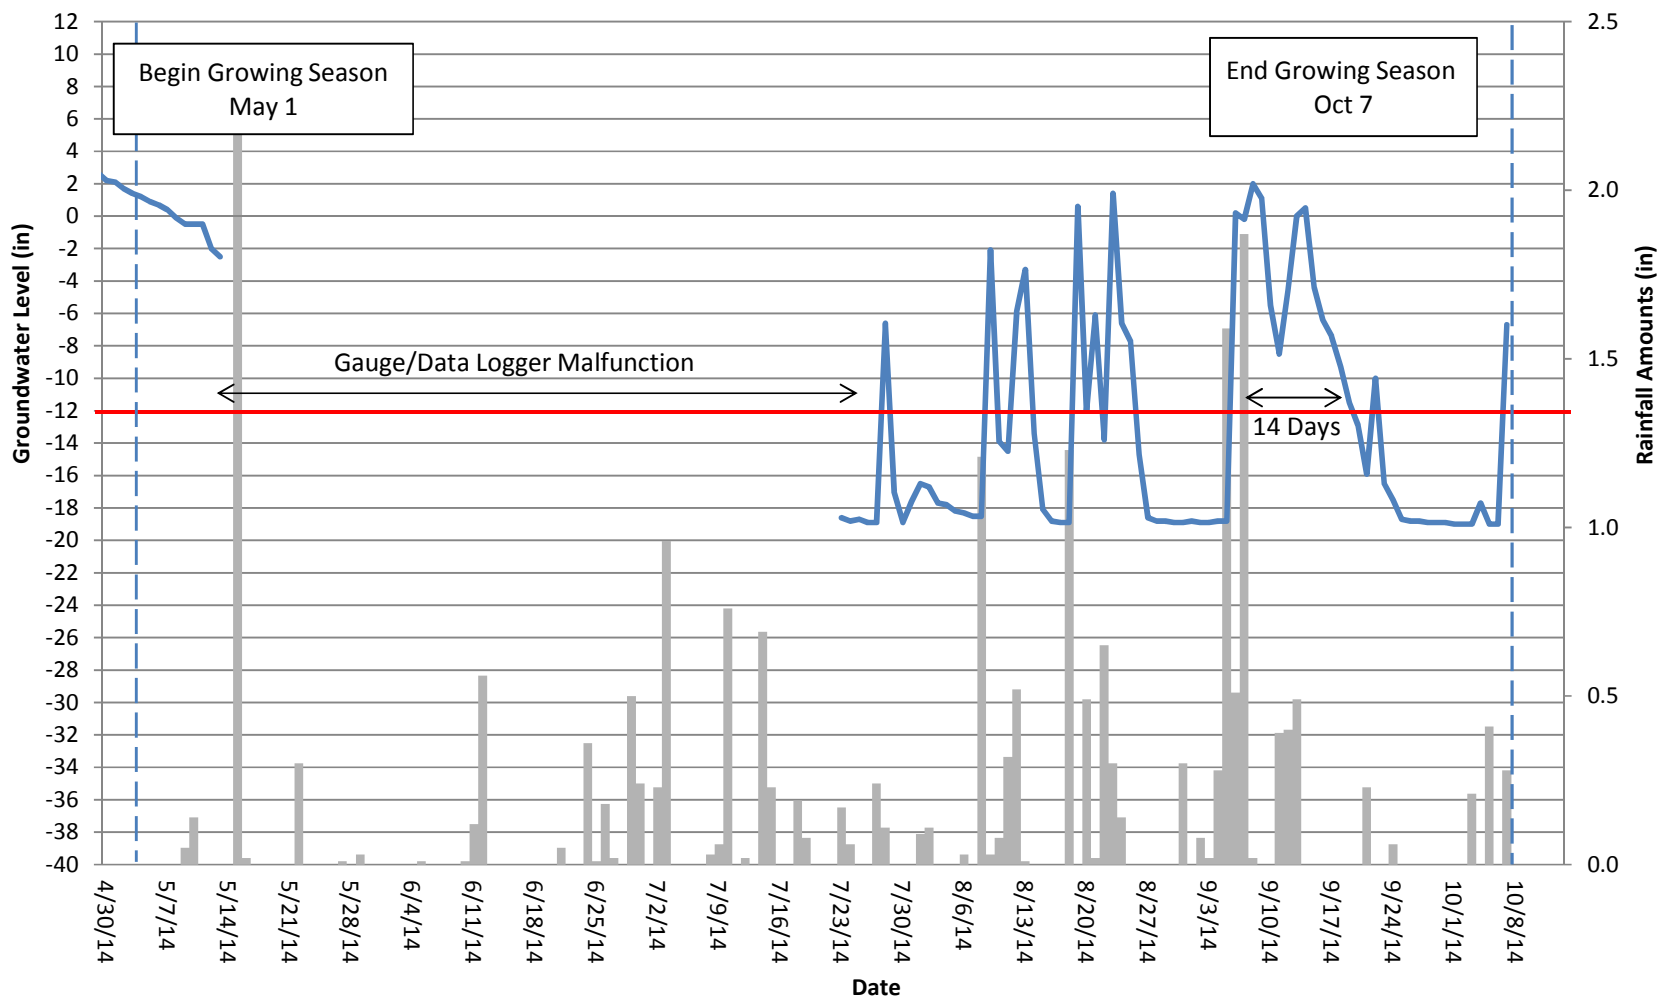
Tate Farm Groundwater Gauge 4 Year 3 (2014 Data)

**Gauge 4 malfunctioned at beginning of 2014 growing season resulting in loss of data. A battery failure at the beginning of the growing season resulted in a loss of data. The gauge was replaced and is currently functioning properly, but during a subsequent visit additional data was lost due to a failed Meazura PDA. Based on hydrology of the additional gauges, in addition to abundant precipitation, it is likely that Gauge 4 would have met success for year 3 (2014).
