FINAL
ANNUAL MONITORING REPORT
YEAR 4 (2015)
TATE FARM (RIPSHIN BRANCH)
STREAM/WETLAND RESTORATION SITE
ASHE COUNTY, NORTH CAROLINA
(DMS Project No. 372, Contract No. 004802)
Construction Completed December 2011

December 2015

Prepared by:
Axiom Environmental, Inc.
218 Snow Avenue
Raleigh, North Carolina 27603

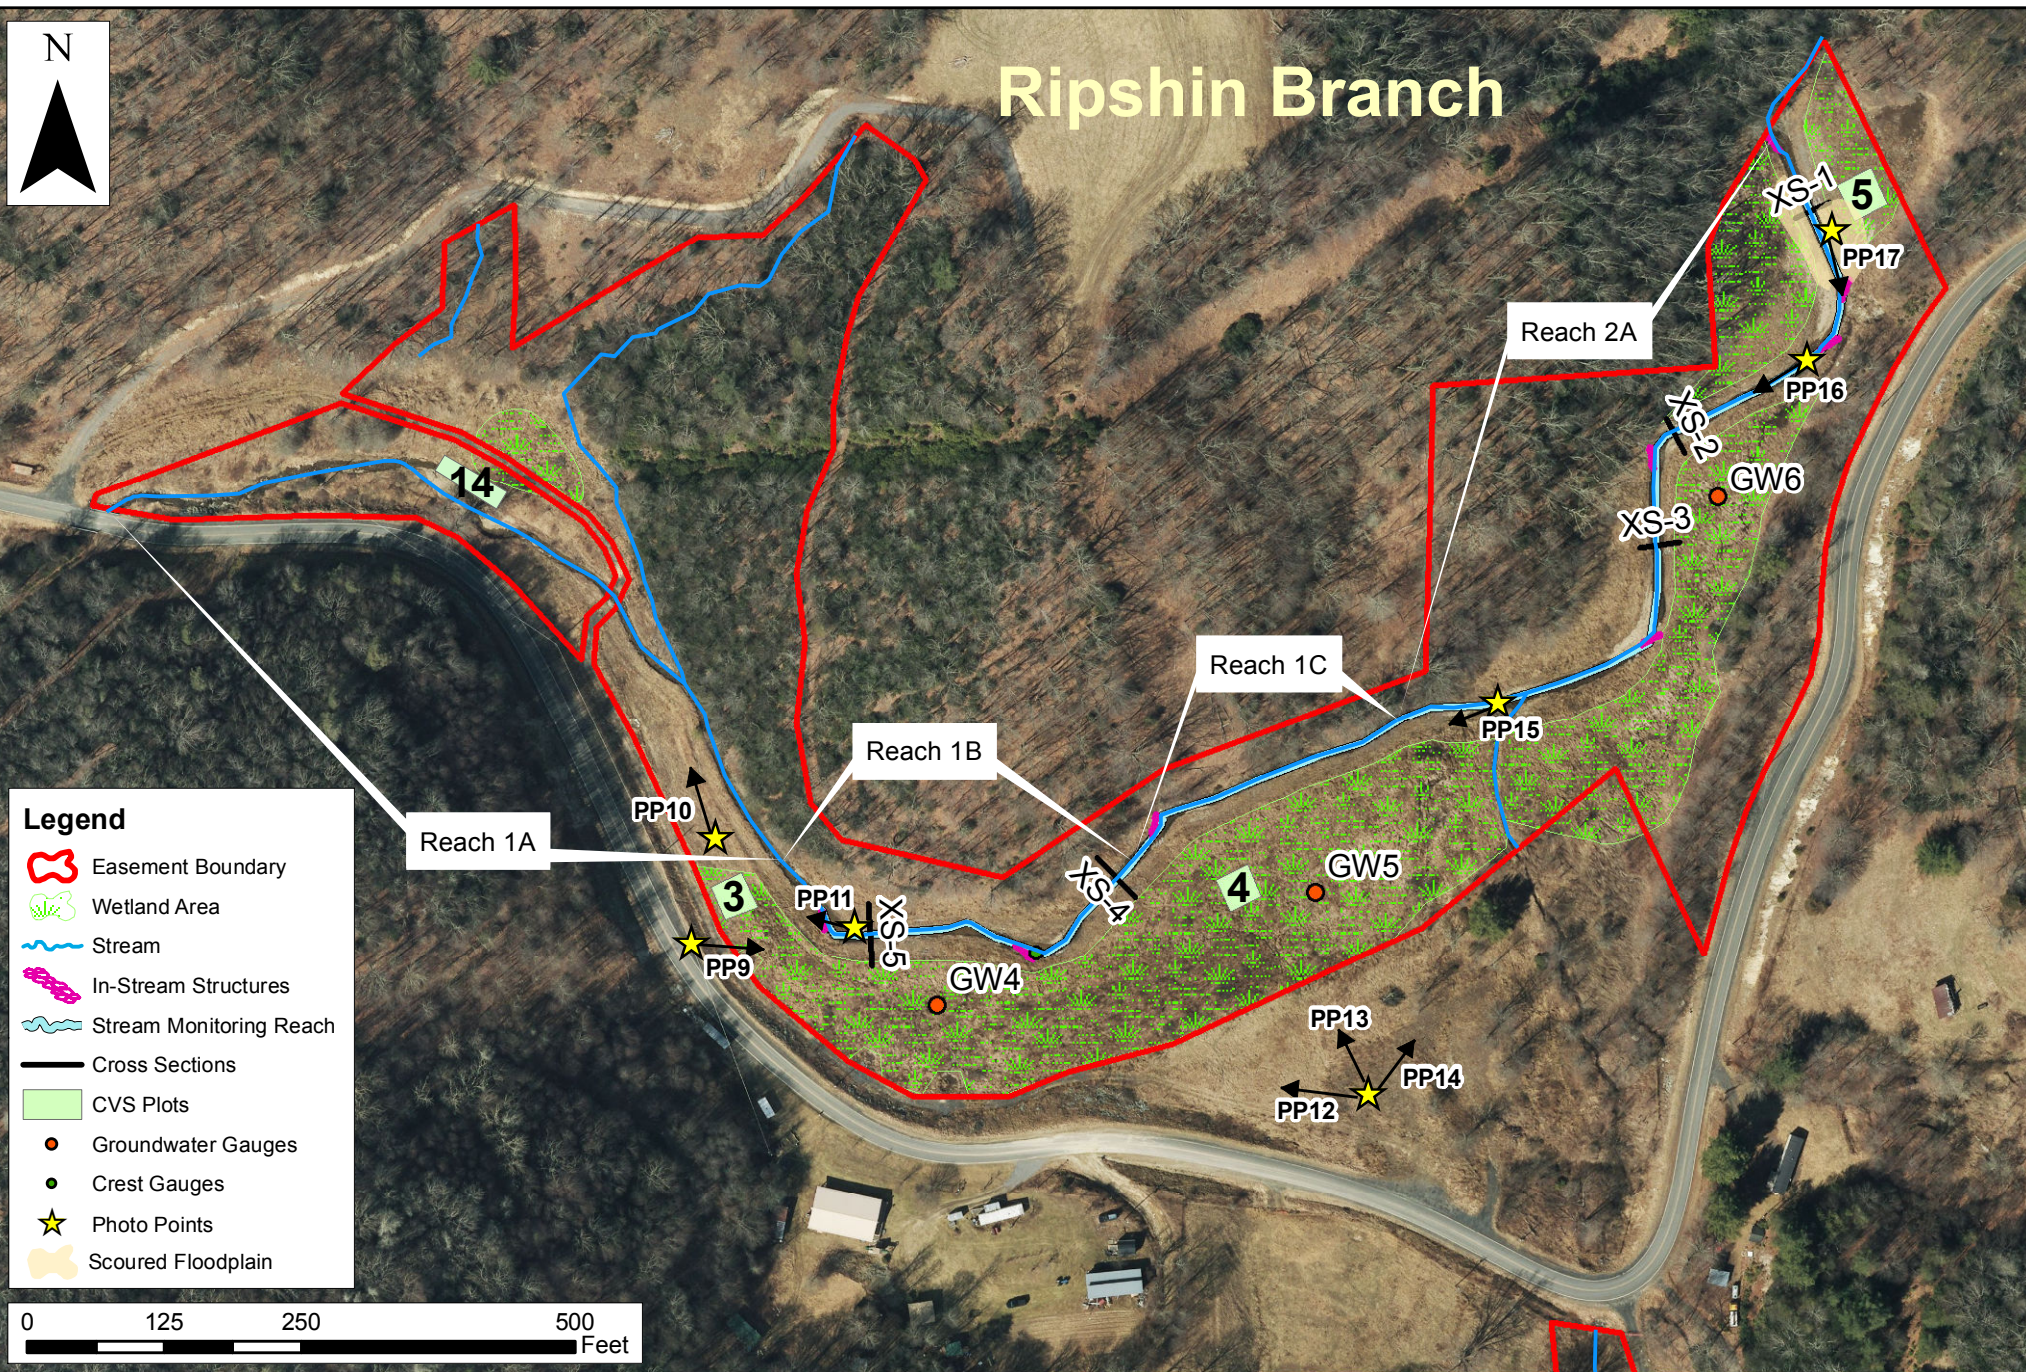
FIGURE
2B

In addition to low stem densities, one vegetation area of concern was noted at the beginning of 2013. An overbank event scoured the floodplain and deposited gravel and silt along both banks at the downstream end of Ripshin Branch near Vegetation Plot 5, and a number of planted stems were buried by debris and sediment. This area appears to have stabilized, with woody stems and herbaceous vegetation reestablishing. However, this area continues to scour during high stream flows and is characterized by poorly developed rocky soils.
