FINAL
ANNUAL MONITORING REPORT
YEAR 5 (2016)
TATE FARM (RIPSHIN BRANCH)
STREAM/WETLAND RESTORATION SITE
ASHE COUNTY, NORTH CAROLINA
(DMS Project No. 372, Contract No. 004802)
Construction Completed December 2011

December 2016

Prepared by:
Axiom Environmental, Inc.
218 Snow Avenue
Raleigh, North Carolina 27603

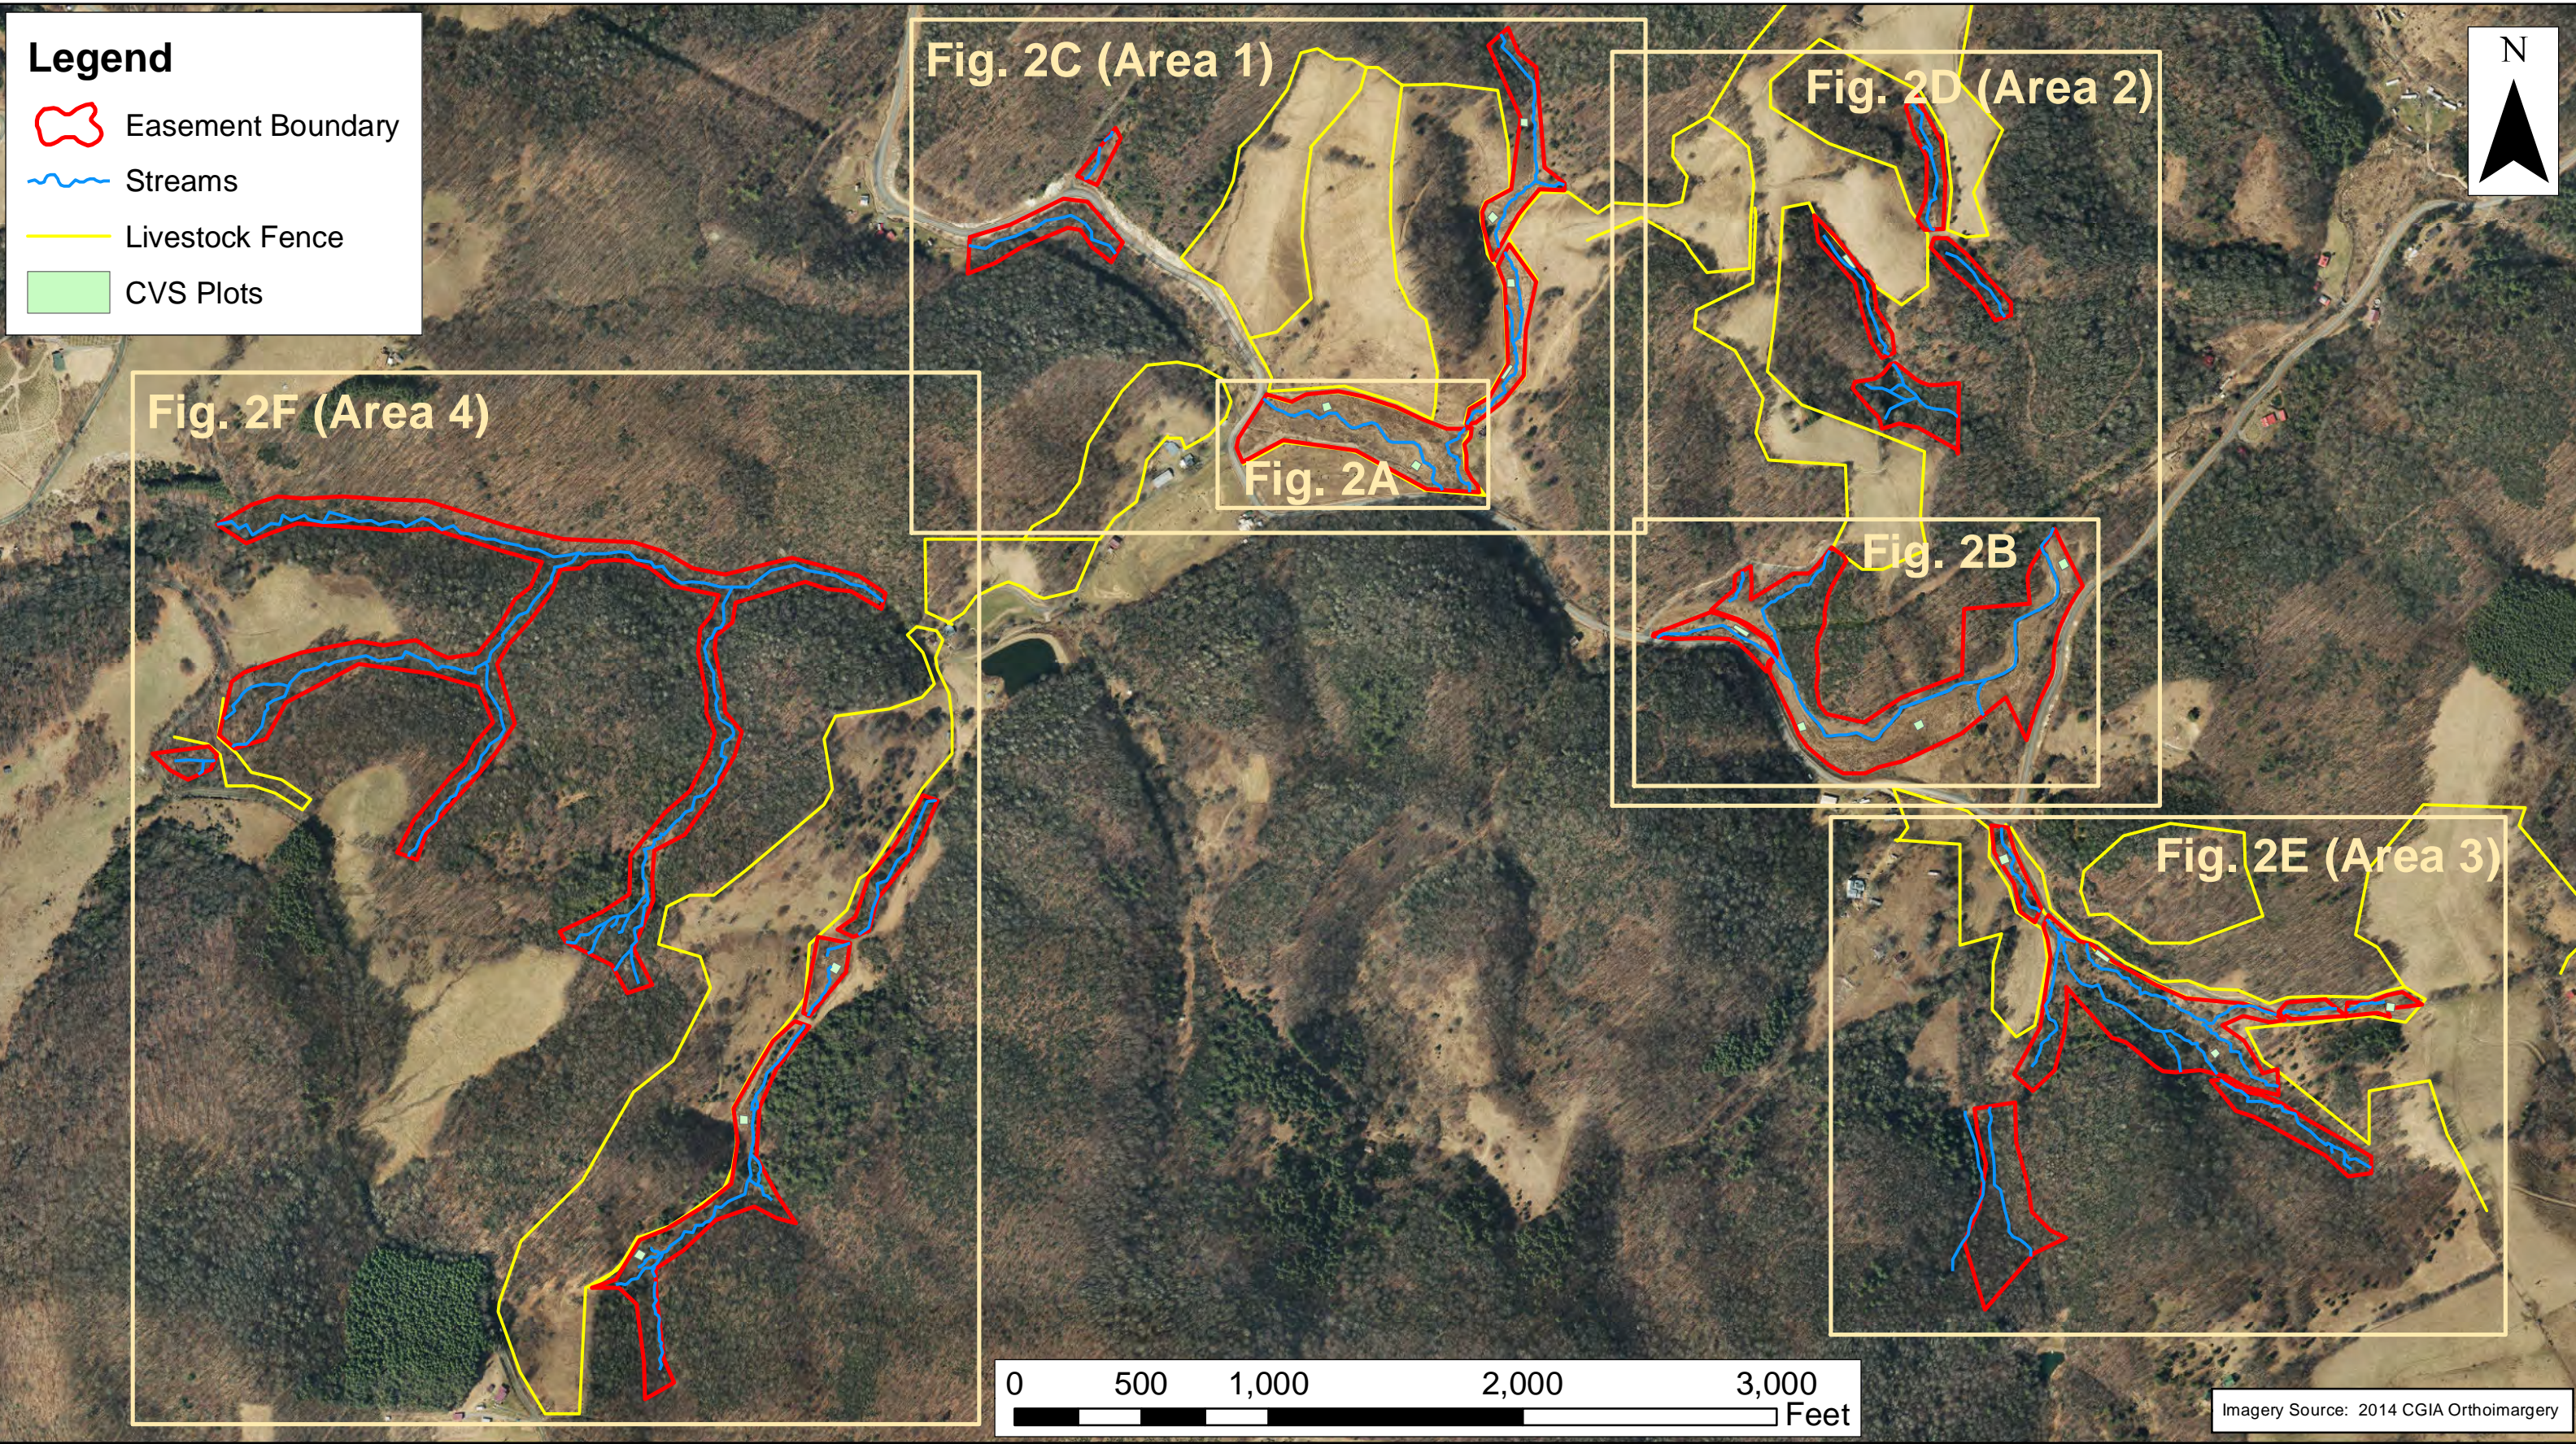
FIGURE
2

A visual assessment and geomorphic survey were completed for the Site. The visual assessment indicated that project reaches were performing within established success criteria ranges as shown below. During a 2013 heavy, summer rain event, a boulder was dislodged in a right bank structure in the lower portion of Ripshin Branch. The boulder has since been stabilized by dense herbaceous vegetation and is no longer dislodged; it has remained stable during year 5 (2016).
