**ANNUAL MONITORING REPORT
YEAR 6 (2017)
TATE FARM (RIPSHIN BRANCH)
STREAM/WETLAND RESTORATION SITE
ASHE COUNTY, NORTH CAROLINA
(DMS Project No. 372, Contract No. 004802)
Construction Completed December 2011**

May 2018

Prepared by:
Axiom Environmental, Inc.
218 Snow Avenue
Raleigh, North Carolina 27603

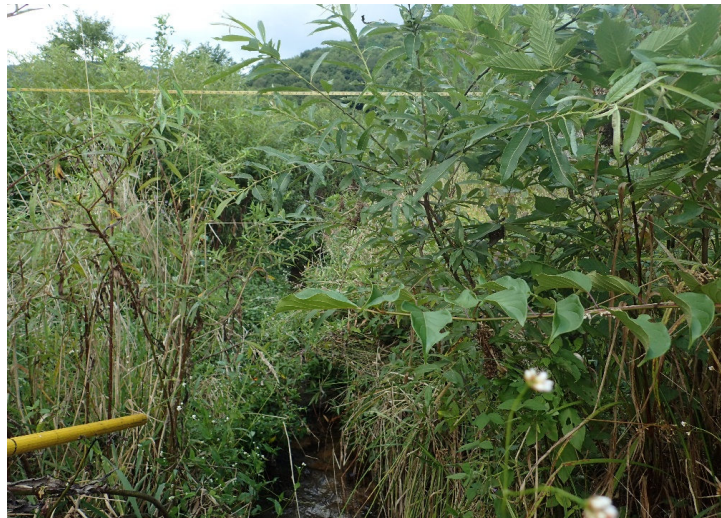
Unnamed Tributary, XS - 8, Riffle

Over the course of the project, cross-section 8 on the Unnamed Tributary exhibited some thalweg movement. This was documented in the annual cross-section data as well as photographs. Prior to year 1 (2012) a gravel bar formed in the riffle at cross-section 8. Several high energy flow events during years 2 (2013) and 3 (2014) pushed much of this gravel downstream. This resulted in the thalweg migrating to the left bank of the stream and becoming slightly scoured at cross-section 8. The sediment was transported downstream and deposited in pools, which is captured in the cross-section 7 data. Though slight changes were observed in the cross-sectional area and thalweg position of these cross-sections, the channel movement is natural and does not indicate instability.
