SECTION I. MITIGATION REPORT
TERRIBLE CREEK BUFFER RESTORATION
WAKE COUNTY, NORTH CAROLINA

(SCO Project Number 050667901)
NEUSE RIVER BASIN
CATALOGING UNIT 03020201

June 2008

Axiom Environmental, Inc.
2126 **Rowland** Pond Drive
Willow Springs, North Carolina 27592
(919) 215-1693 (phone)
(919) 341-3839 (fax)
Project Manager: Grant Lewis

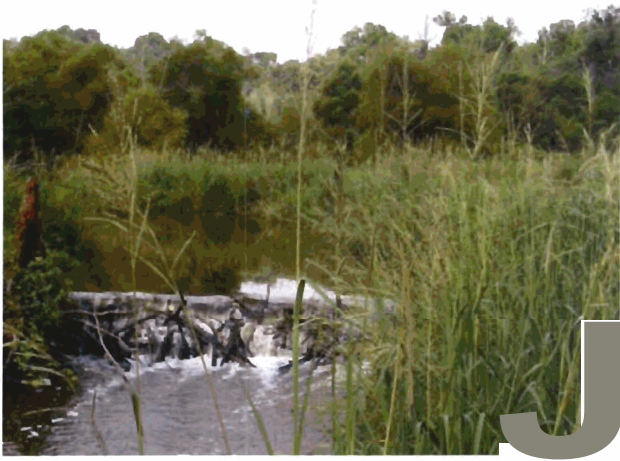
Outer Bend #1 - Looking Upstream
at beaver dam.
(Low Erosion)

| Outer Bend | Extent of Erosion Preconstruction | Treatment to be Installed |
|---|--|---|
| 1 | Low | Outside of easement, no treatment recommended |

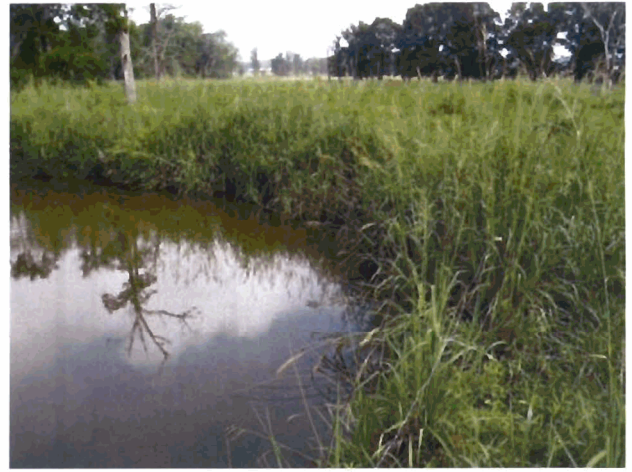
Outer Bend #2 - looking upstream
approximately **150** feet upstream from beaver dam.
(Low Erosion)

| Outer Bend | Extent of Erosion Preconstruction | Treatment to be Installed |
|---|--|---|
| 2 | Low | Outside of easement, no treatment recommended |

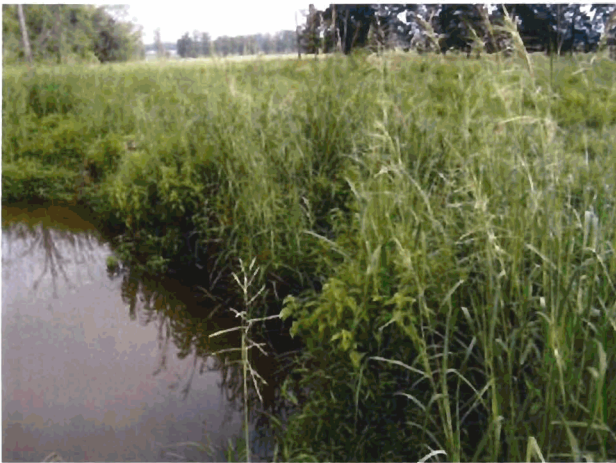
Outer Bend #3 - Looking Upstream
approximately **400** ft upstream from beaver dam,
still in impounded reach.
(Low Erosion)

| Outer Bend | Extent of Erosion Preconstruction | Treatment to be Installed |
|---|--|---|
| 3 | Low | Outside of easement, no treatment recommended |

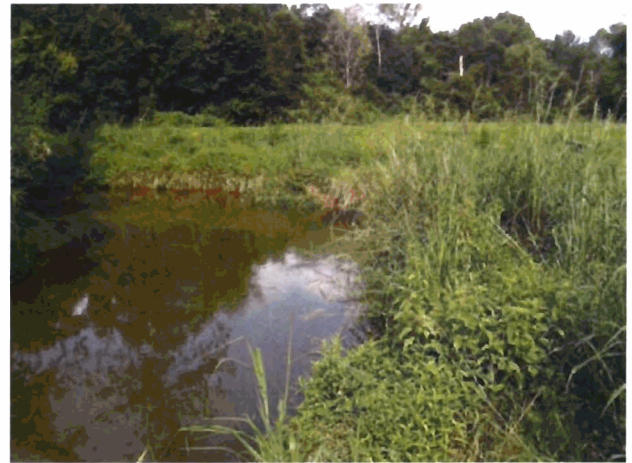
Outer Bend #4 - Looking Upstream
approximately **500** ft upstream from beaver dam,
still in impounded reach.
(Moderate Erosion)

| Outer Bend | Extent of Erosion Preconstruction | Treatment to be Installed |
|---|--|---|
| 4 | Moderate | Leave as is |

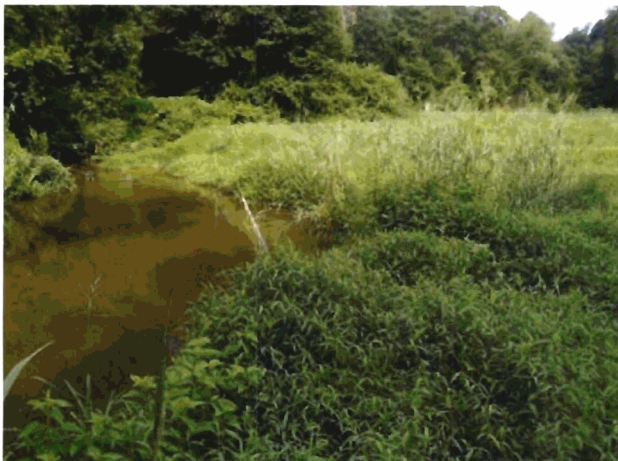
Outer Bend #5 - Looking Upstream
a bend with a larger radius.
(Low Erosion)

| Outer Bend | Extent of Erosion Preconstruction | Treatment to be Installed |
|---|--|---|
| 5 | Low | Leave as is |

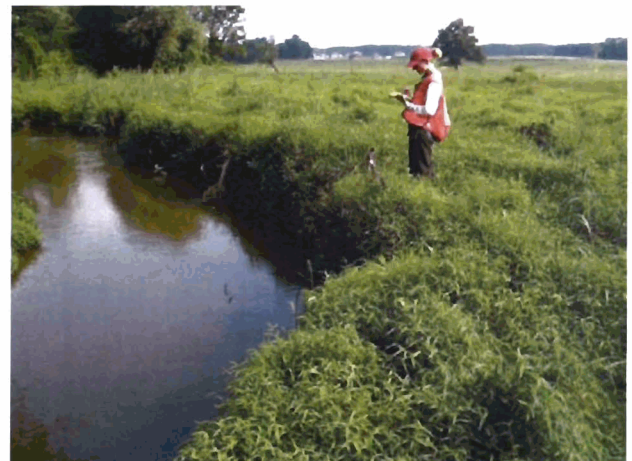
Outer Bend #6 - Looking Upstream
in a double outer bend.
(Moderate Erosion)

| Outer Bend | Extent of Erosion Preconstruction | Treatment to be Installed |
|---|--|---|
| 6 | Moderate | Live stake with erosion control matting |

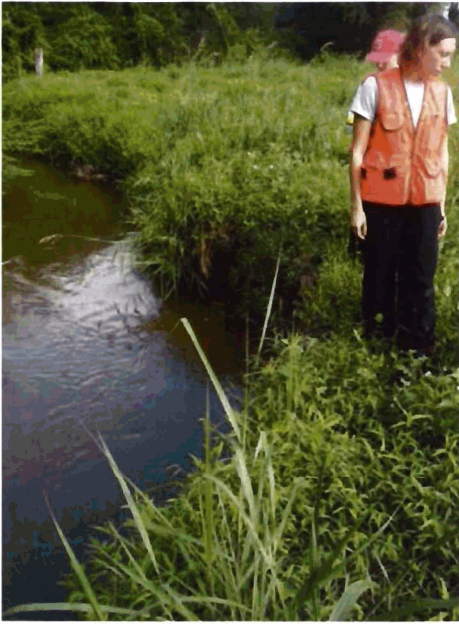
Outer Bend #7 - Looking Upstream
Privet on opposite bank may causing
erosion on Site bank.
(Moderate Erosion)

| Outer Bend | Extent of Erosion Preconstruction | Treatment to be Installed |
|---|--|---|
| 7 | Moderate | Brush mattress |

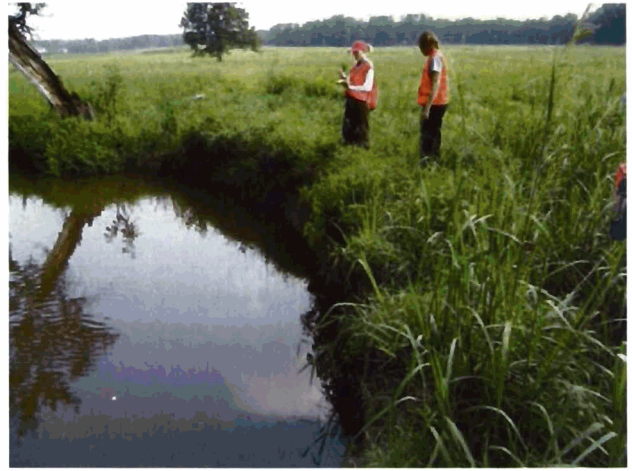
Outer Bend #8 - Looking Upstream
(Severe Erosion)

| Outer Bend | Extent of Erosion Preconstruction | Treatment to be Installed |
|---|--|---|
| 8 | Severe | Live stake with erosion control matting |

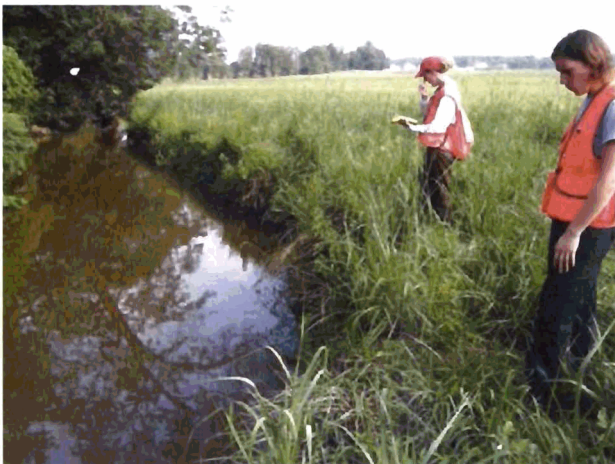
Outer Bend #9 - Looking Upstream
at outer bend in a straight, immediately
upstream from a tight radius.
(Moderate Erosion)

| Outer Bend | Extent of Erosion Preconstruction | Treatment to be Installed |
|---|--|---|
| 9 | Moderate | Brush mattress |

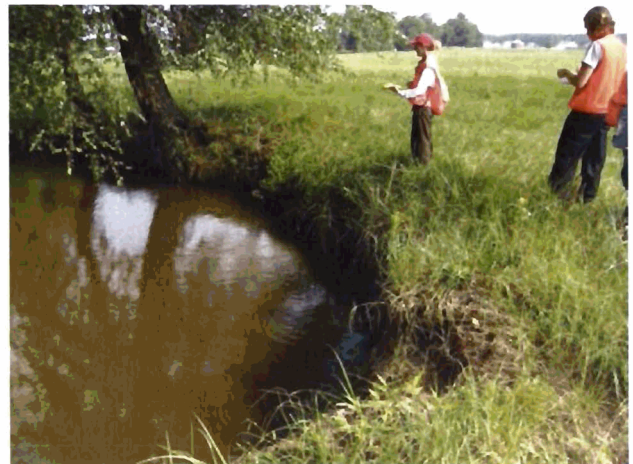
Outer Bend #10 - Looking Upstream
at tight radius below a large river birch.
(Moderate Erosion)

| Outer Bend | Extent of Erosion Preconstruction | Treatment to be Installed |
|---|--|---|
| 10 | Moderate | Leave as is |

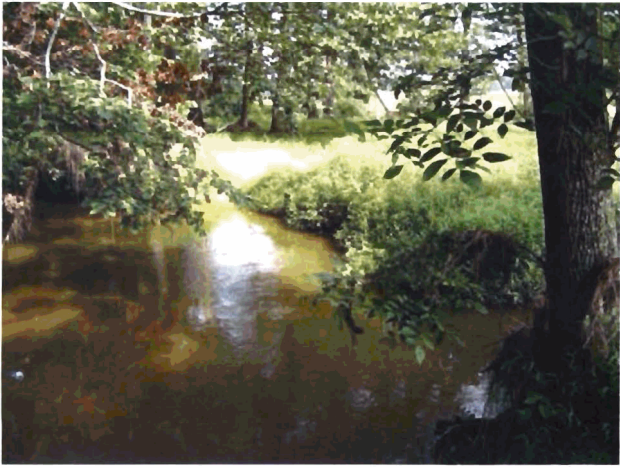
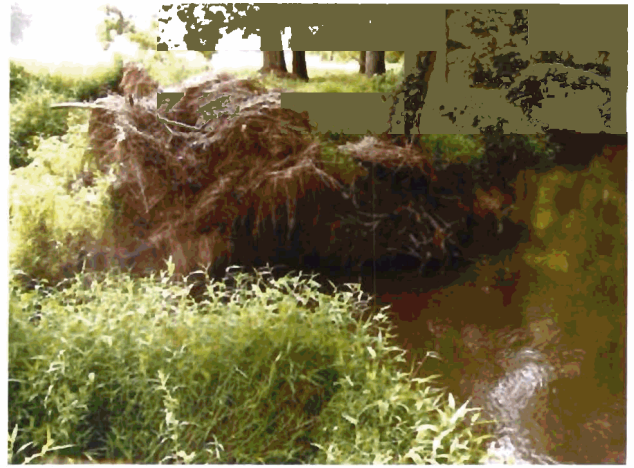
Outer Bend #11 - Looking Upstream at tight radius. A fallen tree has cause a hole in the bank. (Severe Erosion)

Outer Bend #11 - Looking Downstream at fallen tree causing a hole in the bank. (Severe Erosion)

| Outer Bend | Extent of Erosion Preconstruction | Treatment to be Installed |
|---|--|---|
| 11 | Severe | Brush mattress |

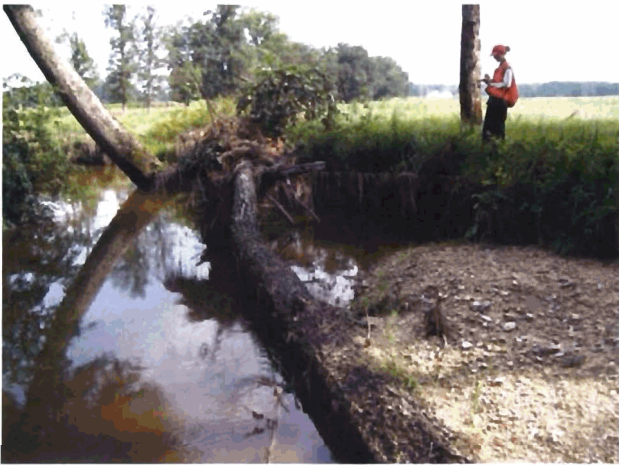
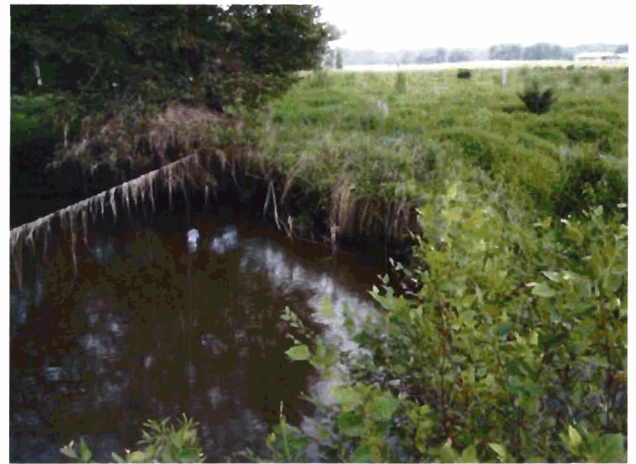
Outer Bend #12 - Looking Upstream (Severe Erosion)

| Outer Bend | Extent of Erosion Preconstruction | Treatment to be Installed |
|---|--|---|
| 12 | Severe | Live stake with erosion control matting |

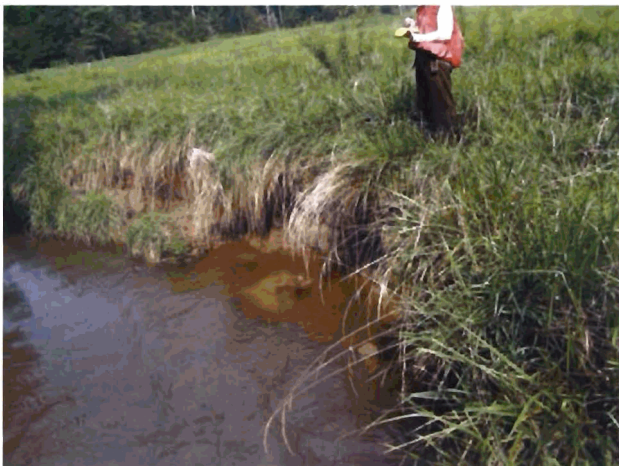
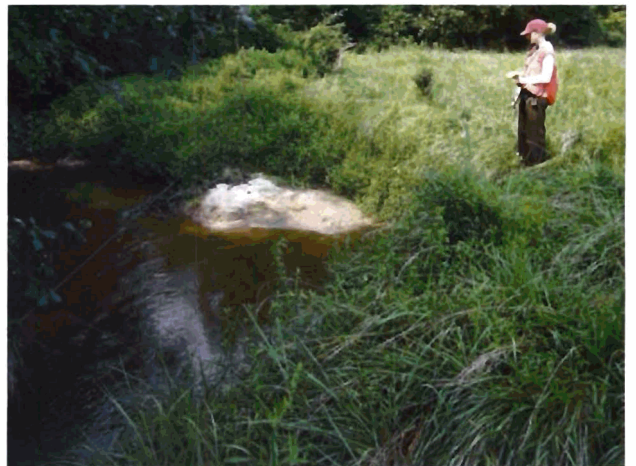
Outer Bend #13 - Looking Upstream
A fallen tree may be causing erosion on Site stream banks. (Severe Erosion)

| Outer Bend | Extent of Erosion Preconstruction | Treatment to be Installed |
|---|--|---|
| 13 | Severe | Brush mattress |

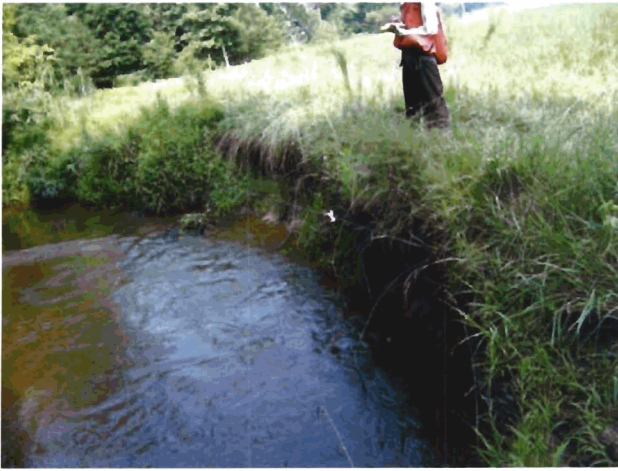
Outer Bend #14 - Looking Upstream at tight radius caused by point bar and transverse bar.
(Severe Erosion)

| Outer Bend | Extent of Erosion Preconstruction | Treatment to be Installed |
|---|--|---|
| 14 | Severe | Leave as is |

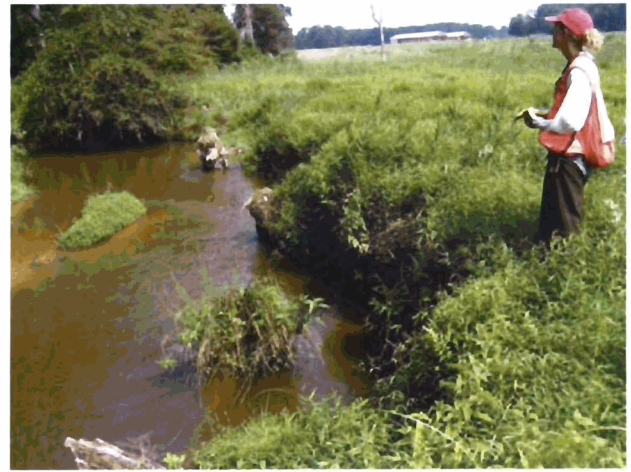
Outer Bend #15 - Looking Upstream at a long bend with two stumps extending into the stream.
(Moderate Erosion)

| Outer Bend | Extent of Erosion Preconstruction | Treatment to be Installed |
|---|--|---|
| 15 | Moderate | Live stake with erosion control matting |

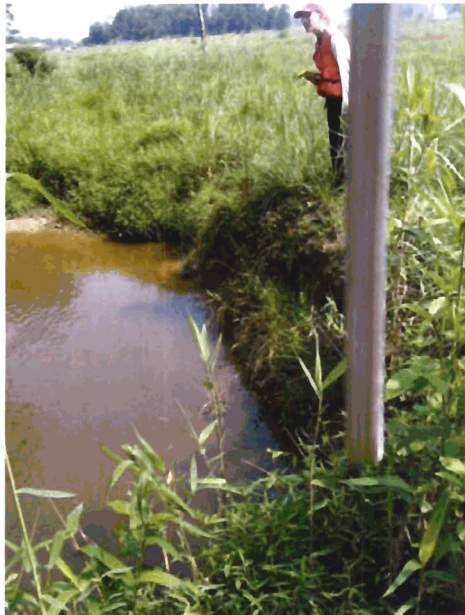
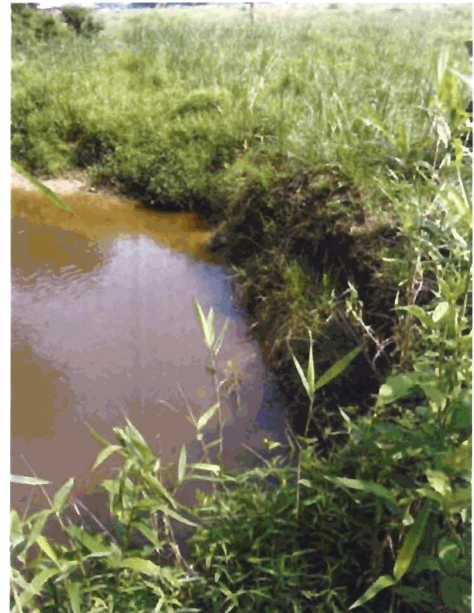
Outer Bend #16 - Looking Upstream at tight bends. This is not a good reach for bank stabilization comparisons.
(Moderate Erosion)

| Outer Bend | Extent of Erosion Preconstruction | Treatment to be Installed |
|---|--|---|
| 16 | Moderate | Brush mattress |

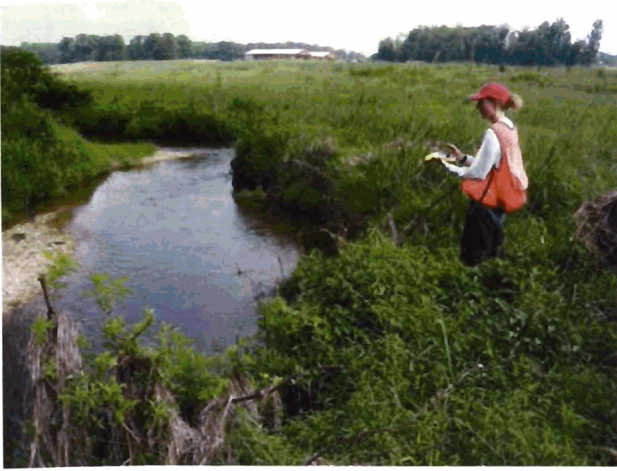
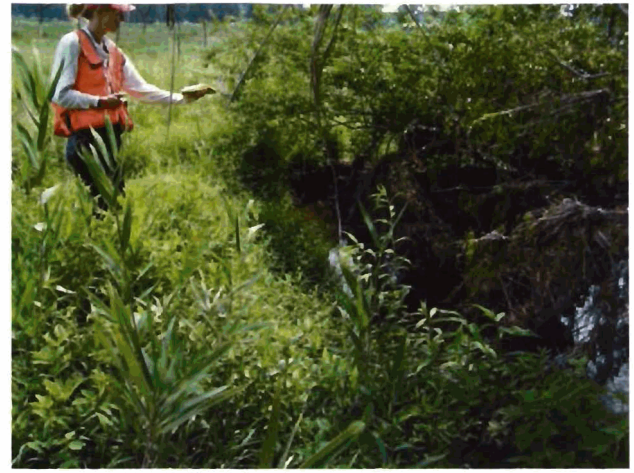
Outer Bend #17 - Looking Upstream
(Severe Erosion)

Outer Bend #17 - Looking Downstream
(Severe Erosion)

| Outer Bend | Extent of Erosion Preconstruction | Treatment to be Installed |
|---|--|---|
| 17 | Severe | Brush mattress |

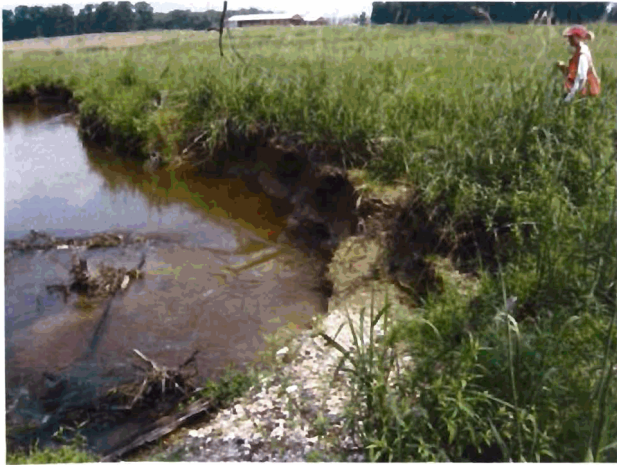
Outer Bend #18 - Looking Upstream
(Extreme Erosion)

| Outer Bend | Extent of Erosion Preconstruction | Treatment to be Installed |
|---|--|---|
| 18 | Extreme | Live stake with erosion control matting |

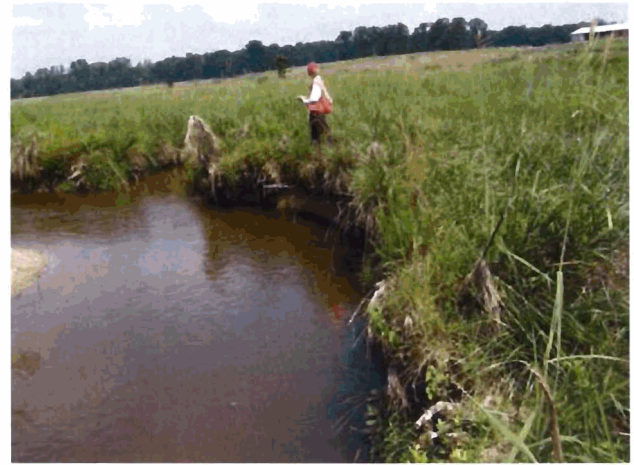
Outer Bend #19 - Looking Upstream
(Severe Erosion)

| Outer Bend | Extent of Erosion Preconstruction | Treatment to be Installed |
|---|--|---|
| 19 | Severe | Leave as is |

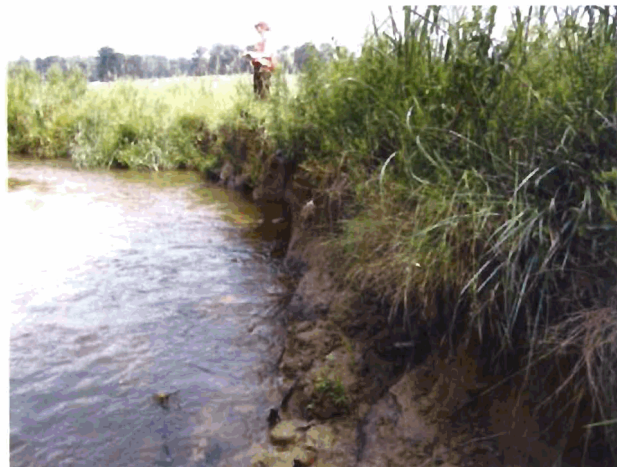
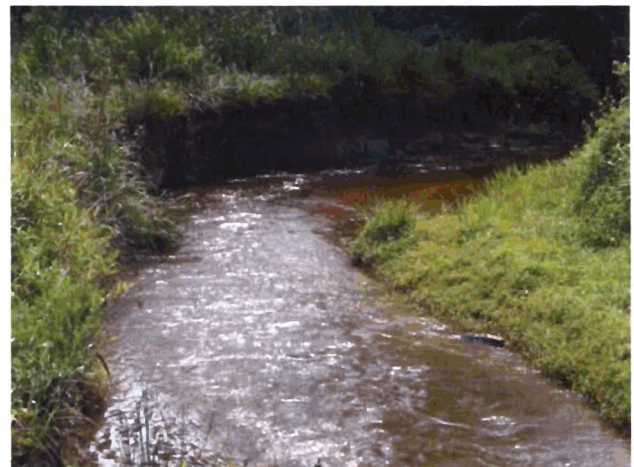
Outer Bend #20 - Looking Upstream
at a long bend with a tight radius in the
middle of the bend.
(Extreme Erosion)

Outer Bend #20 - Looking Downstream
at a long bend with a tight radius in the
middle of the bend.
(Extreme Erosion)

| Outer Bend | Extent of Erosion Preconstruction | Treatment to be Installed |
|---|--|---|
| 20 | Extreme | Brush mattress |

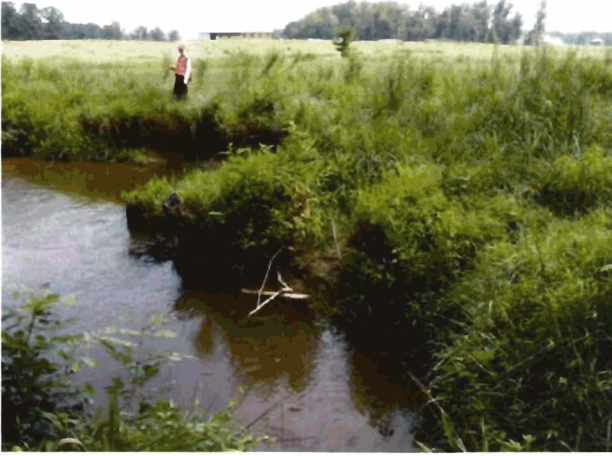
Outer Bend #21 - Looking Upstream
at bank sloughing
(Extreme Erosion)

| Outer Bend | Extent of Erosion Preconstruction | Treatment to be Installed |
|---|--|---|
| 21 | Extreme | Leave as is |

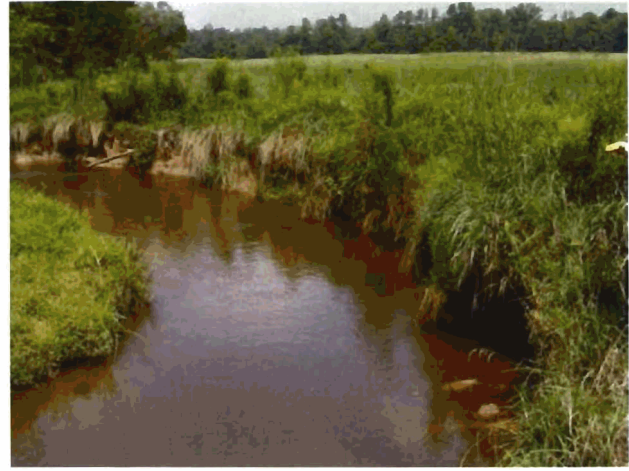
Outer Bend #22 - Looking Upstream
at lateral migration of outer bend with
point bar extension into the stream bed.
(Severe Erosion)

| Outer Bend | Extent of Erosion Preconstruction | Treatment to be Installed |
|---|--|---|
| 22 | Severe | Live stake with erosion control matting |

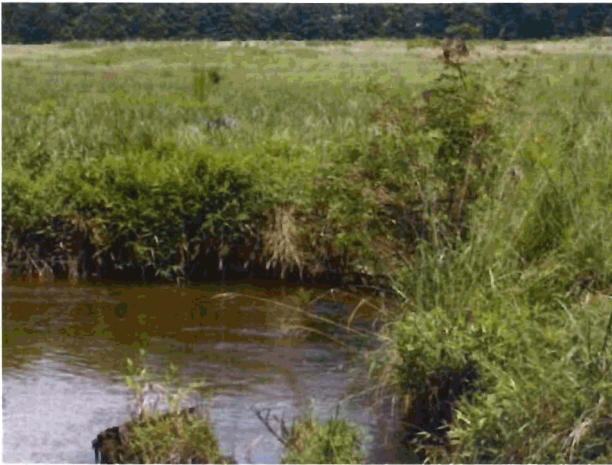
Outer Bend #23 - Looking Upstream
at root balls in channel and bank sloughing
(Severe Erosion)

| Outer Bend | Extent of Erosion Preconstruction | Treatment to be Installed |
|---|--|---|
| 23 | Severe | Brush mattress |

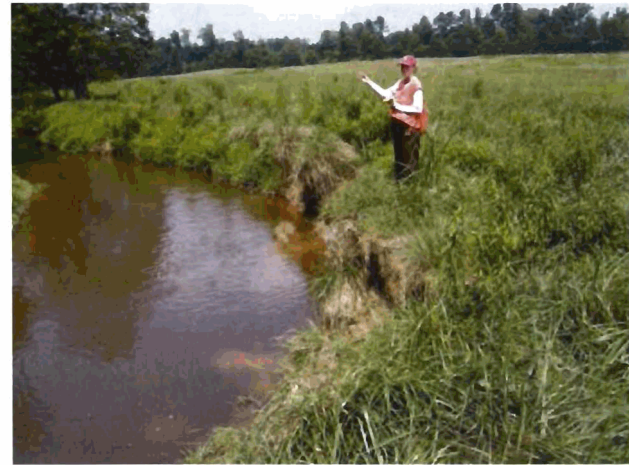
Outer Bend #24 - Looking Upstream
at a short reach of erosion.
(Severe Erosion)

| Outer Bend | Extent of Erosion Preconstruction | Treatment to be Installed |
|---|--|---|
| 24 | Severe | Leave as is |

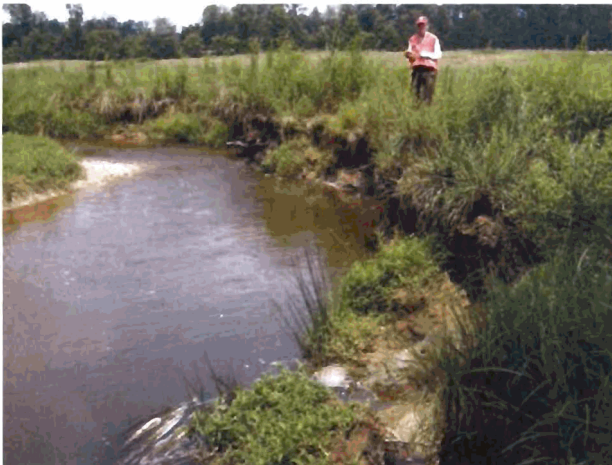
Outer Bend #25 - Looking Upstream
at transverse bar and tight radius at upper
reach of the bend.
(Extreme Erosion)

| Outer Bend | Extent of Erosion Preconstruction | Treatment to be Installed |
|---|--|---|
| 25 | Extreme | Brush mattress |

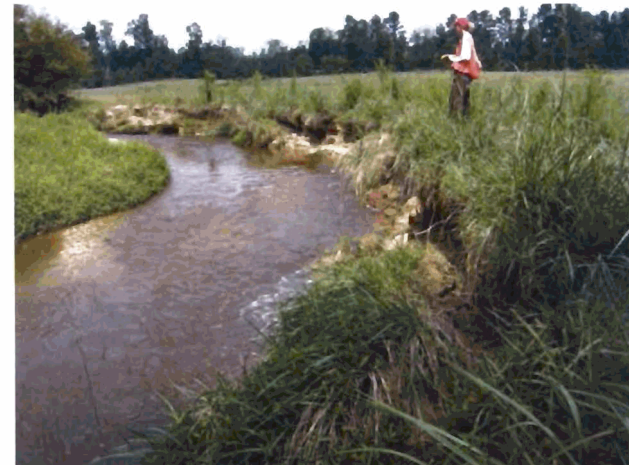
Outer Bend #26 - Looking Upstream
at migrating outer bend and extension of
point bar/transverse bar at lower
reach of bend.
(Extreme Erosion)

| Outer Bend | Extent of Erosion Preconstruction | Treatment to be Installed |
|---|--|---|
| 26 | Extreme | Leave as is |

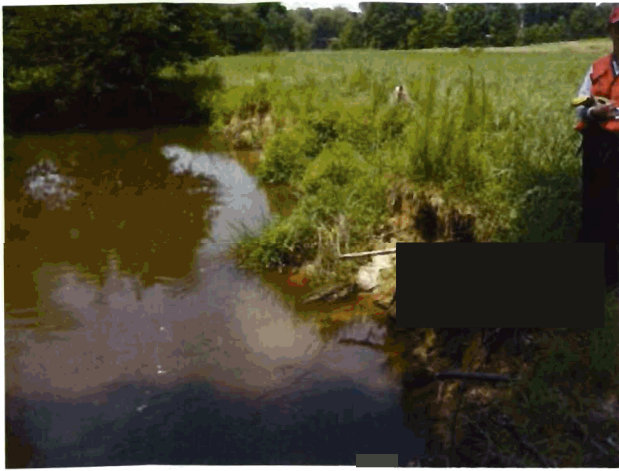
Outer Bend #27 - Looking Upstream at erosion on low slope reach. (Severe Erosion)

| Outer Bend | Extent of Erosion Preconstruction | Treatment to be Installed |
|---|--|---|
| 27 | Severe | Brush mattress |

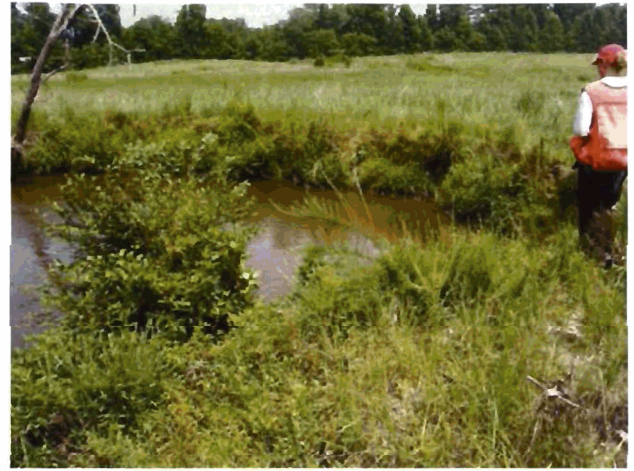
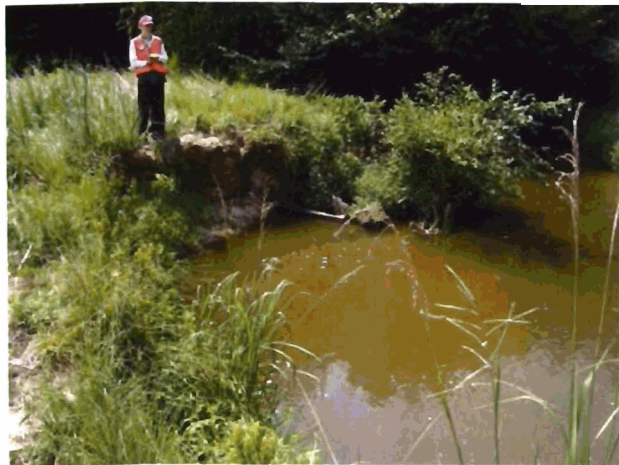
Outer Bend #28 - Looking Upstream at potential shoot cutoff development. (Severe Erosion)

Outer Bend #28 - Looking Downstream at potential shoot cutoff development. (Severe Erosion)

| Outer Bend | Extent of Erosion Preconstruction | Treatment to be Installed |
|---|--|---|
| 28 | Severe | Live stake with erosion control matting |

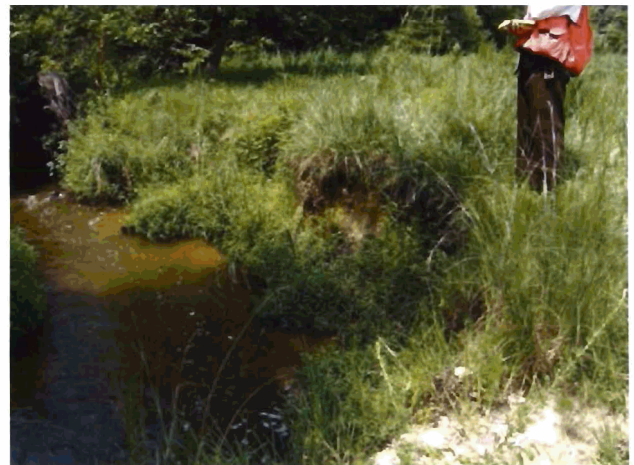
Outer Bend #29 - Looking Upstream at shoot cutoff. Not a good bank erosion treatment comparison area. (Severe Erosion)

| Outer Bend | Extent of Erosion Preconstruction | Treatment to be Installed |
|---|--|---|
| 29 | Severe | Leave as is |

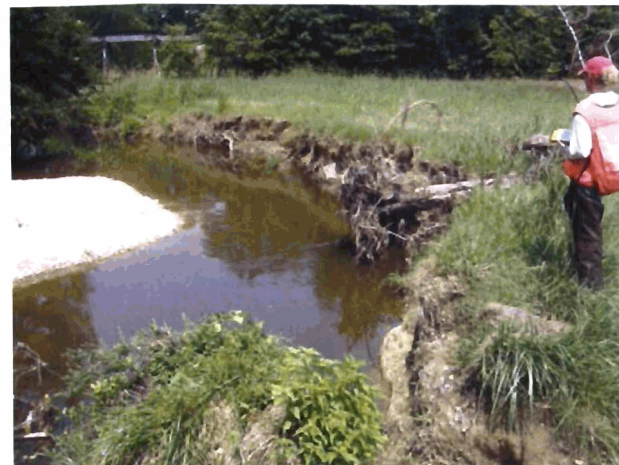
Outer Bend #30 - Looking Upstream at lateral migration of out bend with extension of point bar into the stream bed. (Extreme Erosion)

| Outer Bend | Extent of Erosion Preconstruction | Treatment to be Installed |
|---|--|---|
| 30 | Extreme | Live stake with erosion control matting |

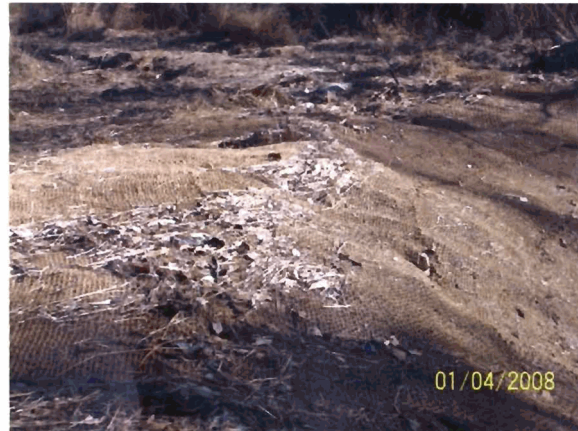
Evidence of Bankfull Event in January 2008
