# **FINAL ANNUAL MONITORING REPORT TERRIBLE CREEK**

**BUFFER RESTORATION  
WAKE COUNTY, NORTH CAROLINA  
(EEP Project Number 134)  
NEUSE RIVER BASIN  
CATALOGING UNIT 03020201  
Monitoring Year 4 of 5 (2011)**

**August 2011**

**Axiom Environmental, Inc.  
218 Snow Avenue  
Raleigh, North Carolina 27603  
(919) 215-1693 (phone)**

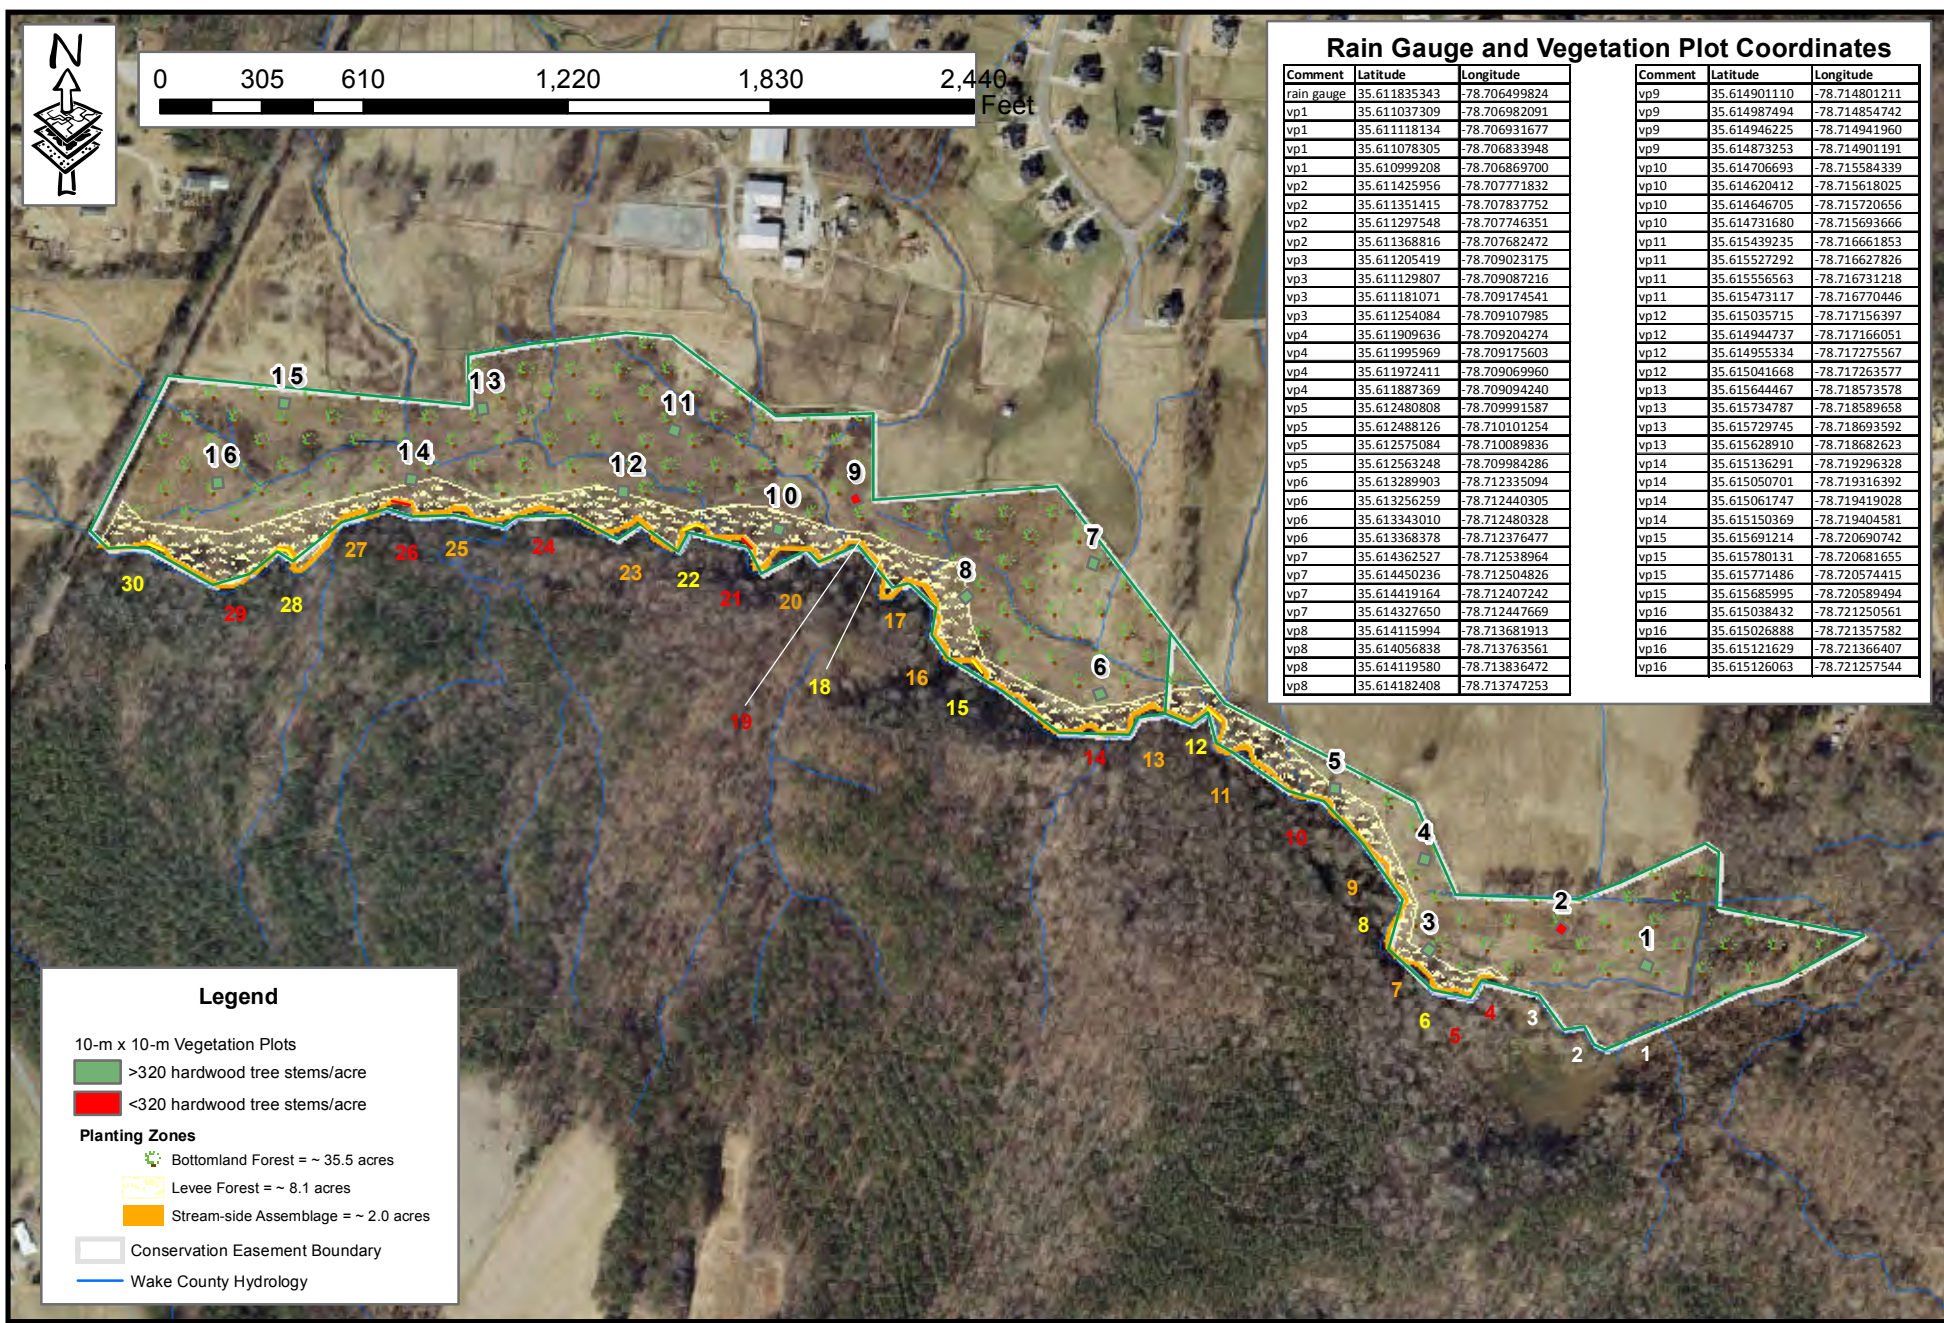
FIGURE  
**2**

<b>Vegetation Plot ID</b>	<b>Vegetation Survival Threshold Met?</b>	<b>Tract Mean</b>
1	Yes	87.5%
2	No	
3	Yes*	
4	Yes	
5	Yes	
6	Yes	
7	Yes	
8	Yes	
9	No	
10	Yes	
11	Yes	
12	Yes	
13	Yes	
14	Yes	
15	Yes	
16	Yes

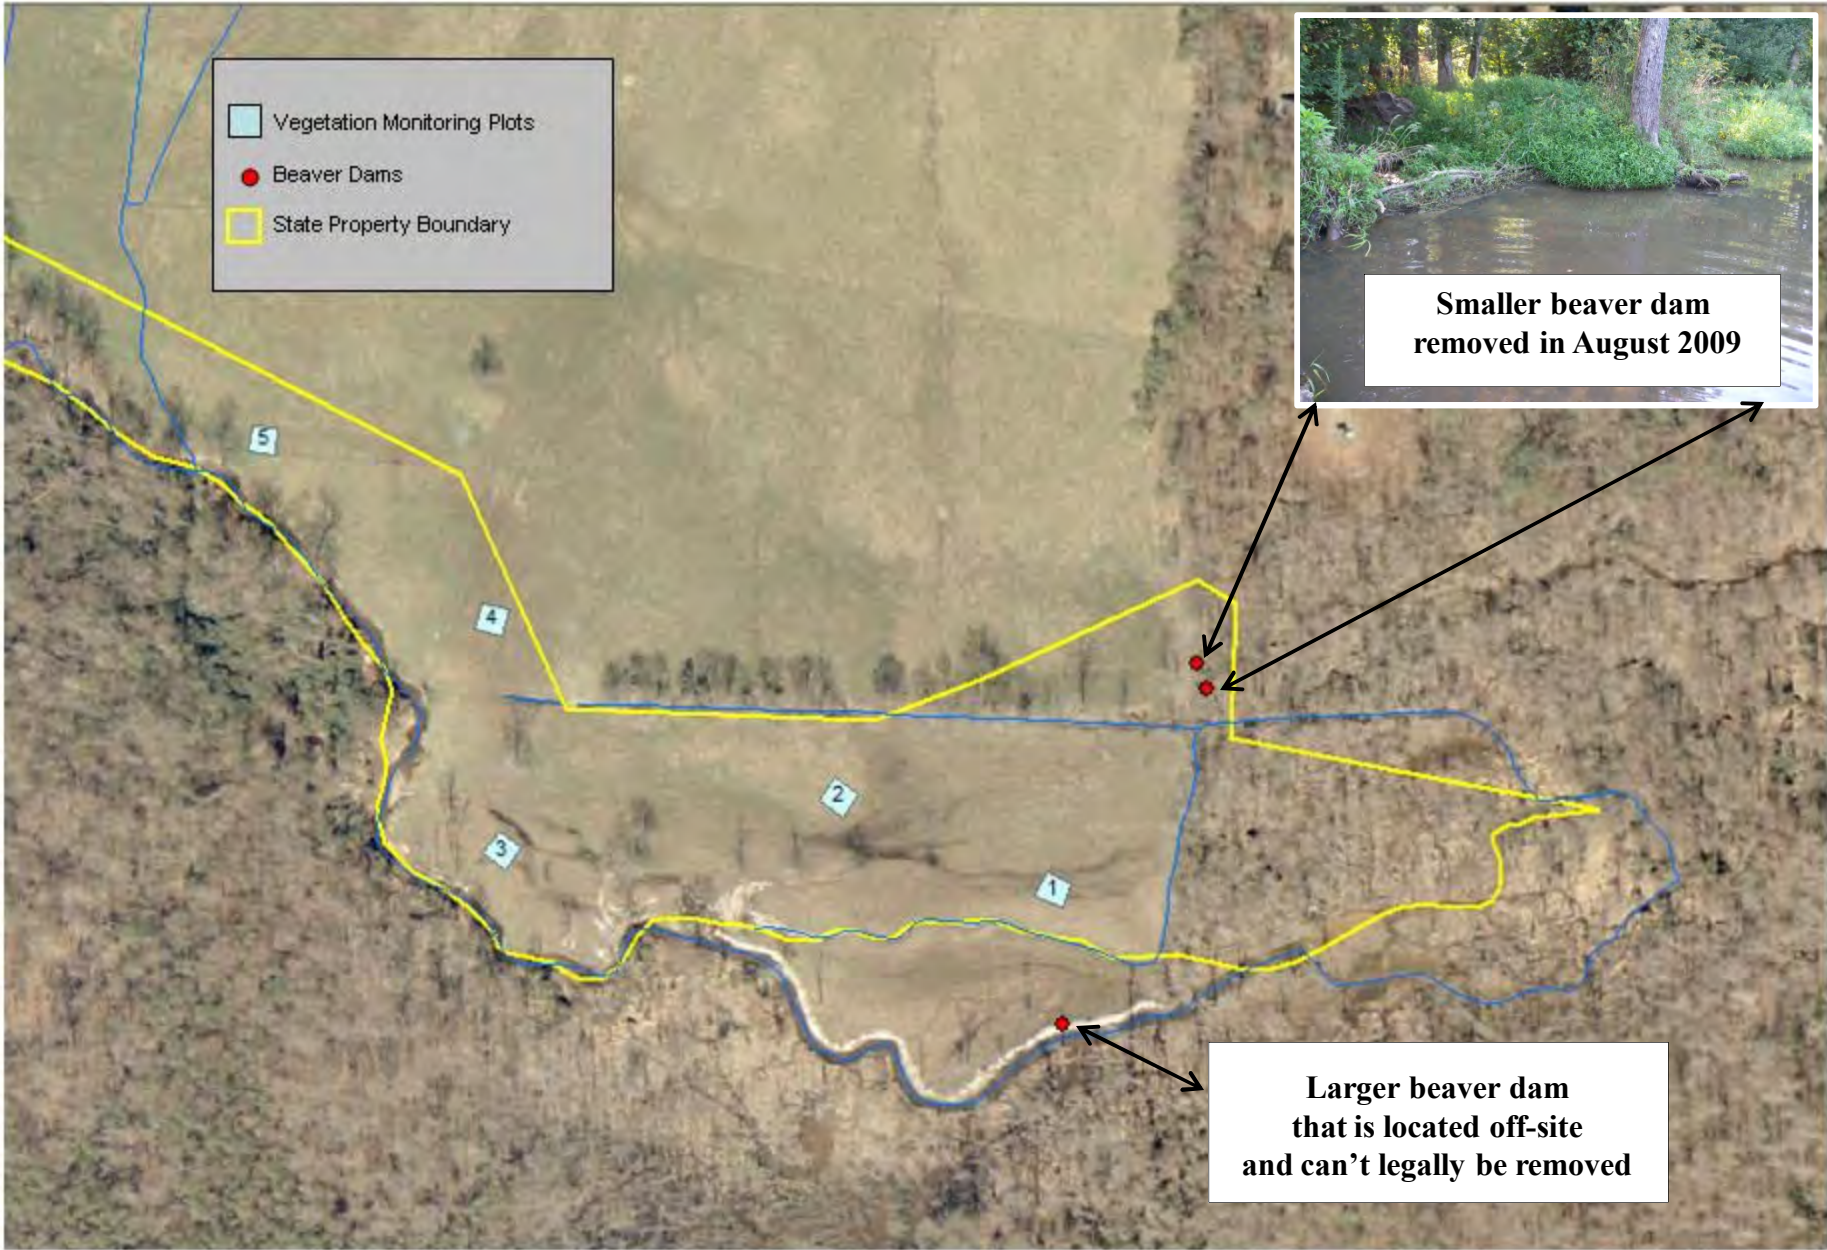
APPENDIX D  
BEAVER MANAGEMENT INFORMATION  
Map of Located and/or Removed Beaver Dams

In summary, the Site achieved success criteria for vegetation in the Fourth Monitoring Year (2011). Approximately 430 linear feet of outerbend within the Site shows some sign of bank sloughing or reduced integrity. However, when compared to preconstruction conditions the issue areas have not worsened and in general, the stream channel as a whole is trending toward more stable conditions. Several small beaver dams located in the northern portion of the Site were removed in August 2009 (Appendix D); the larger dam located just off-site was not removed because it is not located on the State's easement. Beaver dams located within the Site were mapped on January 28, 2011 (Appendix D). These dams are scheduled to be removed in 2011.

**Dam observed 1/28/11**
