**FINAL
ANNUAL MONITORING REPORT
TERRIBLE CREEK**

**BUFFER RESTORATION
WAKE COUNTY, NORTH CAROLINA
(EEP Project Number 134, Contract Number 004458)
NEUSE RIVER BASIN
CATALOGING UNIT 03020201
Monitoring Year 5 of 5 (2012)**

September 2012

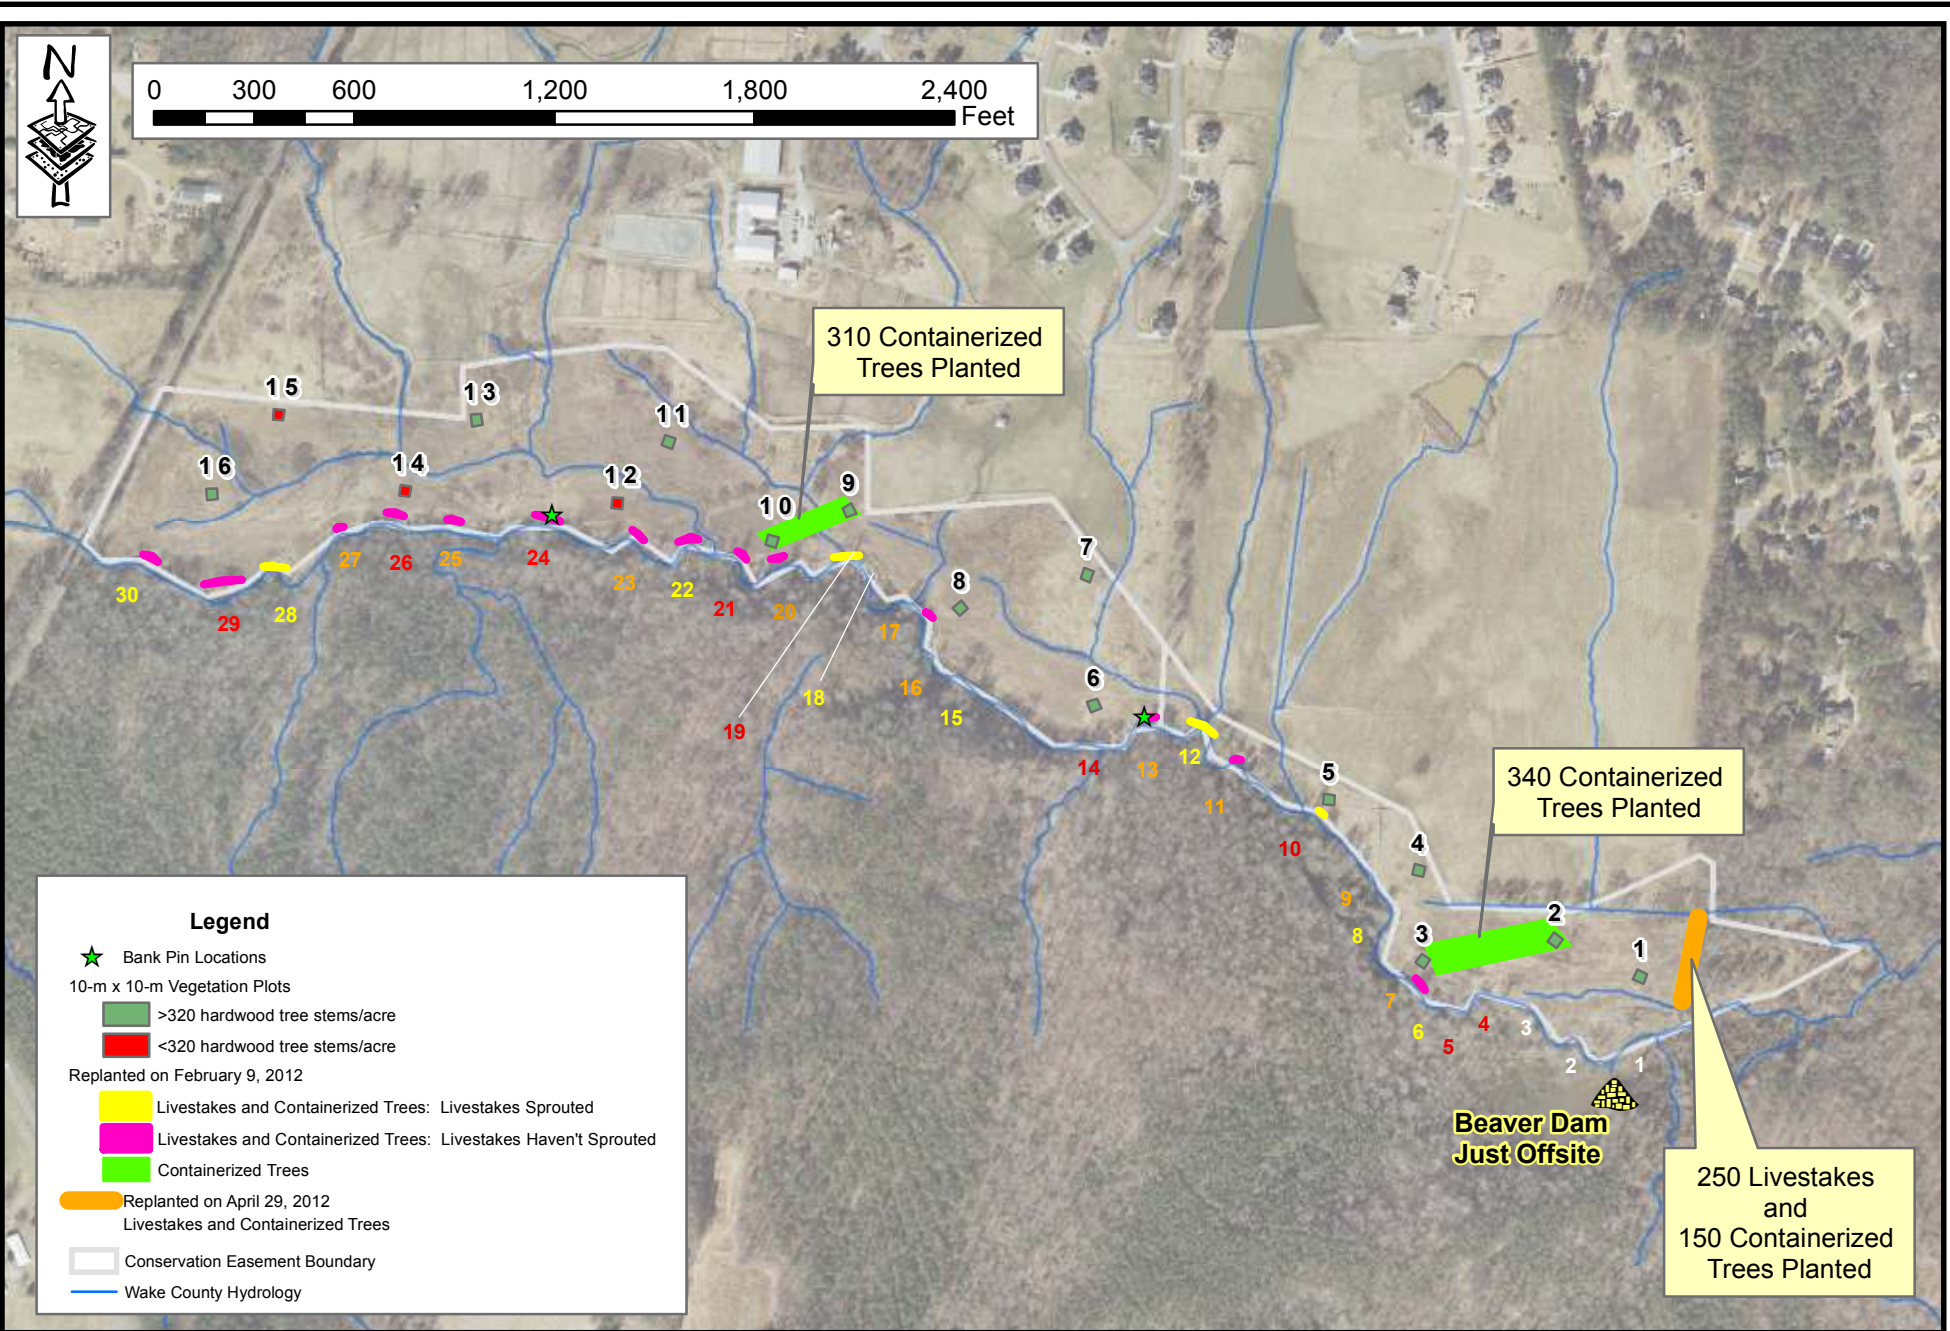
**FIGURE
3**

plots 9-10 were planted with approximately 654 tree stems (shown in lime green on Figure 3, Appendix A). Newly planted containerized trees appear to be thriving. Livestakes have sprouted on four outerbends (depicted in yellow on Figure 3, Appendix A); the remainder of livestockes have not yet sprouted. All replanted trees and livestockes will be reevaluated after completion of the 2012 growing season. Planted species and quantities of each are as follows.

Approximately 430 linear feet of outerbend within the Site shows some sign of bank sloughing/erosion or reduced integrity. However, when compared to preconstruction conditions the issue areas have not worsened and in general, the stream channel as a whole is trending toward more stable conditions. Cut banks tend to be relatively low (3-4 feet in height) and are associated with point/side bars that suggest the cross-sectional area is not increasing. Bank pins were installed on two outerbends ([outerbend 13 and outerbend 24] depicted as green stars on Figure 3, Appendix A) in January 2011 and were subsequently monitored in February 2012 and August 2012. Measurements indicated approximately 12 inches of sloughing from January 2011 to February 2012. Only one bank pin was found in August 2012 due to heavy herbaceous vegetation; this pin indicated minimal changes going from 4 inches of exposure in February 2012 to approximately 5 inches of exposure in August 2012. Bank pins will need to be reevaluated during the winter when herbaceous vegetation has died back and pins are easier to identify.

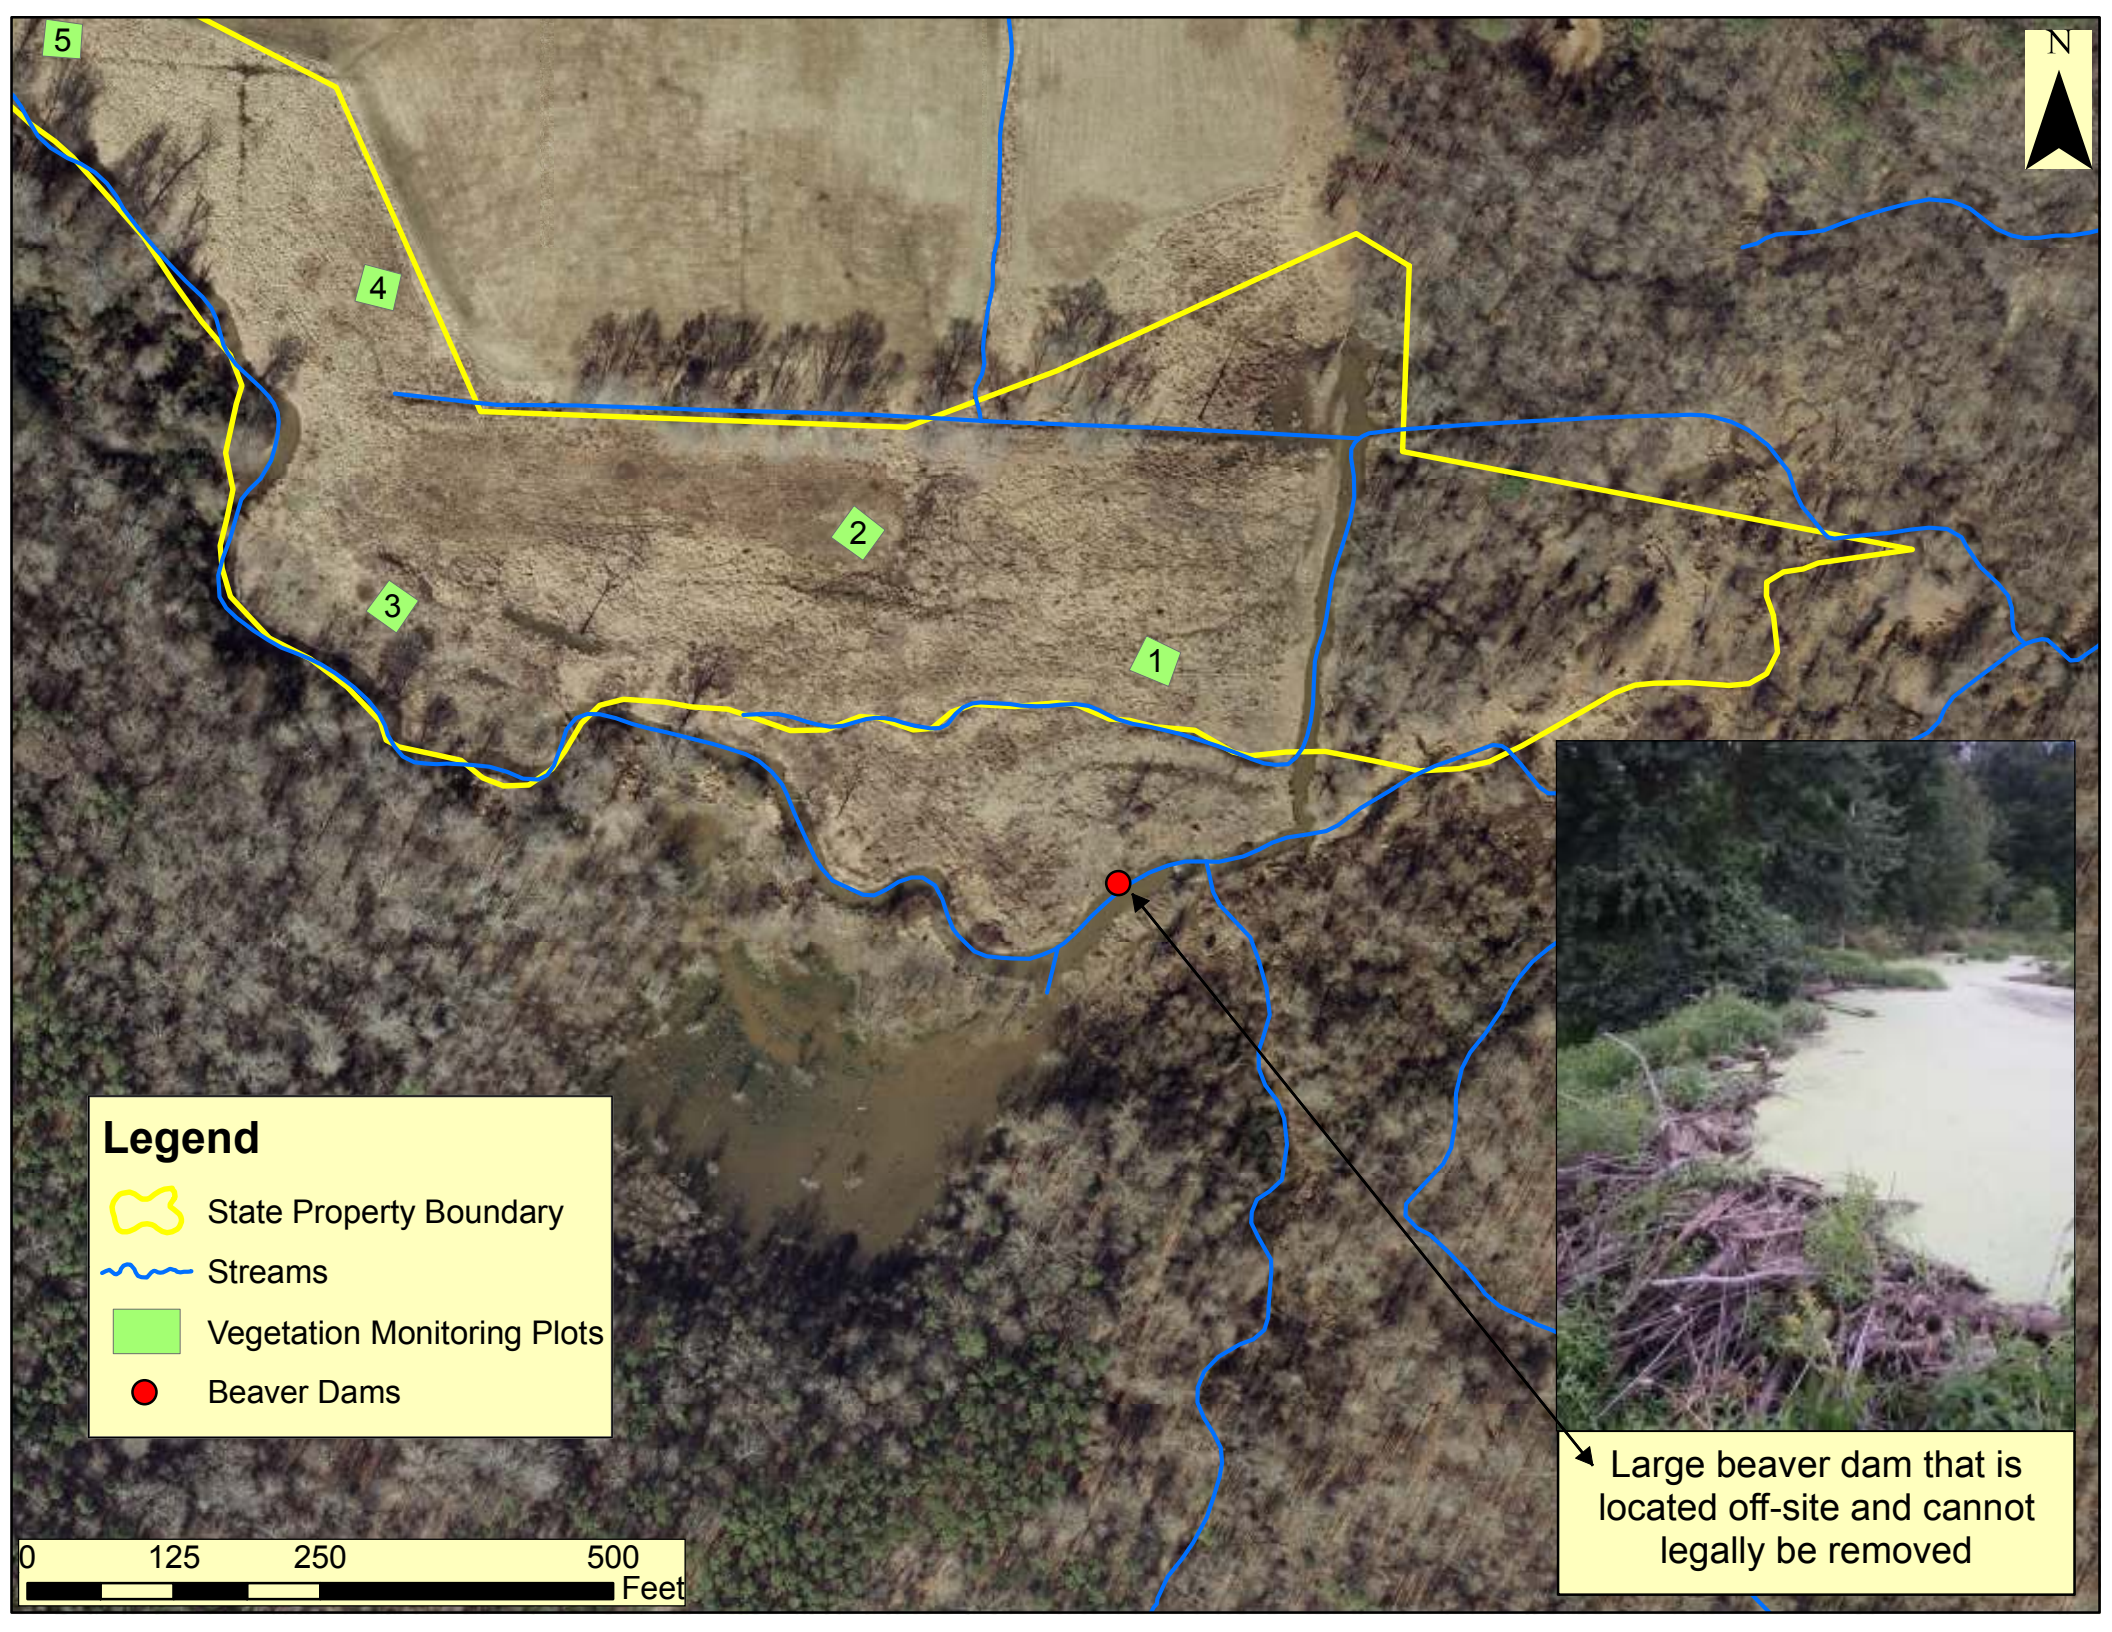
APPENDIX D
BEAVER MANAGEMENT INFORMATION
Map of Located and/or Removed Beaver Dams

Several small beaver dams located in the northern portion of the Site were removed in August 2009 (Appendix D); the larger dam located just off-site was not removed because it is not located on the State's easement and remains in place to date. Beaver dams located within the Site were mapped on January 28, 2011 and subsequently removed (Appendix D).

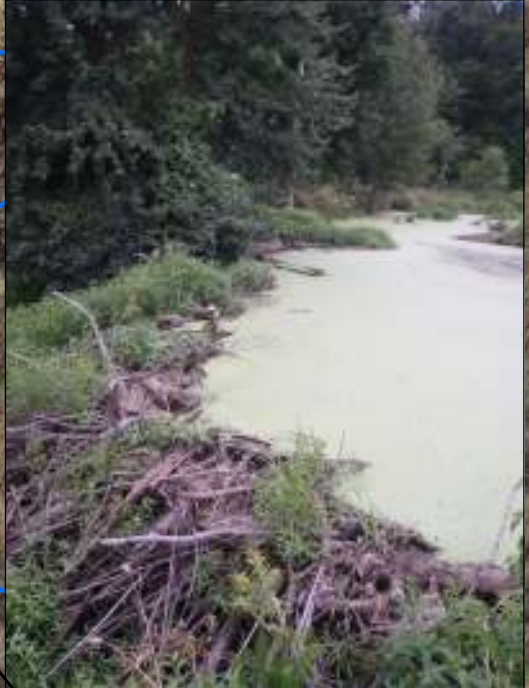
Large beaver dam that is located off-site and cannot legally be removed
