Thomas Creek Restoration Project Year 7 Monitoring/Closeout Report

Wake County, North Carolina

DMS Project ID Number – 96074, DEQ Contract No. 5549

Report Prepared and Submitted by Michael Baker Engineering, Inc.

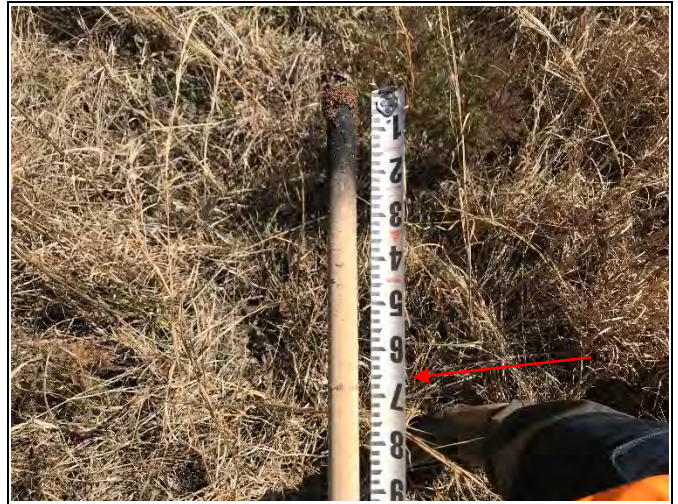
Overbank event of 0.67 ft on 1/3/22
(photo from 3/25/22)

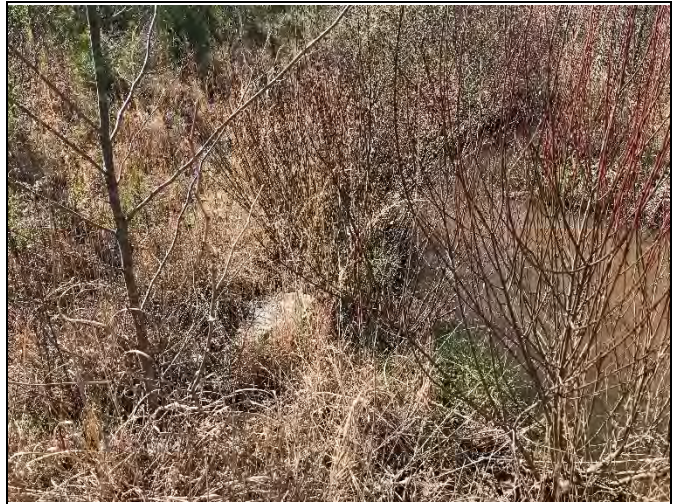
R2 bank scour MY3 (photo: 6/13/18)

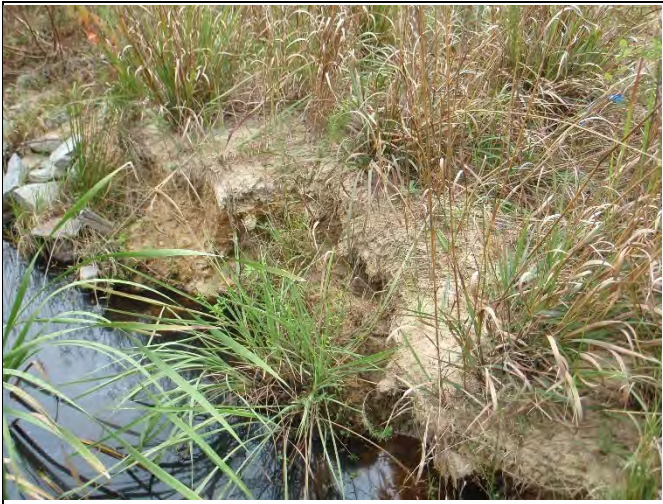
1st previously repaired bank MY7 (photo: 3/25/22)

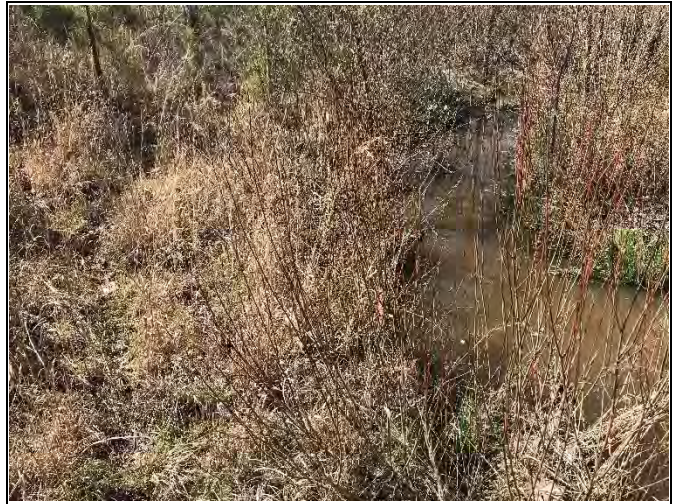
R2 bank scour MY3 (photo: 6/13/18)

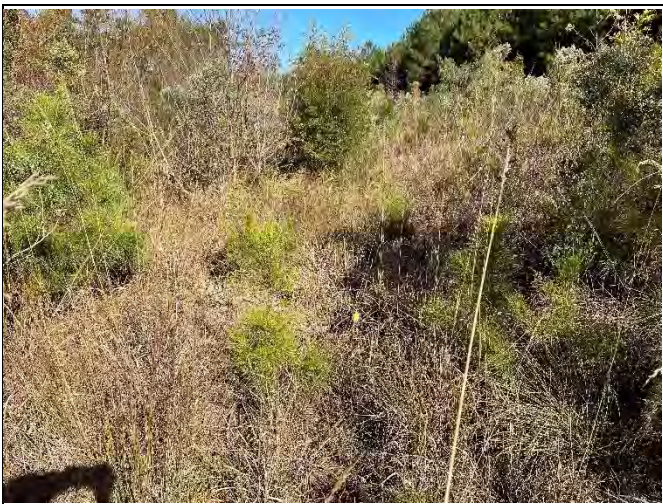
2nd previously repaired bank MY7 (photo: 3/25/22)

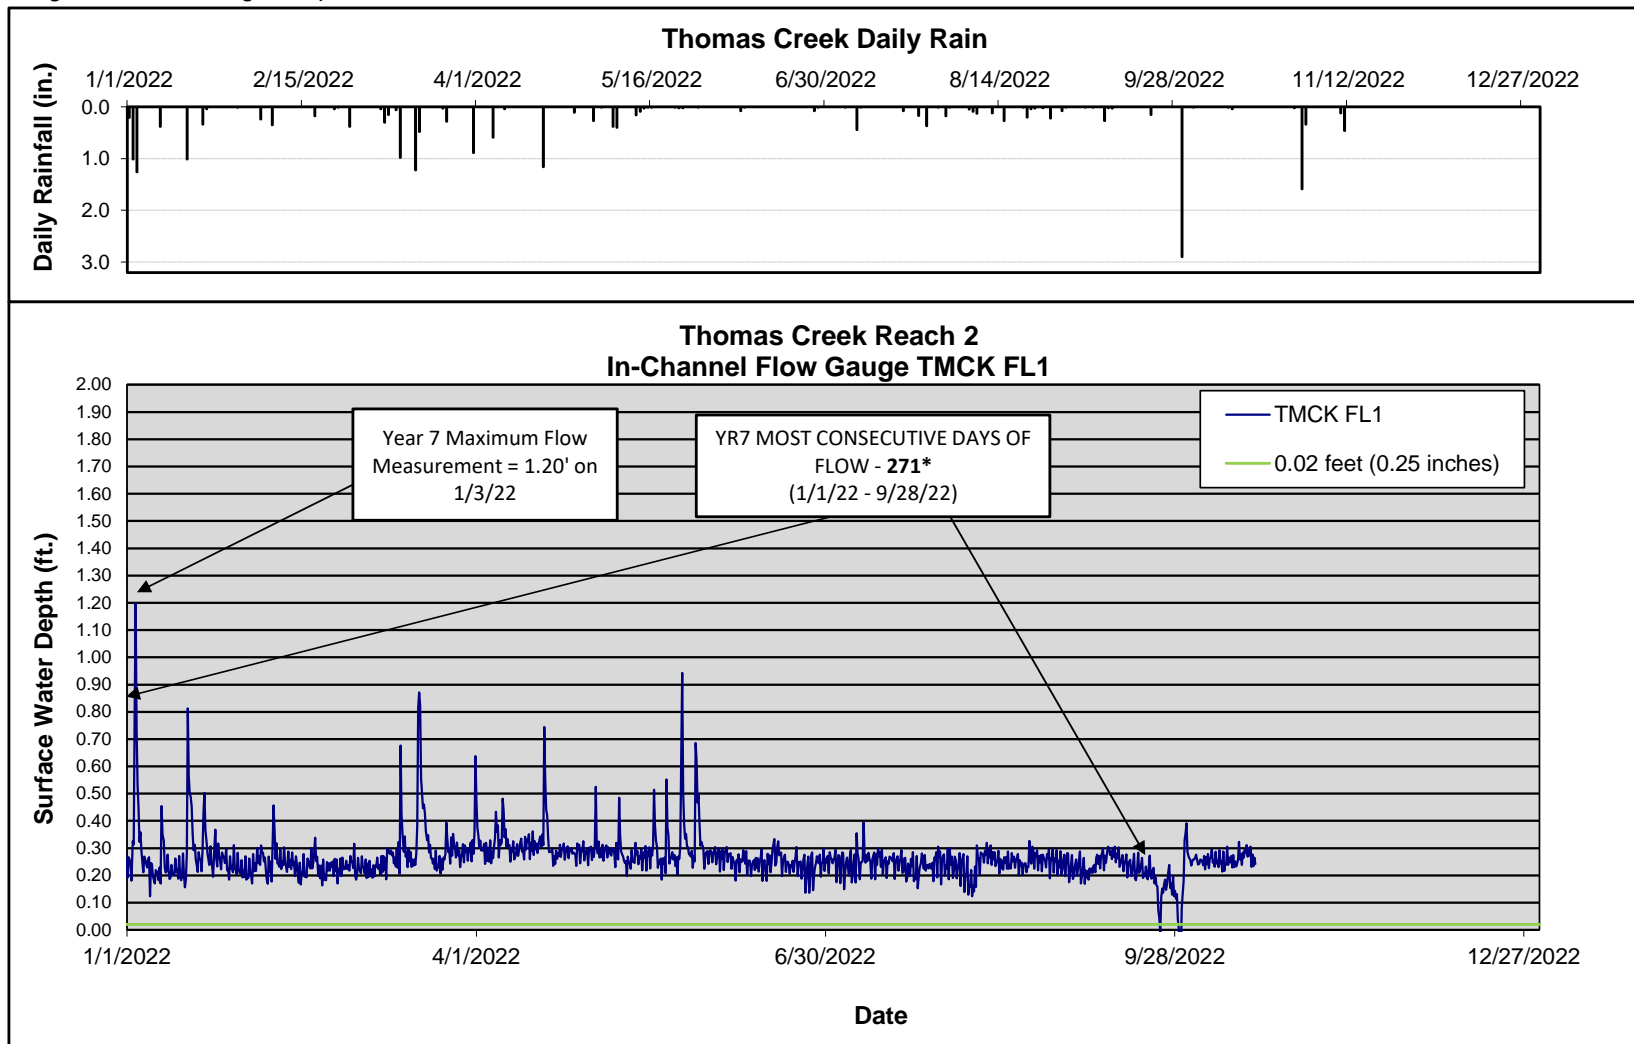
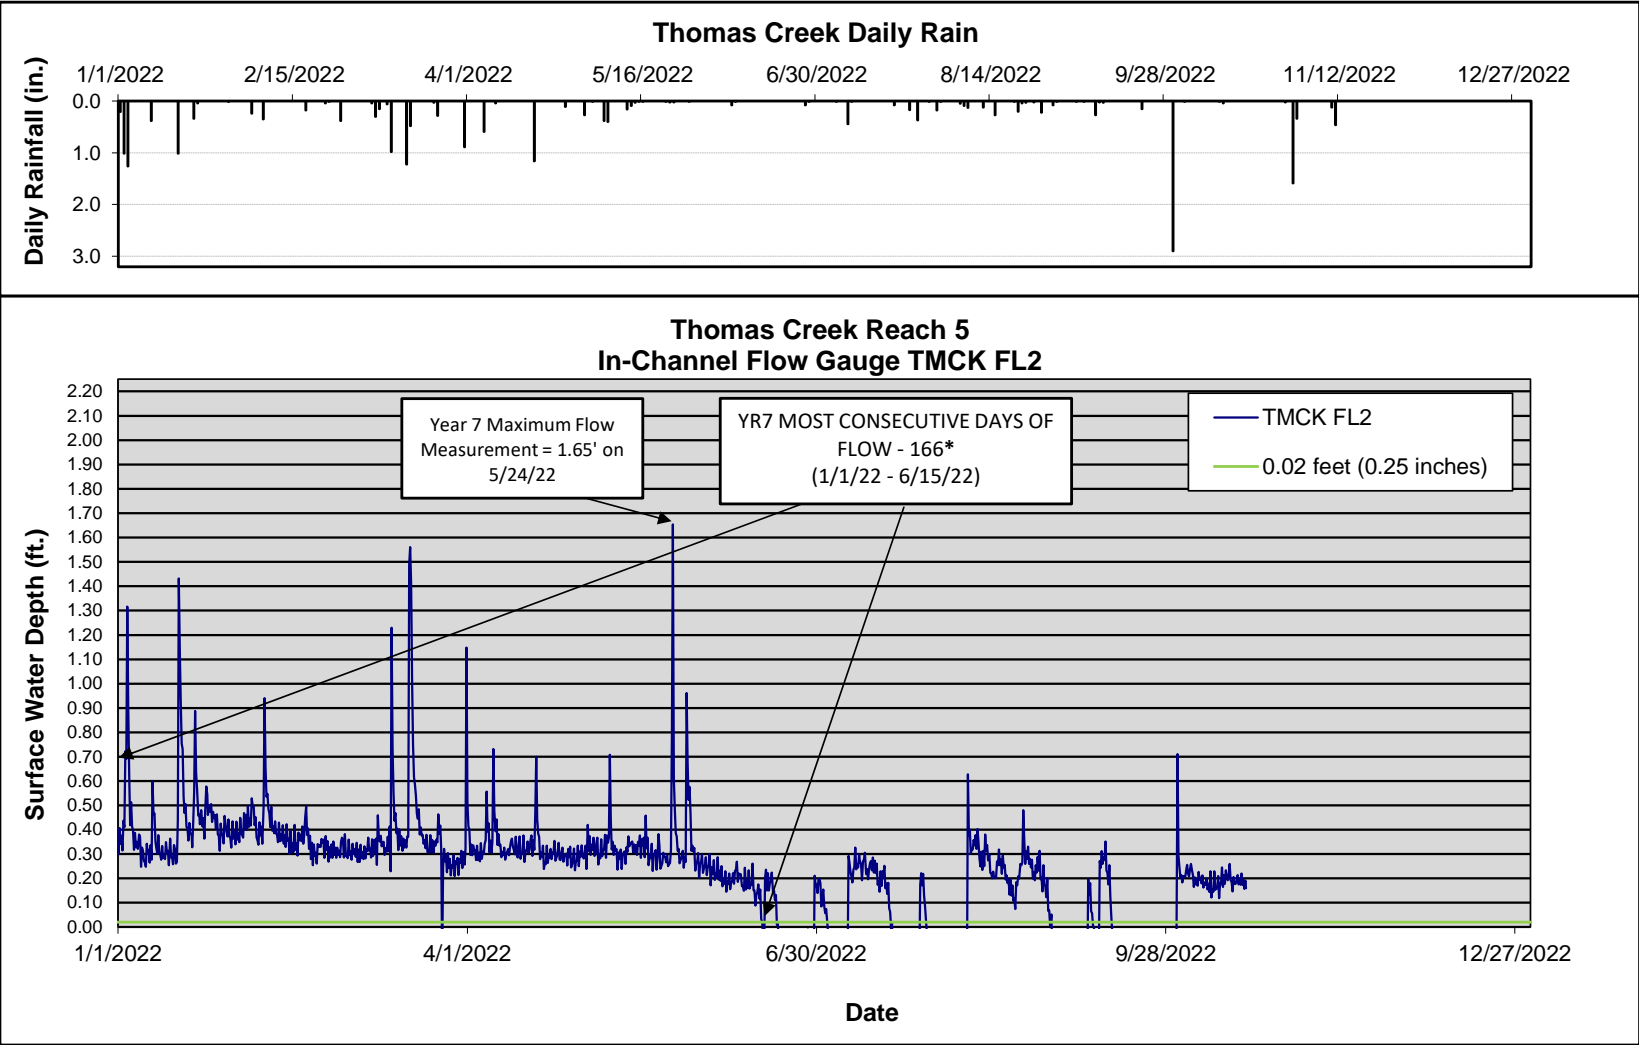
Figure 8. Flow Gauge Graphs

Year 7 flow monitoring demonstrated that both flow gauges (TMCK-FL1 and TMCK-FL2) met the stated success criteria of 30 days or more of consecutive flow through Reaches 2 and 5 respectively. Flow gauge TMCK-FL1 documented 271 days of consecutive flow in Reach 2, while flow gauge TMCK-FL2 documented 166 days of consecutive flow in Reach 5. The flow gauges demonstrated similar patterns relative to rainfall events and can corroborate reported bankfull events from the crest gauge, as shown in the flow gauge graphs in Appendix E.

* Surface water flow is estimated to have occurred when the pressure transducer reading is equal to or above 0.02 feet (0.25 inches) in depth.

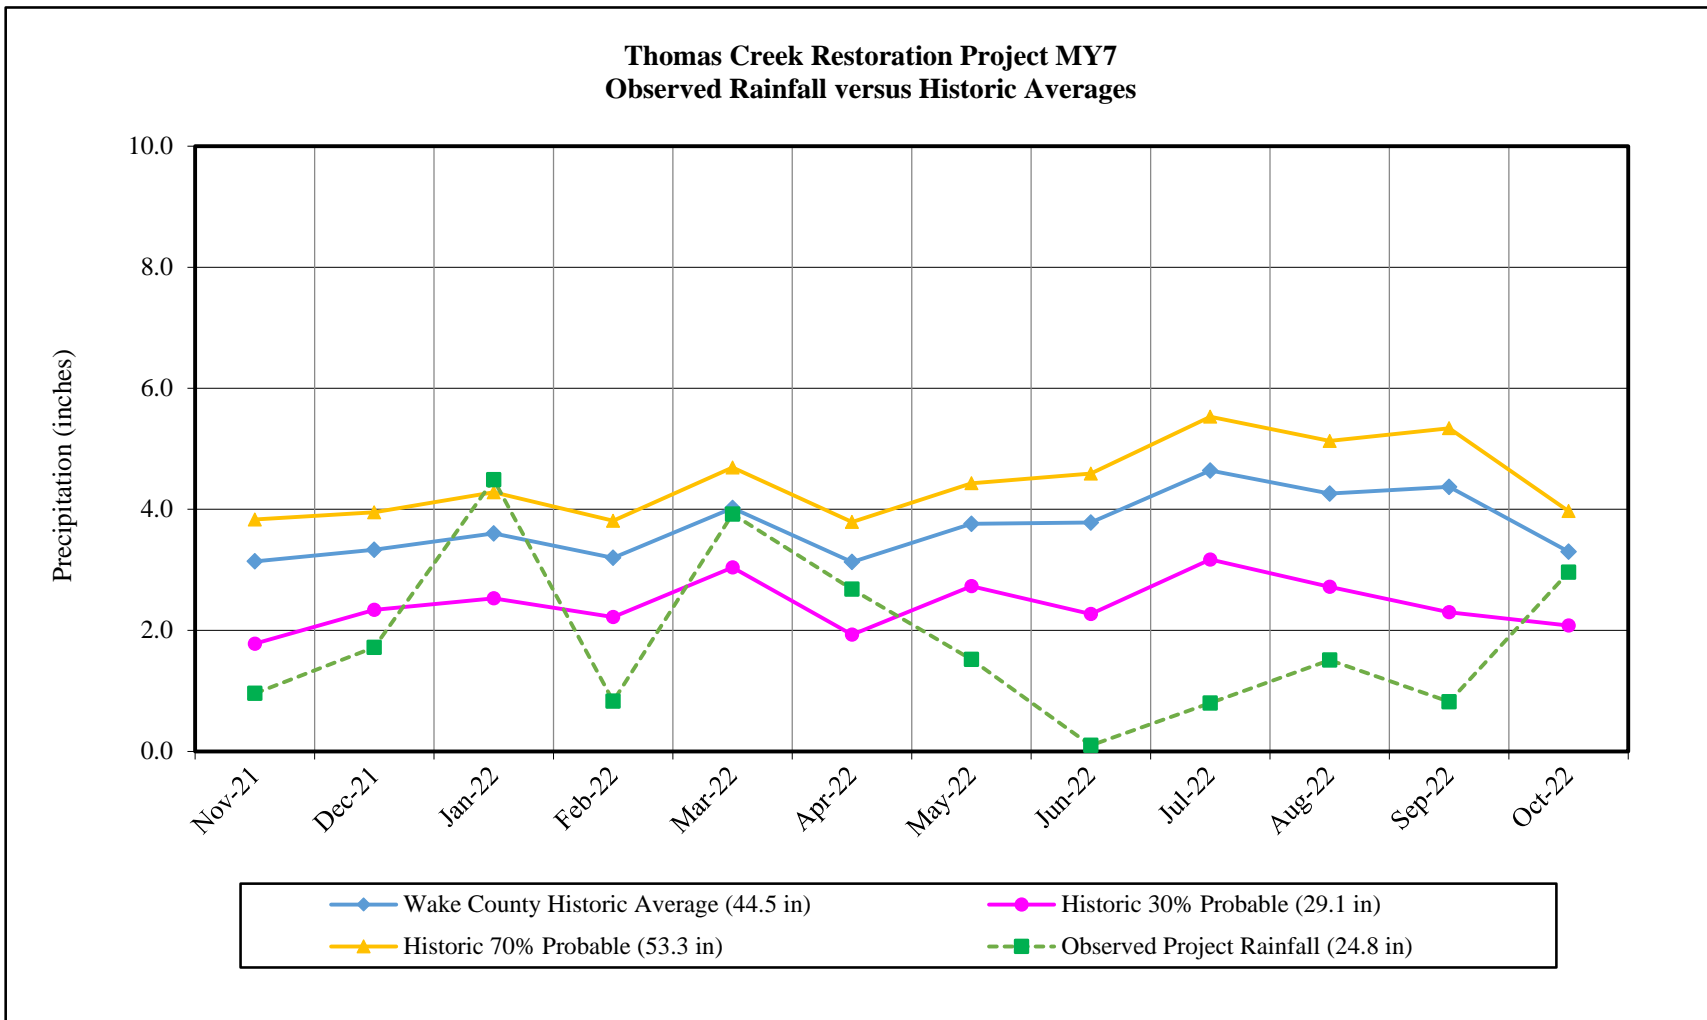
Figure 9. Observed Rainfall Versus Historic Averages

As the observed monthly rainfall data for the project presented in Figure 9 in Appendix E demonstrates, the past 12 months have been dryer as compared to historic averages for Wake County. A total of 24.8 inches of rainfall was observed for the project using the nearest NC-CRONOS station, while Wake County averages 44.5 inches of annual rainfall. The bulk of this excess rainfall came over the winter of 2021-2022, while the summer and fall of 2022 was well below average monthly.

Note: Historic average annual rainfall for Wake County is 44.53", while the observed project rainfall recorded a total of 24.8" over the previous 12 months (from 11/1/2021 to 10/31/2022). Project rainfall data was collected from the NC-CRONOS station LAKE.
