Year 1 Monitoring Report for Stream Restoration of Thompsons Fork and Unnamed Tributary

McDowell County, NC
SCO # D06030-A

Submitted: December 2009

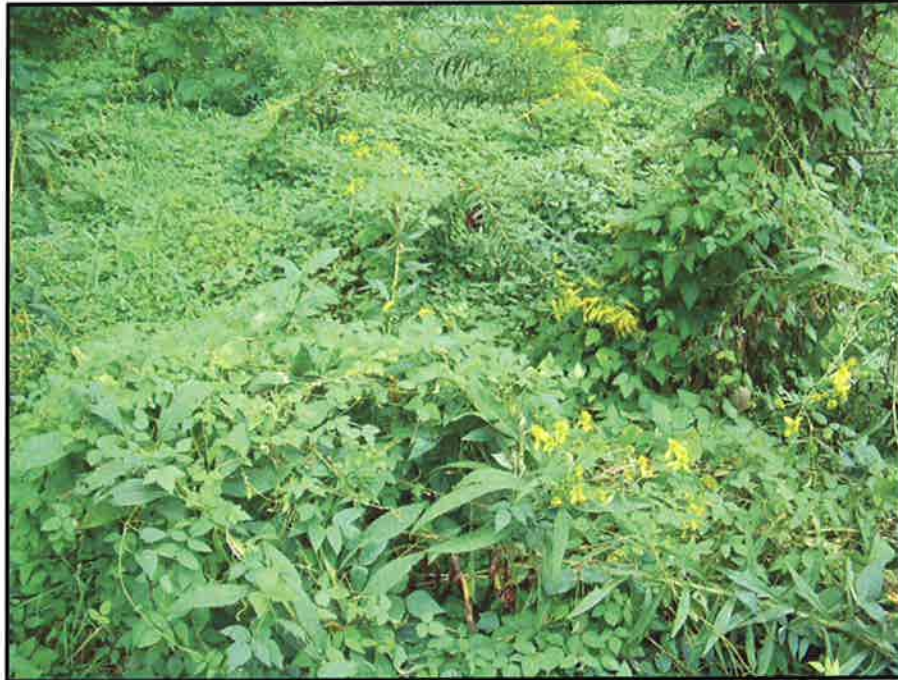
Table VII. Vegetative Problem Areas			
Thompsons Fork Stream Restoration / EEP Project No. D06030-A			
Feature/Issue	Station # / Range	Probable Cause	Photo #
Invasive Population	UT: See Plan View	Native Vine: encroachment from adjacent woodland	VPA 1
	UT: See Plan View	Sericea lespedeza: encroachment from pasture	VPA 2
Bare Floodplain	UT: See Plan View	Unknown: could be poor, rocky soil	VPA 3

View of the dominance by a vine in Vegetation Plot 2, considered a problem area of high concern. The planted woody vegetation is facing strangulation by the vine in this area.
(EMH&T, Inc. 9/18/09)

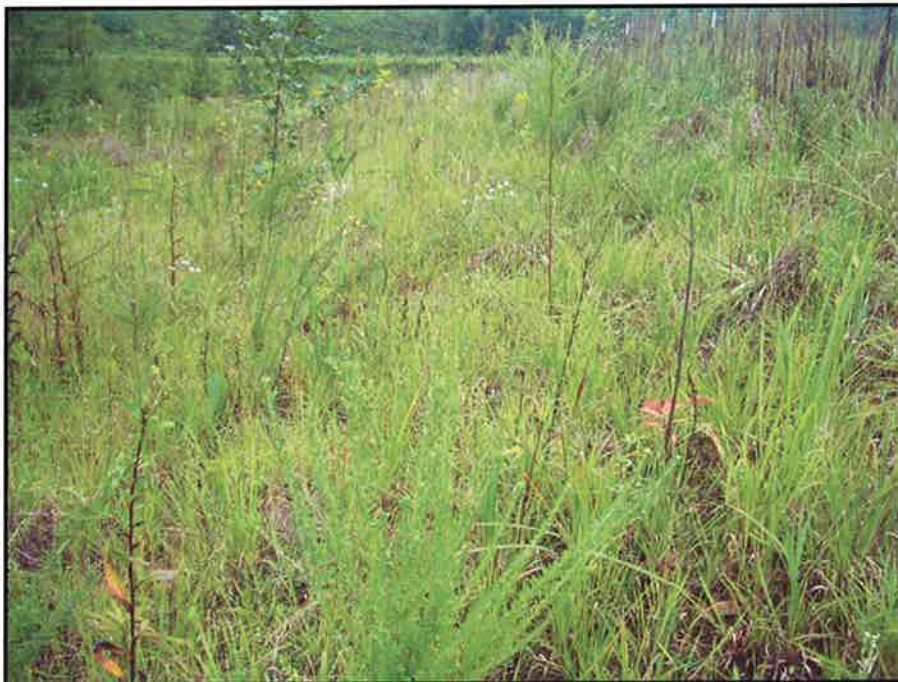
VPA 2

Several areas along the unnamed tributary were noted to have low overall herbaceous cover along the riparian corridor on the right bank. These areas are patchy and scattered throughout the corridor, with none of the areas showing banks that are completely bare. However, due to the threat by invasive species in the same areas along the tributary, particularly *Sericea lespedeza*, the sparse vegetation is noted as an area of concern. If the herbaceous cover does not increase, the open patches will provide an avenue for colonization and spread of the invasive species. The coverage of herbaceous vegetation and the spread of *Sericea lespedeza* along the right bank of the tributary are considered areas of low concern at this time, and will therefore be watched during future years of monitoring. In addition, proactive management in the form of herbicide treatments were conducted on the *lespedeza* throughout the fall, with follow-up planned for the spring, to limit the impact of this species on the vegetative success of the project.

Overview of the patchy spread of Sericea lespedeza along UT1, considered a problem area of low concern.
(EMH&T, Inc. 9/18/09)

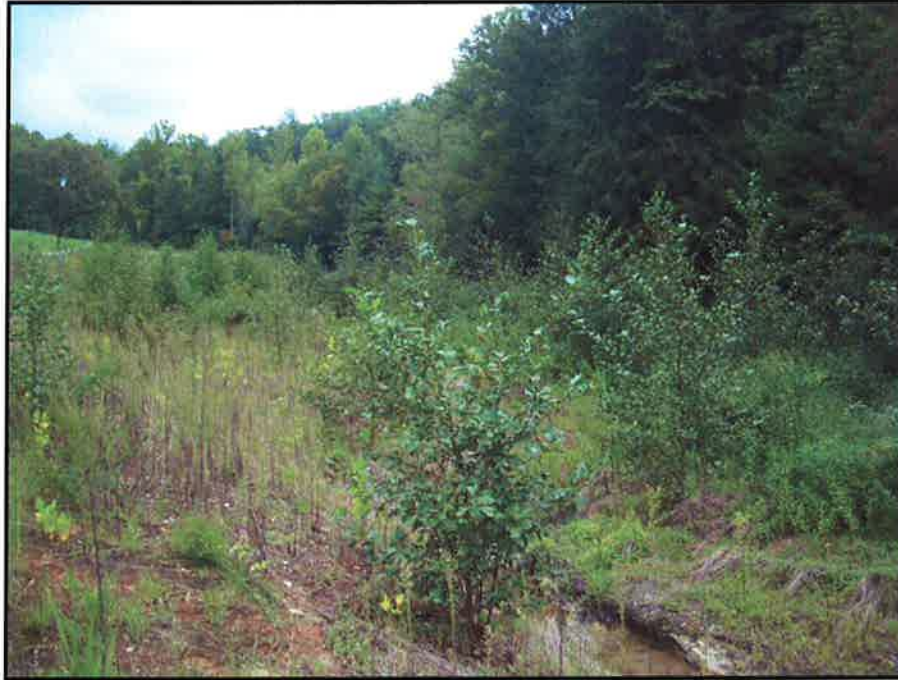
VPA 3

**View of the patchy vegetation along the right bank of UT1. This is only considered a problem due to the threat of spread by *Sericea lespedeza* in the same area of the project.
(EMH&T, Inc. 9/18/09)**

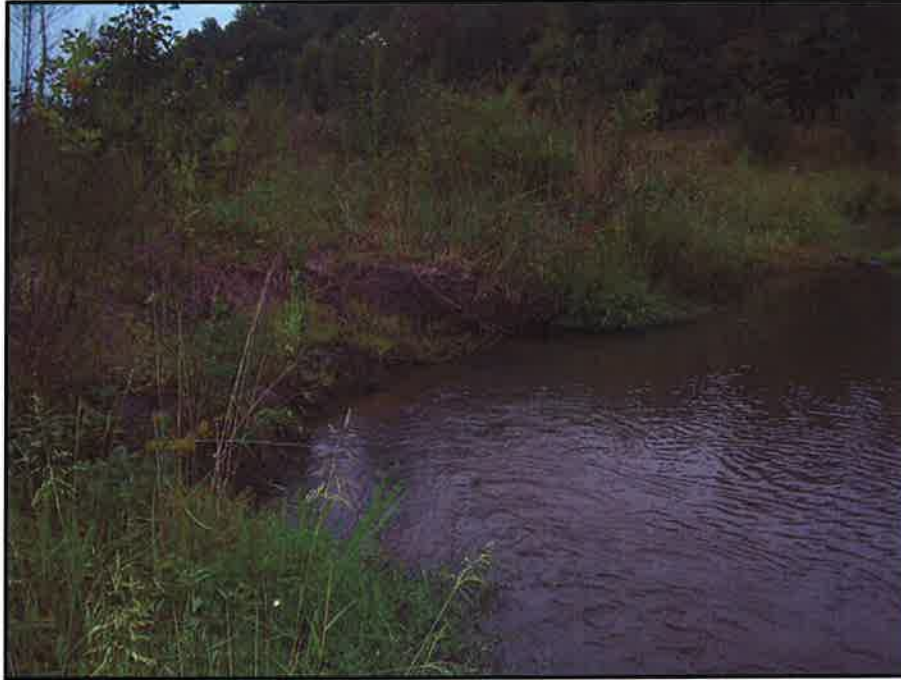
SPA 1

One small area of bank scour was noted along the outside bank of a meander along the Thompsons Fork Mainstem. The scour is isolated to a small area, and given the robust vegetation of the riparian corridor, this area is expected to remain isolated. This problem area is considered low concern at this time, as the scour area itself will likely become vegetated, providing natural bank stabilization without the need for mechanical intervention.

**Minor bank slumping along the left bank of Thomsons Fork near station 9+80.
(EMH&T, Inc. 9/18/09)**

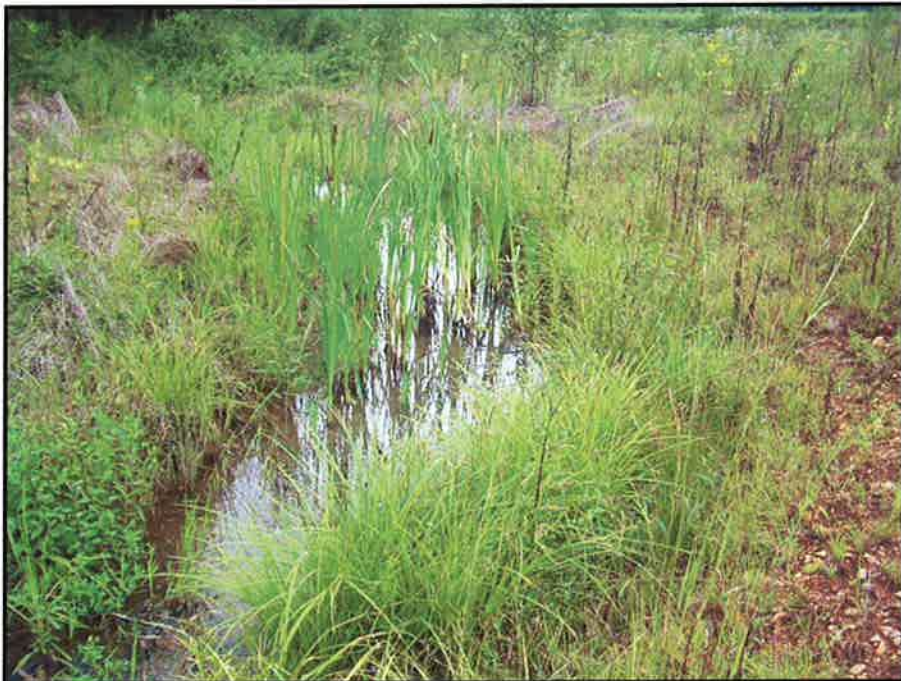
SPA 2

Table X. Stream Problem Areas			
Thompsons Fork Stream Restoration / EEP Project No. D06030-A			
Feature Issue	Station Numbers	Suspected Cause	Photo Number
Bank Scour	9+80 Mainstem	Scour at outside meander bend	SPA 1
Other	Scattered areas along Mainstem and UT; See SPA Plan View	Low flows allow wetland vegetation to colonize the stream channel, which could contribute to sedimentation	SPA 2,3

**Wetland vegetation forming within the stream channel on UT1. There are several wetland
areas found along this stream.
(EMH&T, Inc. 9/18/09)**

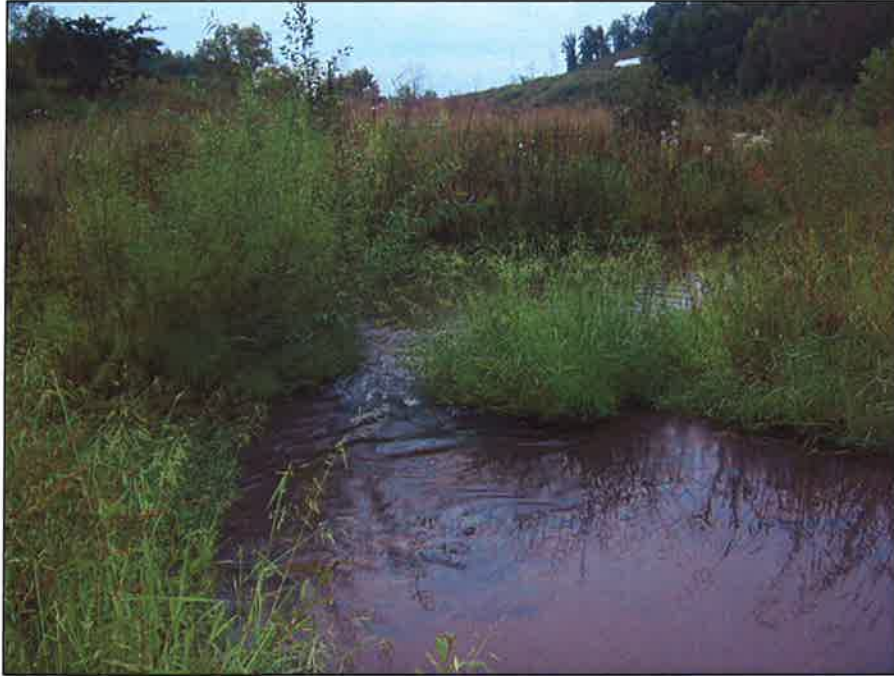
SPA 3

**Wetland vegetation forming within the stream channel on Thompsons Fork near station
8+75, causing a narrowing of the channel.
(EMH&T, Inc. 9/18/09)**
