Subject: Year 2 Monitoring Report for Stream Mitigation of Thompsons Fork
SCO# D06030-A

Year 2 Monitoring Report for Stream Restoration of Thompsons Fork and Unnamed Tributary

McDowell County, NC
SCO # D06030-A

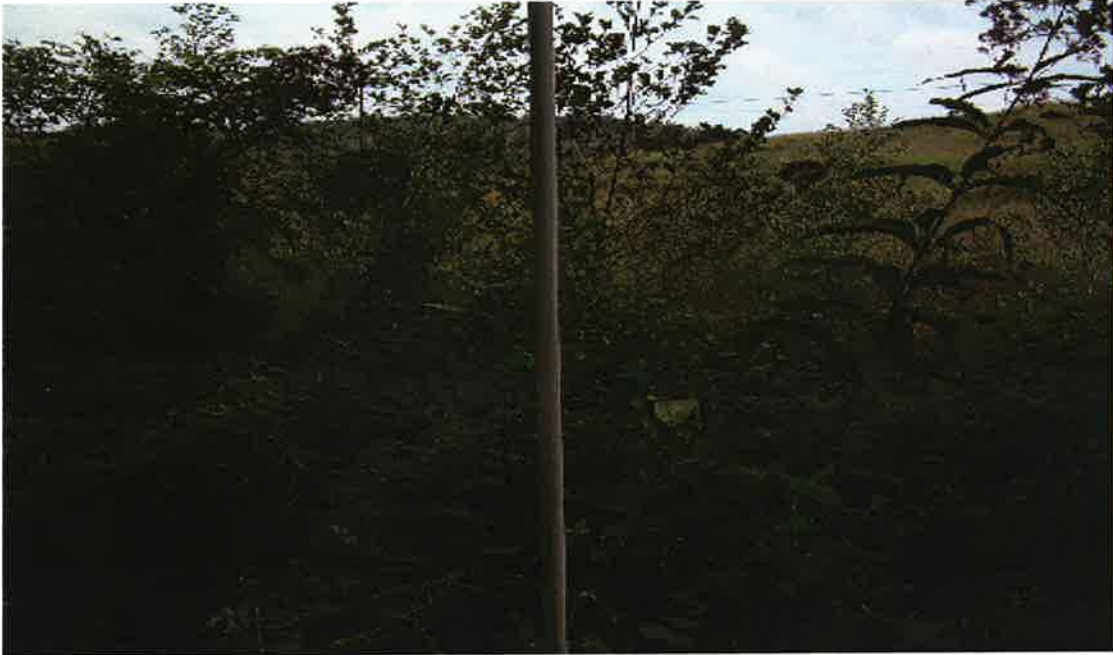
Table VII. Vegetative Problem Areas Thompsons Fork Stream Restoration / EEP Project No. D06030-A			
Feature/Issue	Station # / Range	Probable Cause	Photo #
Invasive Population	UT: See Plan View	Native Vine: encroachment from adjacent woodland	VPA 1
Bare Floodplain	UT: See Plan View	Unknown: could be poor, rocky soil	VPA 2

In 2010, vegetation problem areas occurred on both the right and left banks of the unnamed tributary. In 2009, a species of pea vine had spread into the riparian corridor from the adjacent wooded hillside, with the most dense concentration located in the area of Vegetation Plot 2. The species is a member of the pea family, likely *Amphicarpaea bracteata* (hog peanut), which is native to North Carolina. In the Year 1 monitoring report it was noted that the vine was strangling the woody vegetation in and around monitoring plot 2, where approximately 80% of the planted

View of Vegetation Plot 2 showing the decline in the coverage of unknown vine. This vine is considered a problem area of low concern.

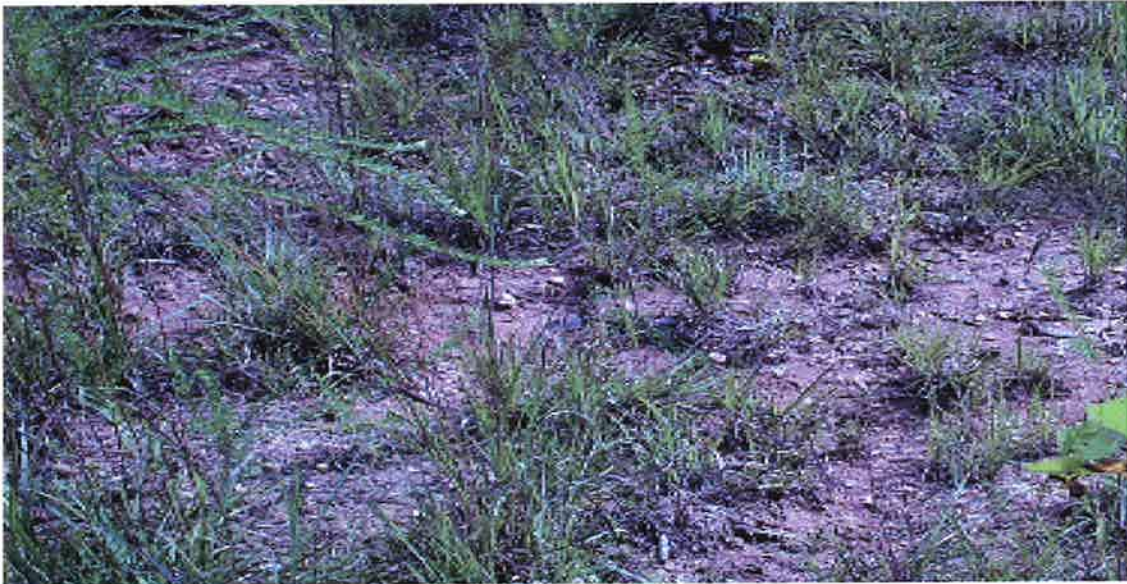
VPA 2

Again in Year 2, several areas along the unnamed tributary were noted to have low overall herbaceous cover along the riparian corridor on the right bank. These areas are patchy and scattered throughout the corridor, with none of the areas showing banks that are completely bare. However, due to the threat by invasive species in the same areas along the tributary, particularly the pea vine mentioned above, the sparse vegetation is noted as an area of concern. If the herbaceous cover does not increase, the open patches will provide an avenue for colonization and spread of invasive species. During 2010 vegetation monitoring however, colonization by invasives did not appear to be happening to any alarming degree.

of the patchy vegetation along the right bank of UT1. This is only considered a problem due to the threat of spread by invasives in the same area of the project.

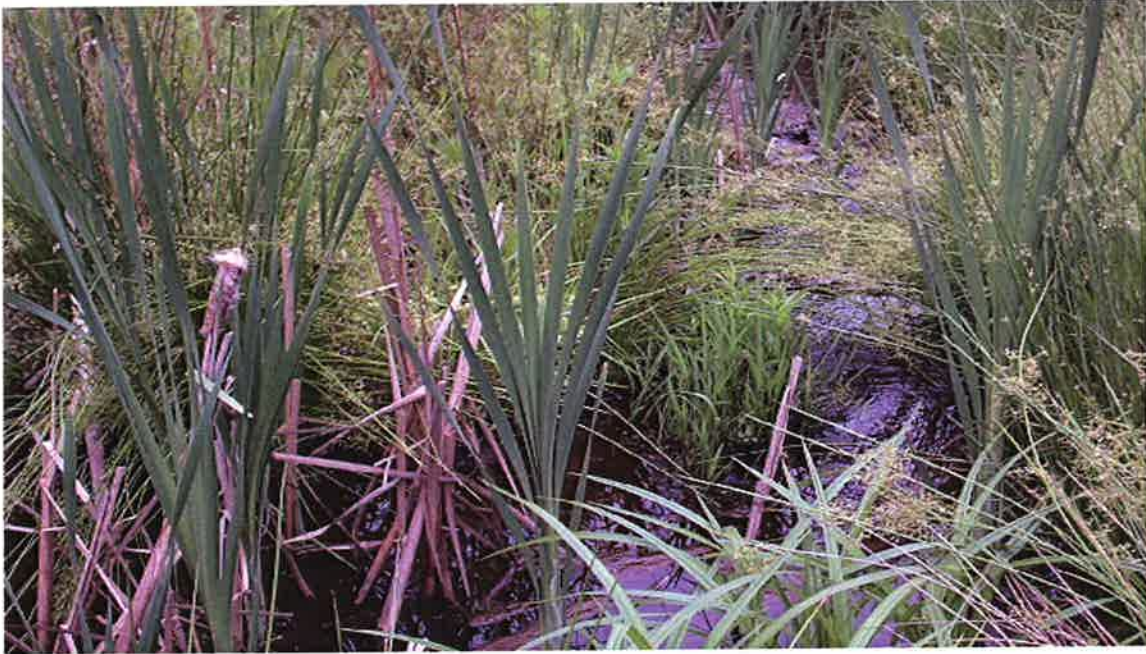
SPA 1

Table X. Stream Problem Areas			
Thompsons Fork Stream Restoration / EEP Project No. D06030-A			
Feature Issue	Station Numbers	Suspected Cause	Photo Number
Aggradation	Scattered areas along UT (mostly) and Mainstem; See SPA Plan View	Low flows allow wetland vegetation to colonize the stream channel, which is contributing to sedimentation	SPA 1,2

As in 2009, in 2010 there was observed to be scattered areas throughout the project reaches that are developing wetland vegetation within the stream channel, particularly along the unnamed tributary. While the wetland vegetation is beneficial for water quality, there is the potential that the vegetation will decrease flows, particularly during times of low flow, thereby allowing sediment to drop into the channel. This type of problem tends to exacerbate itself, as continuing sedimentation allows for further colonization and growth of wetland plants.

This positive feedback loop is most evident on the tributary. Over the past year, sedimentation has continued along the mid-upper half of this reach. Cattails and other wetland vegetation are now established in the channel where sedimentation is most pronounced. The past year's sedimentation has caused the D50 of the tributary's particle distribution to fall into the medium sand category. Because of this, the tributary has changed shifted from a C4 channel classification to a C5 classification. Areas with sedimentation are marked on the stream problem area map as high concern areas. It has been recommended to the client that the channel be cleared of excessive sediment and wetland vegetation and restored back to a more functional channel morphology. The client has agreed to this management and will complete it in the winter of 2010. After channel maintenance has occurred, it will be watched in future years to ensure the channel remains viable as a stream, and does not begin to aggrade into a linear wetland type feature.

Wetland vegetation forming within the stream channel on UT1. There are several wetland areas found along this stream.

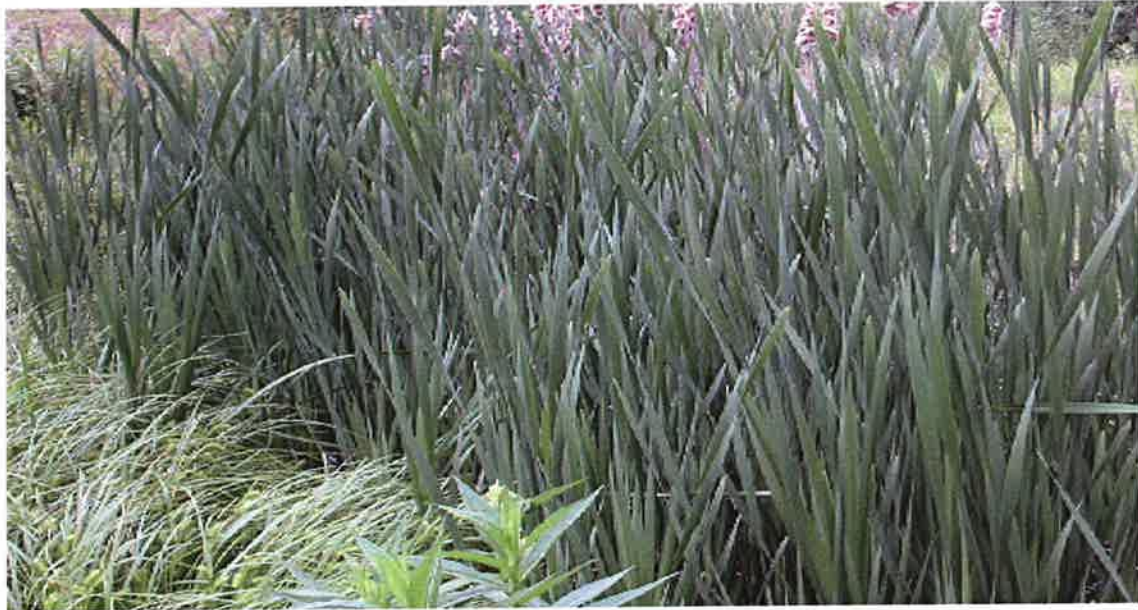
SPA 2

Wetland vegetation forming within the stream channel on UT1. There are several wetland areas found along this stream.
