Year 3 Monitoring Report for Stream Restoration of Thompsons Fork and Unnamed Tributary

McDowell County, NC
SCO # D06030-A

Submitted: December, 2011

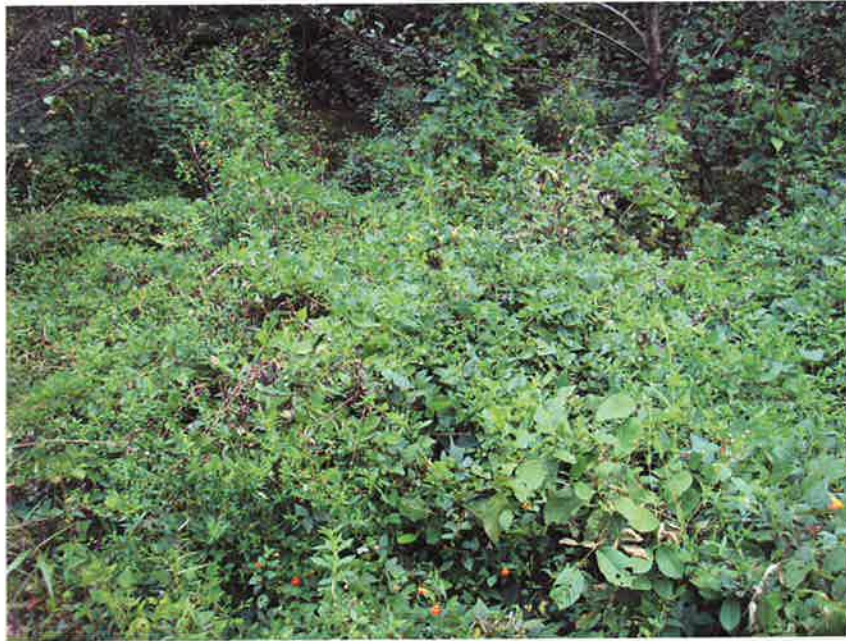
VPA 1

Although treatments appear to be working to some degree, the vine has continued to spread during Year 3 and is affecting a larger area of the riparian corridor along the UT (see Vegetation Problem Area Plan View, Appendix A). Woody plantings installed in late 2009 are beginning to be impacted by the fast growing pea vine. The vine remains a vegetation problem area of high concern in 2011. Spraying will continue to be recommended in order to keep the vine under control within the project corridor. Intensive herbicidal spraying was conducted in the fall of 2011 in order to combat the spread of the vine. Another round of spraying is scheduled for the spring of 2012. The spread of hog peanut vine will be closely monitored and documented during all future years of monitoring.

During 2011 vegetation monitoring, colonization by the problematic hog peanut vine did appear to be happening to an alarming degree along the left bank of the UT. Since 2010 (Year 2), the vine has continued to spread and is now infiltrating the right bank of the tributary, along the majority of its length. The vine is not restricted to areas with low density herbaceous cover, however. Areas observed to have low overall herbaceous cover in Year 2 have seen an increase in native cover over the past year. Due to the reason listed above, areas with lower overall herbaceous cover were not included as vegetation problem areas in Year 3.

**A view along the left bank of UT1 around station 10+00; the spread of hog peanut (*Amphicarpaea bracteata*) vine is apparent.
(EMH&T, 9/15/11)**

Vegetative monitoring was completed in September 2011 following the Carolina Vegetation Survey methodology. Stem counts completed at eight vegetation plots show an average density of 937 stems per acre for the site. This is a significant increase over the Year 2 total of 704. This density exceeds the success criteria of 320 stems/acre after three years of monitoring. All individual plots had stem densities meeting the minimum requirement. Additionally, a large number of recruit stems were found in each plot. A vegetative problem area of high concern was noted in the project area along the riparian corridor of the UT. This problem area includes a growing population of a rapidly spreading vine in the pea family; most likely hog peanut vine (*Amphicarpaea bracteata*). The problematic vine has been proactively managed by herbicide treatment over the past two years. However, the vine continues to spread and increase in density. An intensive herbicidal spraying effort was conducted in the fall of 2011 to knock down the spread. Another spraying effort will be conducted in the spring of 2012.

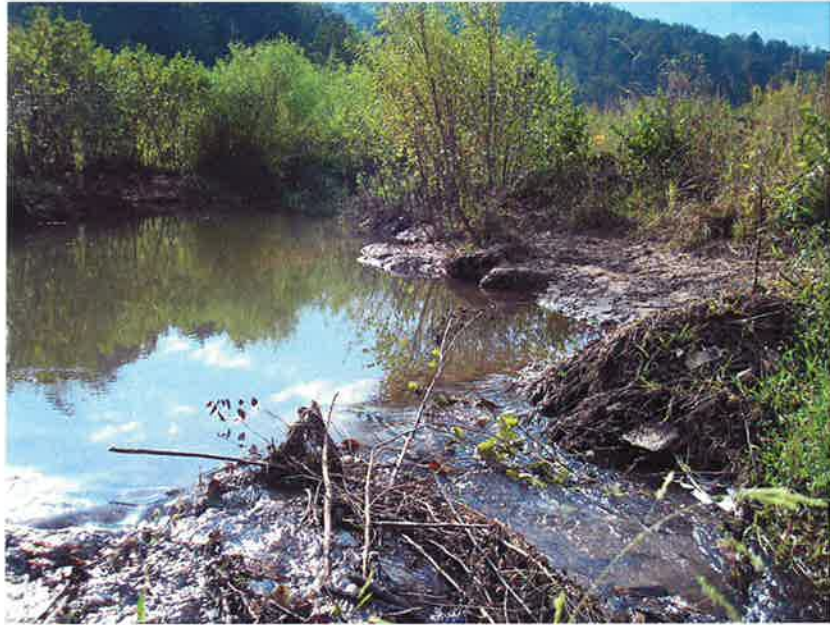
SPA 1

Feature Issue	Station Numbers	Suspected Cause	Photo Number
Bank scour	24+00 , 19+35 and 8+25 on Mainstem	A) Beaver dams caused scour and washout of both right and left bank at stations 24+00 and 19+35. B) Left bank scour most likely caused by a high flow event	SPA 1,2 & 3

Current stream problem areas for Year 3 are located at 3 different stations along the mainstem of Thompsons Fork (see Table X, above). No stream problem areas were noted for the UT. All problem areas for 2011 were scour and bank failure issues. The observed erosion and scour at stations 24+00 and 19+35 (see Stream Problem Area Map, Appendix B) were the result of beaver dams that were constructed in the spring of 2011 and fall of 2010, respectively. Even though both dams were deconstructed within a few months of being built, significant scour and erosion resulted on both the right and left banks at these stations. It is likely that high flow events created excessive erosional flow around the sides and top of each dam. Pictures of the resultant erosion at

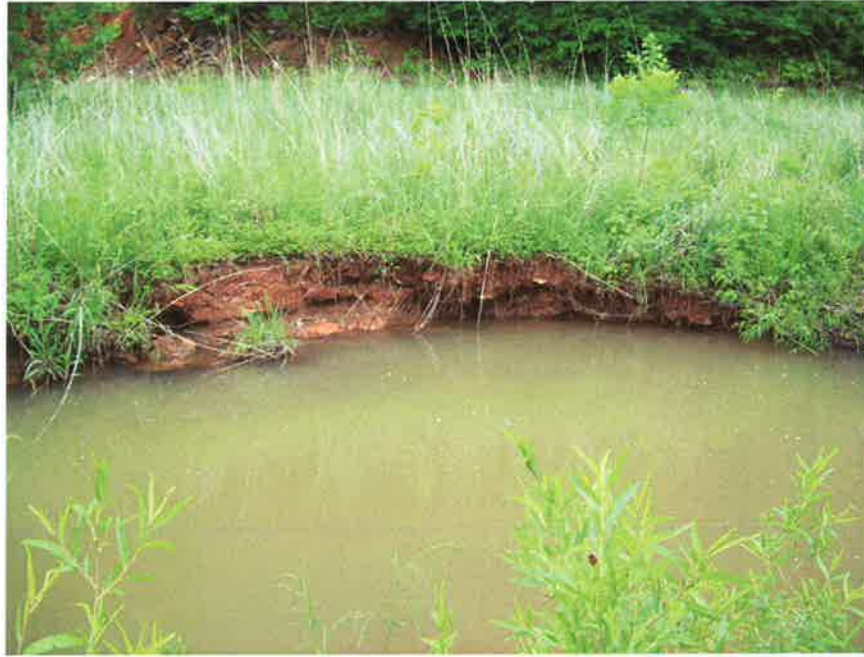
SPA 3

The final area of bank erosion noted in Year 3 was observed on the right bank of a meander bend at station 8+25 on the mainstem. It appears that the sloughing in this area was caused by a high flow event. It is expected that the bank sloughing at this station will be corrected once vegetation establishes on the newly exposed soil. This area will be closely monitored in 2012 in order to assess bank stability. At this time, station 8+25 is being considered a stream problem area of low concern and is demarcated by a yellow scour symbol on the Stream Problem Area Map in Appendix B.

**Scour and sloughing along the right bank of Thompsons Fork Mainstem at station 8+25.
(EMH&T, 9/15/11)**

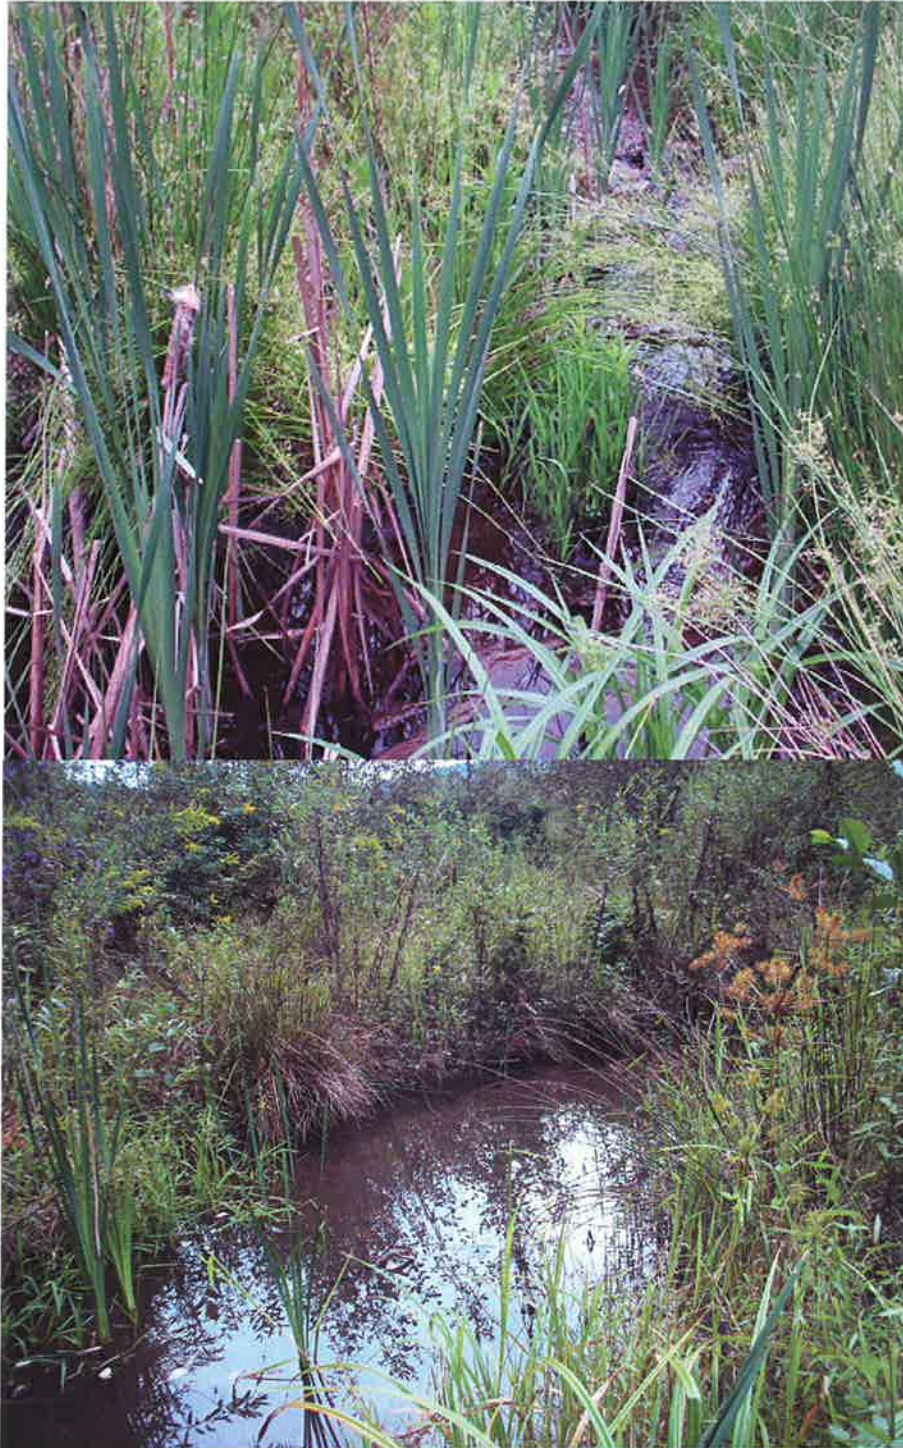
SPA 4 *(resolved)*

In 2009 and 2010, it was observed that aggradation was occurring along the channel of the UT (mostly in the upstream half of the restoration reach). This aggradation led to the colonization of wetland vegetation within the stream channel. It was decided there was a potential the vegetation would decrease channel flow capacity and reduce flow velocities during times of low flow. The reduced flow velocities could likely have led to deposition of additional sediment and continued aggradation within the channel. In order to deter continued sedimentation within the channel and further colonization and growth of wetland plants that would affect channel morphology and performance, channel maintenance was suggested in Year 2.

Aggradation (noted in Years 1 and 2) along the UT has been improved significantly in Year 3 due to the stream maintenance, which was previously discussed. Sedimentation that occurred in some of the pools located near grade-controlling log sills has been alleviated. All pools and associated log sills are still present and functional throughout the stream channel and their stability has increased since the conclusion of maintenance activities. Aggradational trends will be closely monitored for the UT in 2012.
