Subject: Year 4 Monitoring Report for Stream Mitigation of Thompsons Fork
SCO# D06030-A

Year 4 Monitoring Report for Stream Restoration of Thompsons Fork and Unnamed Tributary

McDowell County, NC
SCO # D06030-A

Submitted: December, 2012

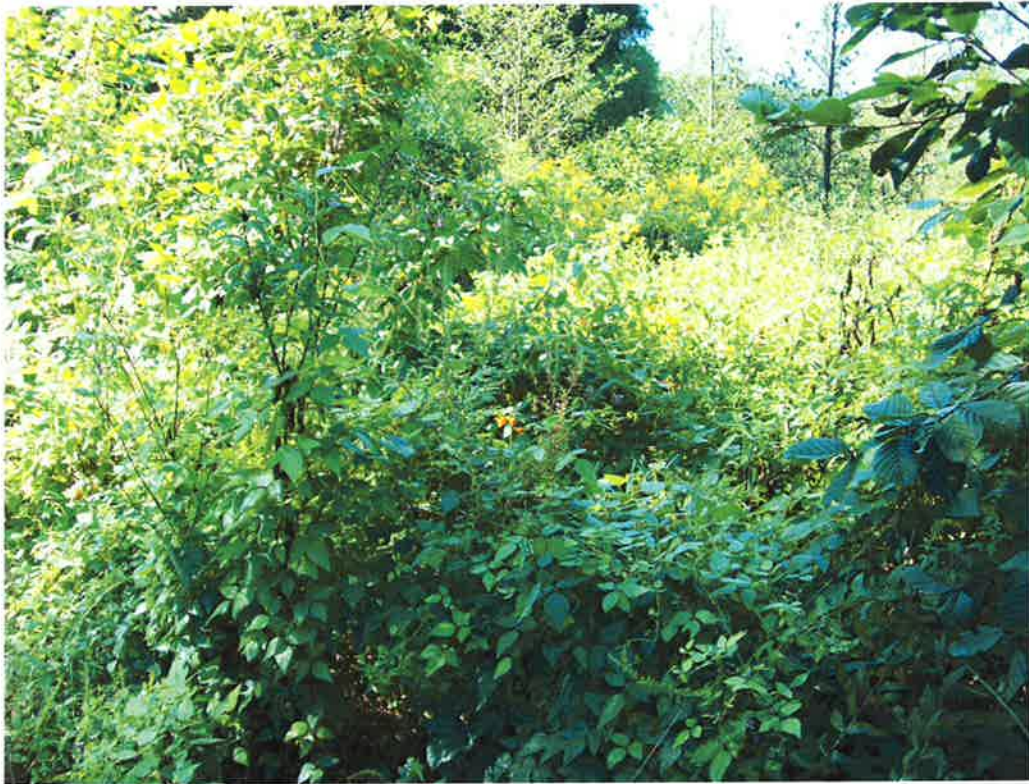
Table VII. Vegetative Problem Areas Thompsons Fork Stream Restoration / EEP Project No. D06030-A			
Feature/Issue	Station # / Range	Probable Cause	Photo #
Invasive Population (likely: Hog Peanut vine - <i>Amphicarpaea bracteata</i>)	UT: See Vegetation Problem Area Plan View (Appendix A)	Native Vine: encroachment from adjacent woodland	VPA 1

A view along the left and right bank of UT1 around station 13+50; the spread of hog peanut vine is apparent. Picture was taken at station 12+30, facing upstream. Vegetation plot 2 is just out of view of the camera, on the left.

The herbicide treatments appear to be working, as the vine has slowed its spread and density in Year 4. Woody plantings installed in late 2009 are no longer being impacted by the fast growing pea vine. Although the vine cover has been much reduced over the past few years, it remains a vegetation problem area of high concern in 2012. Spraying will continue to be recommended in order to keep the vine under control within the project corridor. Another round of intensive herbicide spraying is scheduled for the spring of 2013. The spread of hog peanut vine will be closely monitored and documented during the fifth and final year of monitoring.

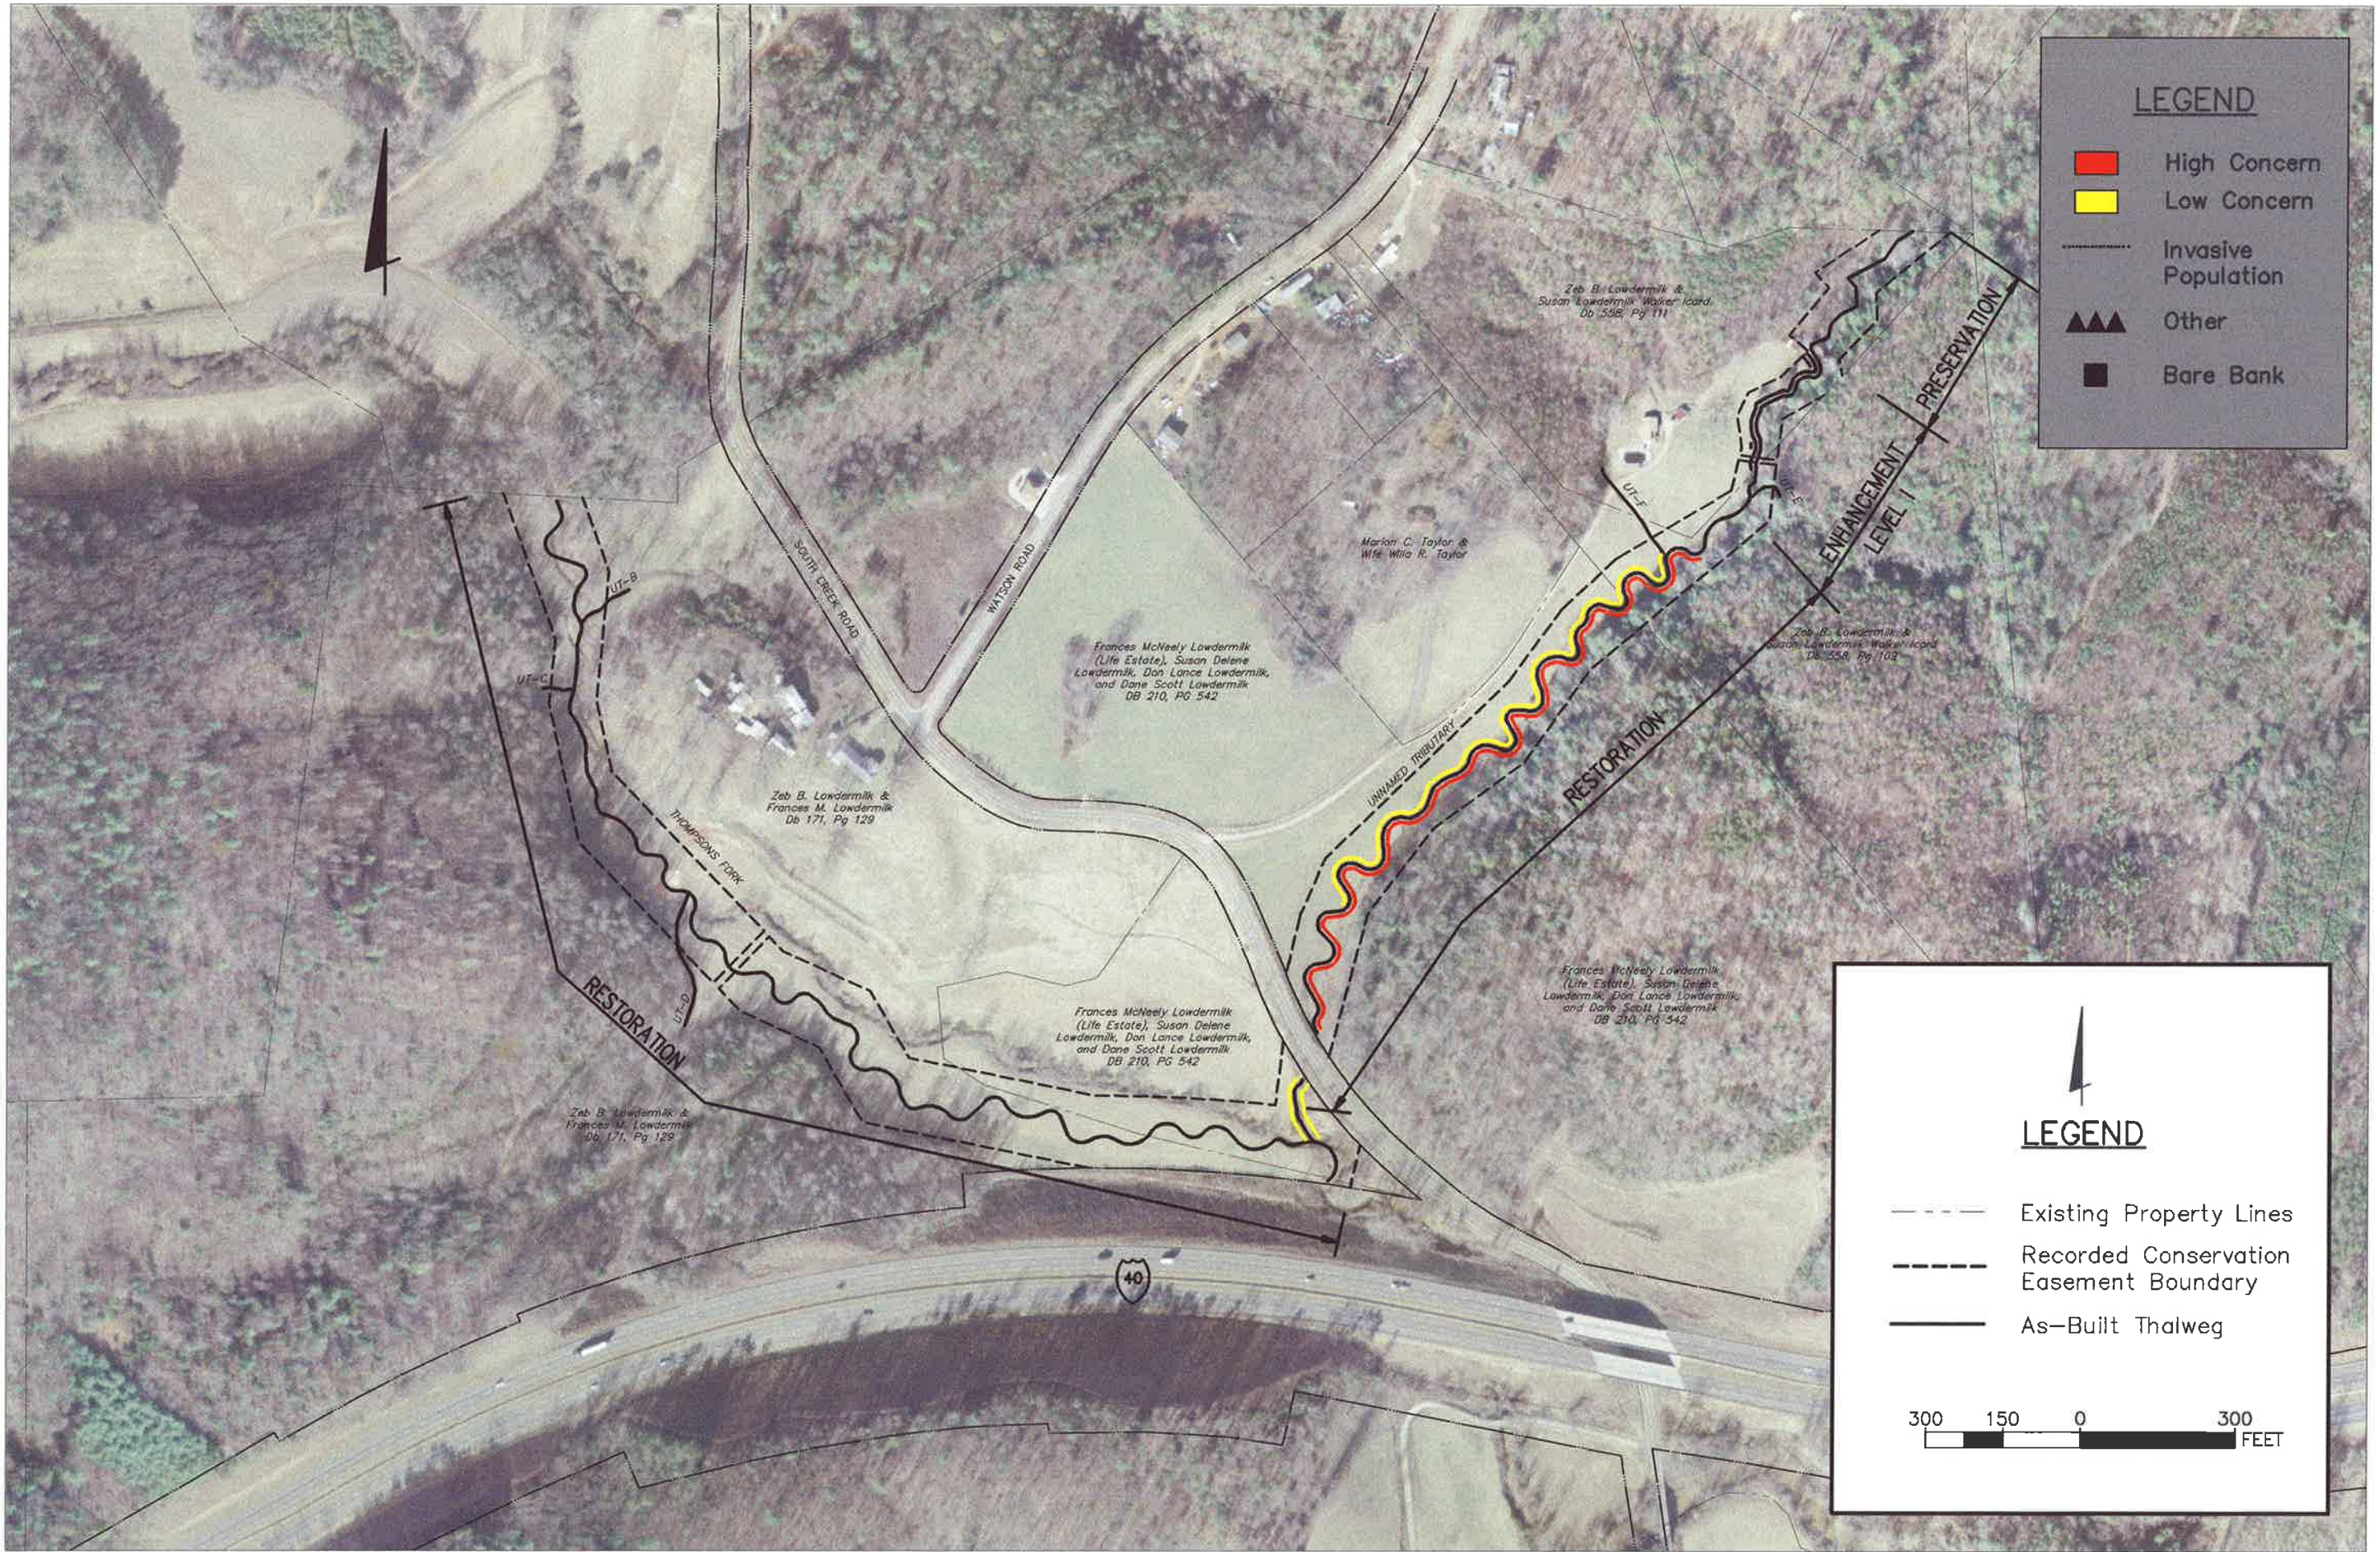
In 2010, vegetation problem areas occurred on both the right and left banks of the unnamed tributary. In 2009, a species of pea vine had spread into the riparian corridor from the adjacent wooded hillside, with the most dense concentration located in the area of Vegetation Plot 2. The species is a member of the pea family, likely *Amphicarpaea bracteata* (hog peanut), which is native to North Carolina. In the Year 1 monitoring report it was noted that the vine was strangling the woody vegetation in and around monitoring plot 2, where approximately 80% of

During 2012 vegetation monitoring, colonization by the problematic hog peanut vine did appear to be happening to the largest degree along the left bank of the UT. Since 2010 (Year 2), the vine has continued to spread and is now infiltrating the right bank of the tributary, along the majority of its length. The vine is not restricted to areas with low density herbaceous cover, however. Areas observed to have low overall herbaceous cover in Year 2 have seen an increase in native cover over the past two years. Due to the reason listed above, areas with lower overall herbaceous cover were not included as vegetation problem areas in Year 4.
