YEAR 3 (2011)
ANNUAL MONITORING REPORT
THREE MILE CREEK RESTORATION SITE
AVERY COUNTY, NORTH CAROLINA
(Contract #16-D06125-A)

FULL DELIVERY PROJECT
TO PROVIDE STREAM AND WETLAND MITIGATION
IN THE FRENCH BROAD RIVER BASIN
CATALOGING UNIT 06010108

October 2011

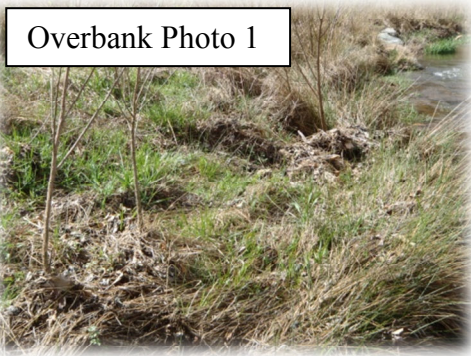
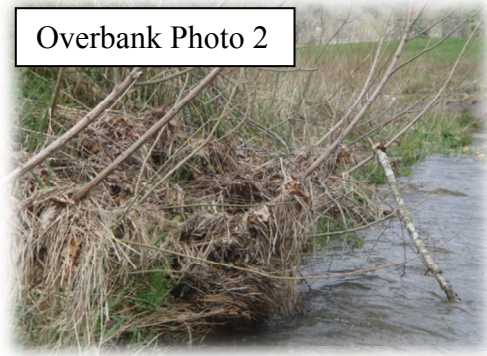
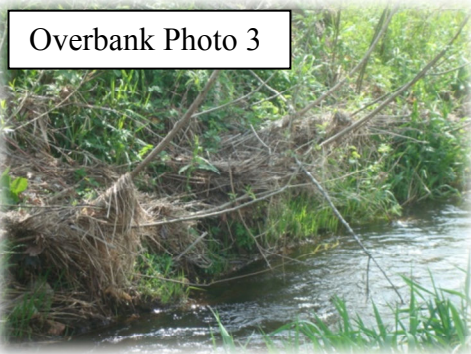
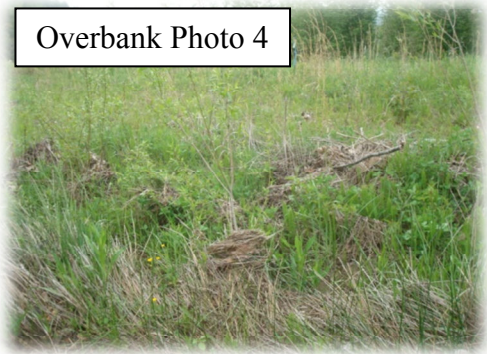
Date of Data Collection	Date of Occurrence	Method	Photo (if available)
April 2011	March 5-6, 2011	Total of 2.5 inches* of rain documented between March 5-6, 2011 at weather station 2.7 miles southwest of site	Photo 1-2
May 2011	April 15-16, 2011	Total of 4.09 inches* of rain documented between April 15-16, 2011 at weather station 2.7 miles southwest of site	Photo 3-4

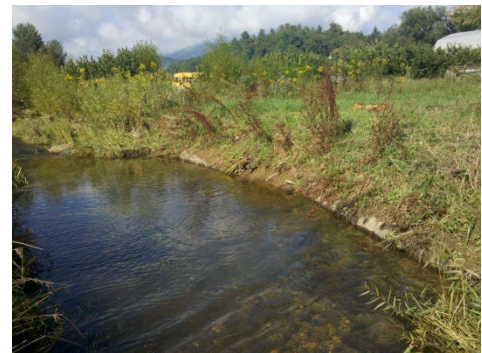
During a heavy, flashy rain event in April 2011, an outer bend near Cross-section 6 was compromised; however, up- and downstream of the outerbend remained stable. The outer bend was repaired and replanted in September 2011, and is doing well (see photo). The outerbend will continue to be monitored closely. The only remaining stream problem area noted within the Site during the Year 3 (2011) monitoring year includes aggradation within a portion of Tributary 1. Aggradation has resulted from the installation of a dirt driveway on the neighboring property in 2010. This reach should be watched over time to ascertain any instability.
