YEAR 4 (2012)
ANNUAL MONITORING REPORT
THREE MILE CREEK RESTORATION SITE (EEP Project# 92664)
AVERY COUNTY, NORTH CAROLINA
(Contract #16-D06125-A)

**FULL DELIVERY PROJECT
TO PROVIDE STREAM AND WETLAND MITIGATION
IN THE FRENCH BROAD RIVER BASIN
CATALOGING UNIT 06010108**

February 2013

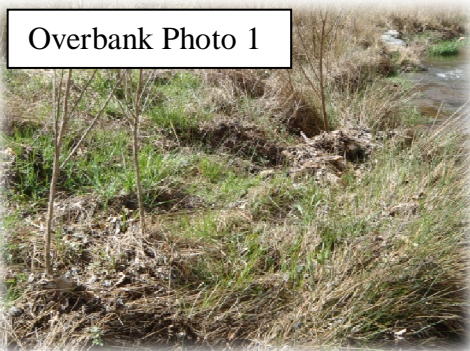
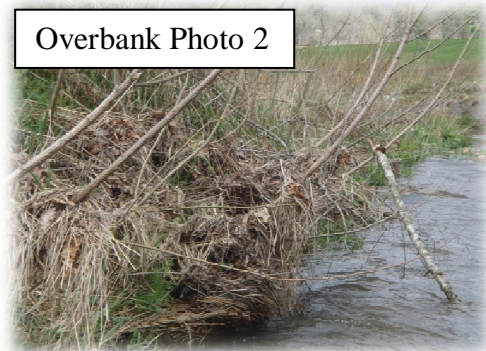
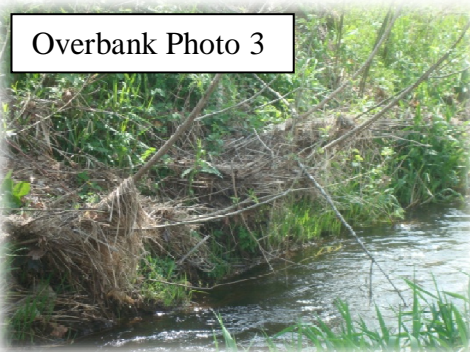
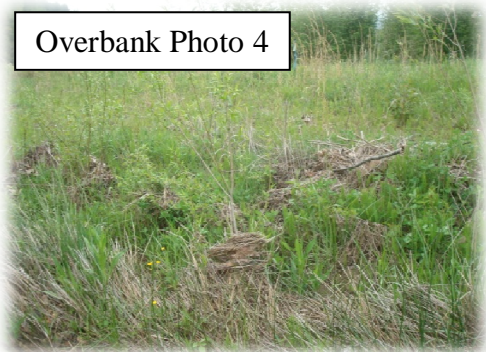
Date of Data Collection	Date of Occurrence	Method	Photo (if available)
April 2011	March 5-6, 2011	Total of 2.5 inches* of rain documented between March 5-6, 2011	Photo 1-2
May 2011	April 15-16, 2011	Total of 4.09 inches* of rain documented between April 15-16, 2011	Photo 3-4
July 23, 2012	May 29, 2012	Total of 1.81 inches* of rain documented on May 29, 2012 after a total of 3.85 inches occurring during the previous 3 week period	--

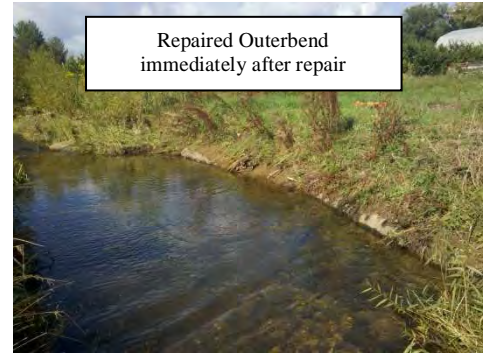
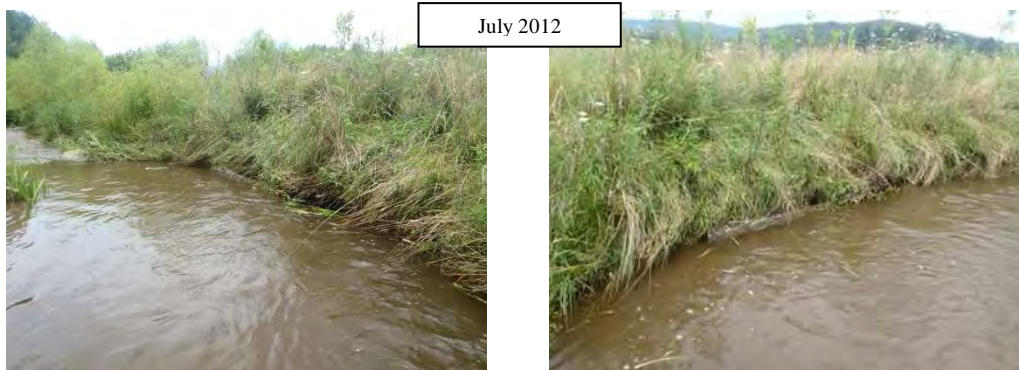
During a heavy, flashy rain event in April 2011, an outer bend near Cross-section 6 was compromised; however, up- and downstream of the outerbend remained stable. The outer bend was repaired and replanted in September 2011, and is doing well (see photos). The outerbend will continue to be monitored closely. The only remaining stream problem area noted within the Site includes aggradation within a portion of Tributary 1, which has resulted from the installation of a dirt driveway on the neighboring property in 2010. Aggradation of sediment in this reach has altered stream flow, which is currently bypassing a portion of the constructed channel. A walkthrough of the reach with NCEEP representatives is being scheduled to determine the appropriate course of action.
