YEAR 5 (2013)
ANNUAL MONITORING REPORT
THREE MILE CREEK RESTORATION SITE
AVERY COUNTY, NORTH CAROLINA
(Contract #16-D06125-A)

FULL DELIVERY PROJECT
TO PROVIDE STREAM AND WETLAND MITIGATION
IN THE FRENCH BROAD RIVER BASIN
CATALOGING UNIT 06010108

November 2013

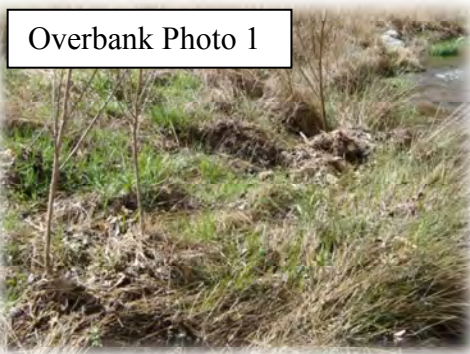
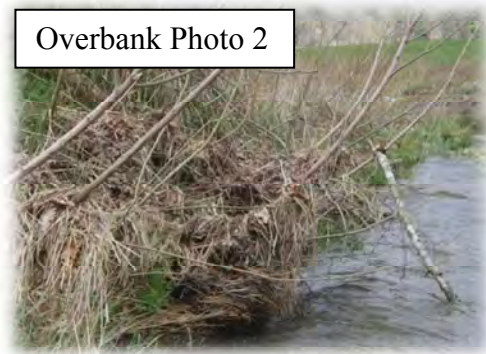
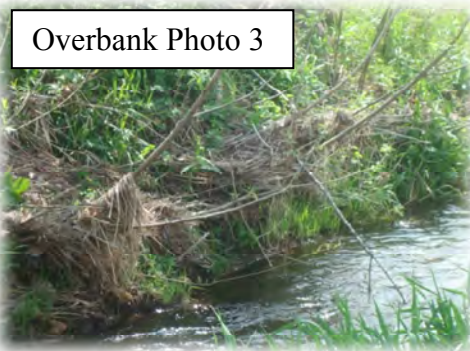
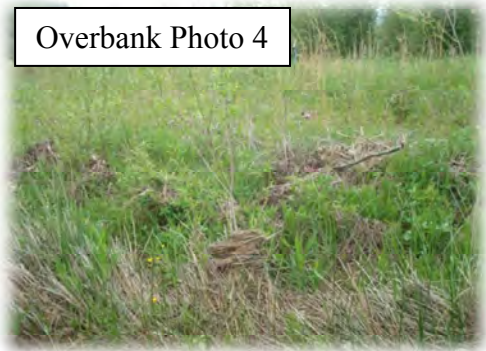
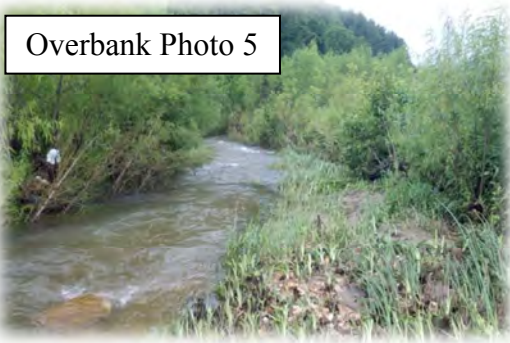
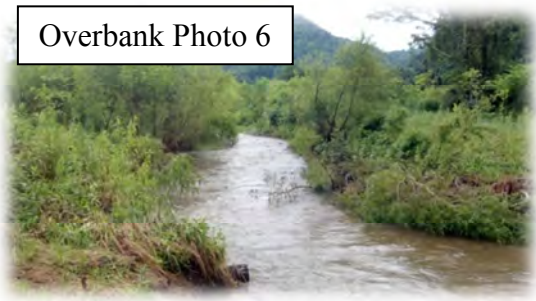
Date of Data Collection	Date of Occurrence	Method	Photo (if available)
April 2011	March 5-6, 2011	Total of 2.5 inches* of rain documented between March 5-6, 2011	Photo 1-2
May 2011	April 15-16, 2011	Total of 4.09 inches* of rain documented between April 15-16, 2011	Photo 3-4
July 23, 2012	May 29, 2012	Total of 1.81 inches* of rain documented on May 29, 2012 after a total of 3.85 inches occurring during the previous 3 week period	--
July 11, 2013	June 30- July 7, 2013	A total of 11.2 inches* of rain fell over a period of eight days	5-6
