**Tick Creek Stream Restoration Project – Project # 379  
Chatham County, North Carolina**

**First Annual Monitoring Report - FINAL  
February 2006**

**TICK CREEK STREAM RESTORATION – Project # 379**  
**2006 MONITORING REPORT**

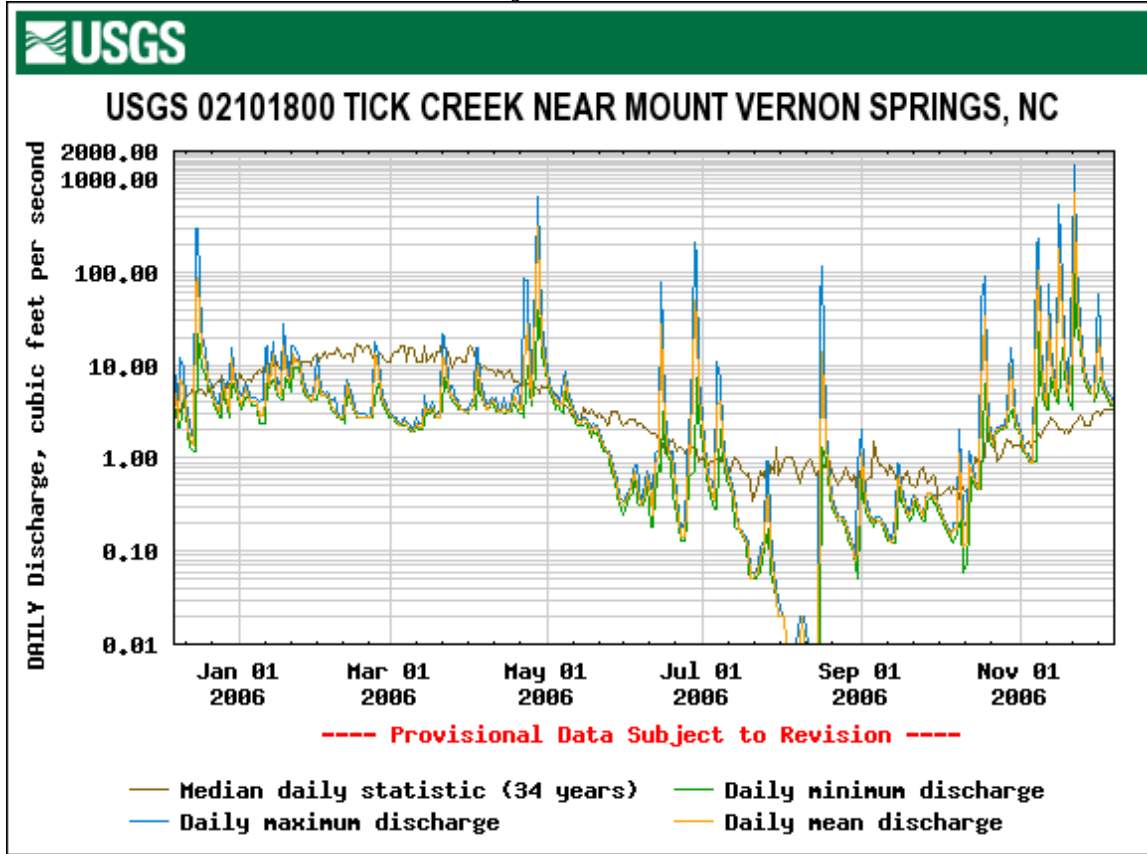
**Figure 3. USGS Stream gauge data for Tick Creek upstream of US 421 - Tick Creek Stream Restoration - EEP Project #379**

No crest gauges are installed on the Tick Creek site and on-site quantitative hydrologic evaluation is not possible. Qualitative evaluation did not indicate any bankfull events during the first growing season. During the September 2006 evaluation, no flowing water was observed. Water was present, along with fish and amphibians, only in pools.

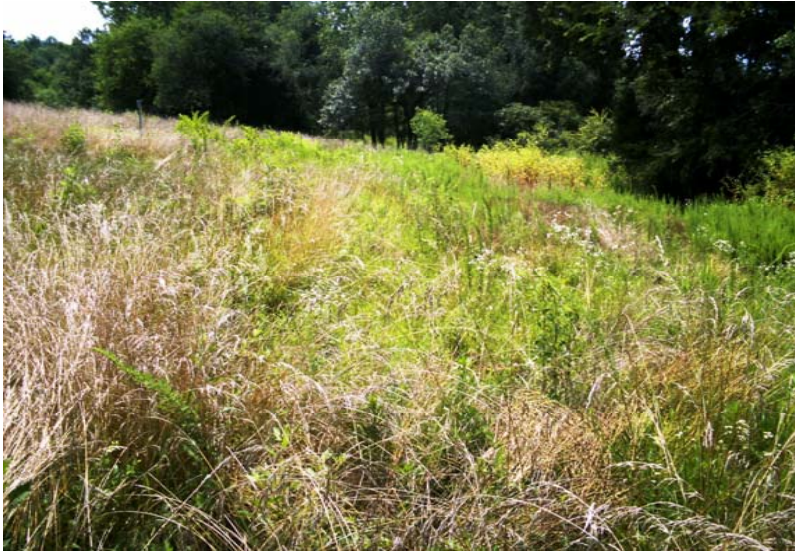
Feature/Issue	Station/Range	Probable Cause	Photo #
No/Limited Planting	00-320	Planting Crew Oversight	VP1
Dense herbaceous invasives	565-1525	Abundant groundwater	VP2
Lower planted woody stem success (relative to Reaches 1 and 2)	2300-2630	Soil Compaction During Construction	VP3

Woody stem planting in the areas furthest from the stream banks was sporadic, minimal, and absent in some places. Because of the lack of overstory from mature trees, which are present in Reach 2 and most of Reach 3, early successional herbaceous volunteer density and relative cover was high (dog fennel (*Eupatorium capillofolium*), and horseweed (*Conyza canadensis*)). Invasive woody volunteers were not quantitatively observed in Reach 1's monitoring plots, and were relatively sparse outside the plots. This type of early successional herbaceous density is common in recently disturbed areas and can be beneficial to the planted stems by prolonging soil moisture in upland areas and reducing early evapotranspiration, provided invasive woody species don't also colonize, and the newly planted *understory* of woody stems remains successful.

**VP1. Sparse Woody Stem Planting**

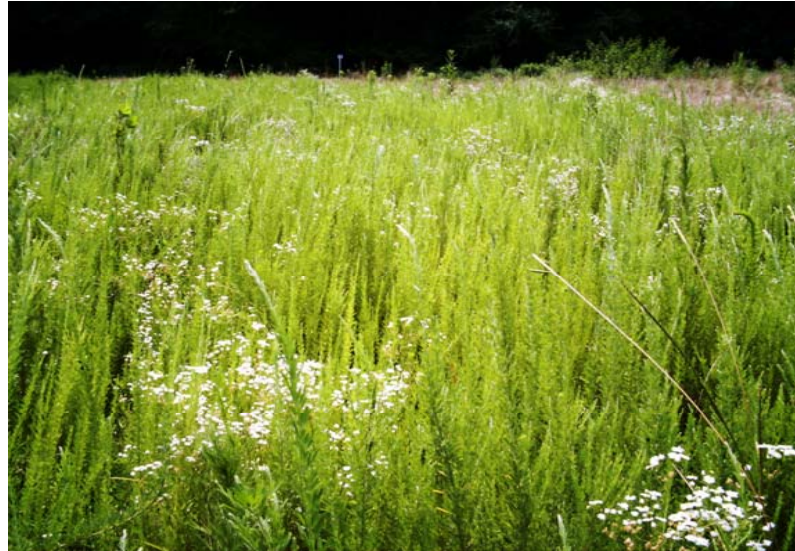
Reach 2 had good success rates for planted individuals, but invasion from autumn olive (*Eleagnus umbellata*), mimosa (*Albizia julibrissin*), and Chinese and Japanese privet (*Ligustrum sinense* and *L. japonicum*, respectively) has begun. In addition to invasive exotic woody species colonization, many native early-successional woody species have begun to colonize Reach 2 (e.g. red maple (*Acer rubrum*), sweet gum (*Liquidambar styraciflua*), Southern red cedar (*Juniperus virginiana*), black cherry (*Prunus serotina*), and Virginia creeper (*Parthenocissus quinquefolia*). These aggressive early-successional woody volunteers are common, and in some places quite dense, in the adjacent undisturbed (during restoration) forests. Because of this, successful management of these species within the restoration area may be difficult, without also eliminating them from the adjacent forest understory. Similarly, the invasive herbaceous Chinese lespedeza (*Lespedeza cuneata*) is relatively dense in portions of Reach 2, especially where groundwater is at the surface. The planted woody stem success under these invasive herbaceous stands is relatively high, so continued observation, without remedial action, is appropriate.

**VP2. Exotic Herbaceous and Woody Invasion**

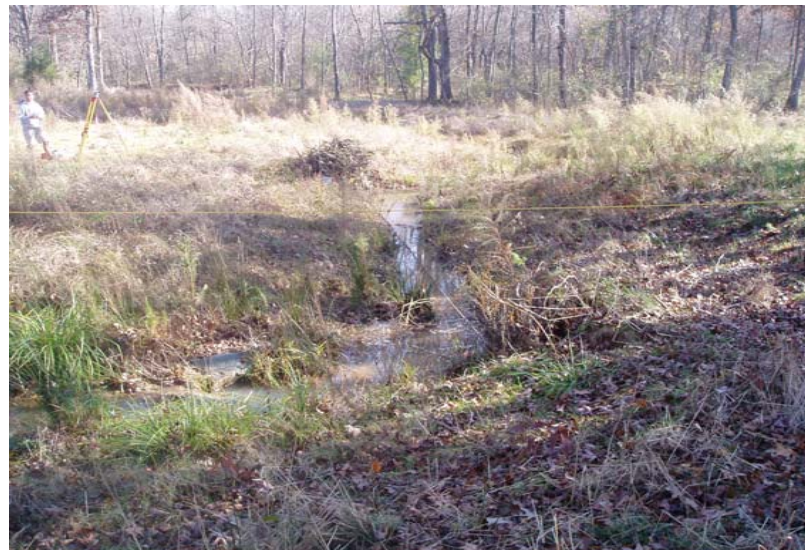
Reach 3 had planted woody stem density well above the targeted 320 stems per acre, and relatively minimal invasive species problems. A number of dead individuals were observed along the inside of Reach 3's final large bend. Invasive individuals were present, but much less dense than in either Reach 1 or Reach 2. A suspected cause of the relatively high mortality inside this large bend is substrate compaction. The Restoration Design Plan View map indicates that a relatively large *staging area* was located here during construction. Because of the adequate live planted stem density in plot 6 no remedial action is recommended at this time. Like in the Reach 1 and Reach 2 problem areas, continued observation is appropriate.

**VP3. Relatively Low Planting Success**

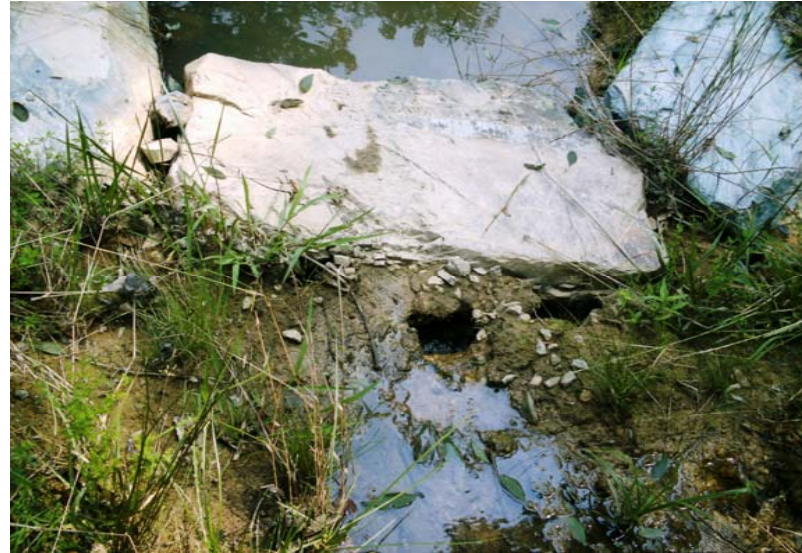
The only potential future structural problems observed were the 18 locations where, during low flow, water flows under, and through the surface rock cross vanes. Water usually *daylights* at or near the surface of downstream pools, above the supporting rock layer. These sites are not considered true *back cuts*, as they only occur between rocks, during extremely low flow conditions. Immediate remedial action is therefore not recommended but on-going observation is appropriate, particularly the downstream-most site (station 27+54), which appears to be growing.

<b>Exhibit Table X. Stream Problem Areas - Tick Creek Stream Restoration - EEP Project #379</b>			
<b>Feature/Issue</b>	<b>Station</b>	<b>Probable Cause</b>	<b>Photo #</b>
Cross Vane Piping/backcutting	290	No coarse backfill	SP1 & 2
Cross Vane Piping/backcutting	545	No coarse backfill	
Cross Vane Piping/backcutting	625	No coarse backfill

**SP2. Piping and minor backcutting (hook/vane)**

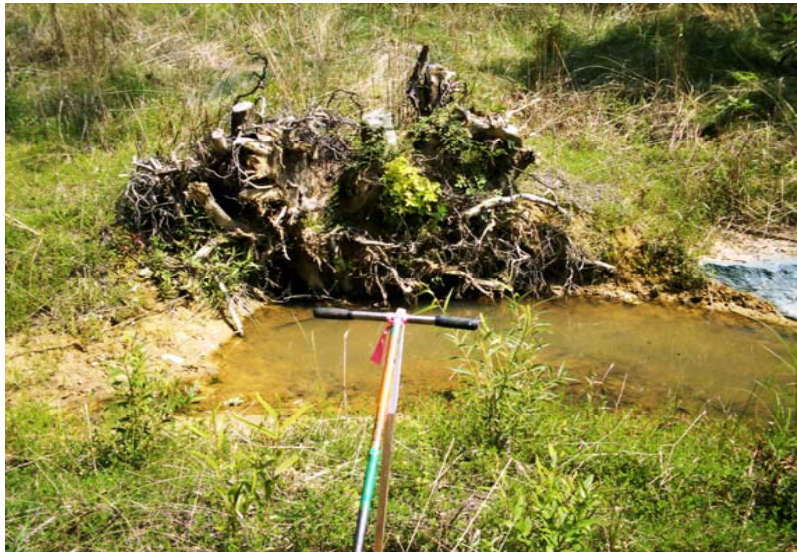
**SP1. Pool Deposition**

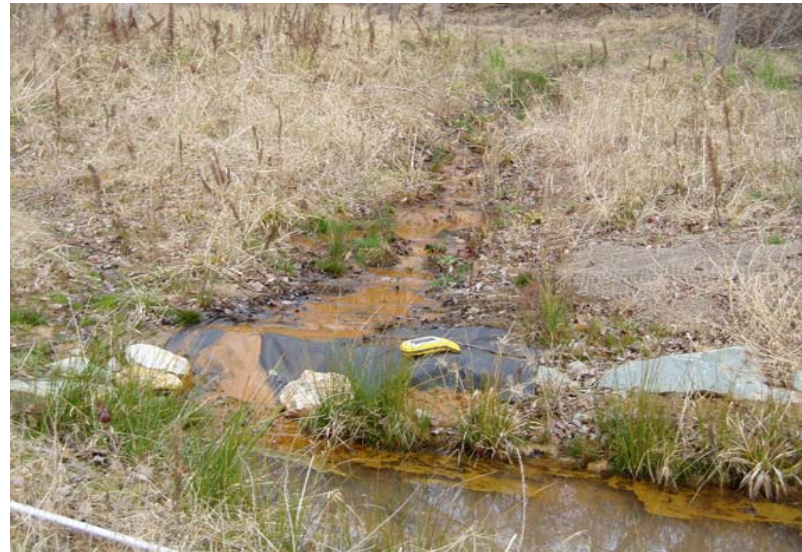
**SP4. Exposed Matting**
