**Tick Creek Stream Restoration Project – Project # 379
Chatham County, North Carolina**

**Second Annual Monitoring Report - FINAL
February 2008**

**TICK CREEK STREAM RESTORATION – Project # 379
2007 MONITORING REPORT**

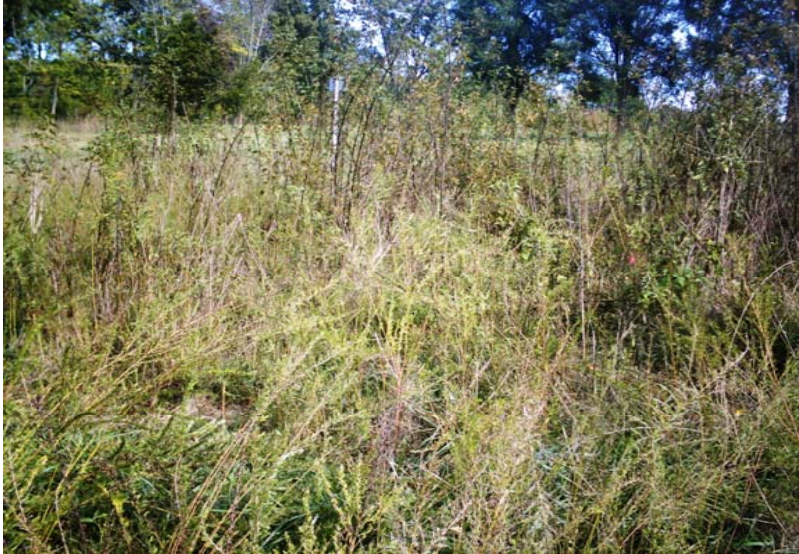
VP1. Sparse Woody Stem Planting

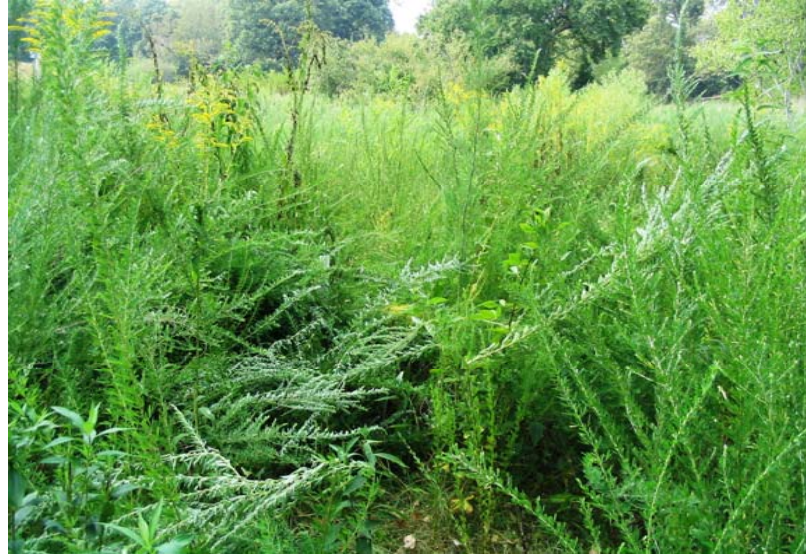
VP2. Exotic Herbaceous and Woody Invasion

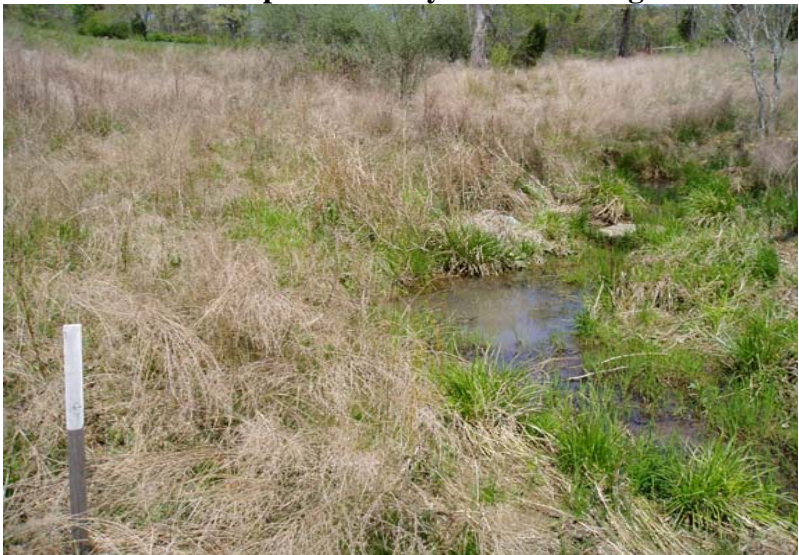
VP3. Relatively Low Planting Success

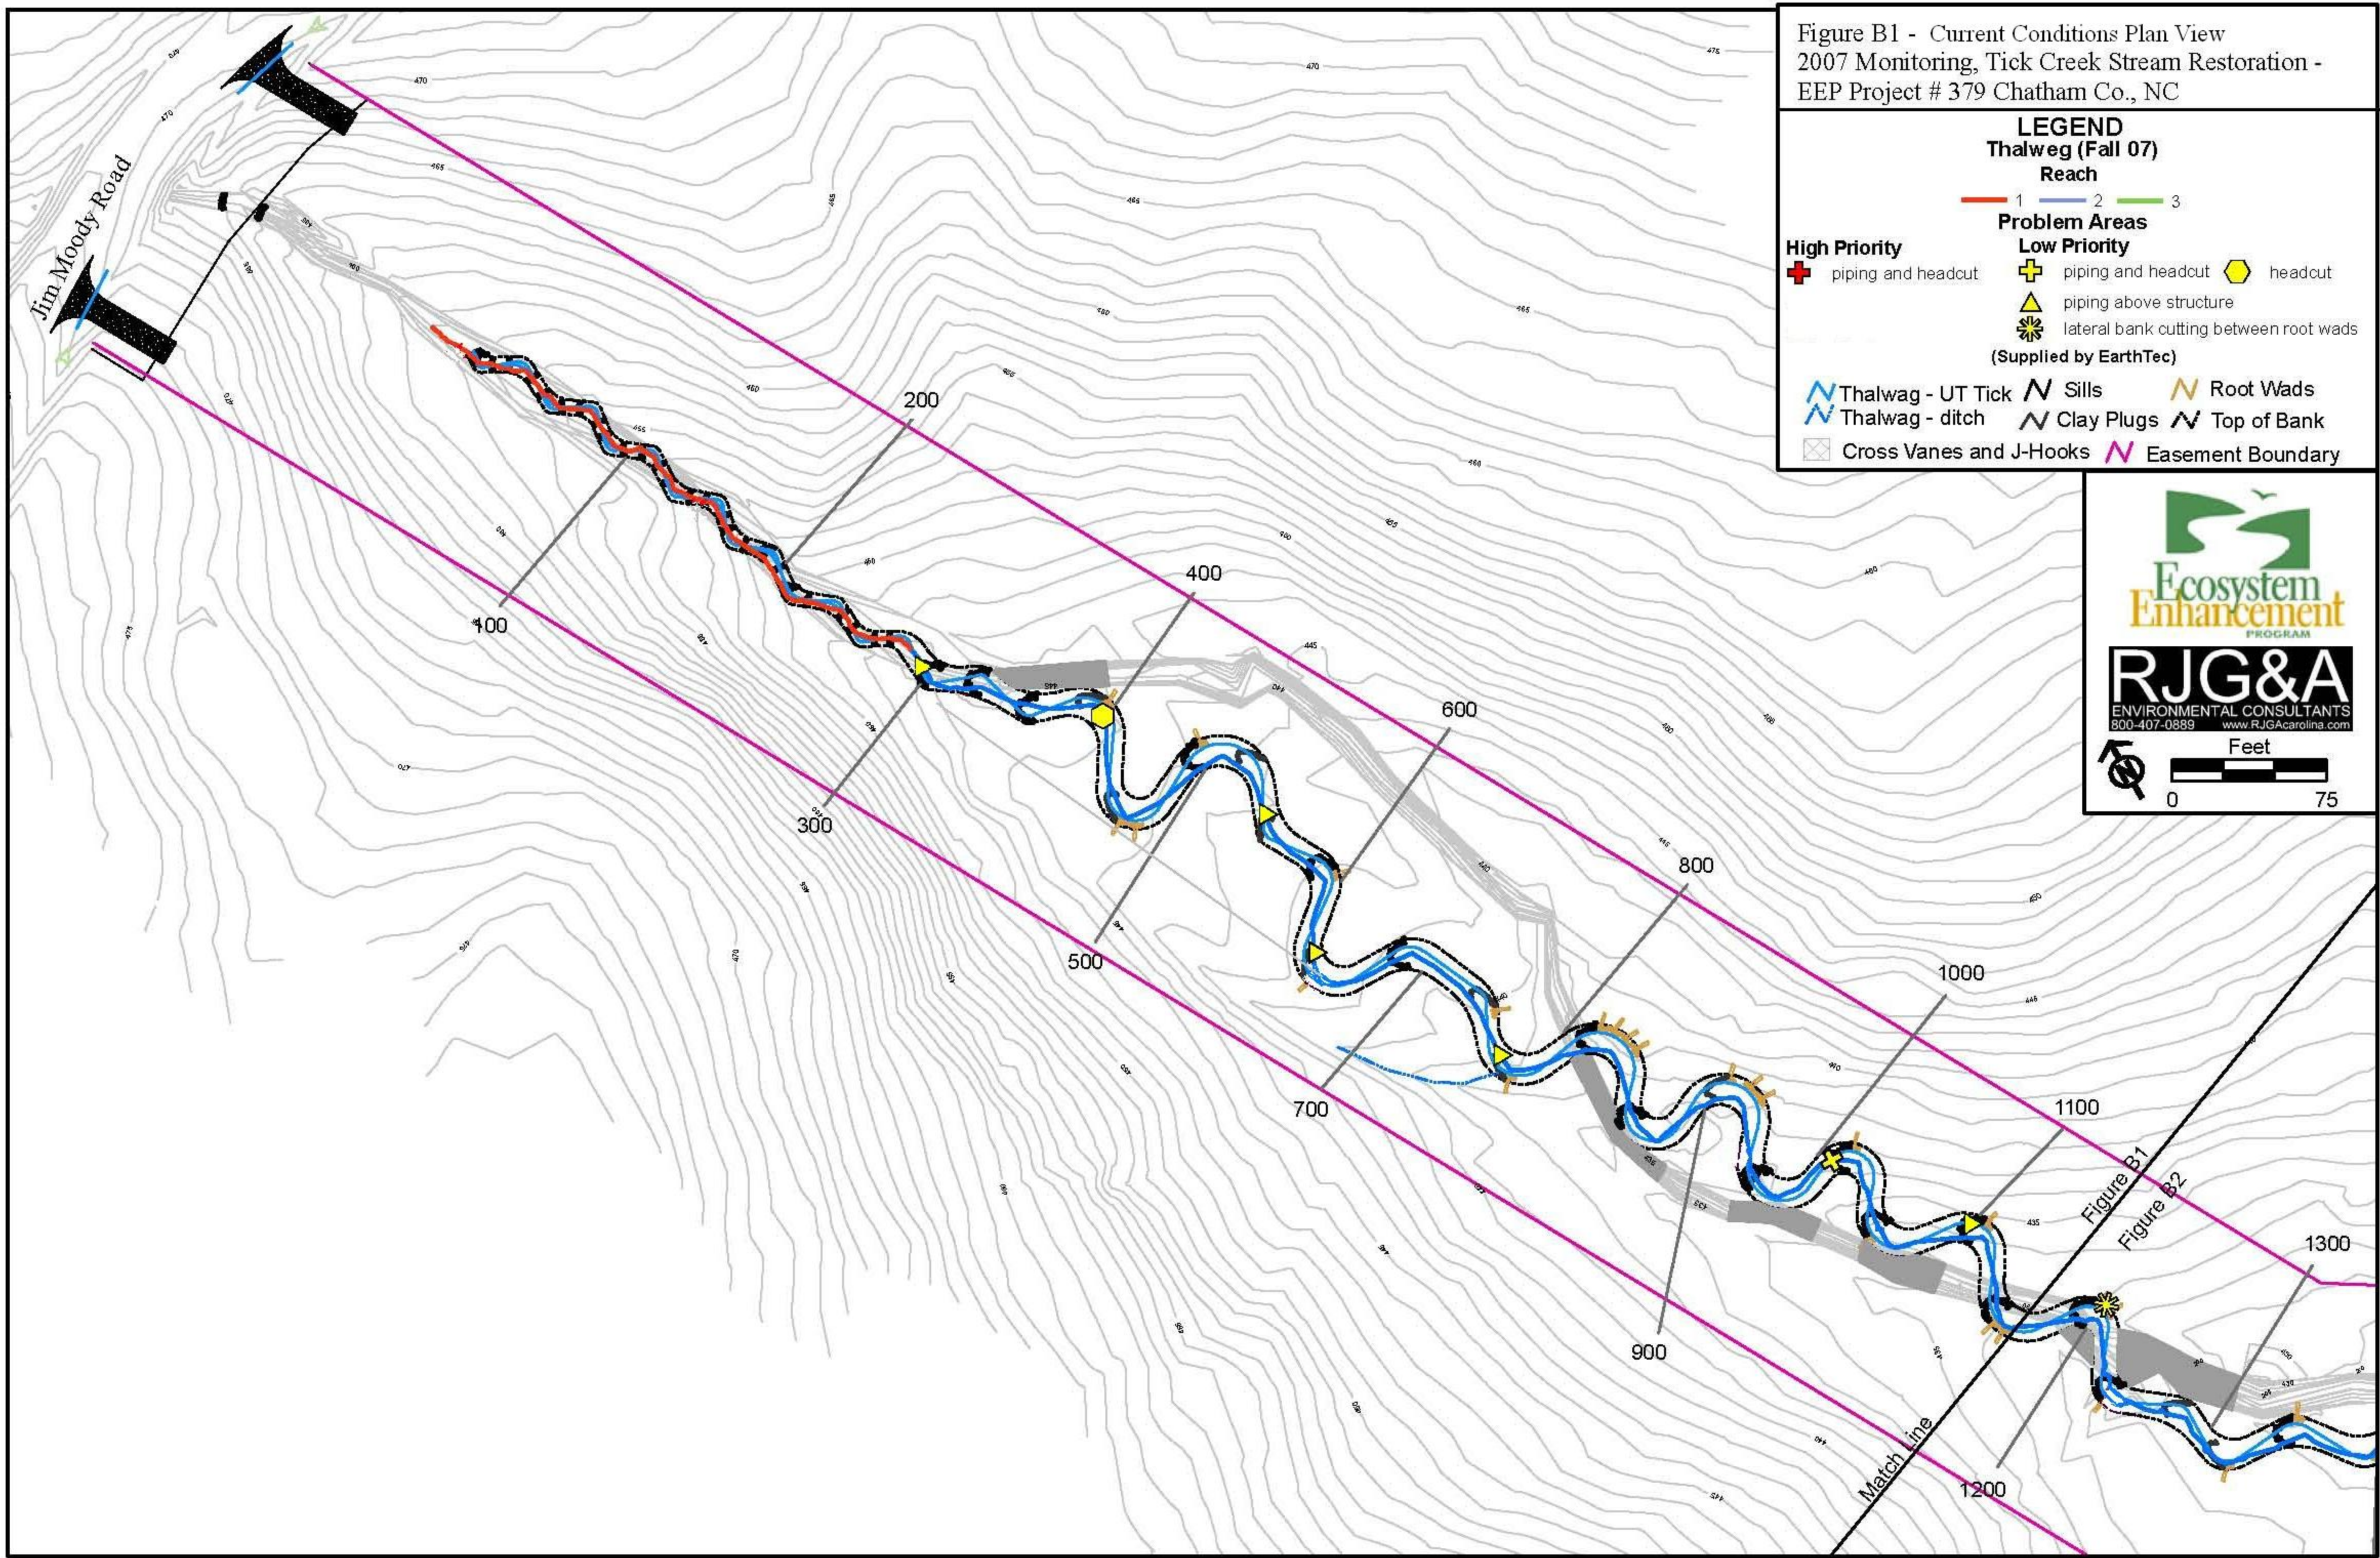
Figure B1 - Current Conditions Plan View
 2007 Monitoring, Tick Creek Stream Restoration -
 EEP Project # 379 Chatham Co., NC

As shown in Appendix B2, 16 structural and substrate problem areas were identified during the 28 October 2007 qualitative evaluation. Two of these, as illustrated in B1 (Current Conditions Plan View (Streams)), have obviously worsened. They are both located in the final series of step pools above restoration Reach 3's confluence with Tick Creek. They warrant close and frequent observation to prevent them from becoming undermined, which could eliminate grade control.

With the exception of the channel headcut (station 396) and the lateral bank cut between rootwads (station 1203), the remaining 12 problem areas identified had been previously observed. Because of the lack of flowing water inside the restored channel, the condition of five of them (stations 290, 545,760, and 2,373) was not clear. Several problem areas identified as locations with moderate piping during April 2007 appeared to have stabilized.

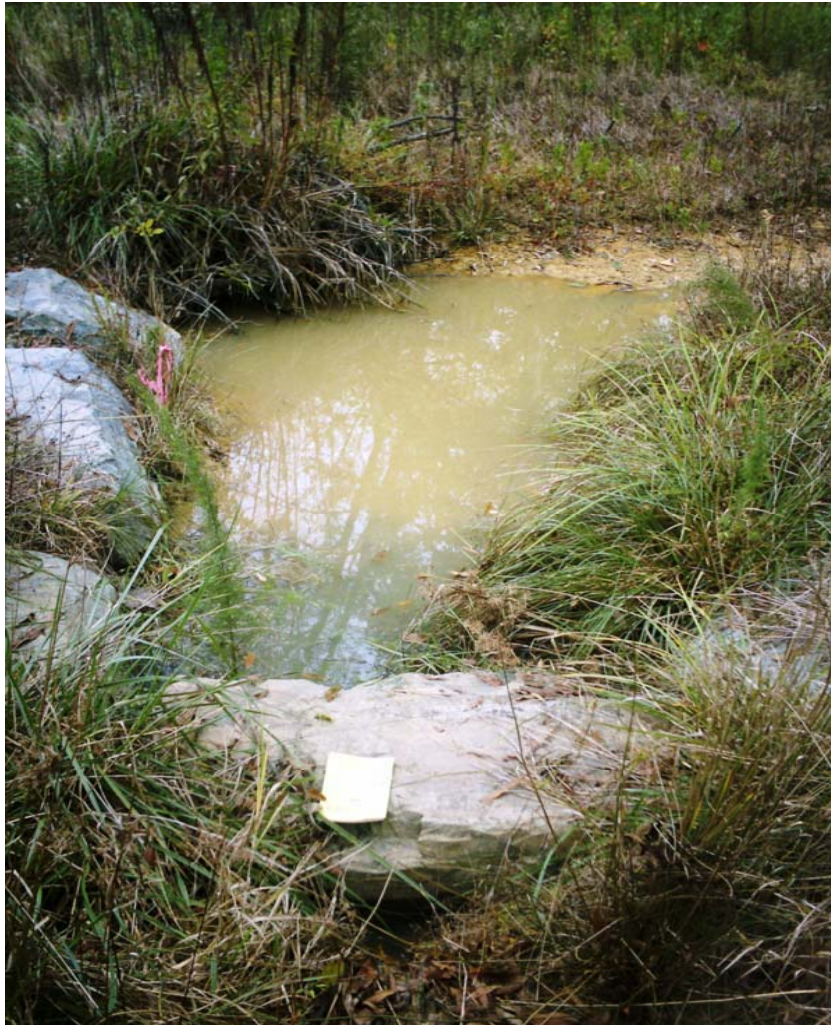
SP1. Piping above rock structure

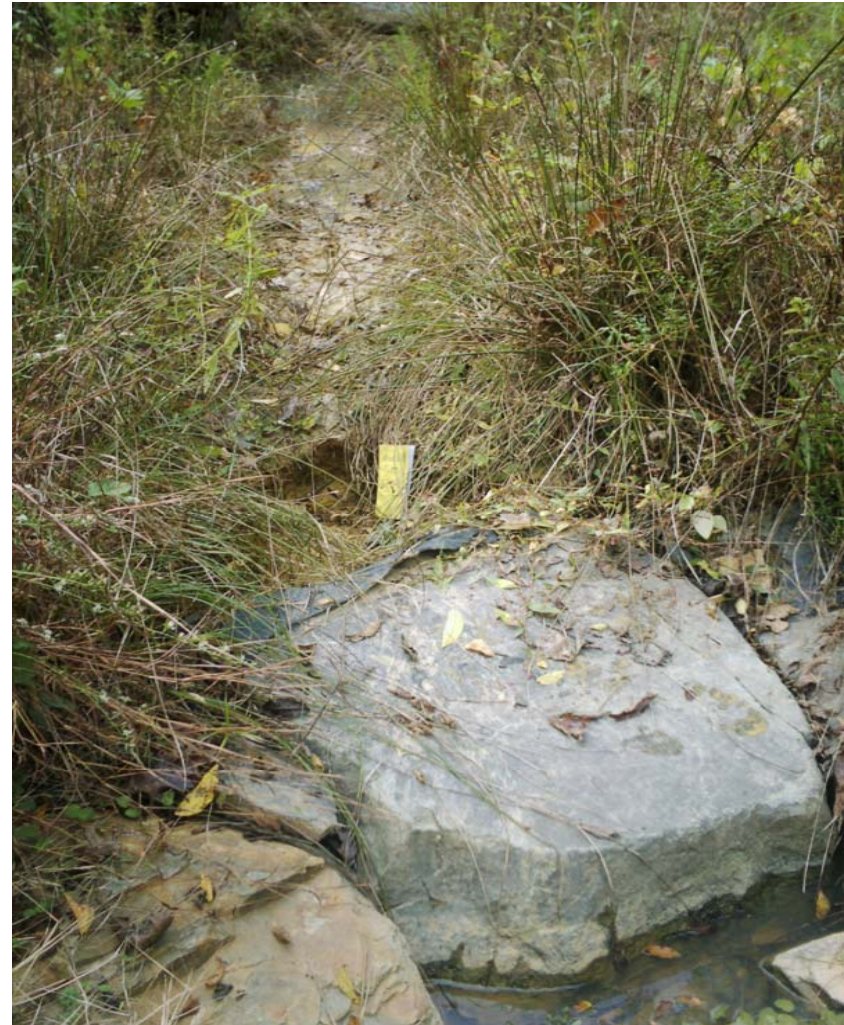
SP2. Piping and headcutting

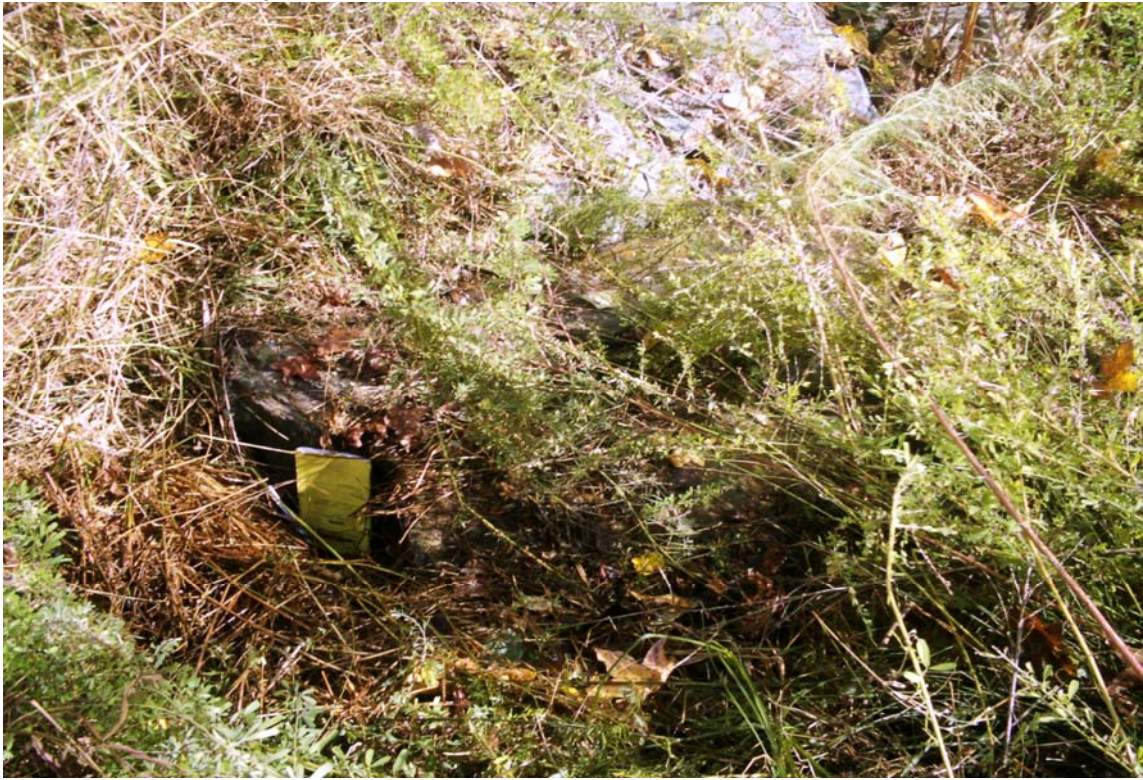
SP3. Headcut in channel

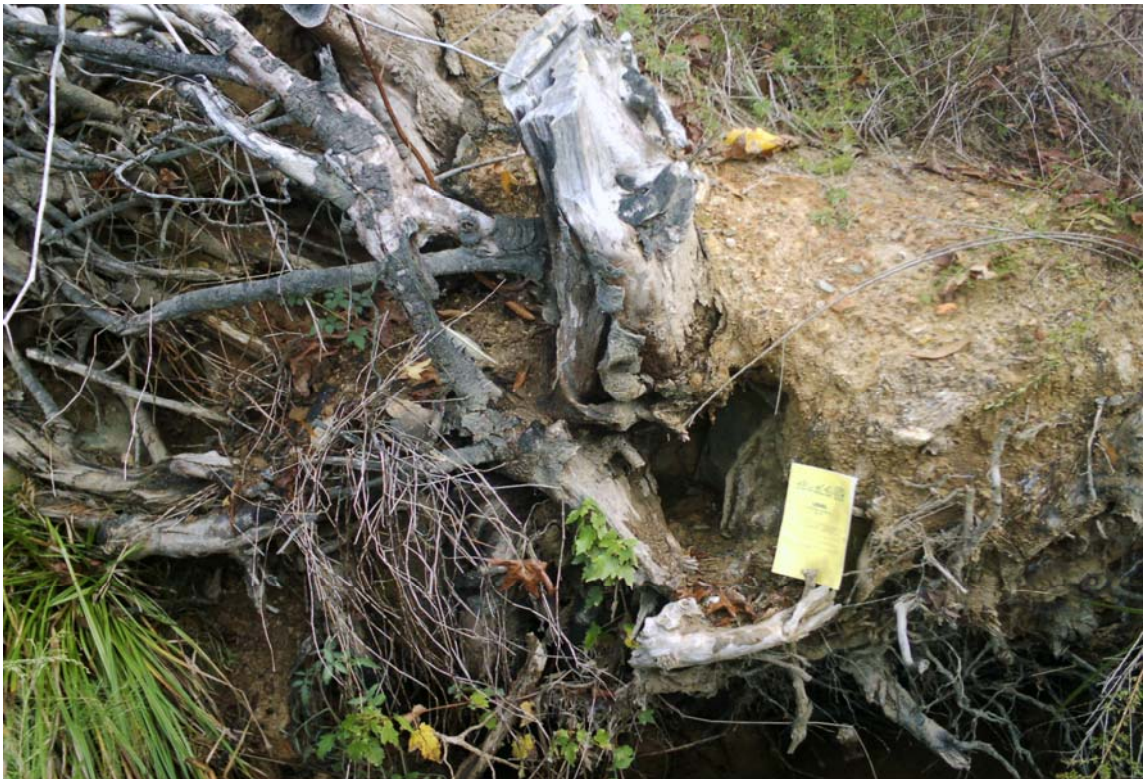
SP4. Lateral bankcut in rootwad
