**TICK CREEK STREAM RESTORATION – NCEEP Project #379**

**Third Annual Monitoring Report – FINAL**

**January 2009**

**TICK CREEK STREAM RESTORATION – Project # 379  
2008 MONITORING REPORT**

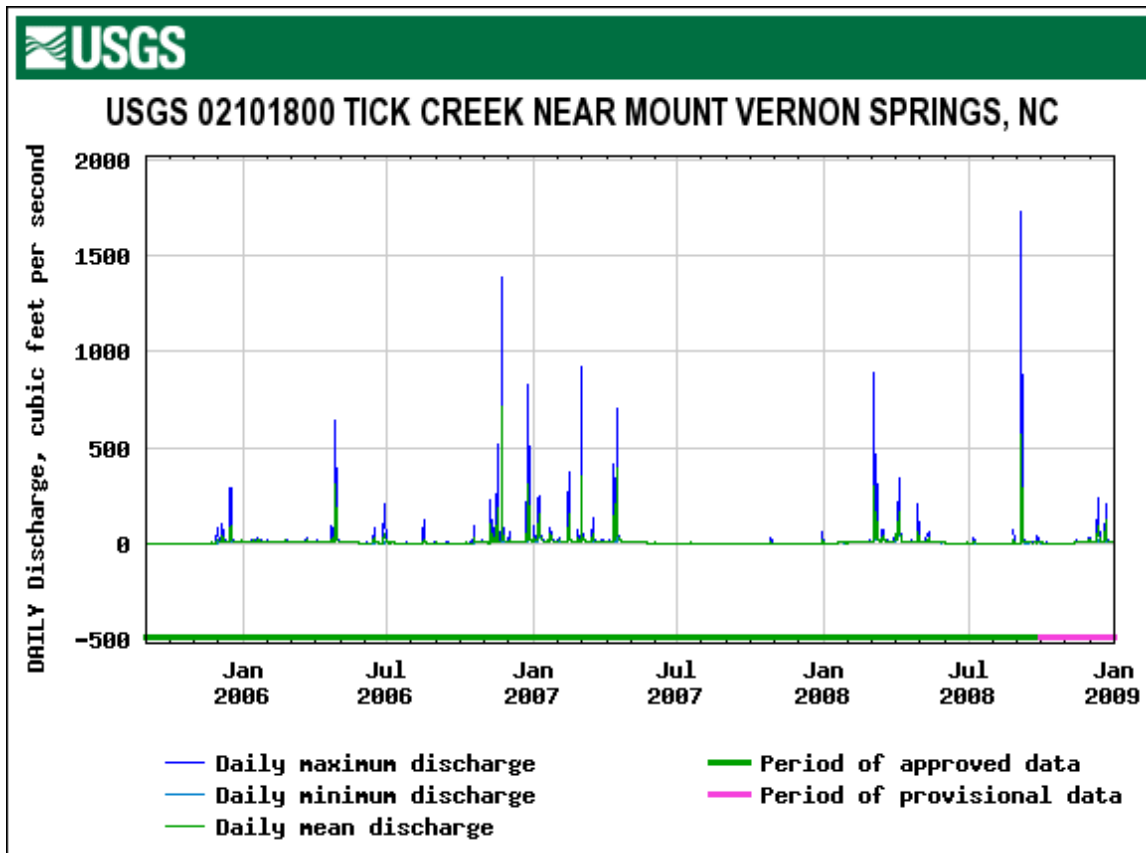
**Figure 3. USGS Stream gauge data for Tick Creek upstream of US 421 - Tick Creek Stream Restoration - EEP Project #379**

The USGS stream gauge on Tick Creek near Mount Vernon Springs (USGS 02101800) is located approximately three miles upstream from the restoration's confluence with Tick Creek. It has a drainage of 15.5 square miles. Bankfull discharge at this gage is 655.2 cubic feet per second (cfs) (Harmen 1999). Data from this gage from September 2005, when construction was completed, to December 2008 appears in Figure 3 (USGS 2009) and demonstrates that bankfull events likely occurred in November and December of 2006, April and May of 2007, and March and September 2008. The graph also highlights the drought that affected the area for much of 2007 into the first few months of 2008. Heavy precipitation on 4 March and 6-7 September confirms the likelihood of bankfull events at the restoration site (NC CRONOS 2009).

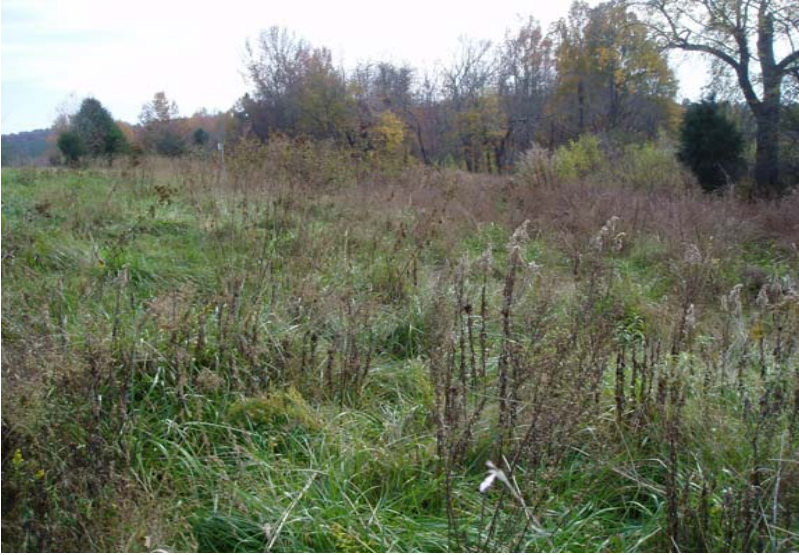
**VP1 - Limited/No planting (11/11/2008)**

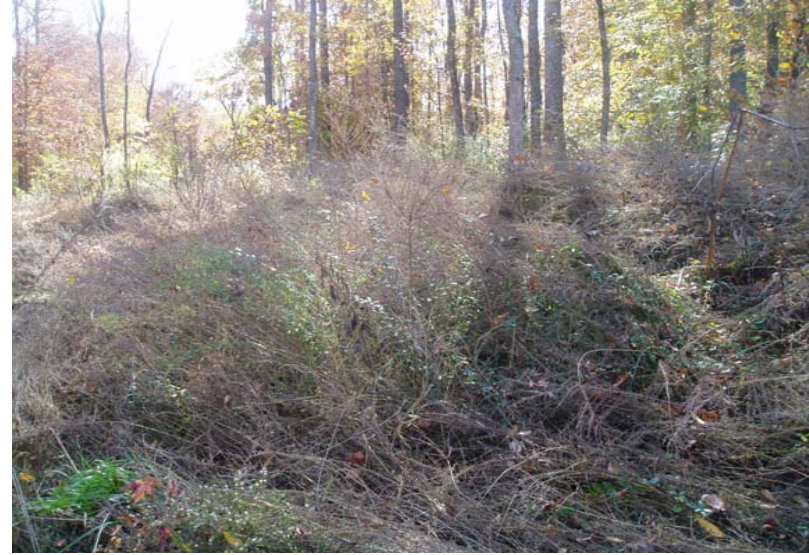
In Reach 2, dog fennel (*Eupatorium capillofolium*), and Chinese lespedeza's (*Lespedeza cuneata*) continue to be a problem (Appendix A.3.-VP2). The planted woody stem success under these invasive herbaceous stands is relatively high, so, continued observation, without remedial action, is appropriate.

**VP2 - Dense herbaceous cover (11/11/2008)**

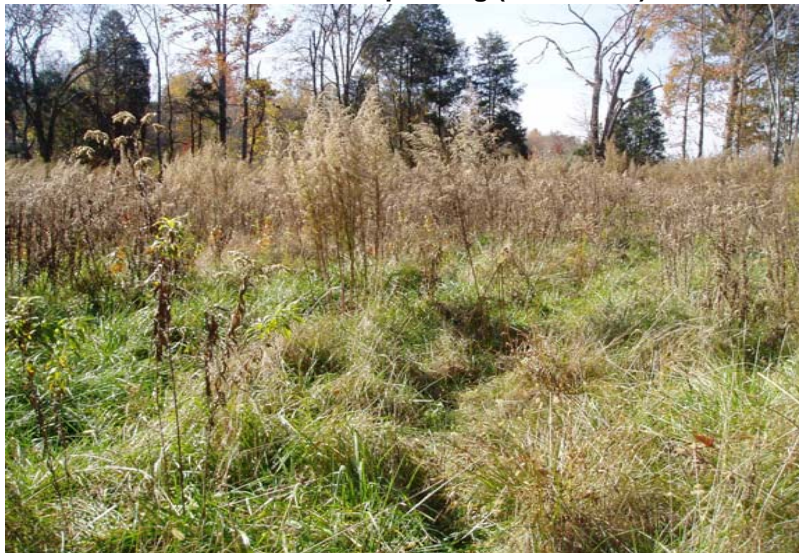
Reach 3 continues to have relatively minimal invasive species problems. *Rubus argutus* has become more widespread around monitoring plot 8. Plot 6 continues to suffer from a lower success rate than the remaining plots in the restoration (Appendix A.3.-VP3). As noted in previous years, suspected cause is substrate compaction. The Restoration Design Plan View map indicates that a relatively large *staging area* was located here during construction. Because of the adequate live planted stem density in plot 6, no remedial action is recommended at this time.

| <b>Table 6. Vegetation Problem Areas – Tick Creek Stream Restoration</b> | | | |
|--|---|---|---|
| Lower planted woody stem success (relative to Reaches 1 and 2) | 2340 - 2575 | Soil compaction during construction | VP3 |

**VP3 - Lower planted woody stem success (11/11/2008)**

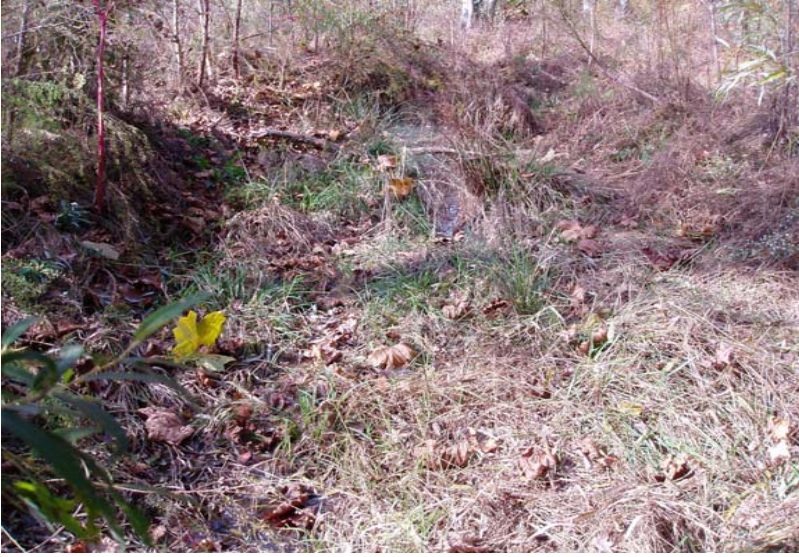
**SP1 - Lack of defined channel (11/11/2008)**

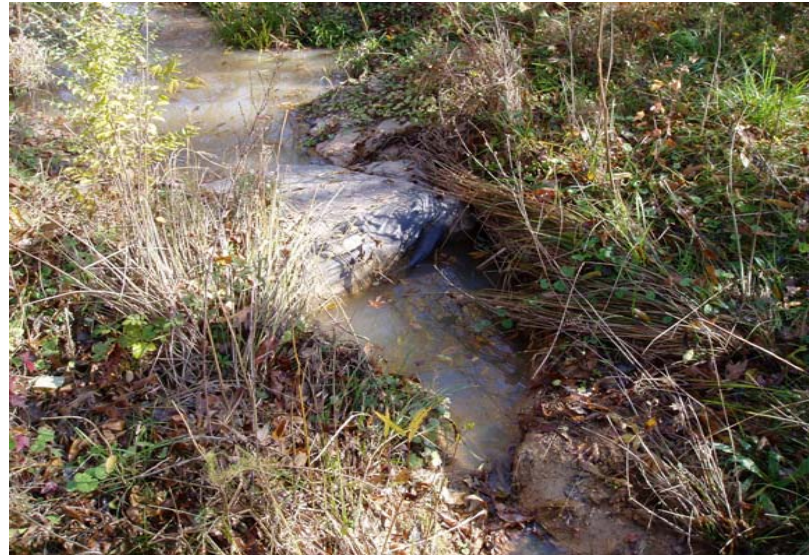
| <b>Feature/Issue</b> | <b>Station</b> | <b>Suspected Cause</b> | <b>Photo #</b> |
|---|---|--|---|
| Backcut and piping | 2748 | Low flows, poor sediment transport, lack of coarse backfill | SP2 & SP3 |

**SP2 - Backcut and piping (11/11/2008)**

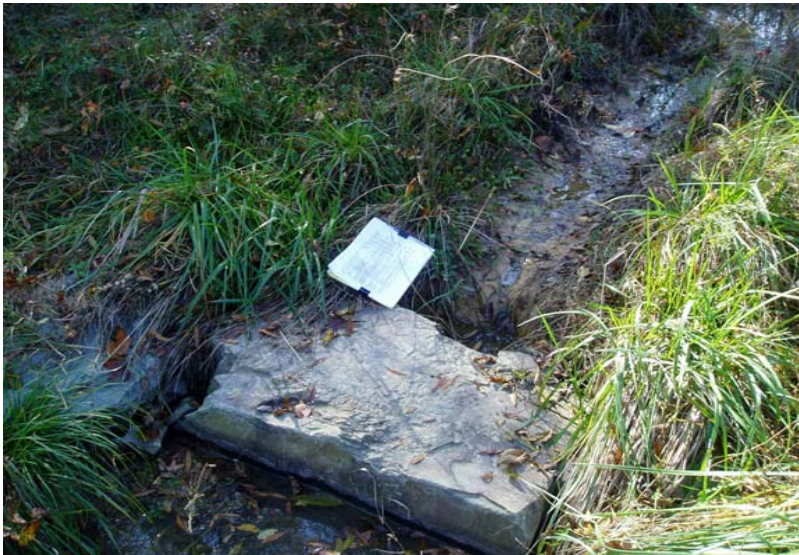
**SP3 - Backcut and piping (11/11/2008)**
