# **Town Creek Restoration Project – Option B Year 1 Monitoring Report**

**Stanly County, North Carolina**

**DMS Project ID Number – 95026; NC DEQ Contract No. 003990**

**Submission Date: December 2017**

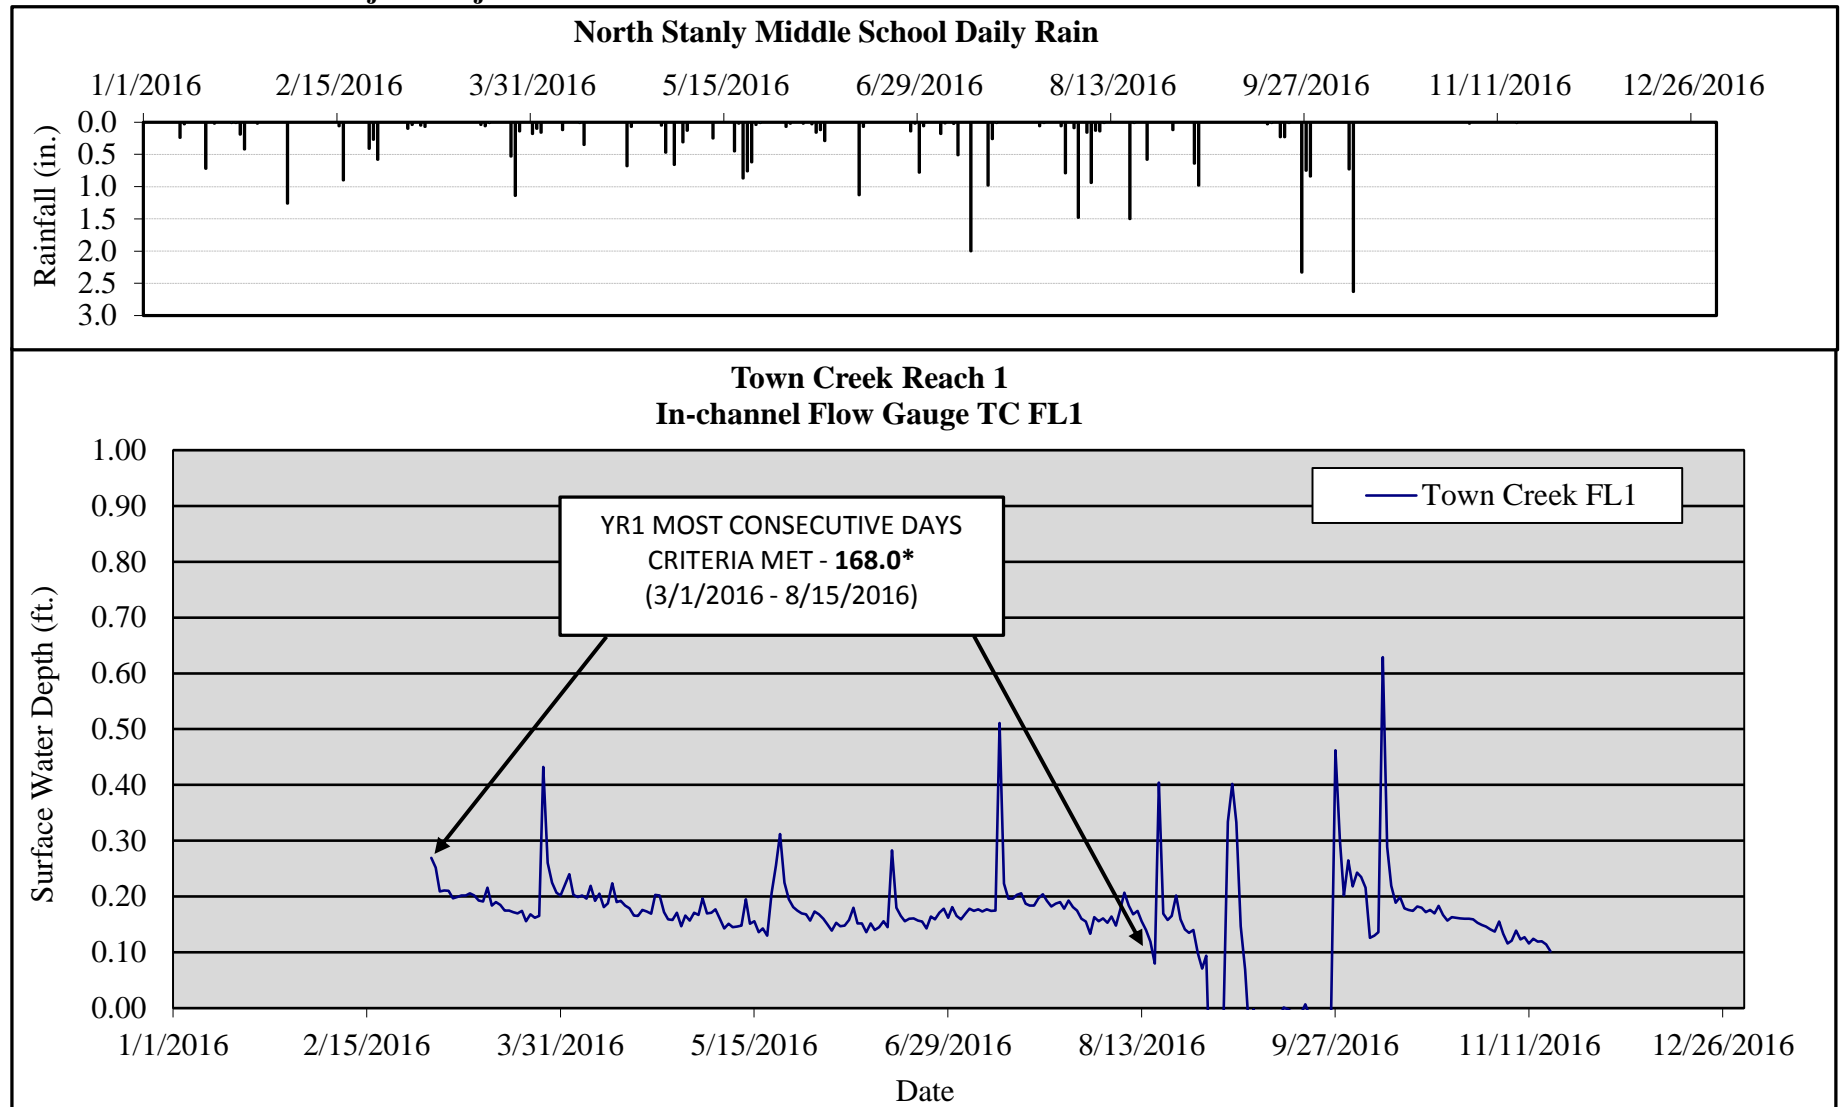
**Figure 5a. In-Stream Flow Gauge Graphs**  
**Town Creek Restoration Project: Project No. 95026**

In-stream pressure transducers, TC FL1 and TC FL2, were installed on Reach 1 to document intermittent flow conditions throughout the monitoring year. Since post-construction installation, each gauge has documented at least one period of consecutive stream flow for the required minimum of 30 days, with a maximum of 168 consecutive days for TC FL1 and 150 consecutive days for TC FL2. Figures 5a and 5b in Appendix E, depict the documented flow conditions for each gauge from installation through Monitoring Year 1 relative to local rainfall data, while Table 13 documents both the total cumulative days of flow and the maximum number of consecutive days of flow.
