Town Creek Restoration Project – Option B Year 2 Monitoring Report

Stanly County, North Carolina

DMS Project ID Number – 95026; NC DEQ Contract No. 003990

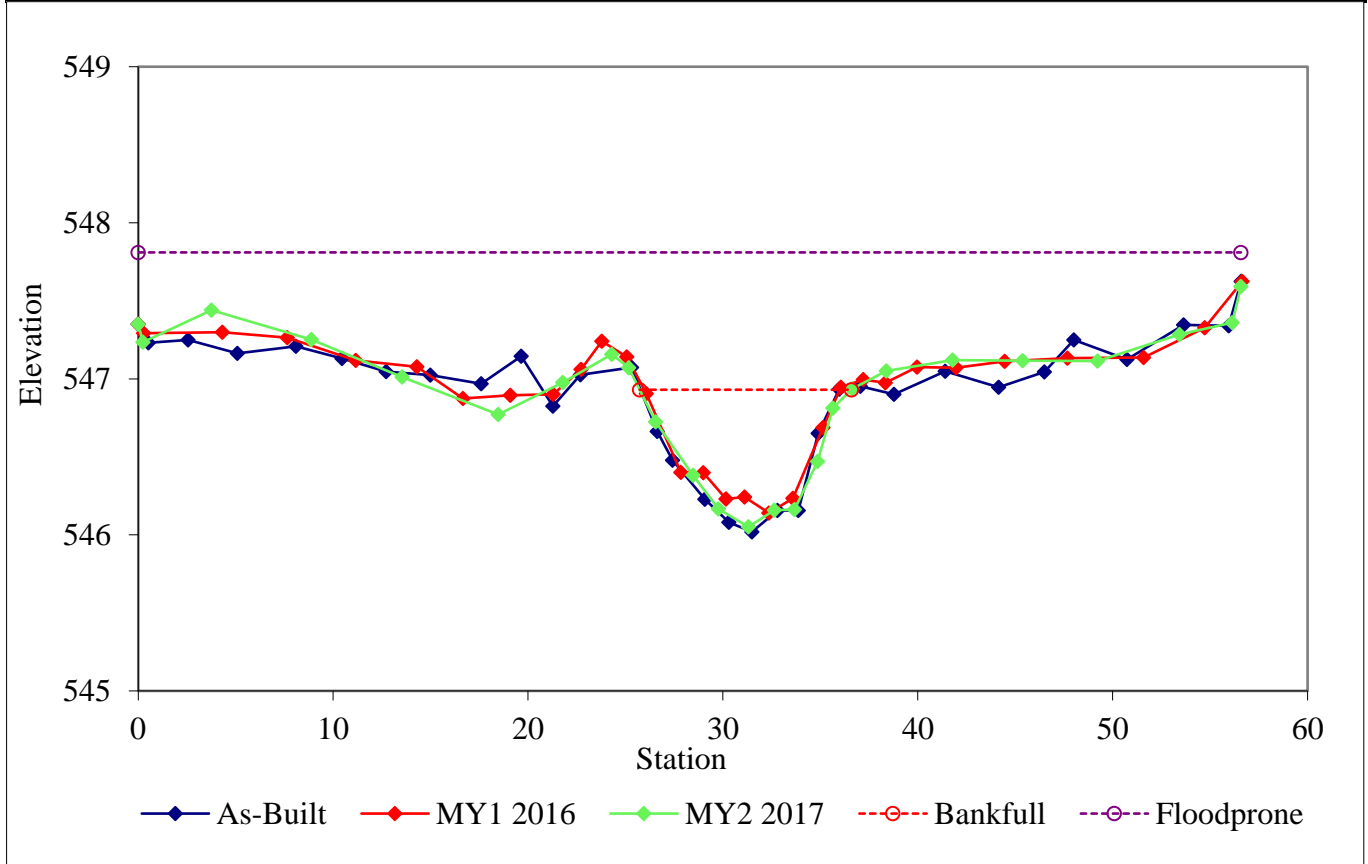
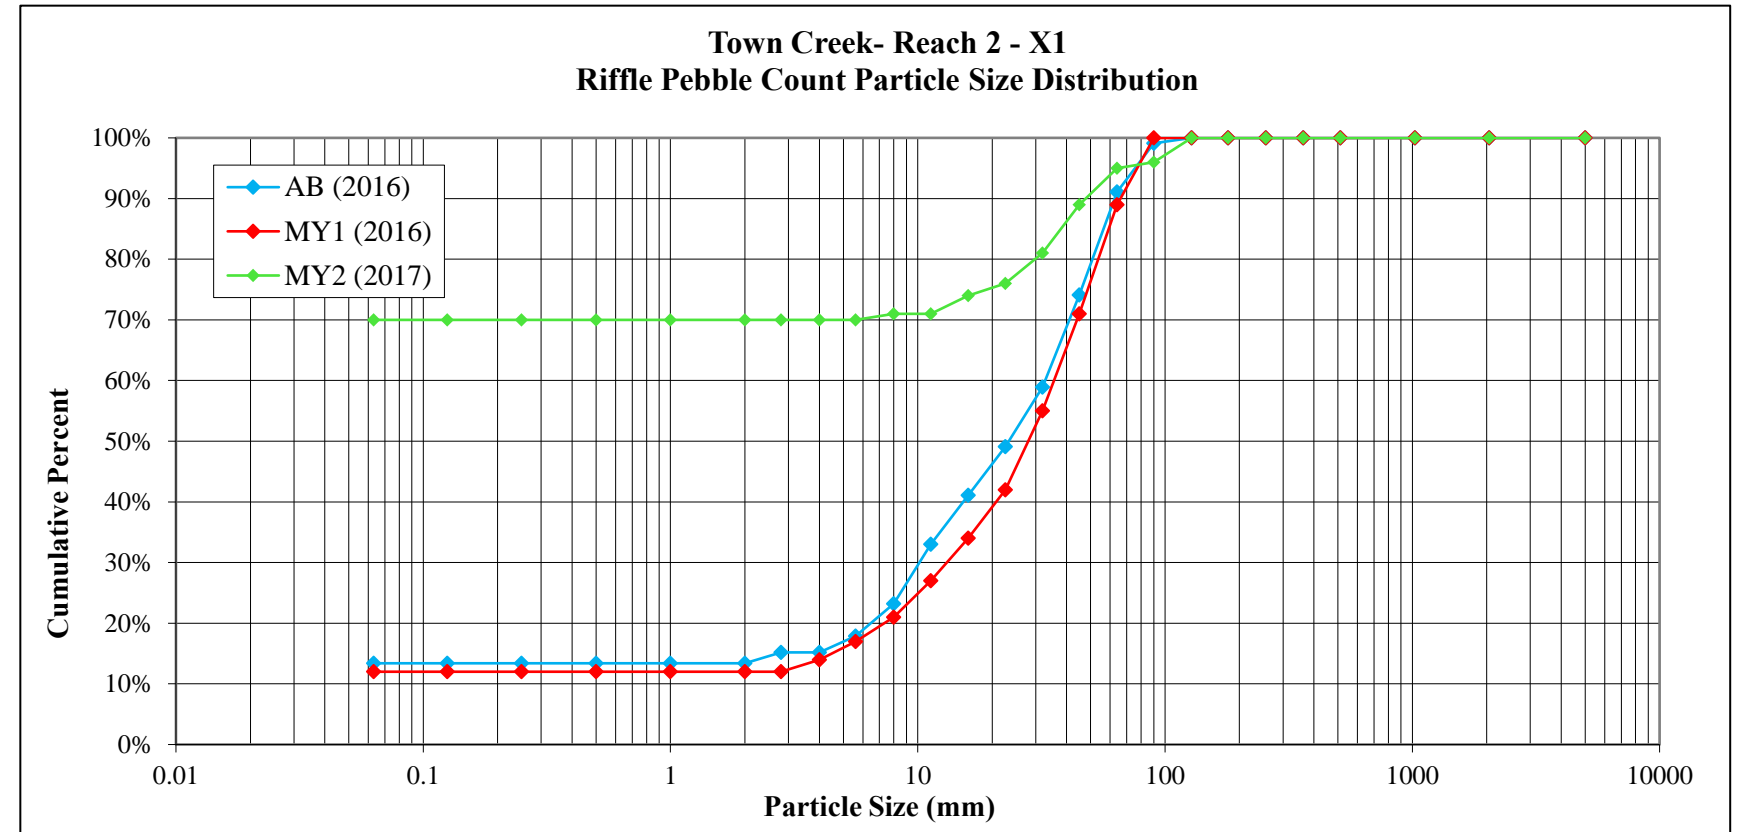
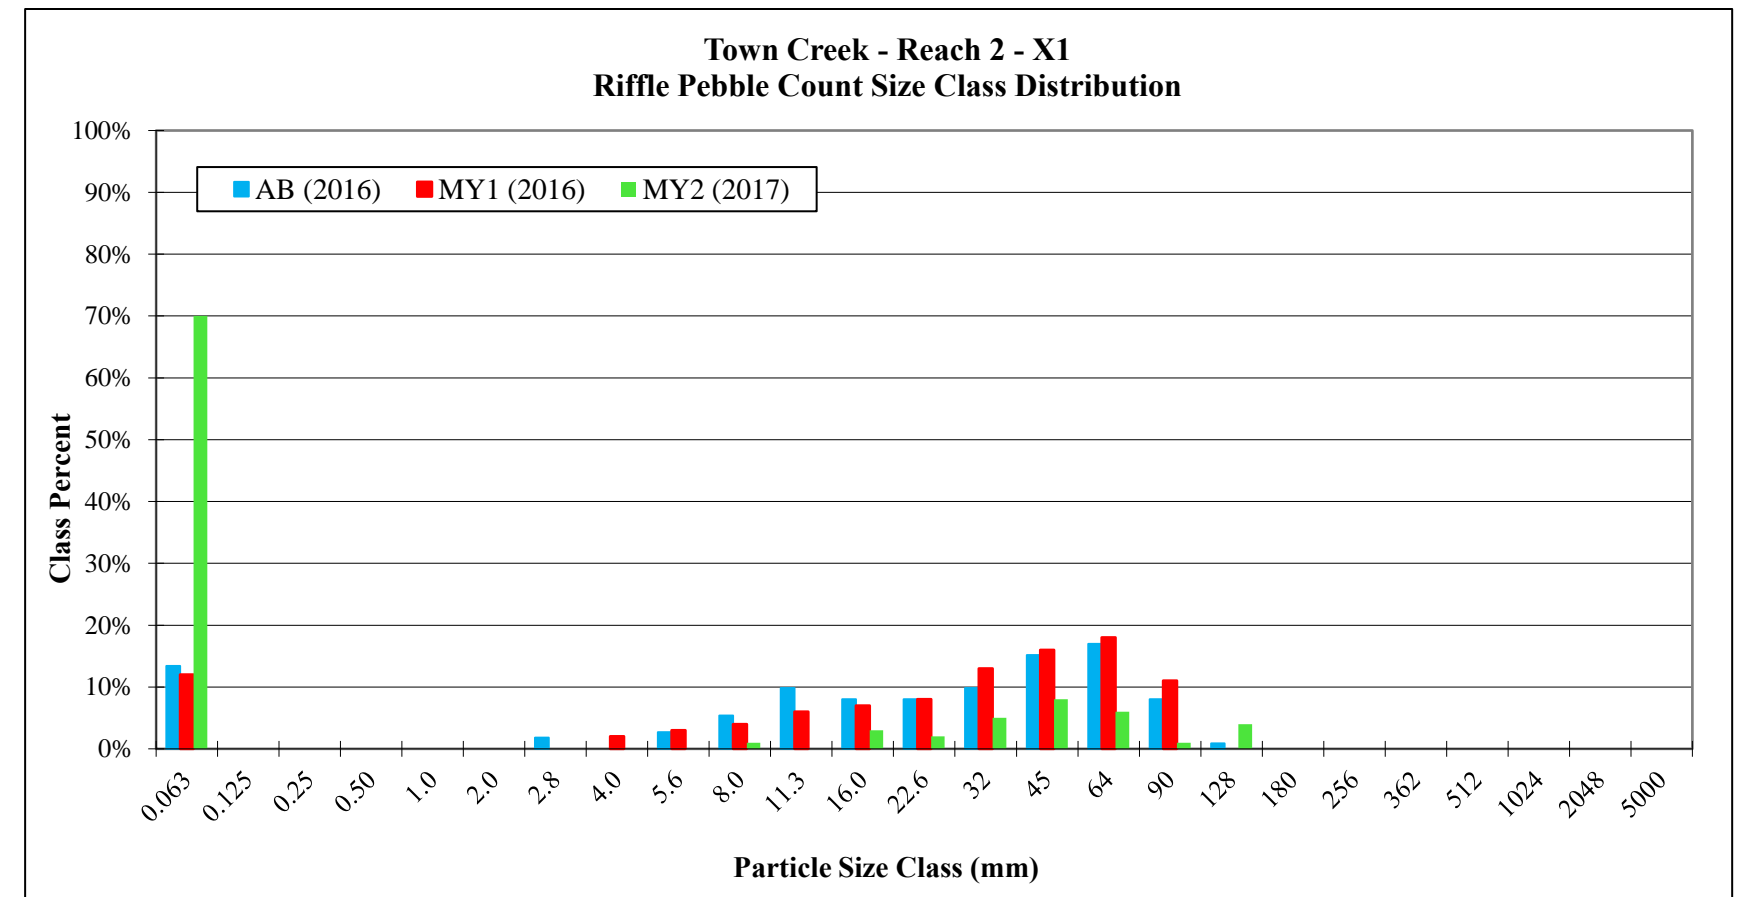
Figure 4. Riffle Pebble Count Size Class Distribution with Annual Overlays
Town Creek Restoration Project: Project No. 95026

system. Predominantly, riffles are comprised of a mix of substrates with the bed material moving towards a mix of coarser substrates; however, data from X-1 shows an increase in the percentage of fines within that cross-sections riffle substrate. It is likely that this anomaly is due to a large storm event on 10/23/2017, which produced almost two inches of rainfall at the site. This event would have contributed a rapid influx of fines; however, due to the lack of subsequent rainfall, base flow conditions were not sufficient to move the fines through the system prior to data collection. Cross-sectional and pebble count data are provided in Figures 3 and 4, respectively, in Appendix D.

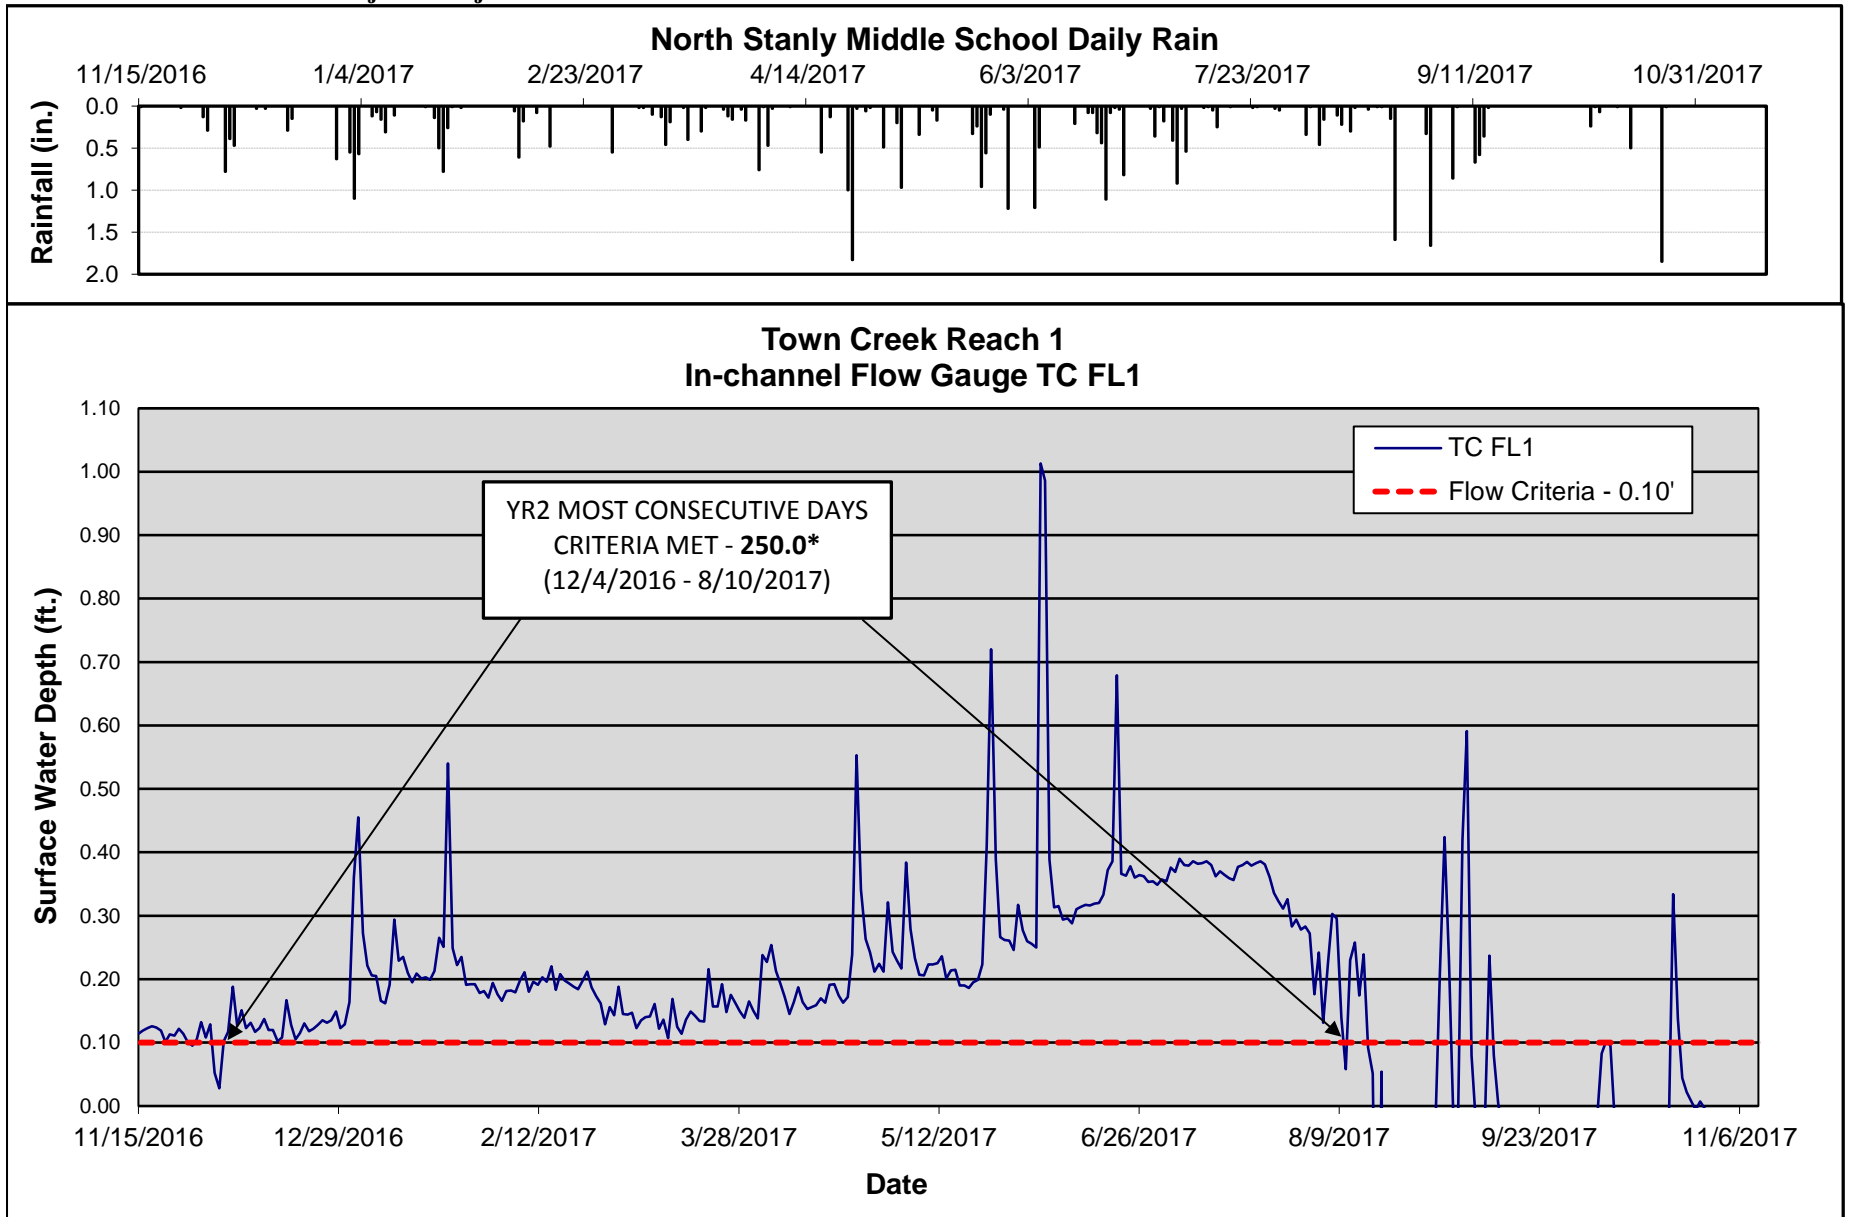
Figure 5a. In-Stream Flow Gauge Graphs
Town Creek Restoration Project: Project No. 95026

In-stream pressure transducers, TC FL1 and TC FL2, were installed on Reach 1 to document intermittent flow conditions throughout the monitoring year. Since post-construction installation, each gauge has documented at least one period of consecutive stream flow for the required minimum of 30 days, with a maximum of 250 consecutive days for TC FL1 and 202 consecutive days for TC FL2. Figures 5a and 5b in Appendix E, depict the documented flow conditions for each gauge from installation through Monitoring Year 2 relative to local rainfall data, while Table 13 documents both the total cumulative days of flow and the maximum number of consecutive days of flow.
