# **Town Creek Restoration Project – Option B Year 3 Monitoring Report**

**Stanly County, North Carolina**

**DMS Project ID Number – 95026; NC DEQ Contract No. 003990**

**Monitoring Year: 3 of 5**

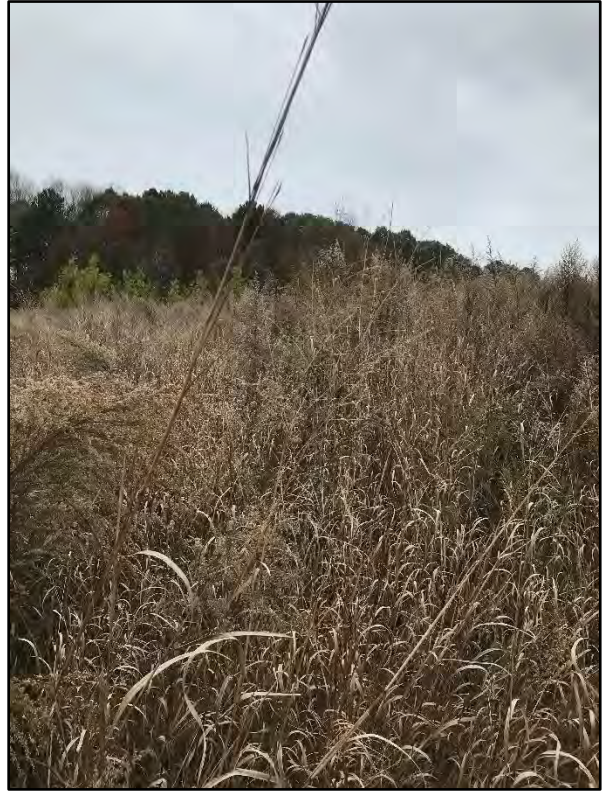
**PID 8: Station 14+65 – Left Floodplain  
Matted Drainage Swale (11/14/18)**
