Town Creek Restoration Project – Option B Year 4 Monitoring Report

Stanly County, North Carolina

DMS Project ID Number – 95026; NC DEQ Contract No. 003990

Report Prepared and Submitted by Michael Baker Engineering, Inc.

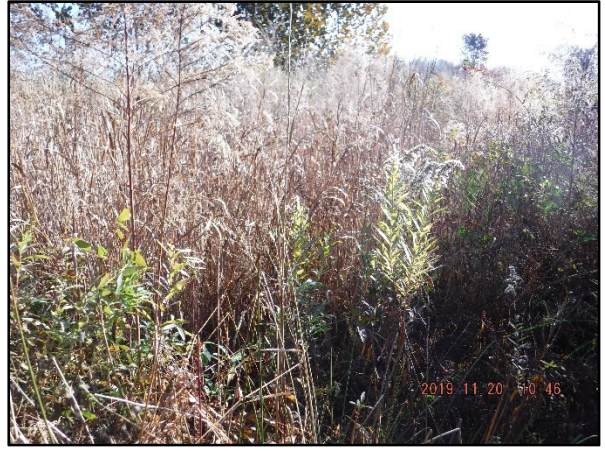
**PID 8: Station 14+65 – Left Floodplain
Matted Drainage Swale (11/20/19)**

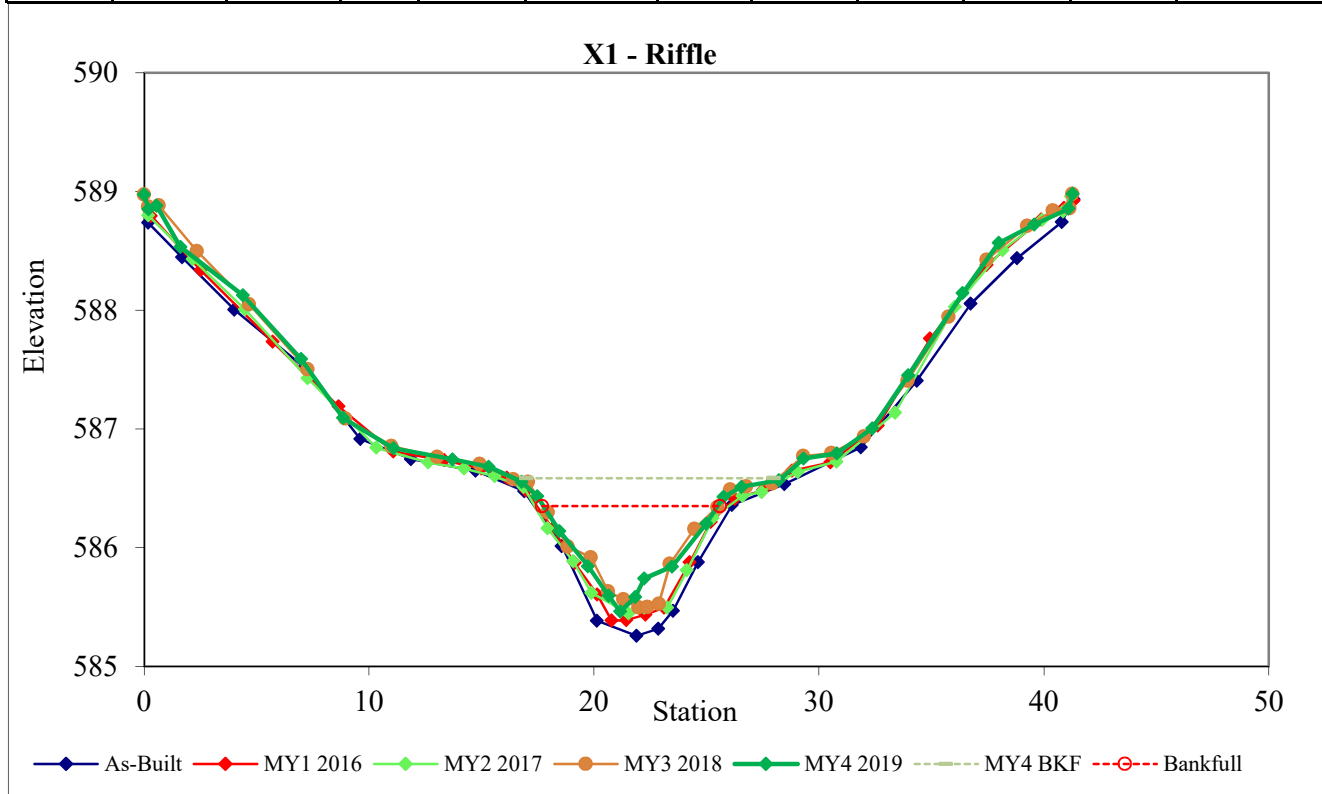
Feature	Stream Type	BKF Area	BKF Width	BKF Depth	Max BKF Depth	W/D	BH Ratio*	ER	BKF Elev	TOB Elev	WFPA
Riffle	C	3.59	7.70	0.50	0.9	16.70	1.00	3.70	586.35	586.60	24.90

*BHR=1.0 is based on asbuilt bkf area of 5.79 at an elevation of 586.586. Remainder of data based on actual bankfull elevation from as-built which is 586.35. Thalweg elevation is 585.462

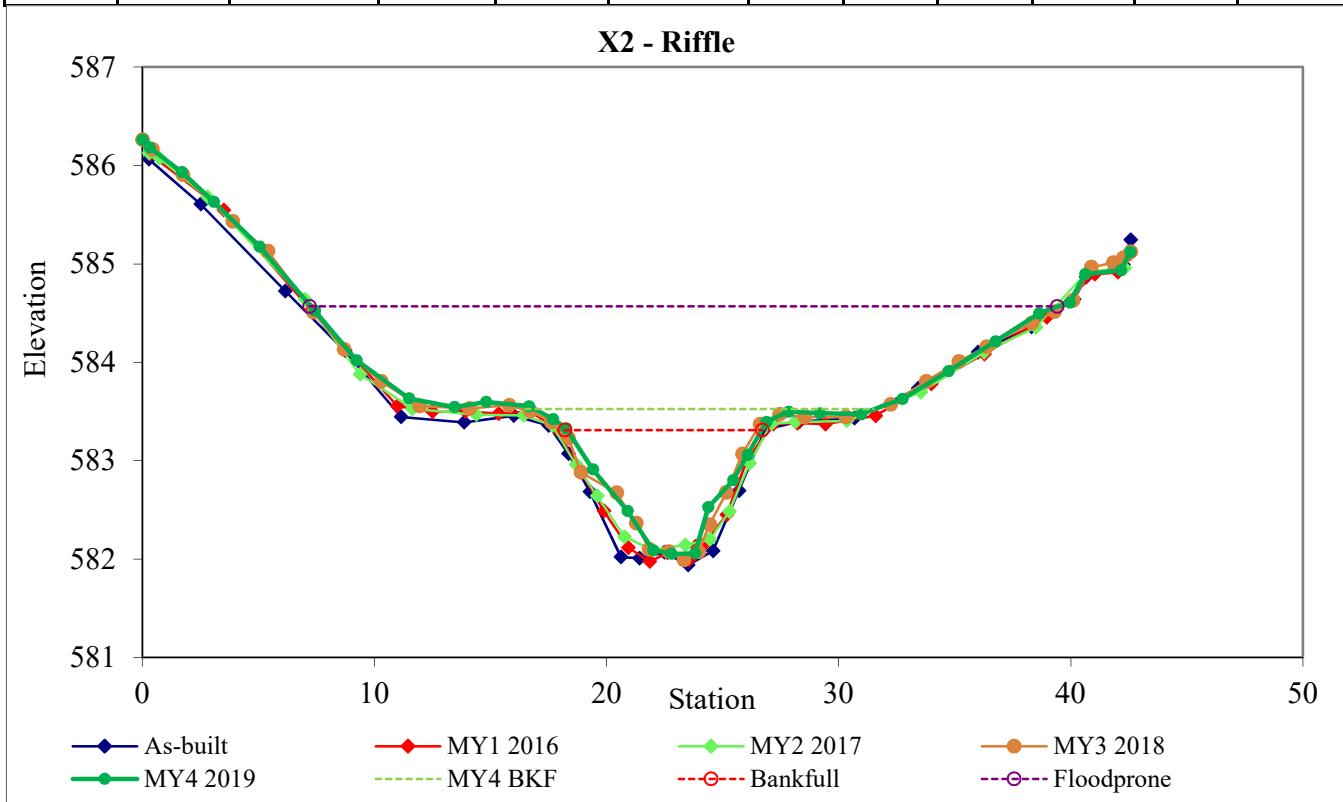
Feature	Stream Type	BKF Area	BKF Width	BKF Depth	Max BKF Depth	W/D	BH Ratio*	ER	BKF Elev	TOB Elev	WFPA
Riffle	E	6.09	8.40	0.70	1.30	11.50	0.90	3.80	583.31	583.33	32.20

*BHR=0.90 is based on asbuilt bkf area of 8.28 at an elevation of 583.524. Remainder of data based on actual bankfull elevation from as-built which is 583.31. Thalweg elevation is 582.052

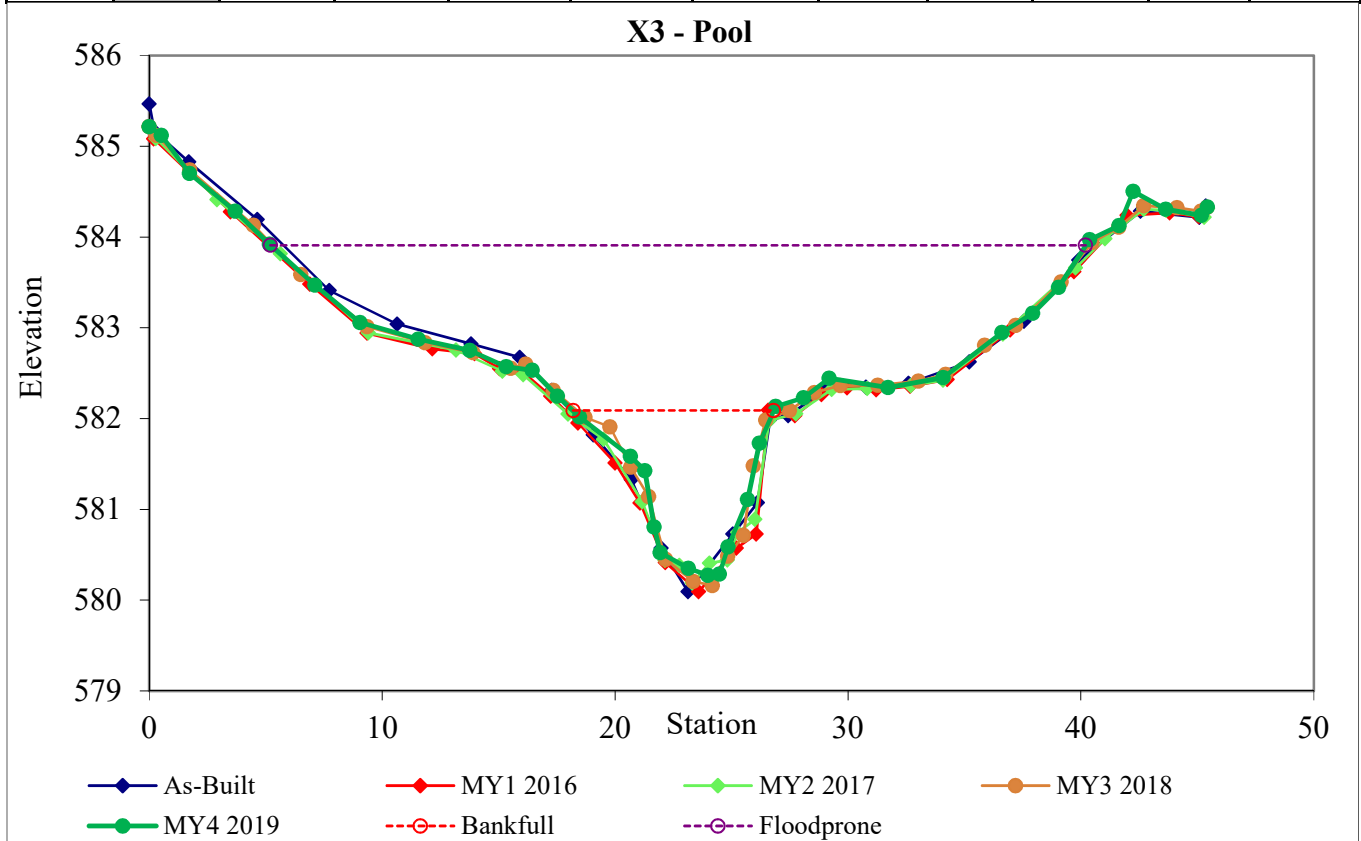
Permanent Cross-section
X3 Pool - Reach 2
(Monitoring Year 4 - Collected September 2019)

Feature	Stream Type	BKF Area	BKF Width	BKF Depth	Max BKF Depth	W/D	BH Ratio	ER	BKF Elev	TOB Elev	WFGPA
Pool		8.26	8.60	1.00	1.80	9.10	-	-	582.09	582.13	35.00

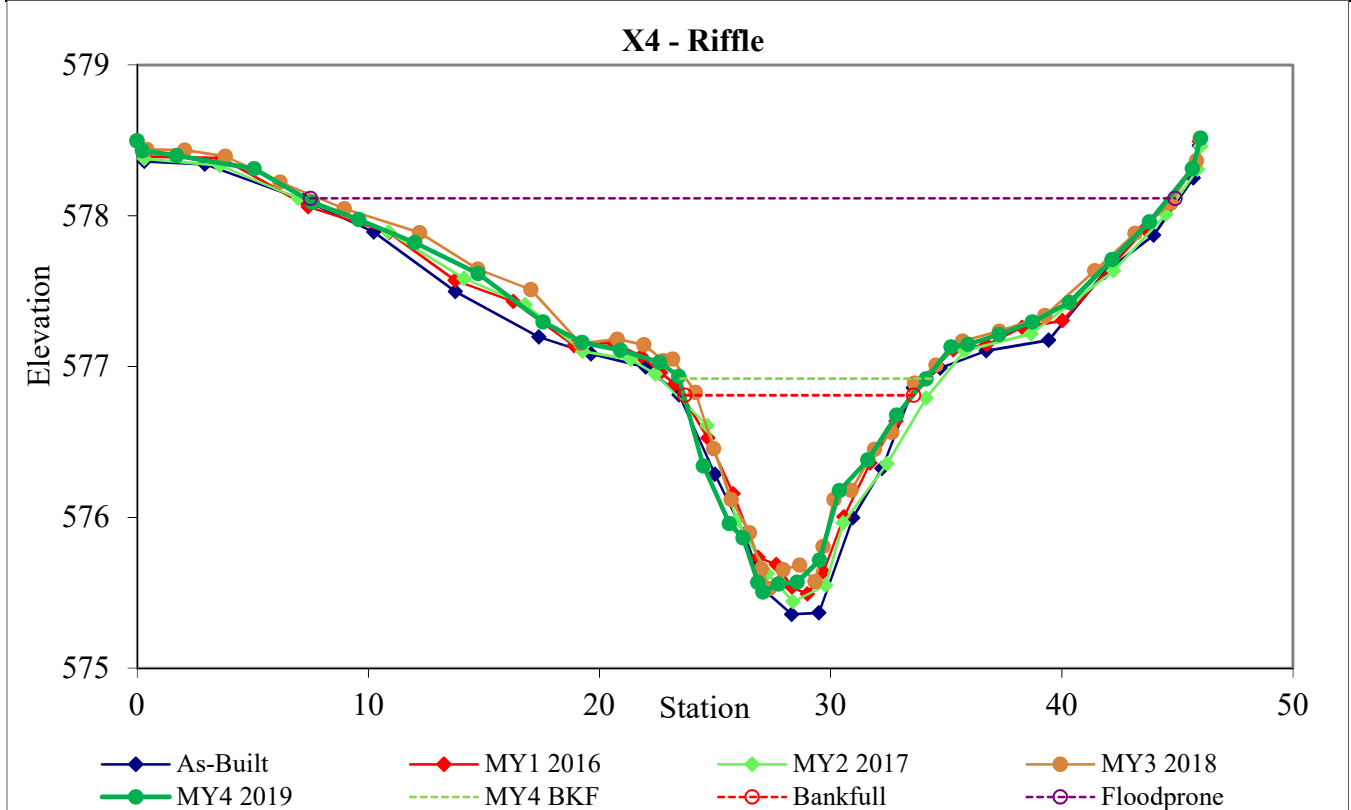
Permanent Cross-section
X4 Riffle - Reach 2
(Monitoring Year 4 - Collected September 2019)

Feature	Stream Type	BKF Area	BKF Width	BKF Depth	Max BKF Depth	W/D	BH Ratio	ER	BKF Elev	TOB Elev	WFPA
Riffle	C	7.24	9.90	0.70	1.30	13.50	1.00	3.80	576.81	576.93	37.40

*BHR = 1.0 is based on as-built bkf area of 8.38 at an elevation of 576.92. Remainder of data based on actual bankfull elevation from as-built which is 576.81. Thalweg elevation is 575.504

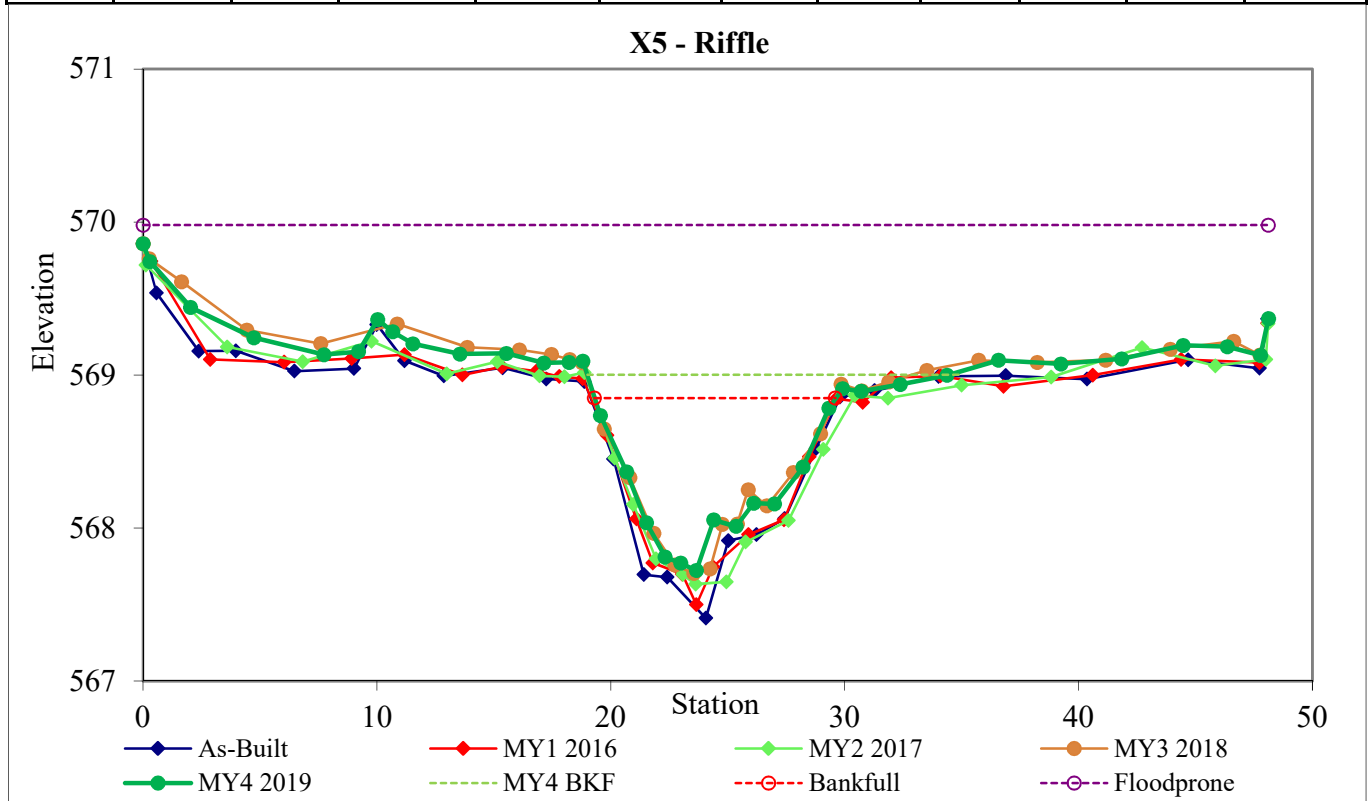
Permanent Cross-section
X5 Riffle - Reach 3
(Monitoring Year 4 - Collected September 2019)

Feature	Stream Type	BKF Area	BKF Width	BKF Depth	Max BKF Depth	W/D	BH Ratio	ER	BKF Elev	TOB Elev	WFGA
Riffle	C	6.76	10.30	0.70	1.10	15.80	0.90	4.70	568.85	568.91	48.10

*BHR = 0.9 is based on as-built bkf area of 8.68 at an elevation of 569.002. Remainder of data based on actual bankfull elevation from as-built which is 568.85. Thalweg elevation is 567.771.

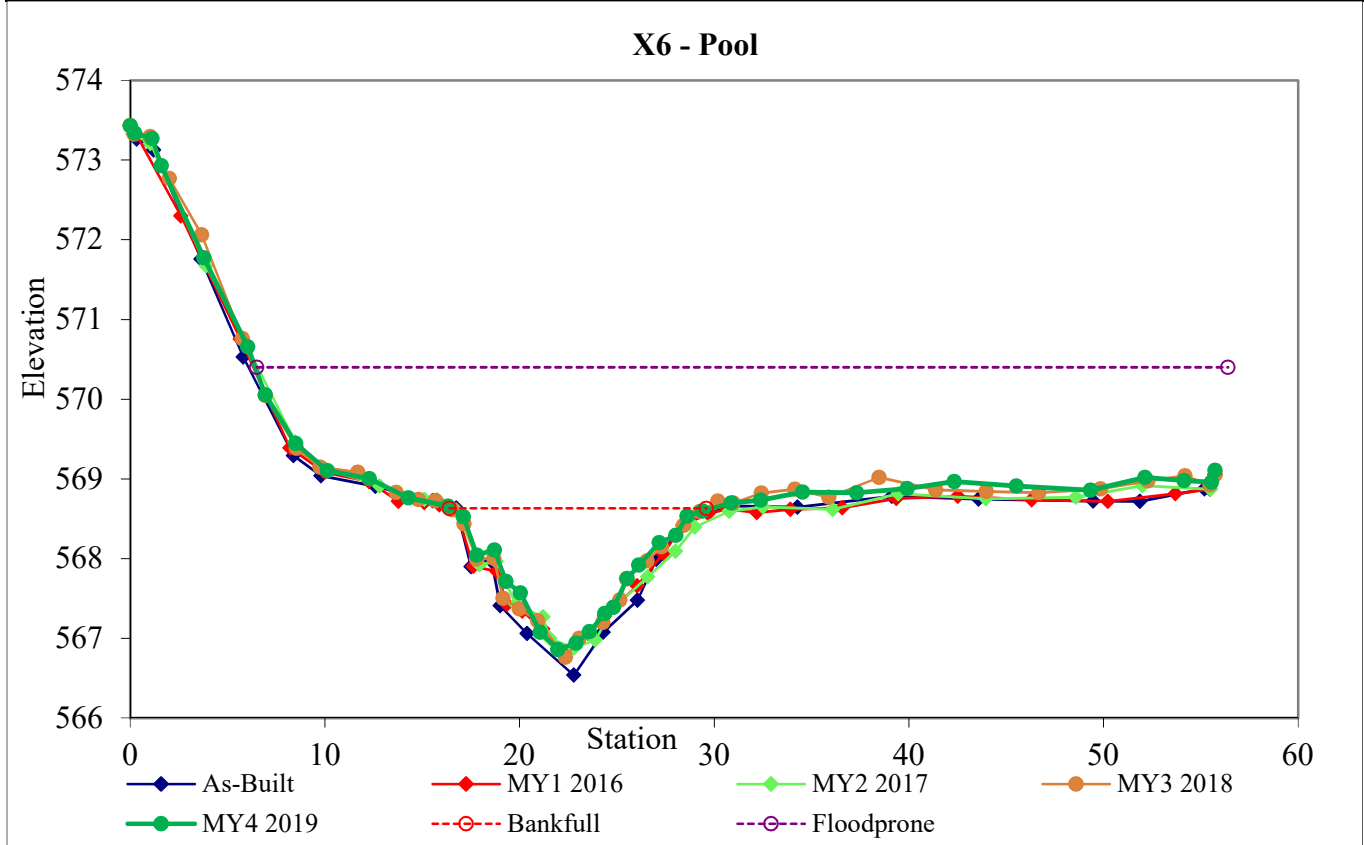
Permanent Cross-section
X6 Pool - Reach 3
(Monitoring Year 4 - Collected September 2019)

Feature	Stream Type	BKF Area	BKF Width	BKF Depth	Max BKF Depth	W/D	BH Ratio	ER	BKF Elev	TOB Elev	WFPA
Pool		11.54	13.40	0.90	1.80	15.60	-	-	568.63	568.53	49.30

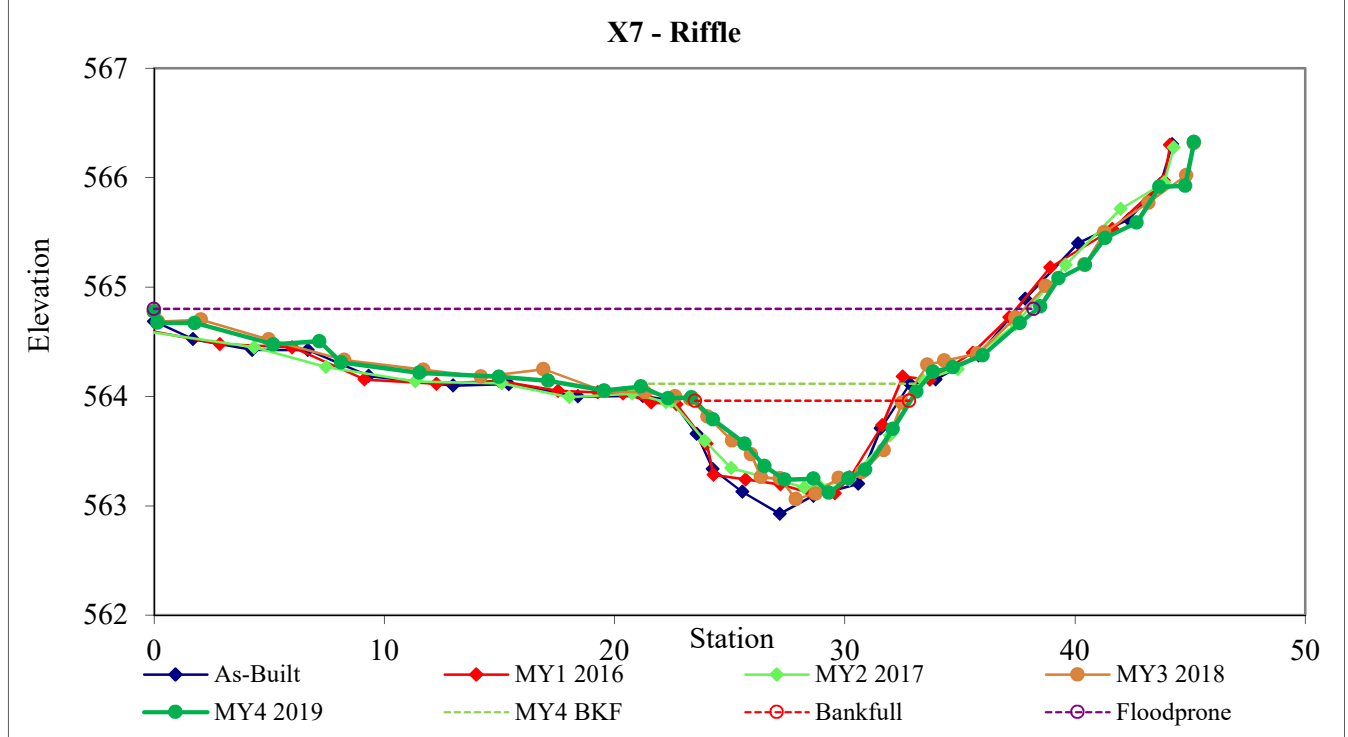
Permanent Cross-section
X7 Riffle - Reach 3
(Monitoring Year 4 - Collected September 2019)

Feature	Stream Type	BKF Area	BKF Width	BKF Depth	Max BKF Depth	W/D	BH Ratio	ER	BKF Elev	TOB Elev	WFPA
Riffle	C	4.65	9.40	0.50	0.80	18.90	0.90	4.20	563.96	563.98	38.00

*BHR = 0.9 is based on as-built bkf area of 6.51 at an elevation of 564.115. Remainder of data based on actual bankfull elevation from as-built which is 563.96. Thalweg elevation is 563.120.

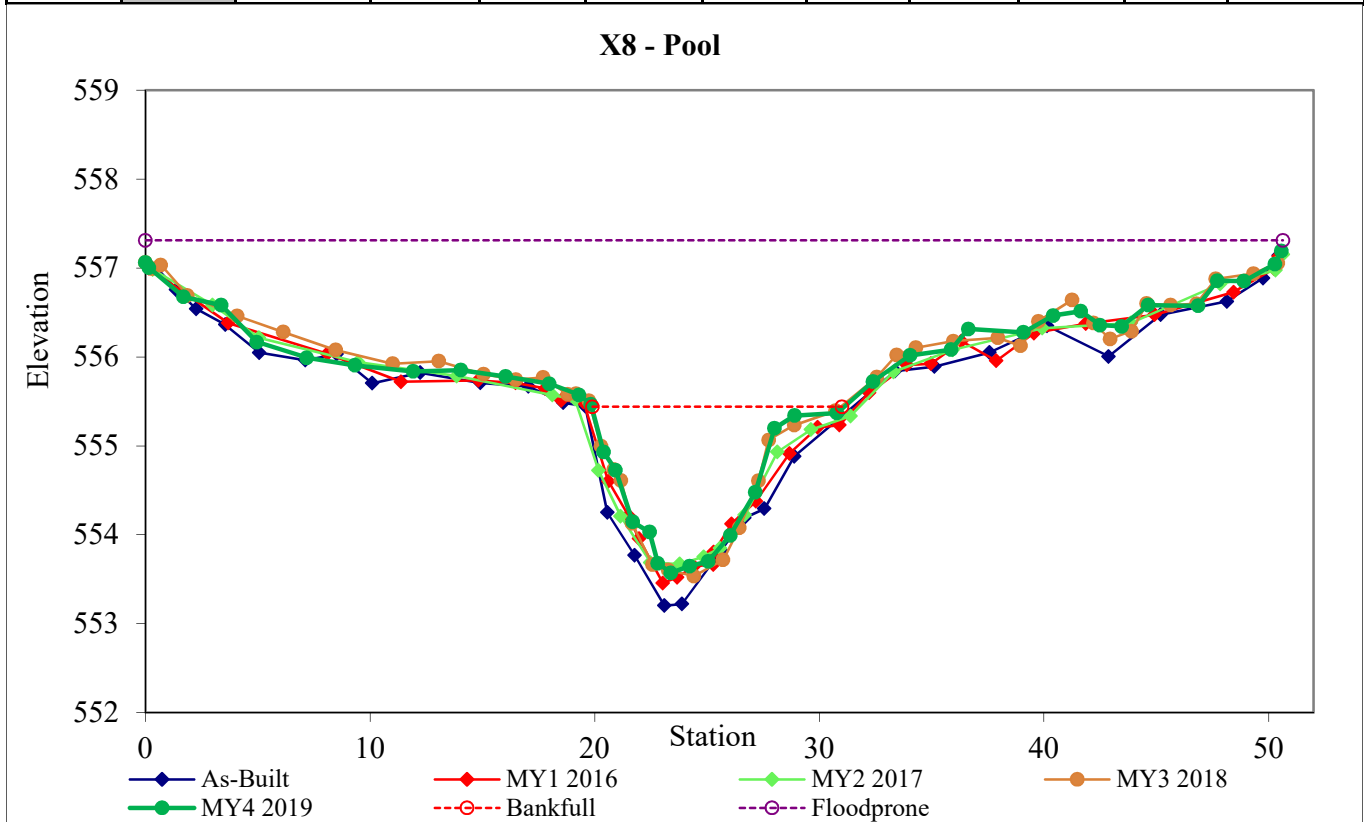
Permanent Cross-section
X8 Pool - Reach 3
(Monitoring Year 4 - Collected September 2019)

Feature	Stream Type	BKF Area	BKF Width	BKF Depth	Max BKF Depth	W/D	BH Ratio	ER	BKF Elev	TOB Elev	WFPA
Pool		10.62	11.20	0.90	1.90	11.90	-	-	555.44	555.20	50.60

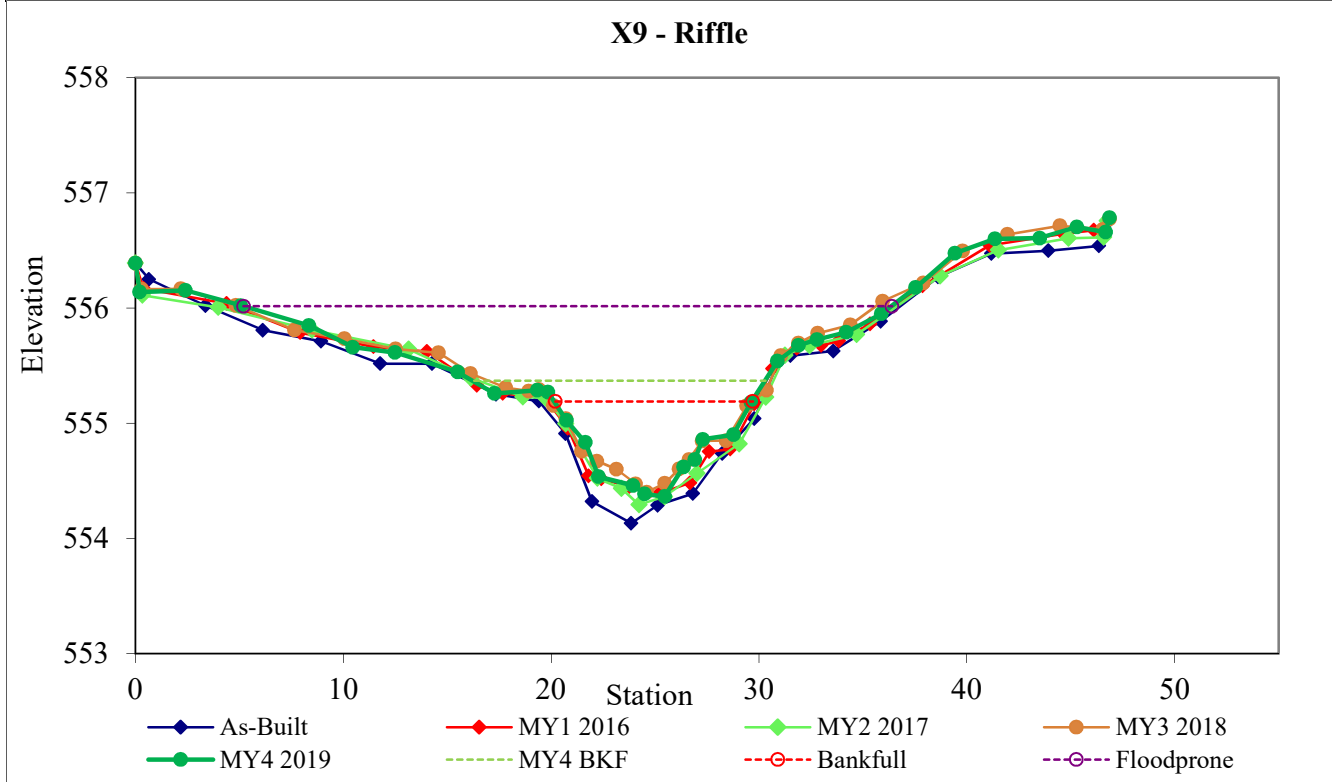
Permanent Cross-section
X9 Riffle - Reach 3
(Monitoring Year 4 - Collected September 2019)

Feature	Stream Type	BKF Area	BKF Width	BKF Depth	Max BKF Depth	W/D	BH Ratio	ER	BKF Elev	TOB Elev	WFPA
Riffle	C	4.63	9.50	0.50	0.80	19.50	0.90	3.30	555.19	555.27	31.20

*BHR = 0.9 is based on as-built bkf area of 6.79 at an elevation of 555.37. Remainder of data based on actual bankfull elevation from as-built which is 555.19. Thalweg elevation is 554.388.

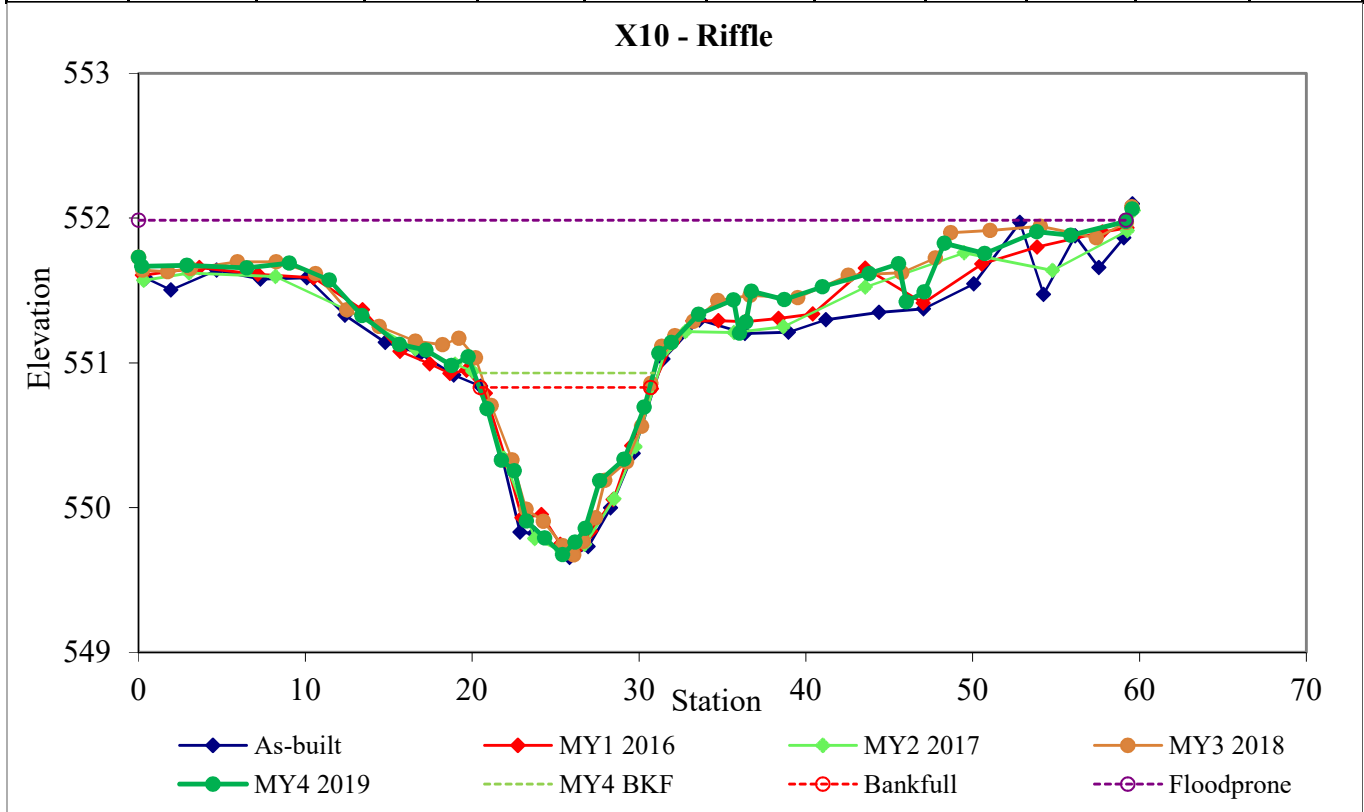
Permanent Cross-section
X10 Riffle - Reach 5
(Monitoring Year 4 - Collected September 2019)

Feature	Stream Type	BKF Area	BKF Width	BKF Depth	Max BKF Depth	W/D	BH Ratio	ER	BKF Elev	TOB Elev	WFGPA
Riffle	C	6.92	10.20	0.70	1.20	15.10	1.10	5.80	550.83	551.03	59.20

*BHR = 1.1 is based on as-built bkf area of 8.0 at an elevation of 550.93. Remainder of data based on actual bankfull elevation from as-built which is 550.83. Thalweg elevation is 549.674.

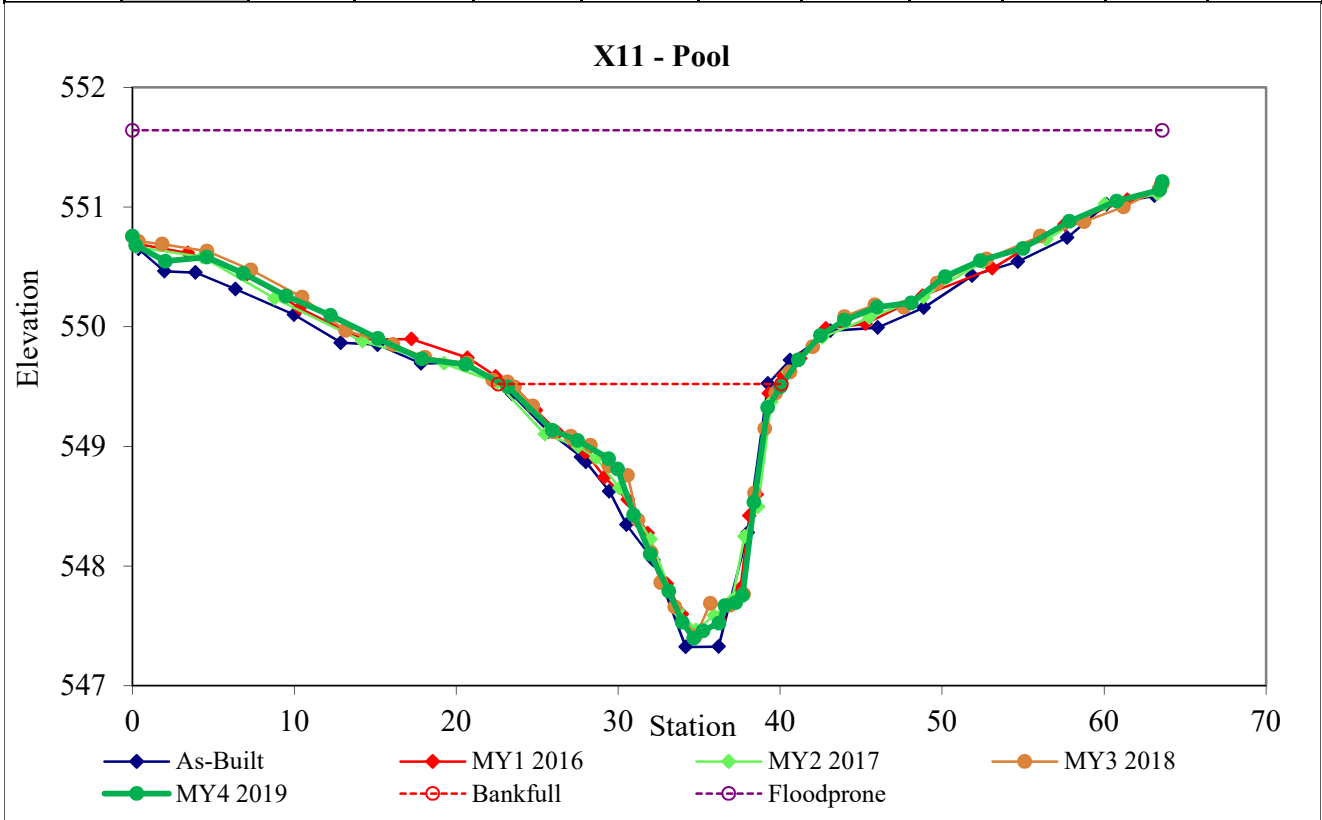
Permanent Cross-section
X11 Pool - Reach 5
(Monitoring Year 4 - Collected September 2019)

Feature	Stream Type	BKF Area	BKF Width	BKF Depth	Max BKF Depth	W/D	BH Ratio	ER	BKF Elev	TOB Elev	WFPA
Pool		17.10	17.30	1.00	2.10	17.40	-	-	549.52	549.32	63.60

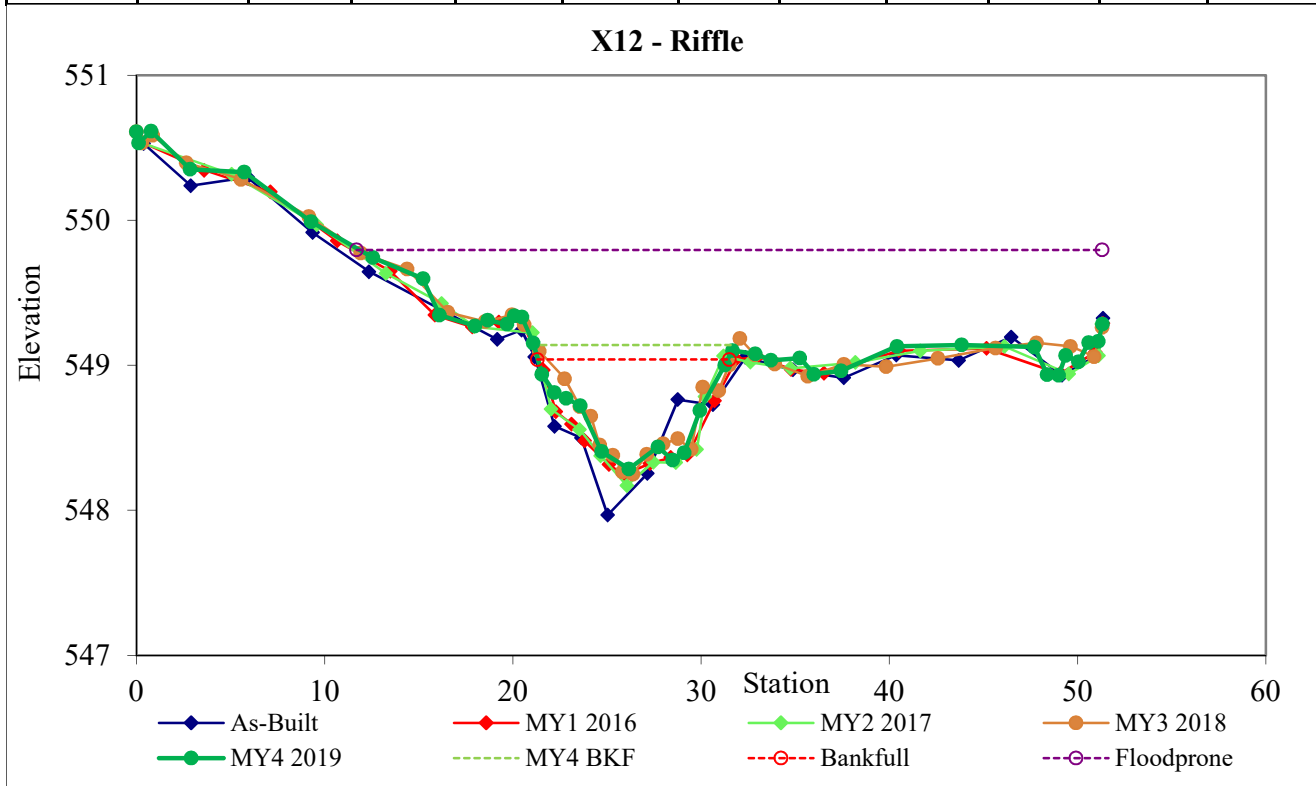
Permanent Cross-section
X12 Riffle - Reach 5
(Monitoring Year 4 - Collected September 2019)

Feature	Stream Type	BKF Area	BKF Width	BKF Depth	Max BKF Depth	W/D	BH Ratio	ER	BKF Elev	TOB Elev	WFPA
Riffle	C	4.69	10.10	0.50	0.80	21.80	1.00	4.20	549.04	549.18	39.4

*BHR = 1.0 is based on as-built bkf area of 5.71 at an elevation of 549.14. Remainder of data based on actual bankfull elevation from as-built which is 549.04. Thalweg elevation is 548.285.

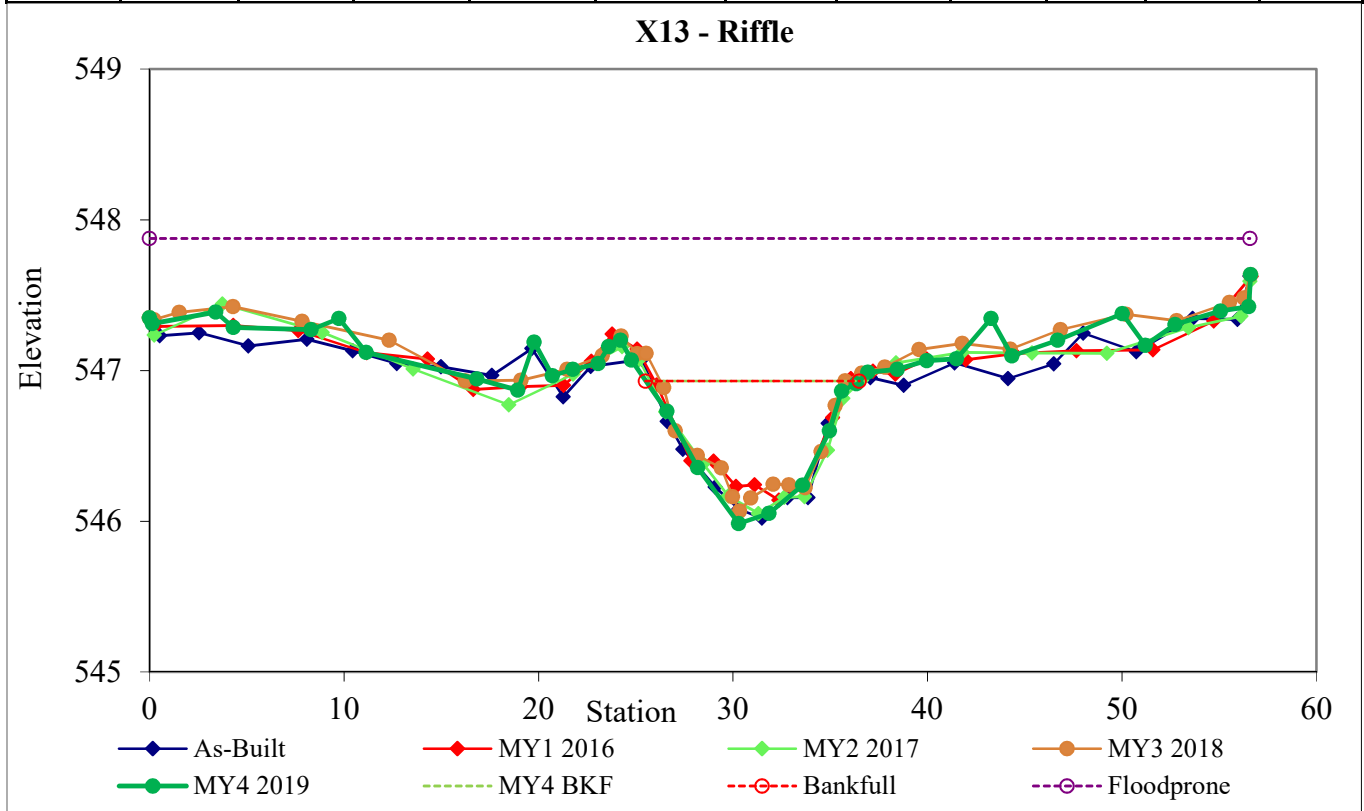
Permanent Cross-section
X13 Riffle - Reach 5
(Monitoring Year 4 - Collected September 2019)

Feature	Stream Type	BKF Area	BKF Width	BKF Depth	Max BKF Depth	W/D	BH Ratio	ER	BKF Elev	TOB Elev	WFGPA
Riffle	C	5.97	11.00	0.50	0.90	20.10	1.10	5.20	546.93	546.98	56.6

*BHR = 1.1 is based on as-built bkf area of 5.97 at an elevation of 546.93. Remainder of data based on actual bankfull elevation from as-built which is 546.93. Thalweg elevation is 545.984.

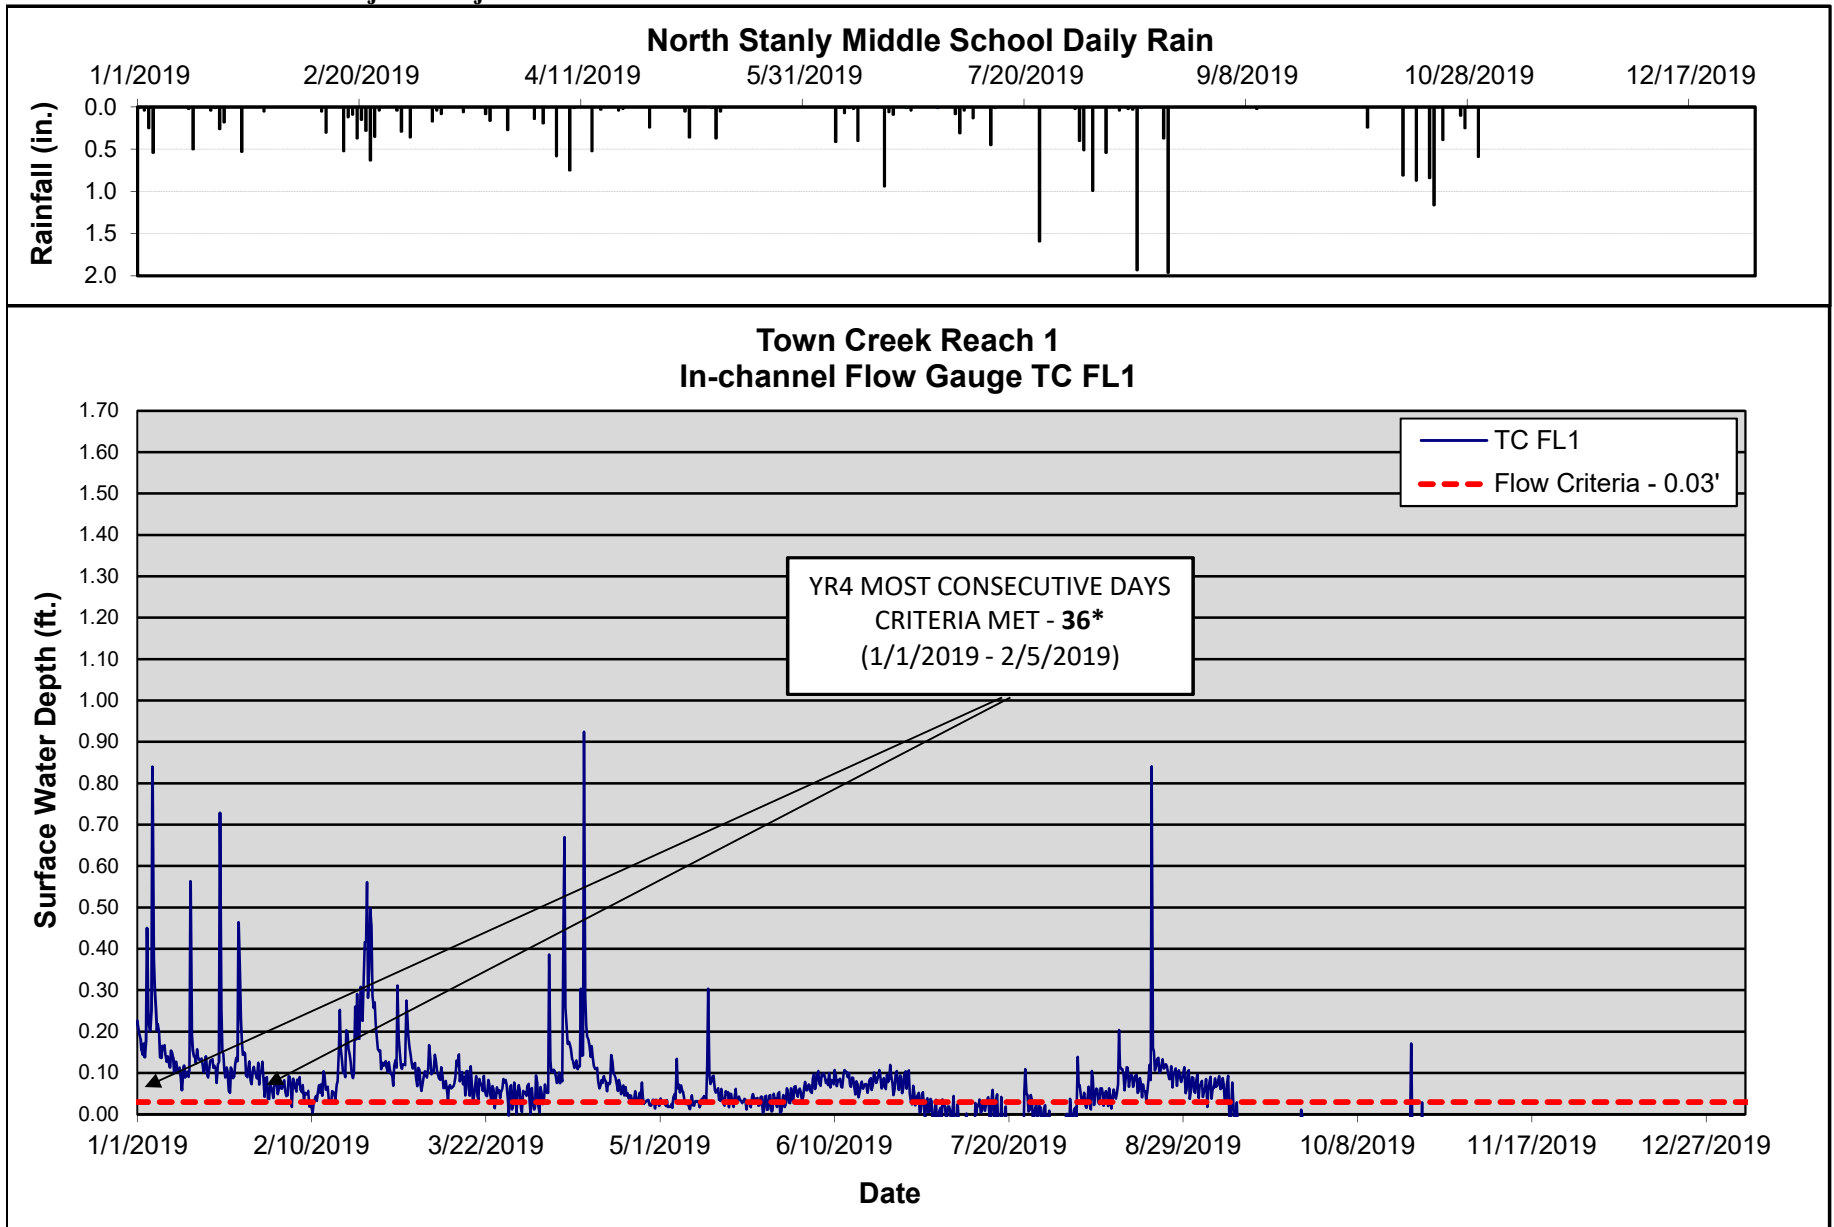
Figure 5a. In-Stream Flow Gauge Graphs
Town Creek Restoration Project: Project No. 95026

* Surface water flow is estimated to have occurred when the pressure transducer reading is equal to or above 0.03 feet in depth.
 MICHAEL BAKER ENGINEERING, INC., DMS PROJECT NO. 95026
 TOWN CREEK RESTORATION PROJECT - OPTION B
 YEAR 4 MONITORING REPORT - 2019, YEAR 4 OF 5

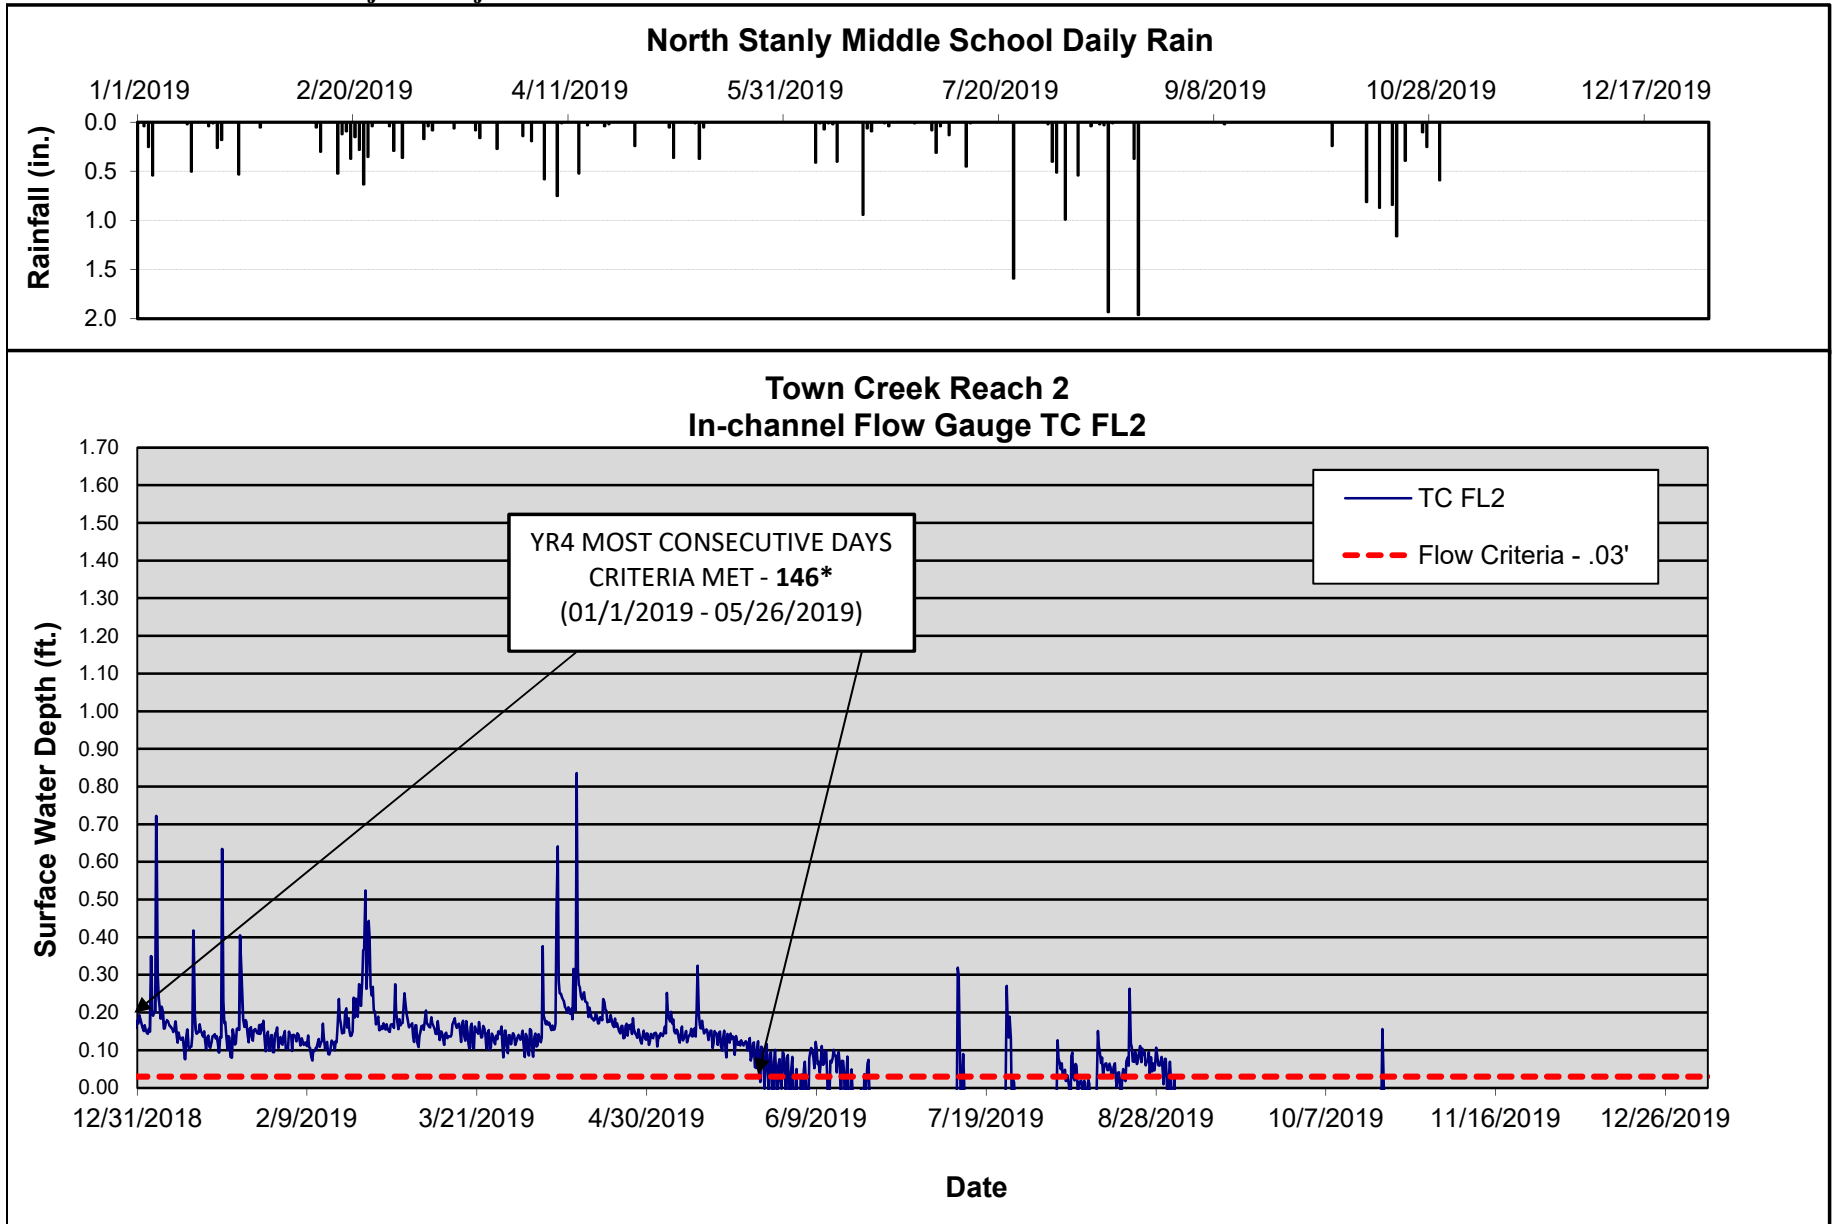
Figure 5b. In-Stream Flow Gauge Graphs
Town Creek Restoration Project: Project No. 95026

* Surface water flow is estimated to have occurred when the pressure transducer reading is equal to or above 0.03 feet in depth.
