**YEAR 1 of 5 Monitoring Report
Tributaries of Wicker Branch Stream Restoration
Union County, North Carolina
DMS Project Number: 95022
Contract No: 003982
USACE Action Id No: SAW 2013-01680**

**Data Collection Period October 2015
Submitted: March 2016**

AECOM

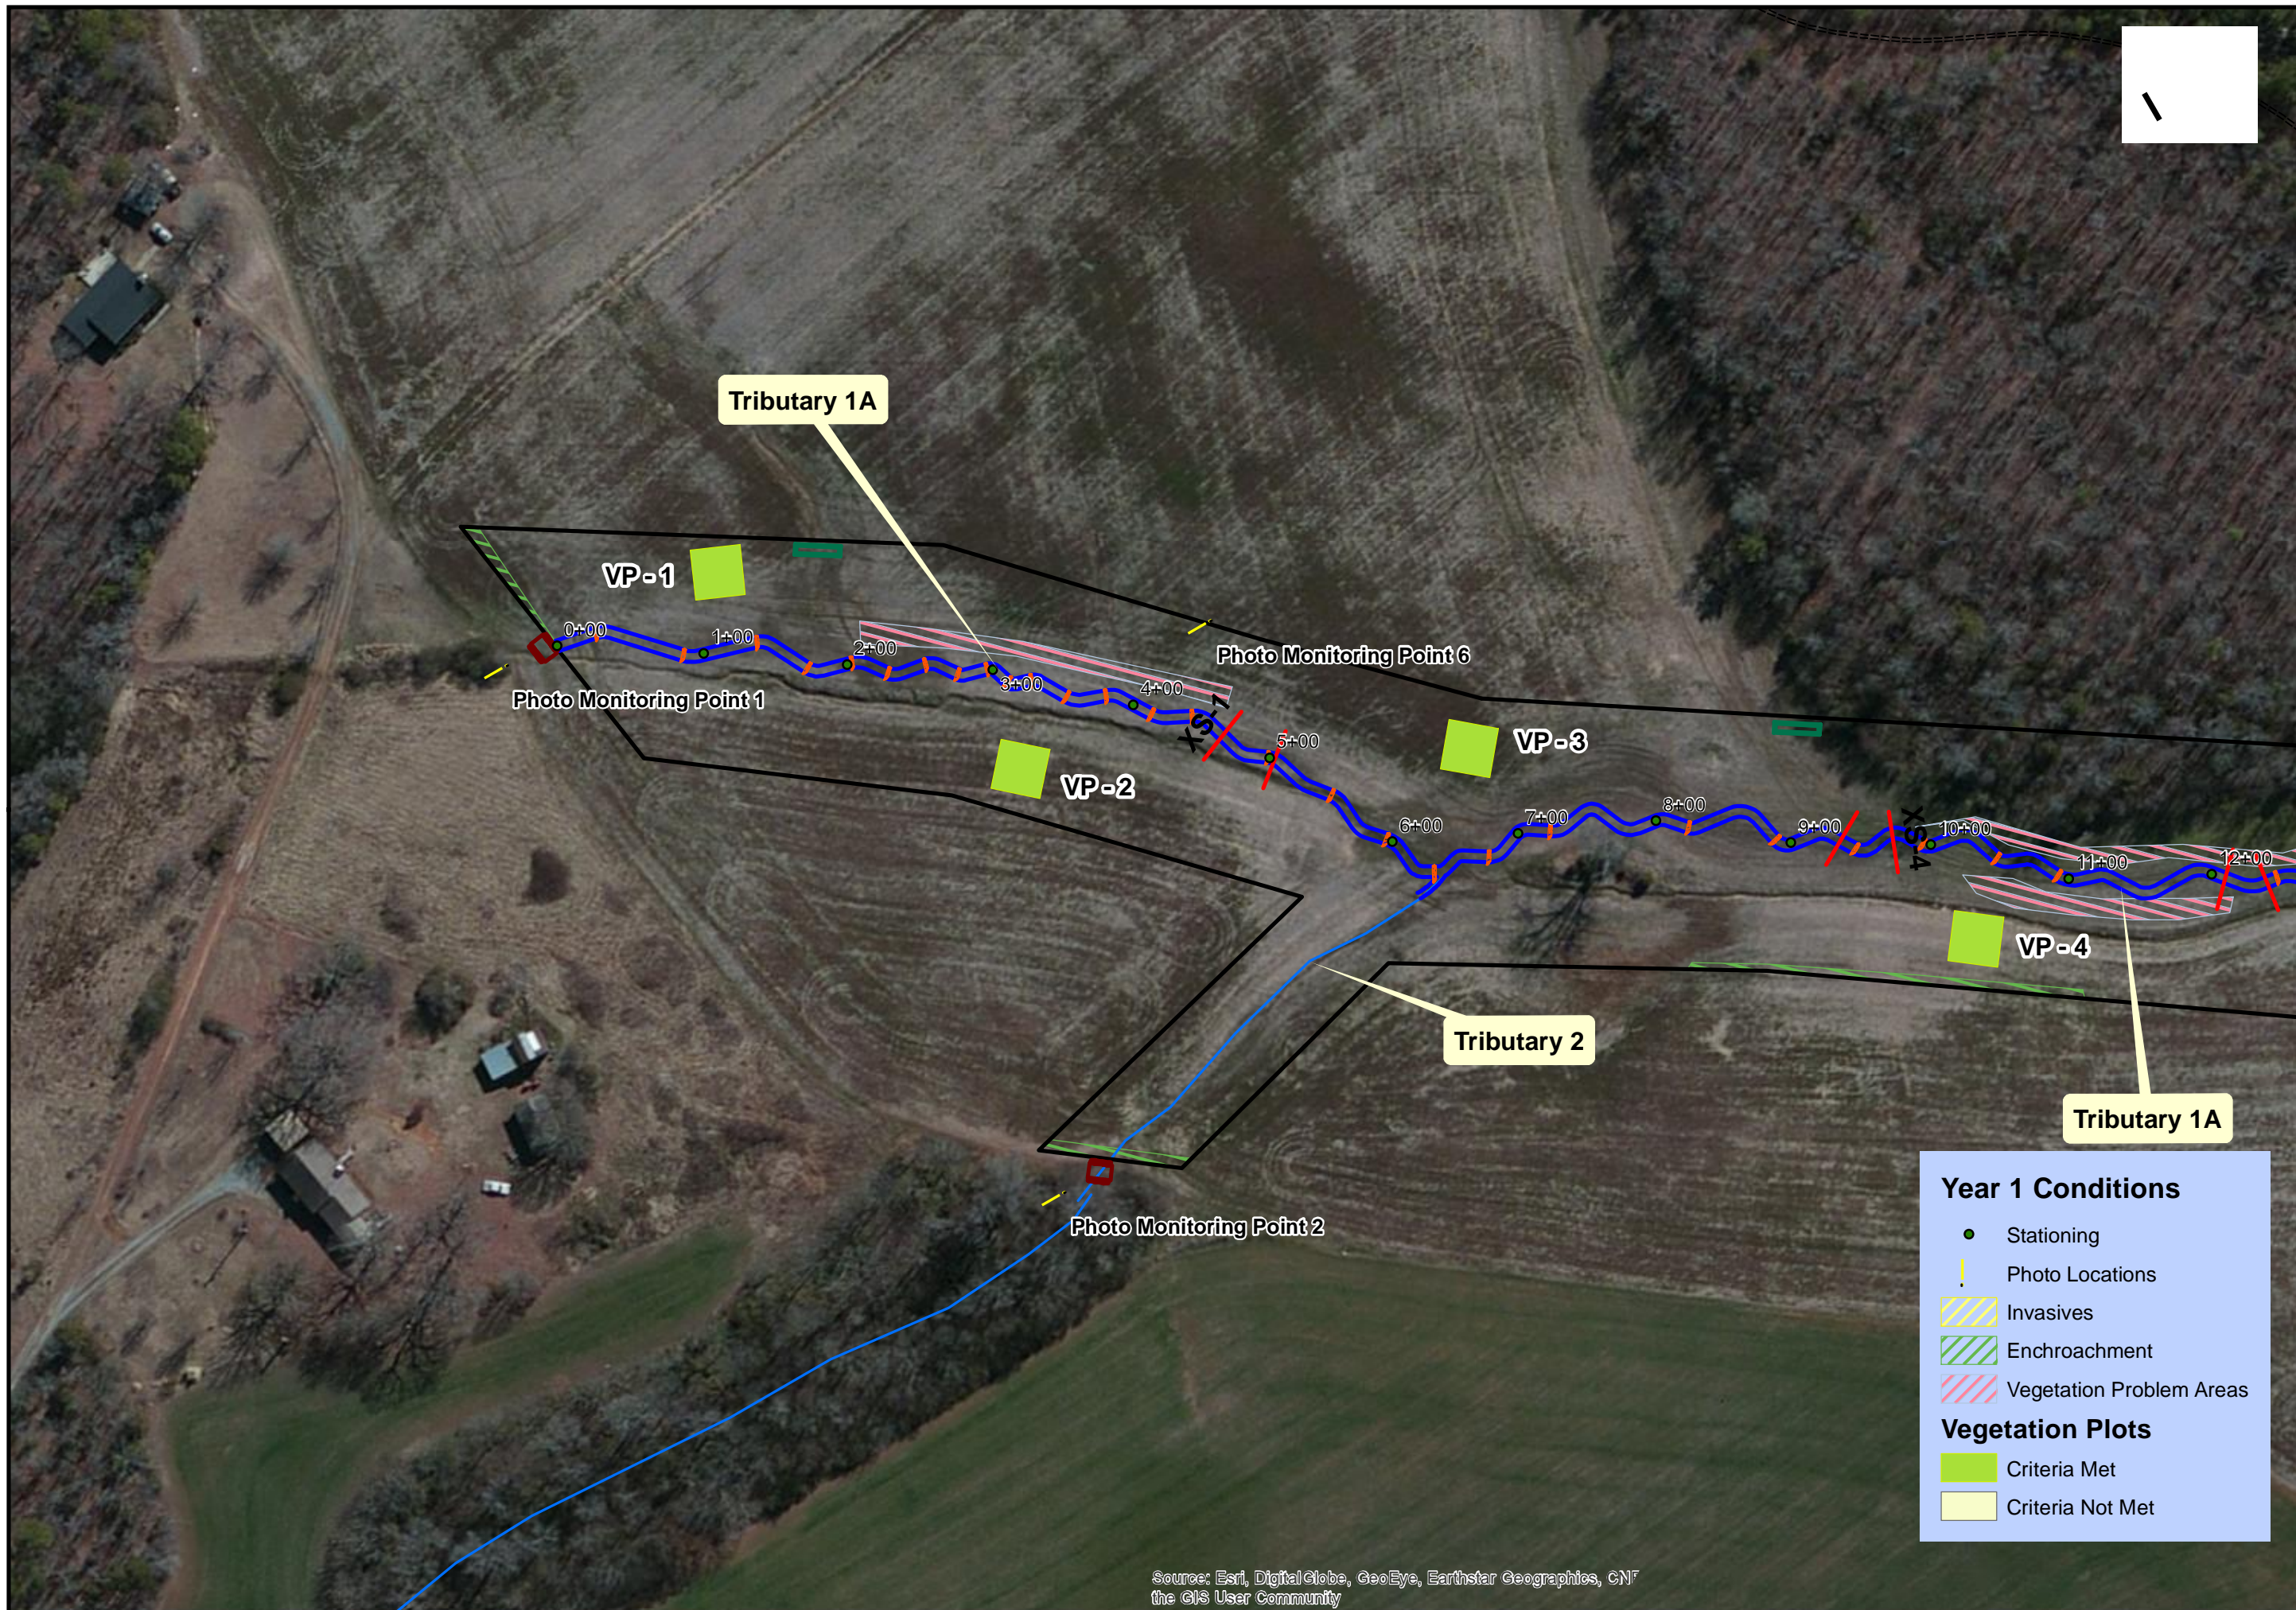
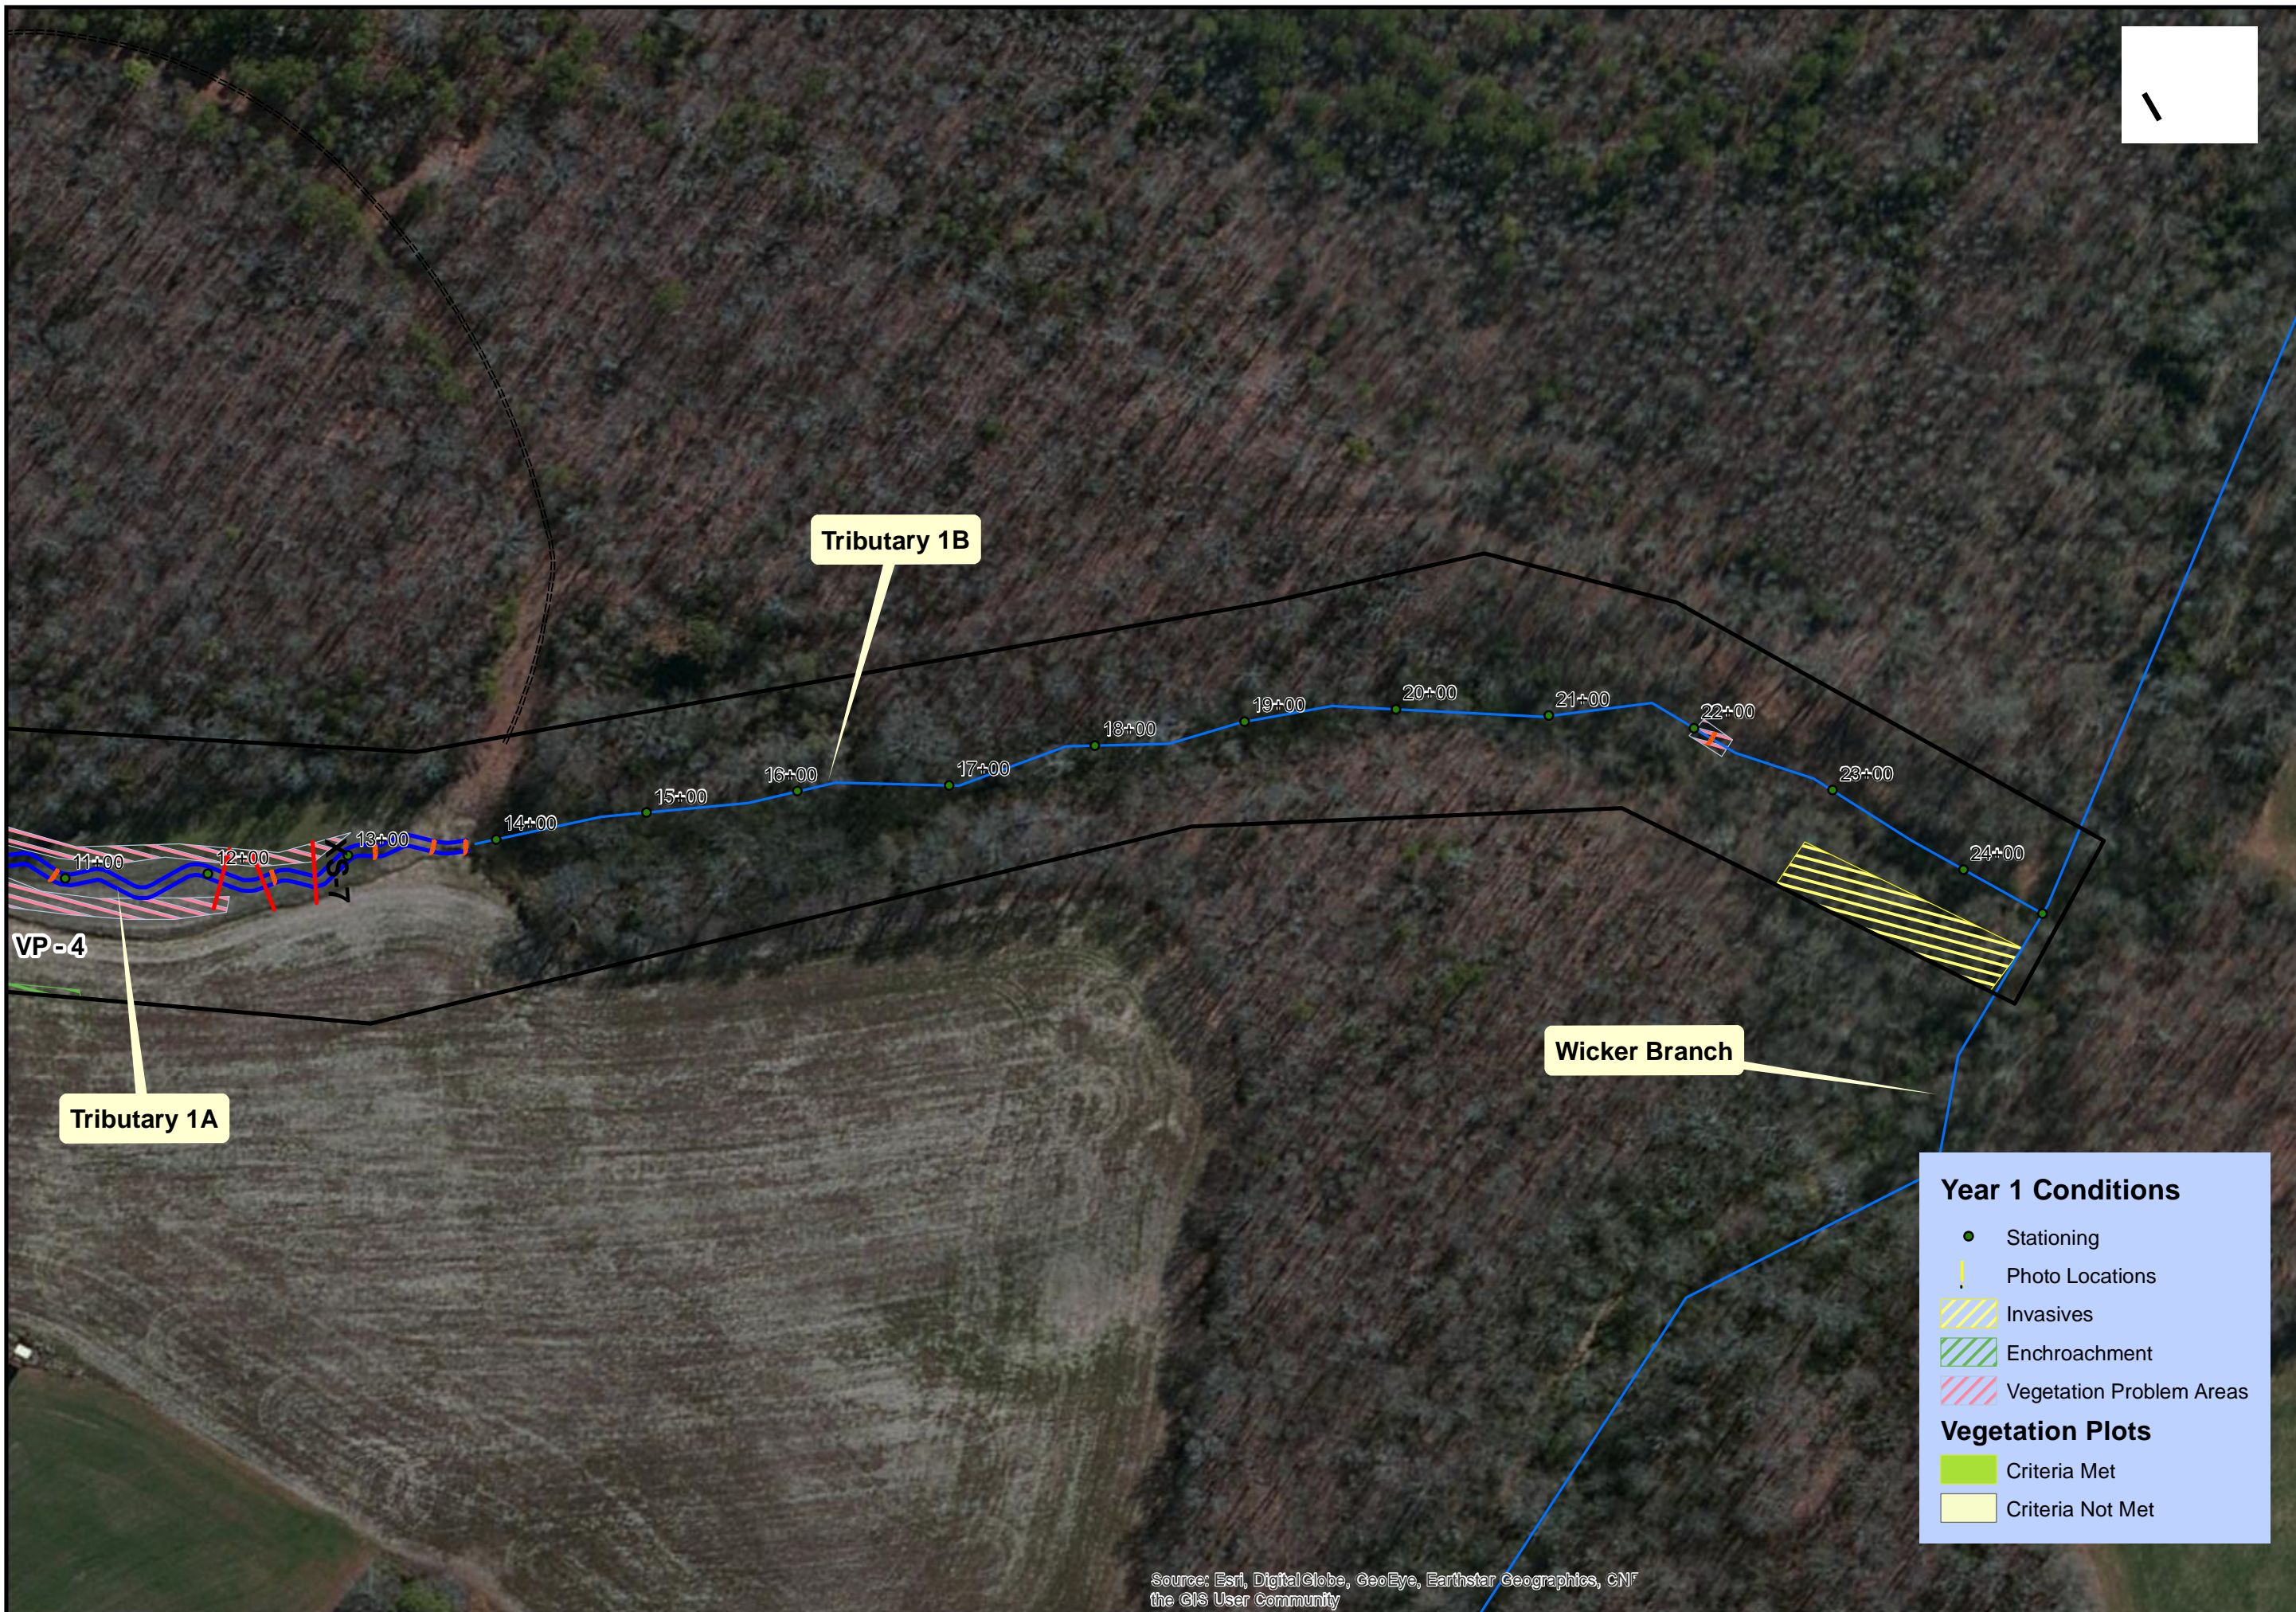
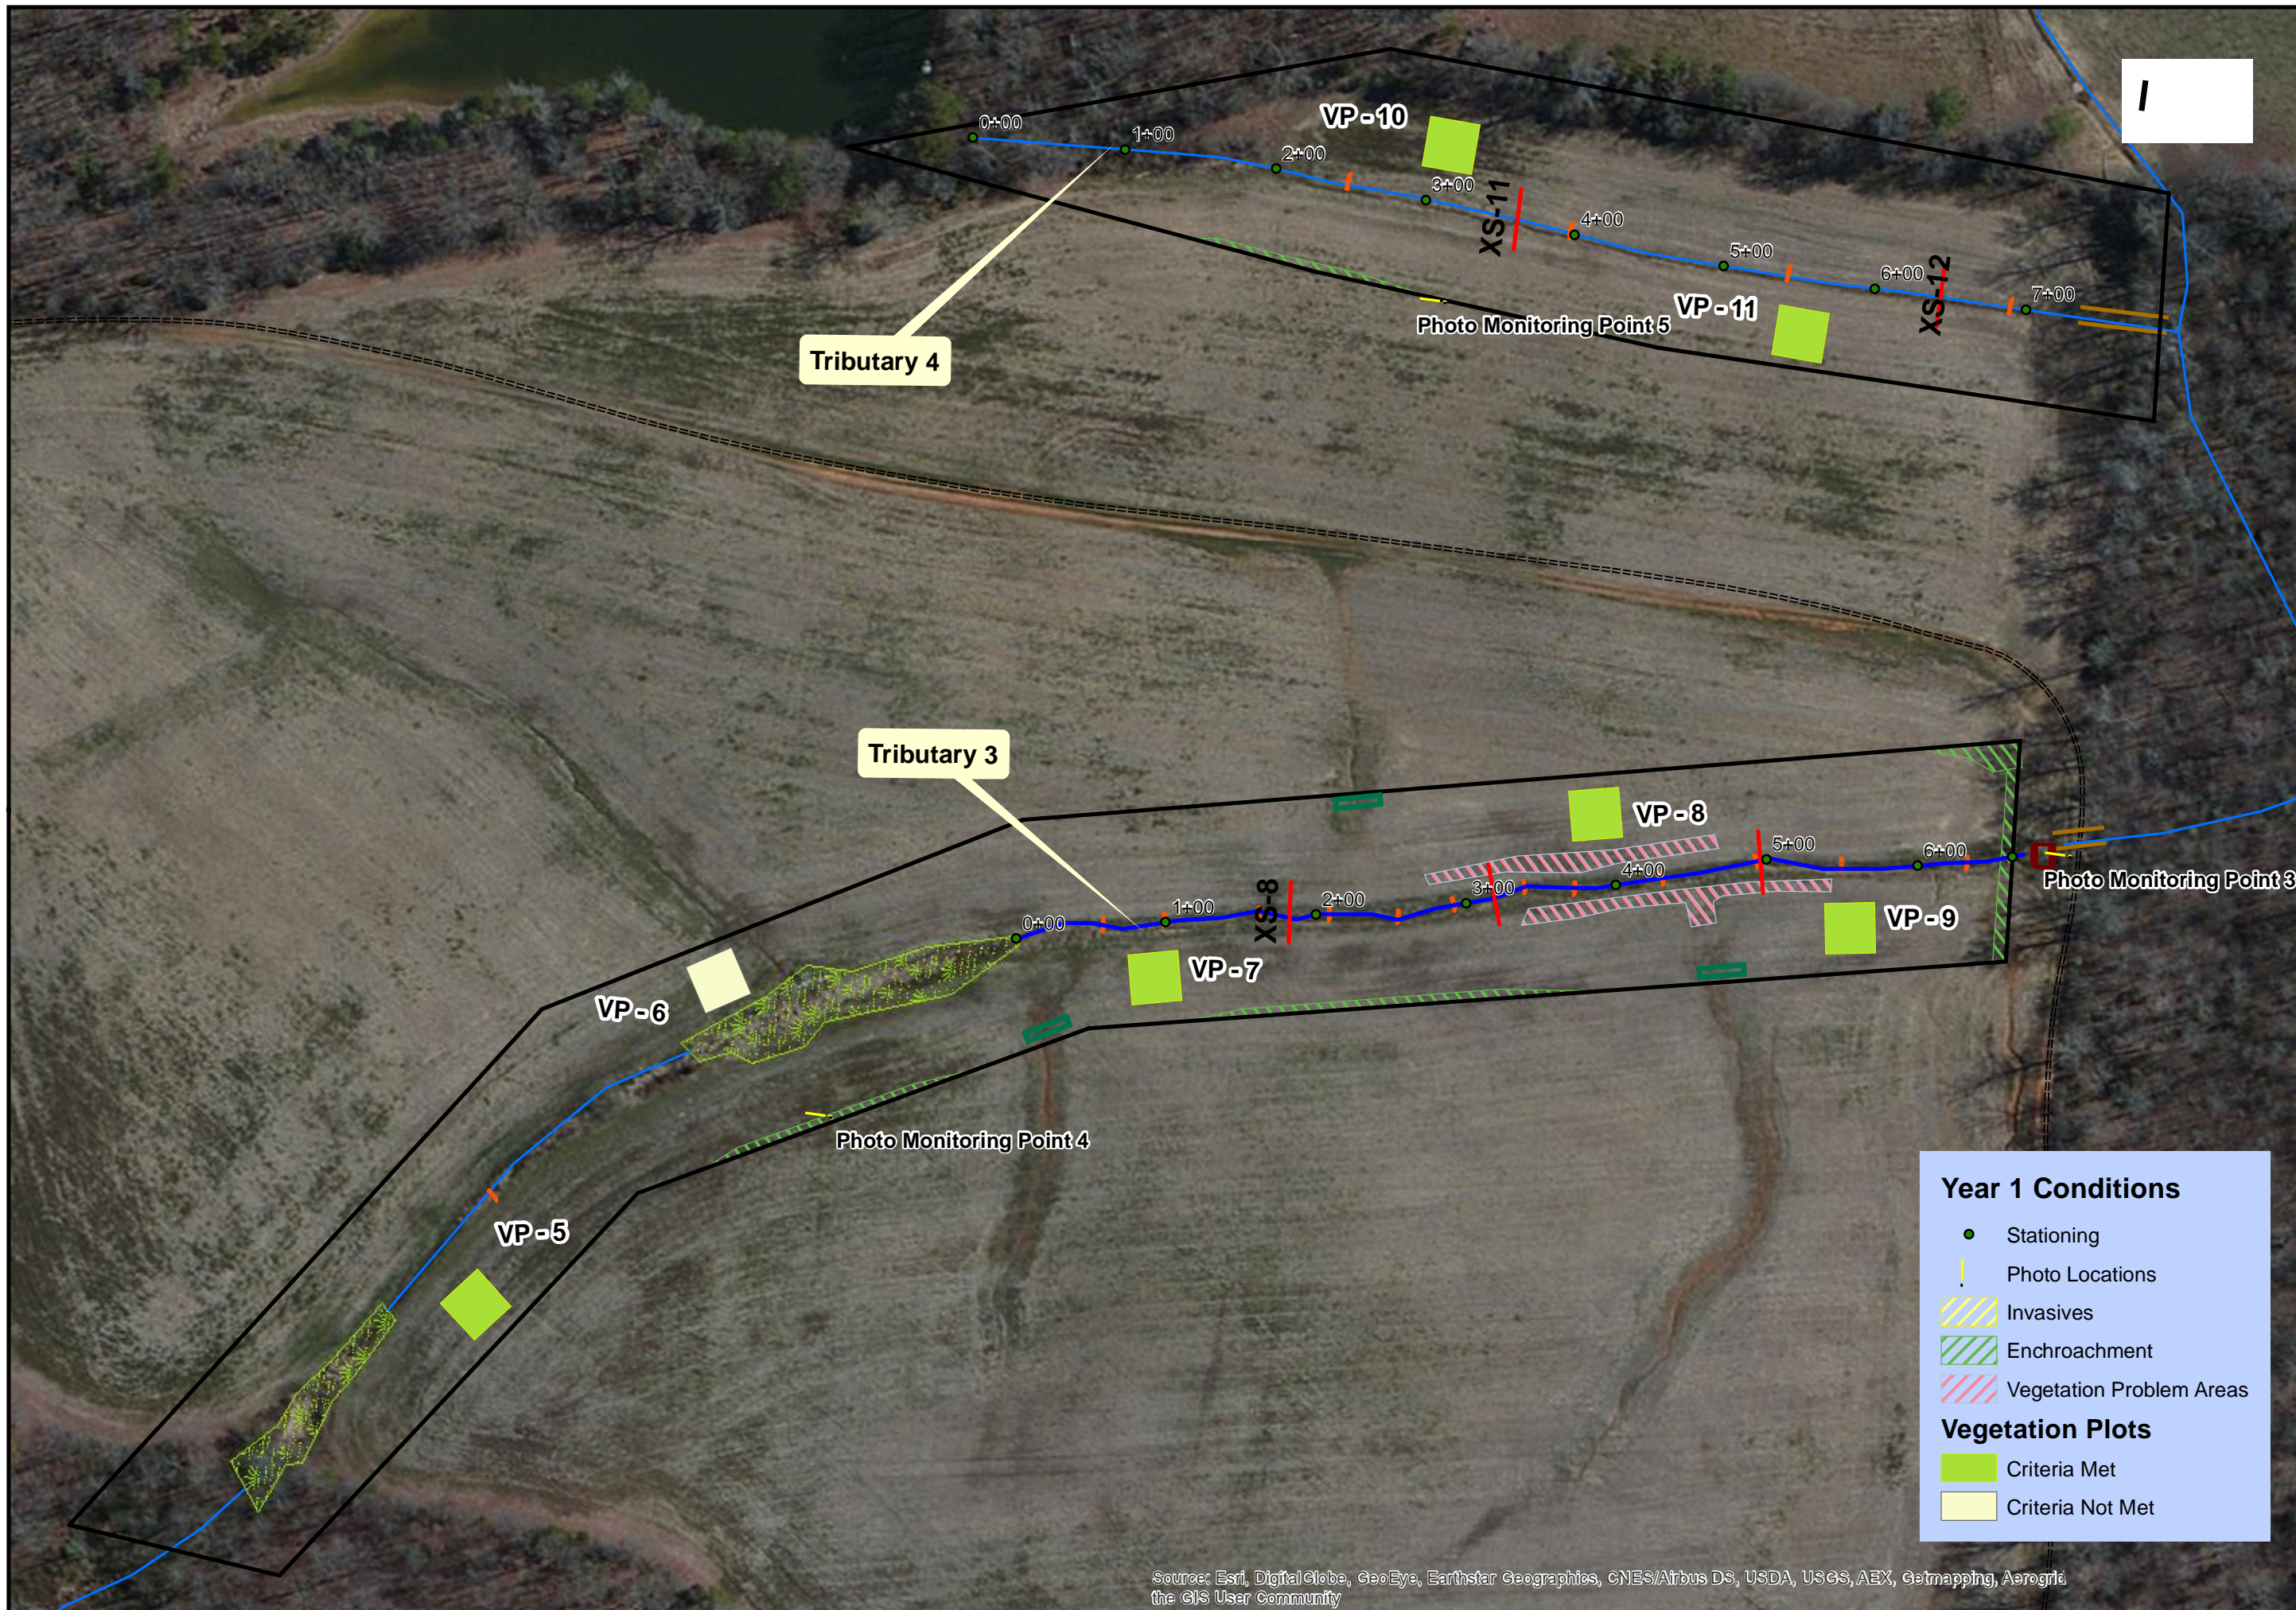
Figure 3: Current Condition Plan View

These repair areas are shown on **Figure 3** in **Appendix B** as vegetation problem areas as the repairs removed the woody stems from these areas. These areas will be replanted in February of 2016 during the dormant growth period.

The adjacent fields were planted in corn prior to establishing all the signage along the edge of the easement. This resulted in slight encroachments along the edges of the easement in several locations as it was difficult to determine the exact edge of the easement due to contours in the land. Additional signage will be installed prior to the 2016 planting season to help eliminate the encroachment. The areas of encroachment are shown on **Figure 3** in **Appendix B**.

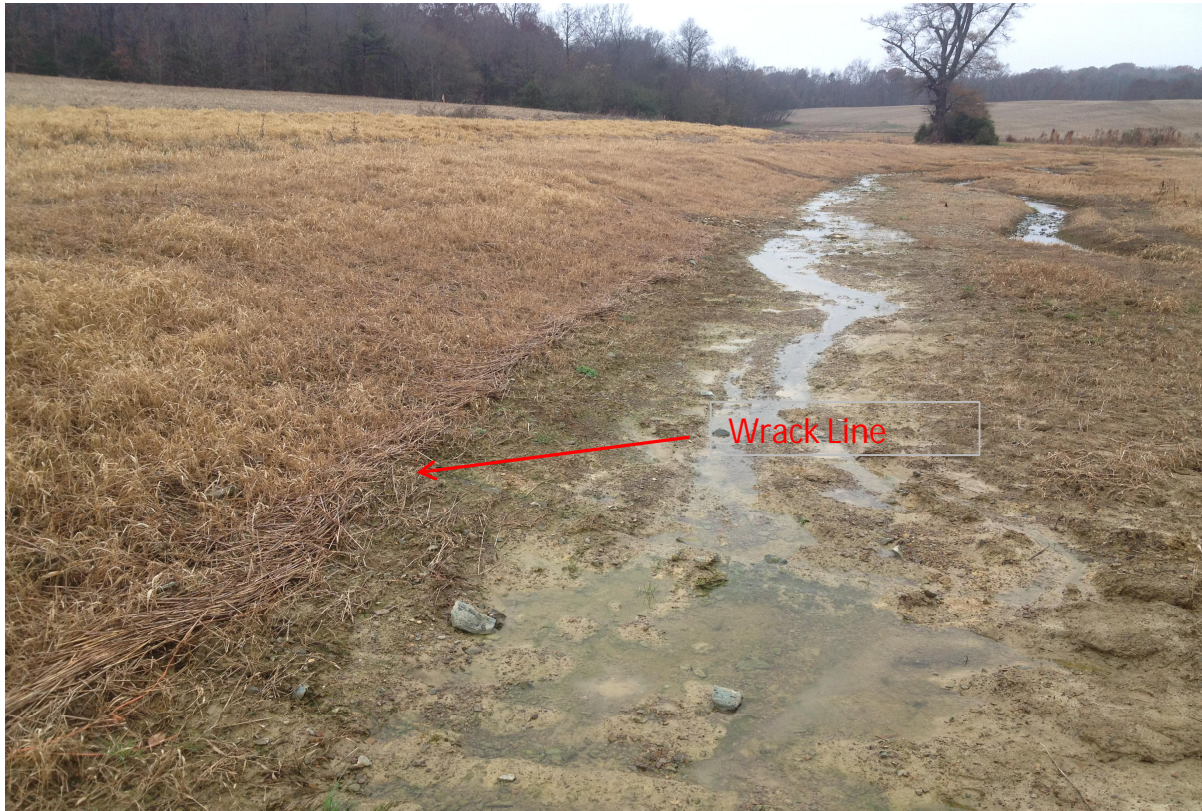
Date of Observation	Date of occurrence	Method	Greater Than $Q_{gs}=Q_2*0.66$ Stage	Greater than Q_{bkf} Stage?	Notes
12/3/2014	11/23/2014	Photo on-site wrack line		Yes	See photo below
