**YEAR 2 of 5 Monitoring Report  
Tributaries of Wicker Branch Stream Restoration  
Union County, North Carolina  
DMS Project Number: 95022  
Contract No: 003982  
USACE Action Id No: SAW 2013-01680**

**Data Collection Period October 2015  
Submitted: January 2017**

**AECOM**

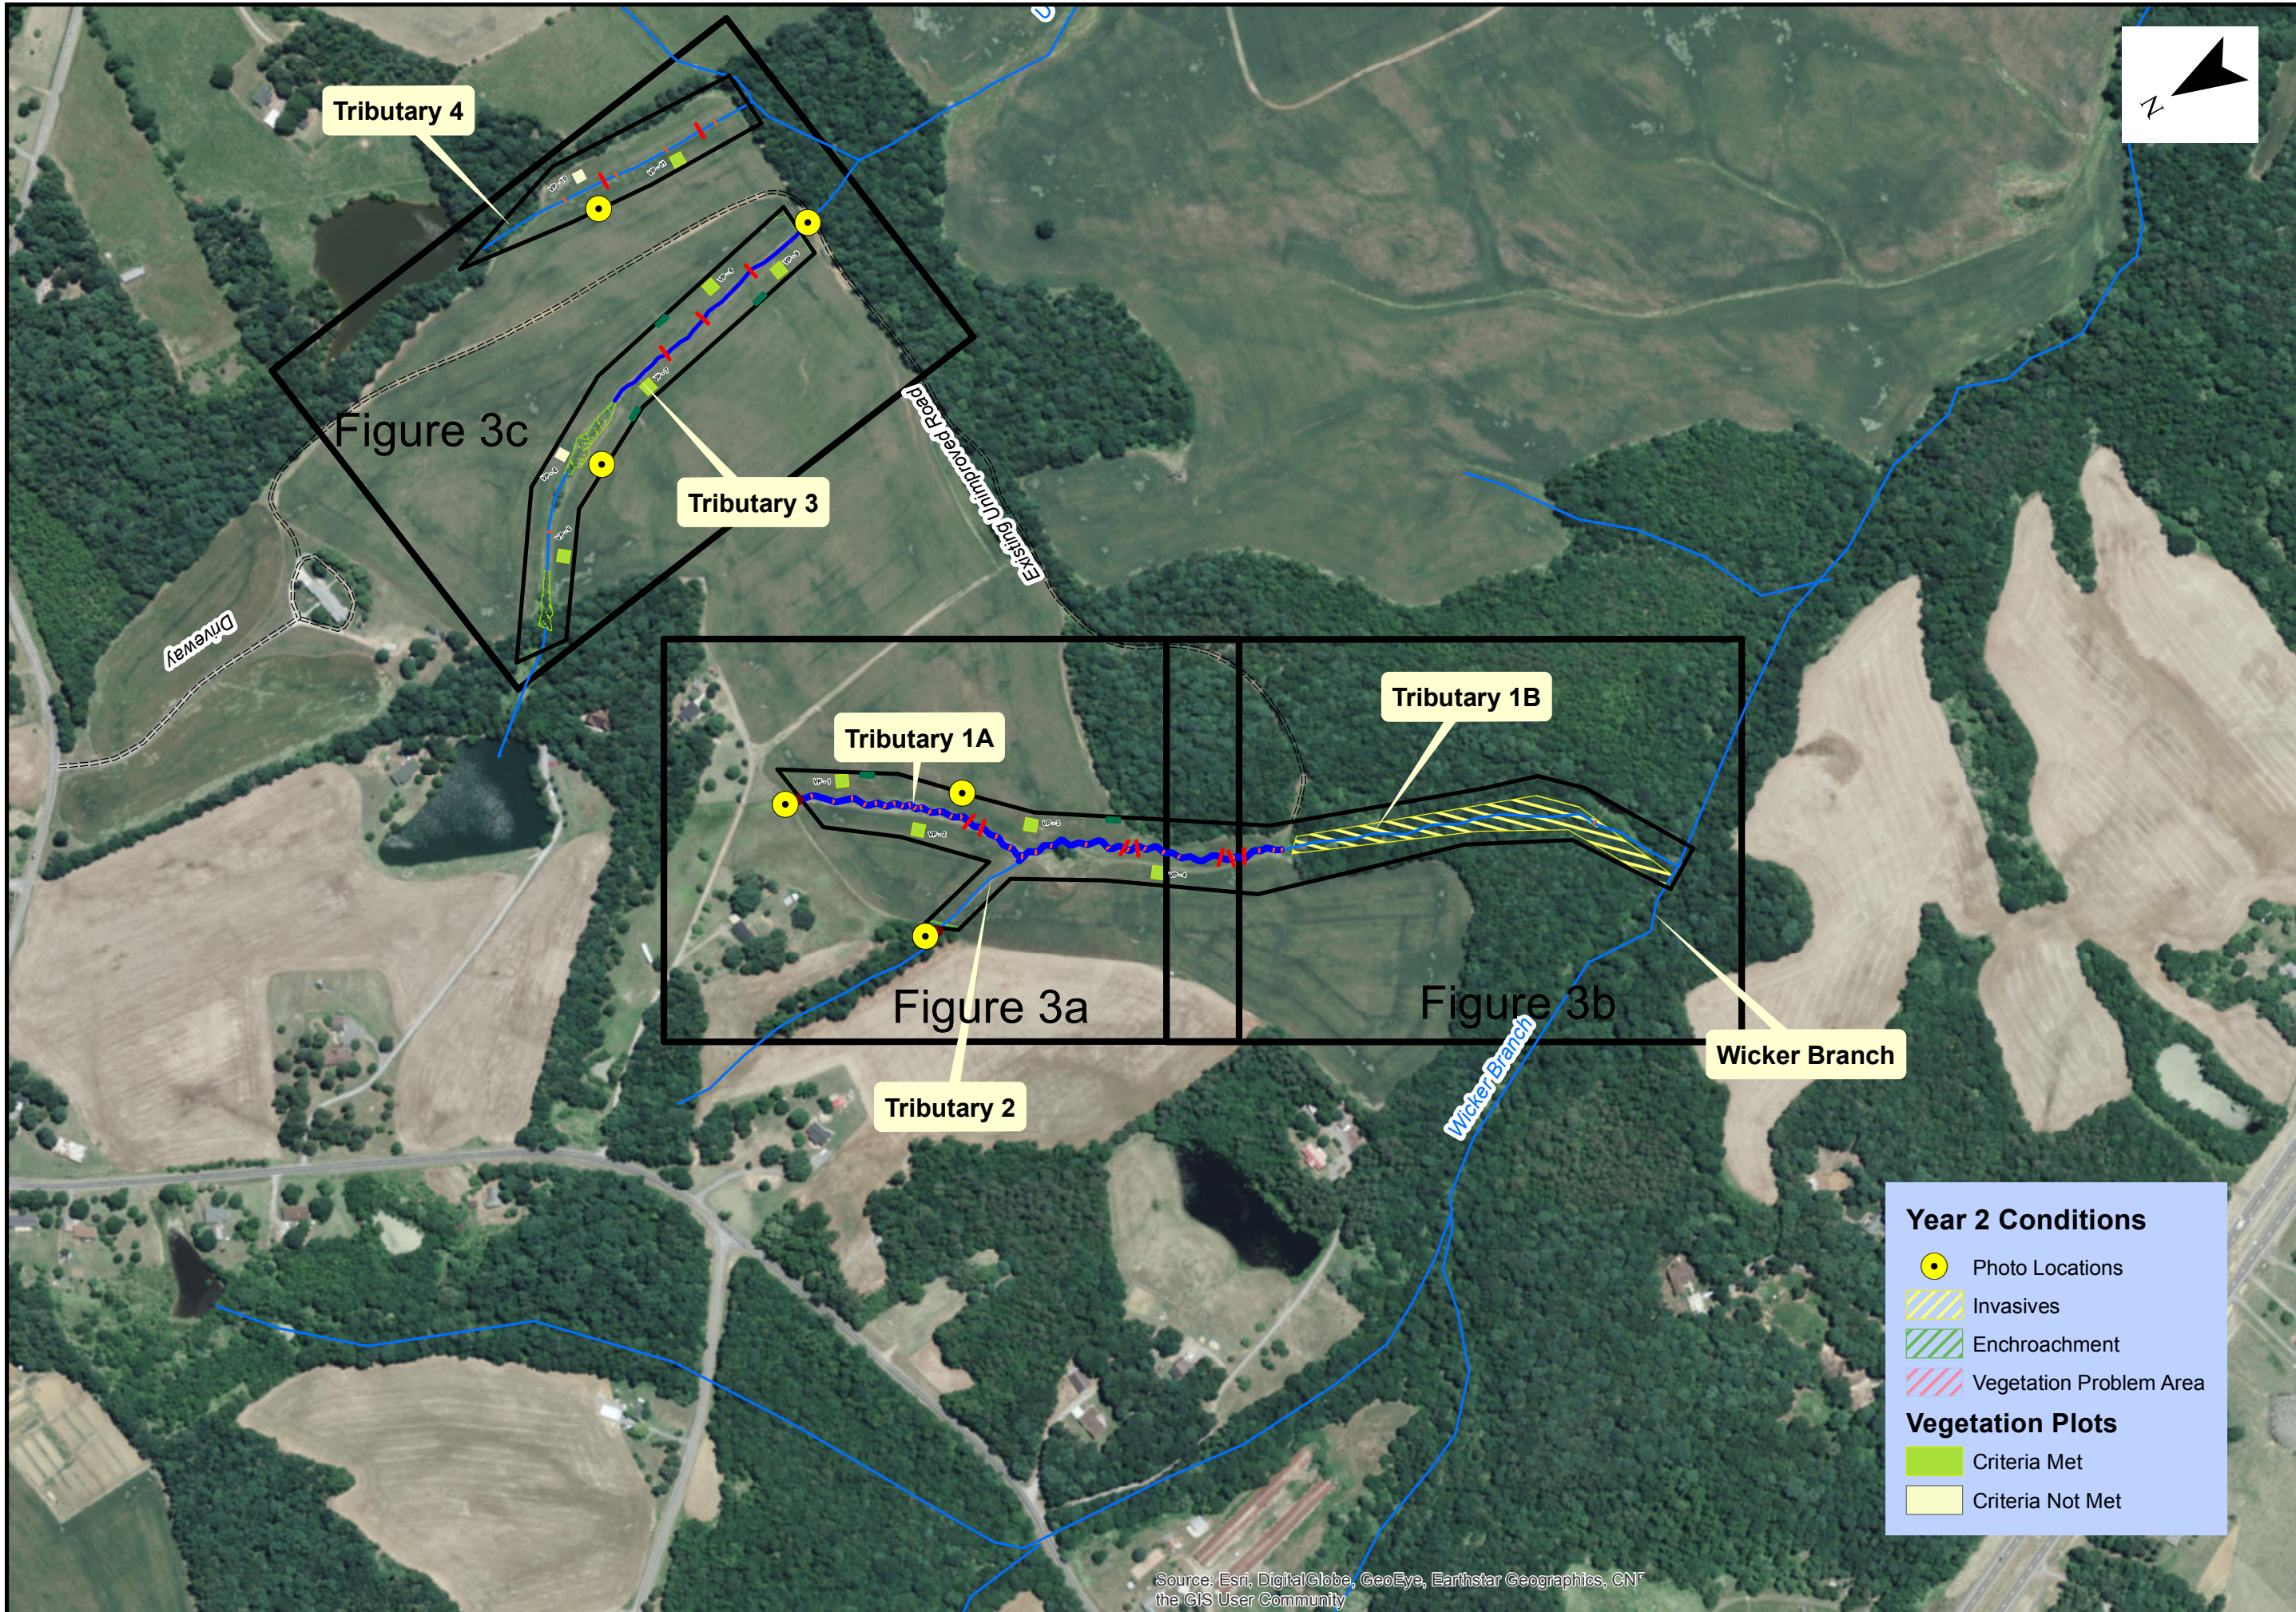
The adjacent fields were planted in soybeans in 2016. Additional signage was installed in the spring of 2016 to address encroachments along the edges of the field. There is still some encroachment into the easements at the equipment crossings and AECOM will continue to work with the landowner and the current farmer to address these encroachments. The areas of encroachment are shown on **Figure 3 in Appendix B**.

- Photo Locations
- Invasives
- Encroachment
- Vegetation Problem Area

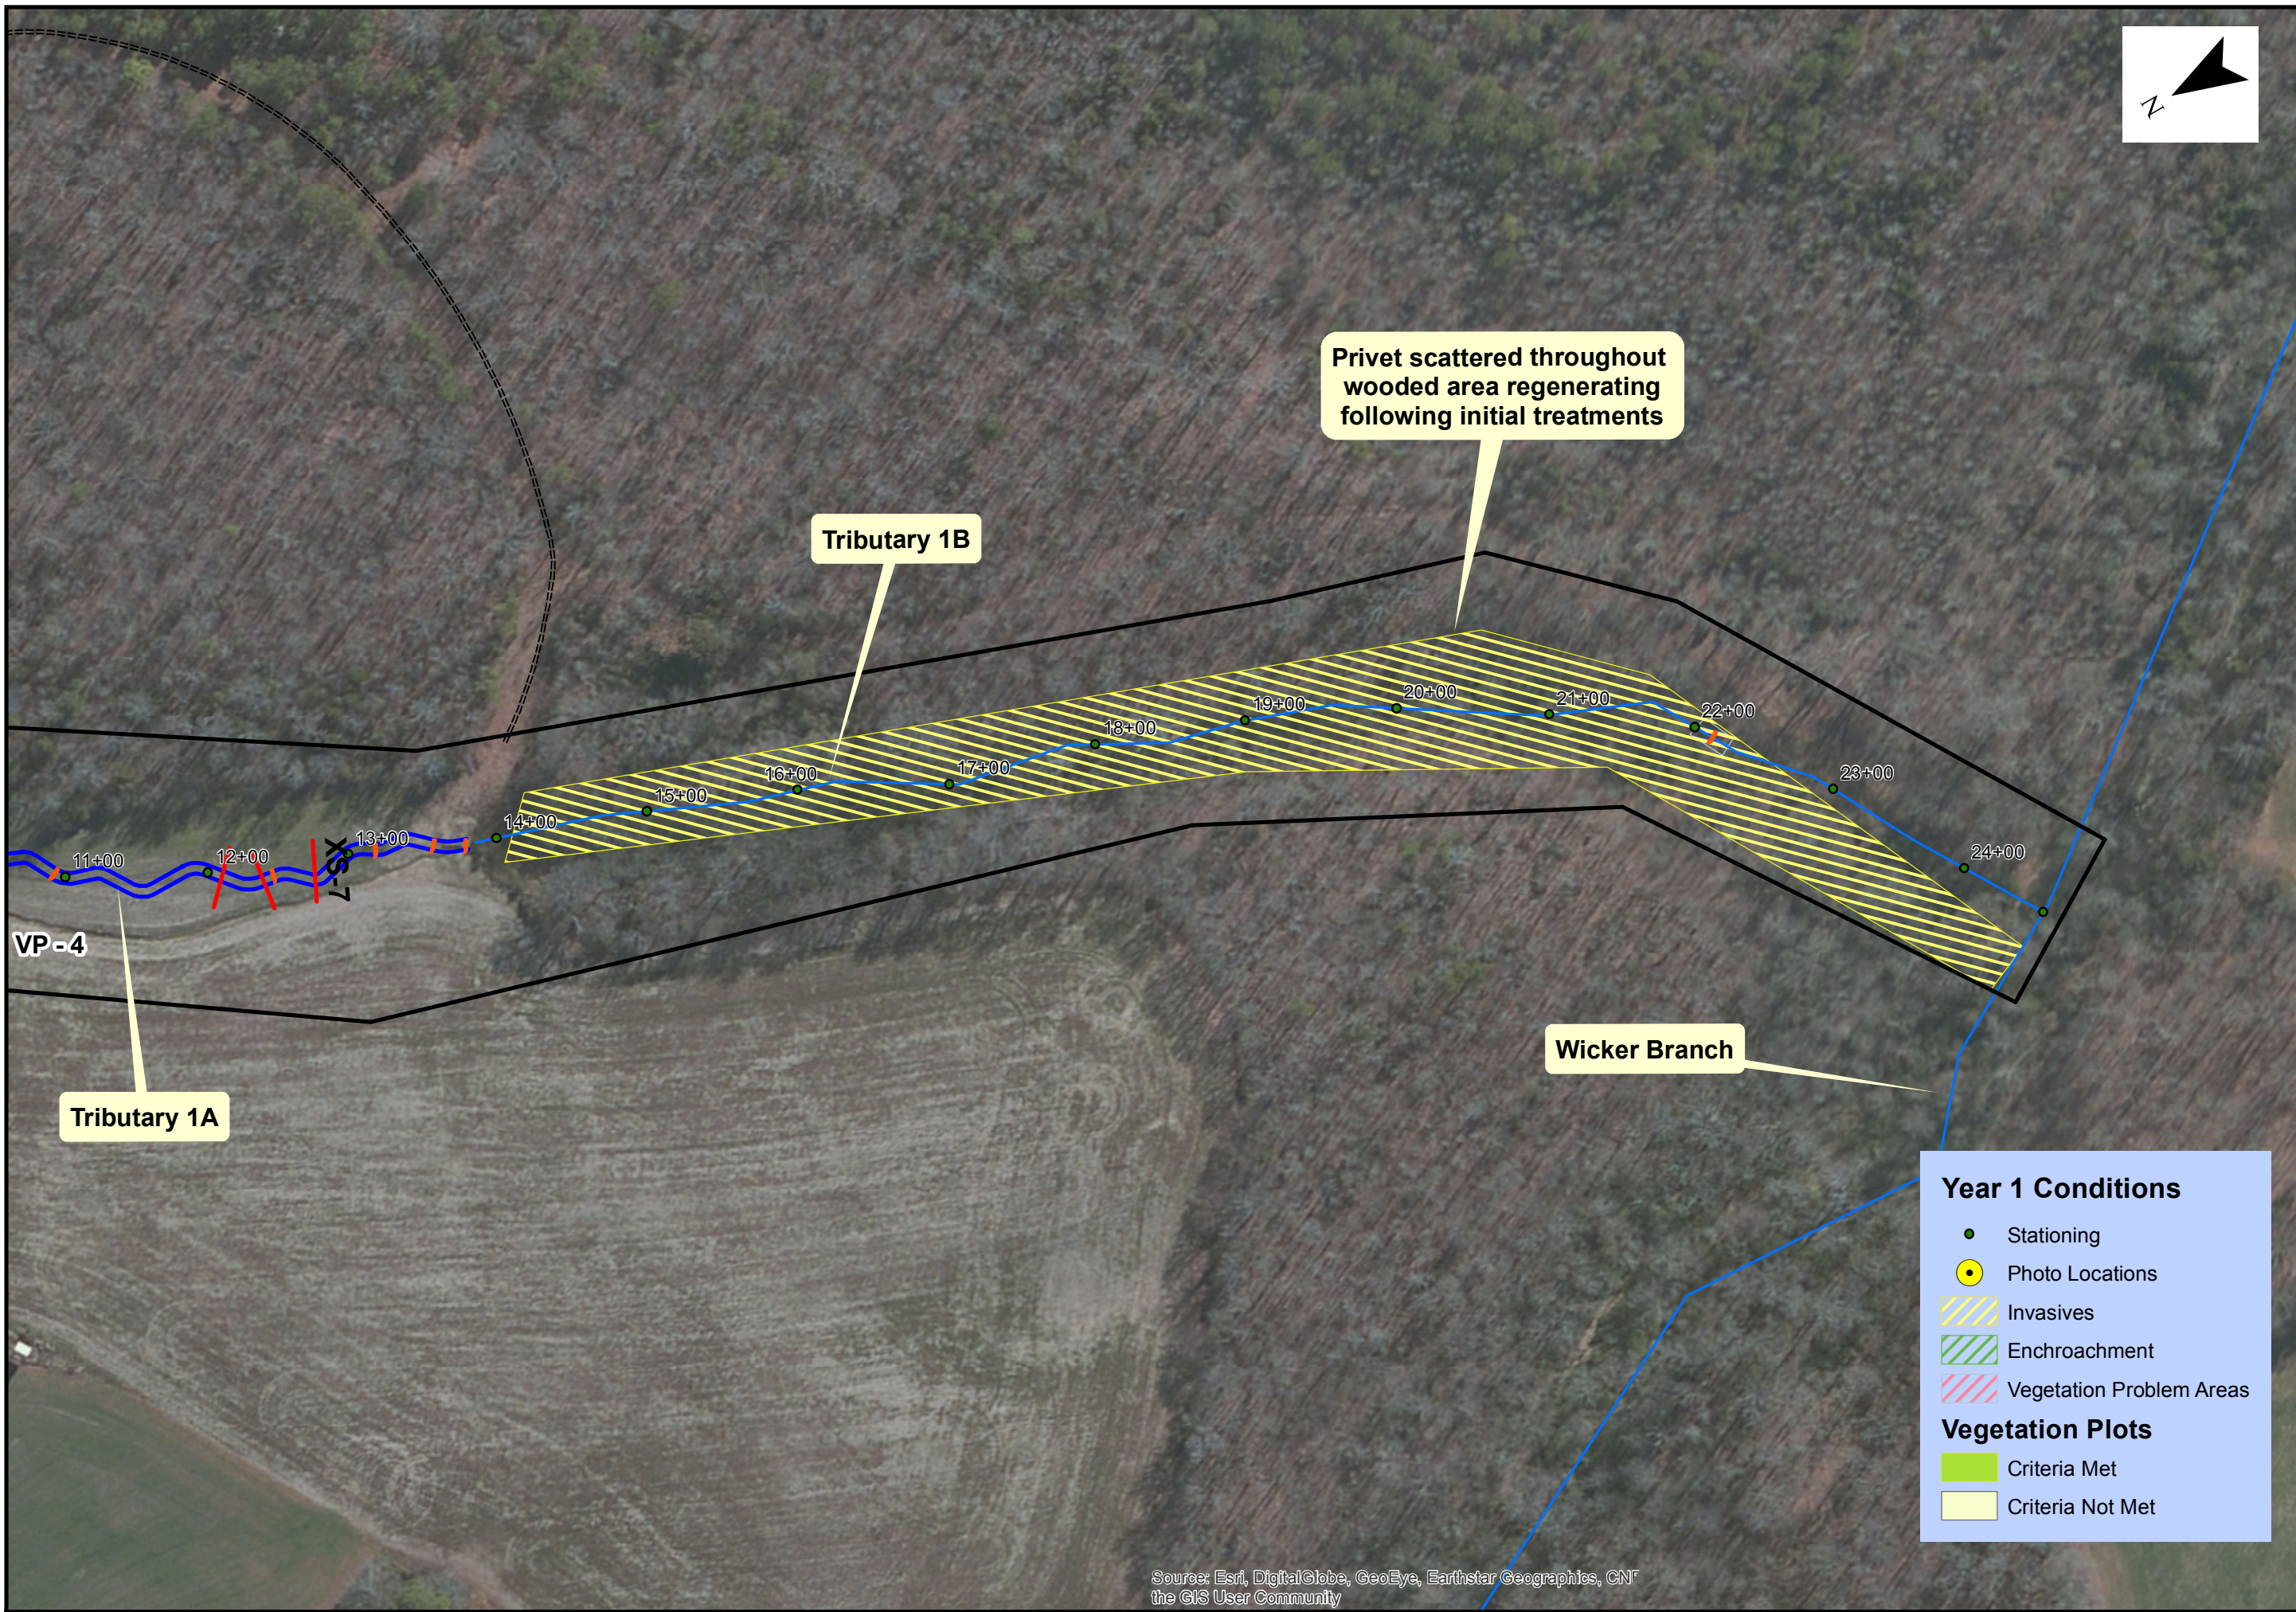
Tributary 1B

Chinese privet (*Ligustrum sinense*) is present in the buffer along Tributary 1B. An extensive removal effort occurred during construction in 2014 but stems remain. A second treatment occurred in the spring of 2016 but it was not very effective and it will need to be retreated. These areas will be addressed again more vigorously during spring and summer of 2017.

Privet scattered throughout wooded area regenerating following initial treatments

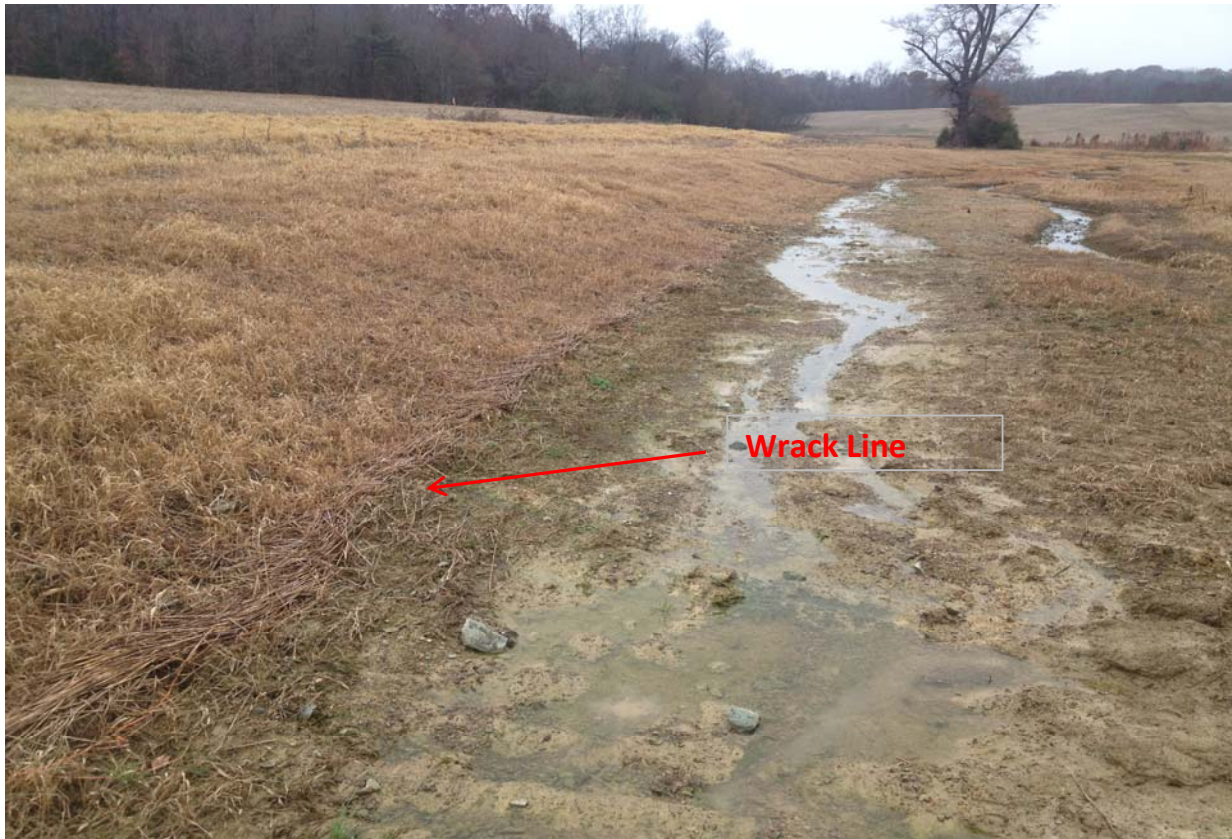
Date of Observation	Date of occurrence	Method	Greater Than $Q_{gs}=Q_2^{*0.66}$ Stage	Greater than $Q_{bkf}$ Stage?	Notes
12/3/2014	11/23/2014	Photo on-site wrack line		Yes	See photo below
