**YEAR 3 of 5 Monitoring Report  
Tributaries of Wicker Branch Stream Restoration  
Union County, North Carolina  
DMS Project Number: 95022  
Contract No: 003982  
USACE Action Id No: SAW 2013-01680**

**Yadkin River  
03040105**

**RE: Year 3 (2017) Monitoring Report the Tributaries of Wicker Branch Project (DMS Project # 95022)**

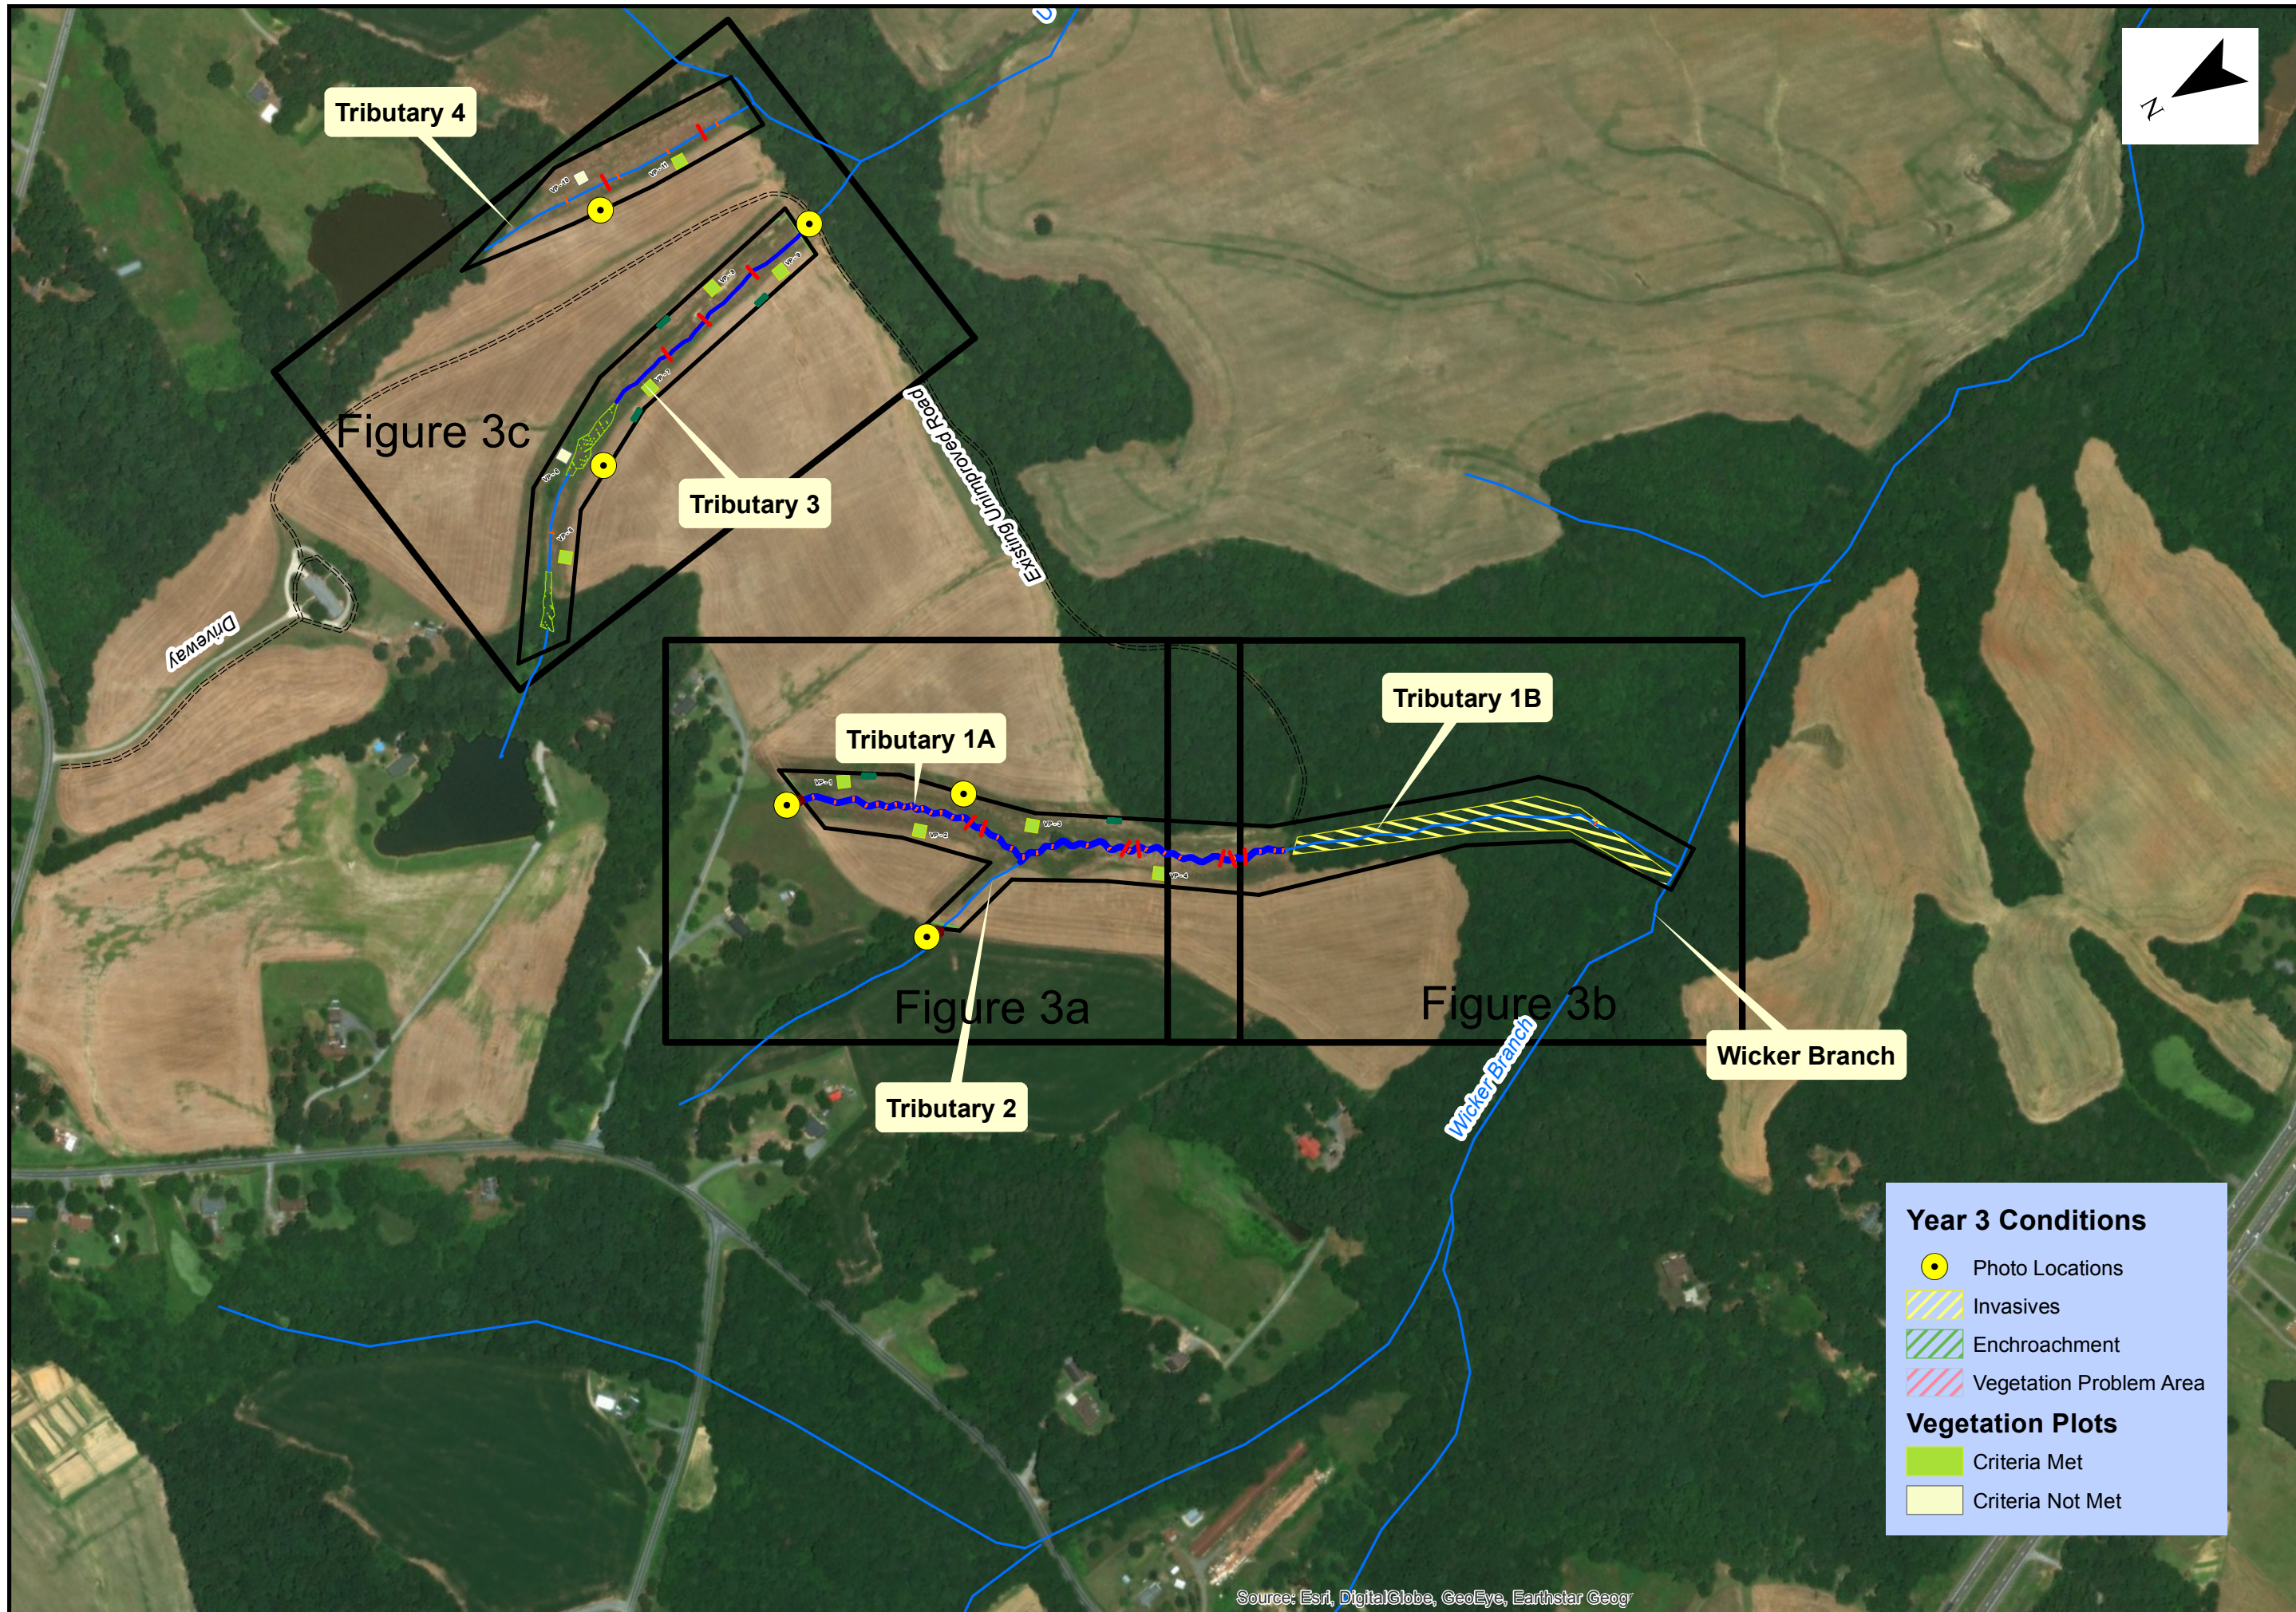
**FIGURE 3**

The adjacent fields were planted in corn in 2017. Additional signage installed in the spring of 2016 was augmented in 2017. Only minor encroachment at the crossings of Tributary 2 and 3 is occurring and AECOM will continue to work with the landowner and the current farmer to address these minor encroachments. The areas of encroachment are shown on **Figure 3** in **Appendix B**.

**Easement violations** – AECOM has periodically met with the farmer in 2017 to discuss the equipment crossings and will continue to monitor, post/repost boundary markings as necessary to ensure compliance.

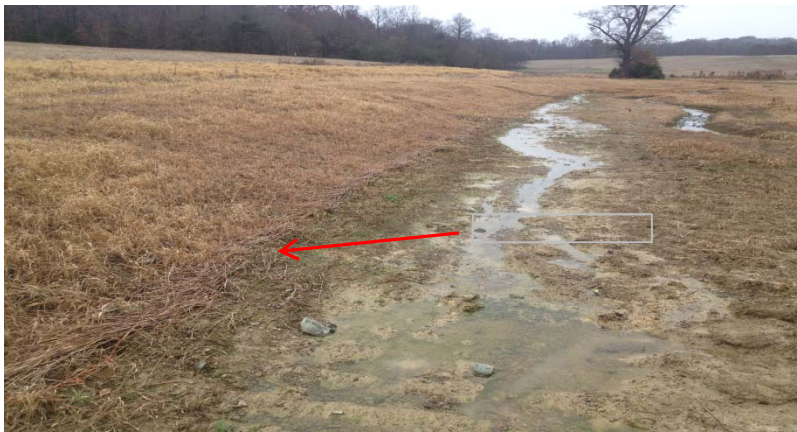
Date of Observation	Date of occurrence	Method	Greater Than Qgs=Q2*0.66 Stage	Greater than Qbkf Stage?	Notes
12/3/2014	11/23/2014	Photo on-site wrack line		Yes	See photo below
4/17/2017	Apr-17	Crest Gauge			See photos below. Most likely occurred on 1/2/2017 or 1/3/2017 when site received a total of 1.5 inches of rain

Photo of wrack lines from 11/23/2014 bankfull event

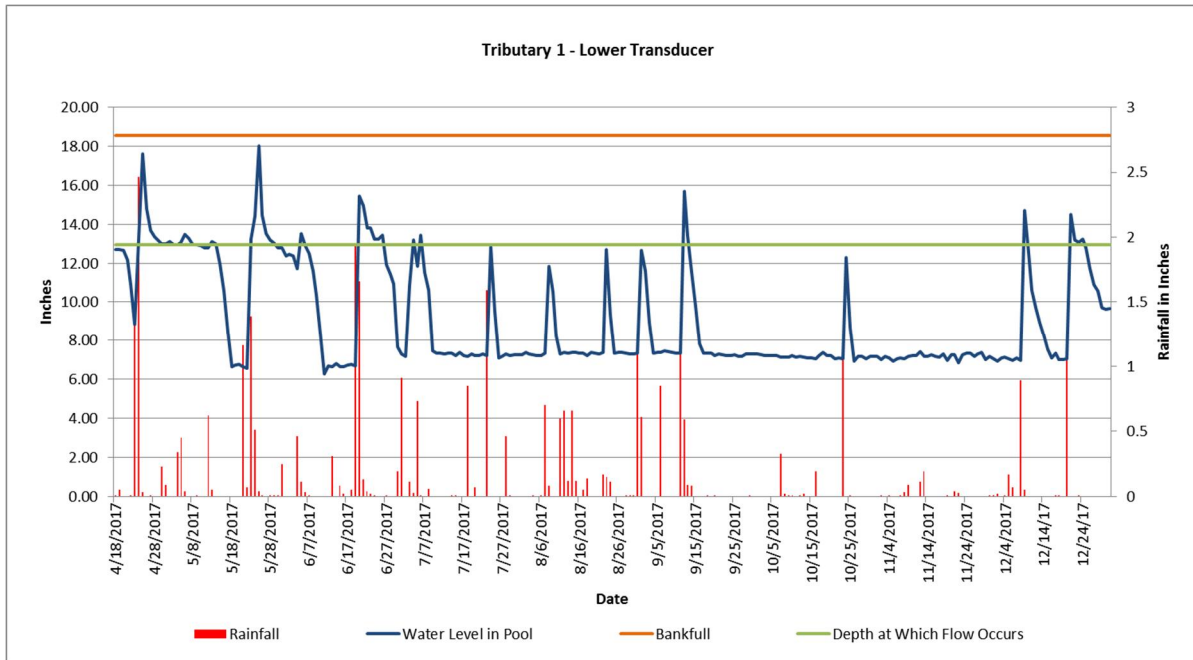
Tributary 1 had 22 days of continuous flow from 4/24/2017 to 5/15/2017

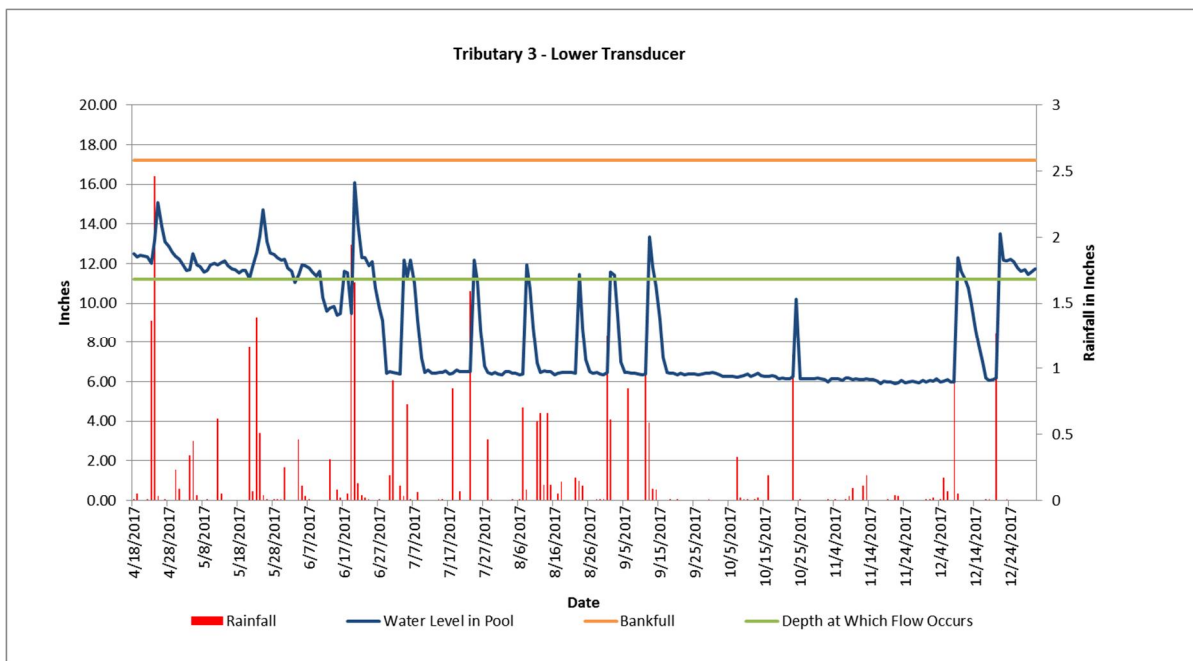
Tributary 3 had at least 52 days of continuous flow from 4/18/2017 to 6/10/2017
