**YEAR 4 of 5 Monitoring Report
Tributaries of Wicker Branch Stream Restoration
Union County, North Carolina
DMS Project Number: 95022
Contract No: 003982
USACE Action Id No: SAW 2013-01680**

YEAR 4 of 5 Monitoring Report
Tributaries of Wicker Branch Stream Restoration
Union County, North Carolina
DMS Project Number: 95022
Contract No: 003982
USACE Action Id No: SAW 2013-01680

RE: Year 4 (2018) Monitoring Report the Tributaries of Wicker Branch Project (DMS Project # 95022)

To	Harry Tsomides, DMS Project Manager	Page	1
CC			
Subject	Tributaries of Wickers Branch – 10/16/2018 Site Visit Comments		
From	Ron Johnson		
Date	January 23, 2019

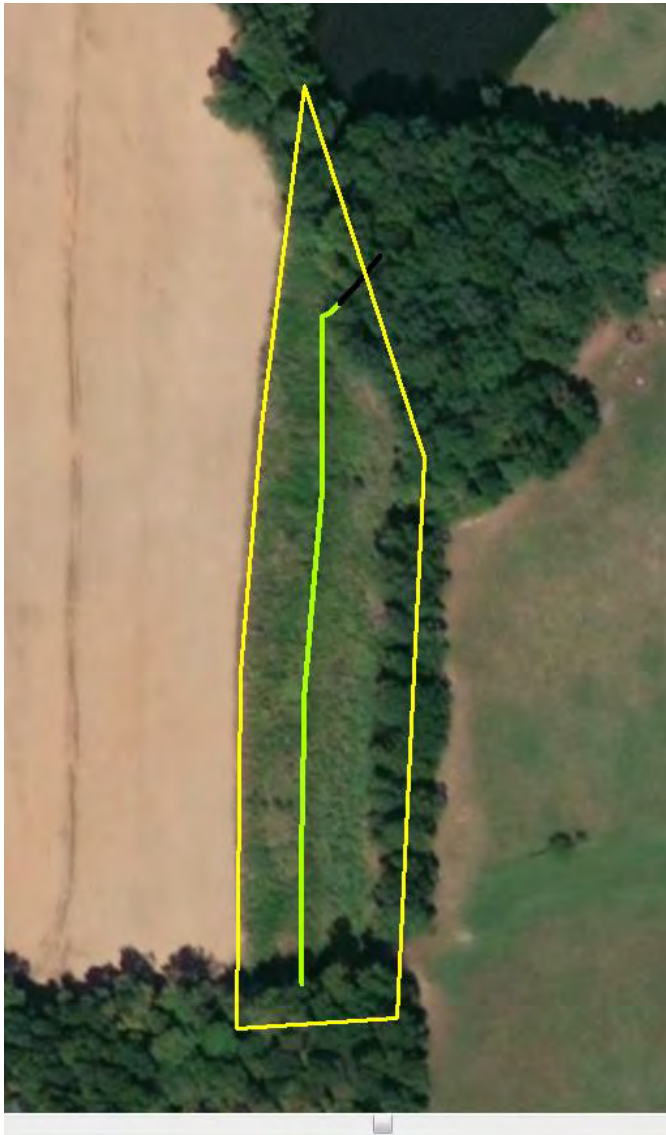
Stream mapping – It appears trib 4 may be migrating out of the easement before reentering it; this will need to be analyzed and rectified if necessary since any streams outside the easement will not yield assets.

This should not be an issue with asset generation. The very upper portion of Tributary 4 (shown in black) is not included in the asset calculations. As shown on the figure to the left only the lower 631 feet of Tributary 4 is generating credits (highlighted in green).

The Asset map submitted with the MY4 report was updated to more accurately reflect which portions of Tributaries 3 and 4 are generating assets.

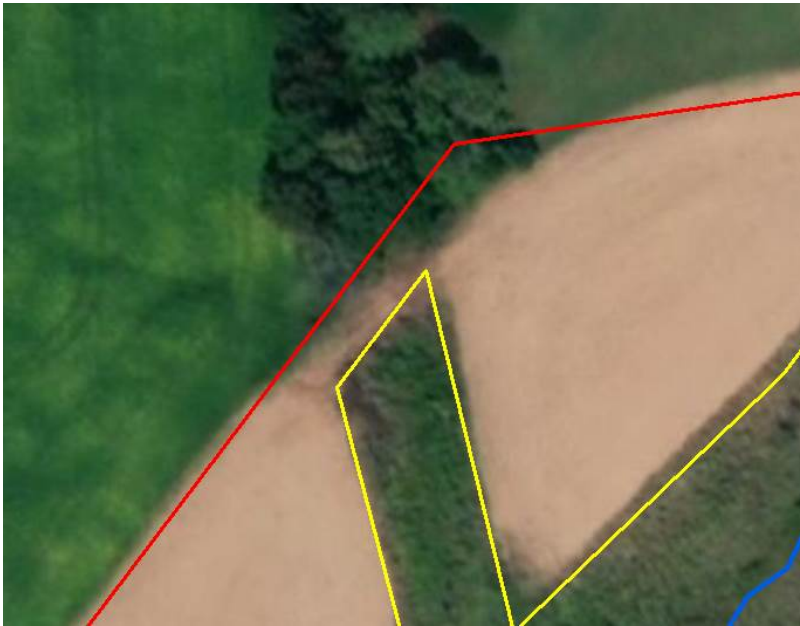
Easement encroachment – Clipping of crossing corners. What is being done to rectify this? This was noted in the MY03 report as an issue in progress with the landowner. What is the current status?

The crossing at the top of Tributary 2 remains problematic. A 35 wide easement was established at this crossing during the early stages of site development. When the easement was established AECOM assumed that the edge of the property was the edge of the treeline. The easement boundary was established in CAD prior to surveying the easement in the field. When the easement was finally surveyed and marked in the field it became apparent that there was not enough room between the edge of the easement and the treeline for the farmer to cross

a taller post this winter/spring when other boundary markers are upgraded.

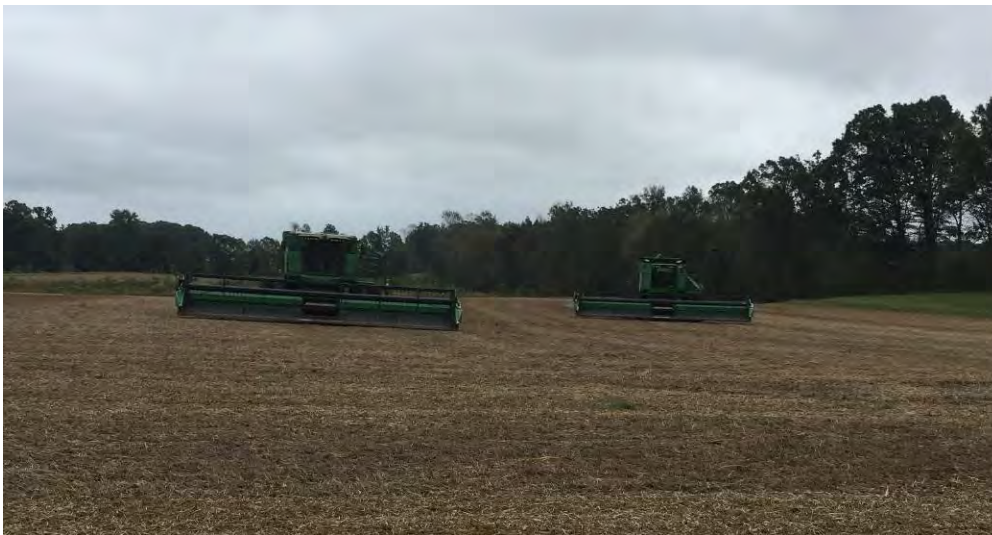
the easement with his equipment. The photo below depicts that combines that the farmer utilizes to harvest crops on the property .

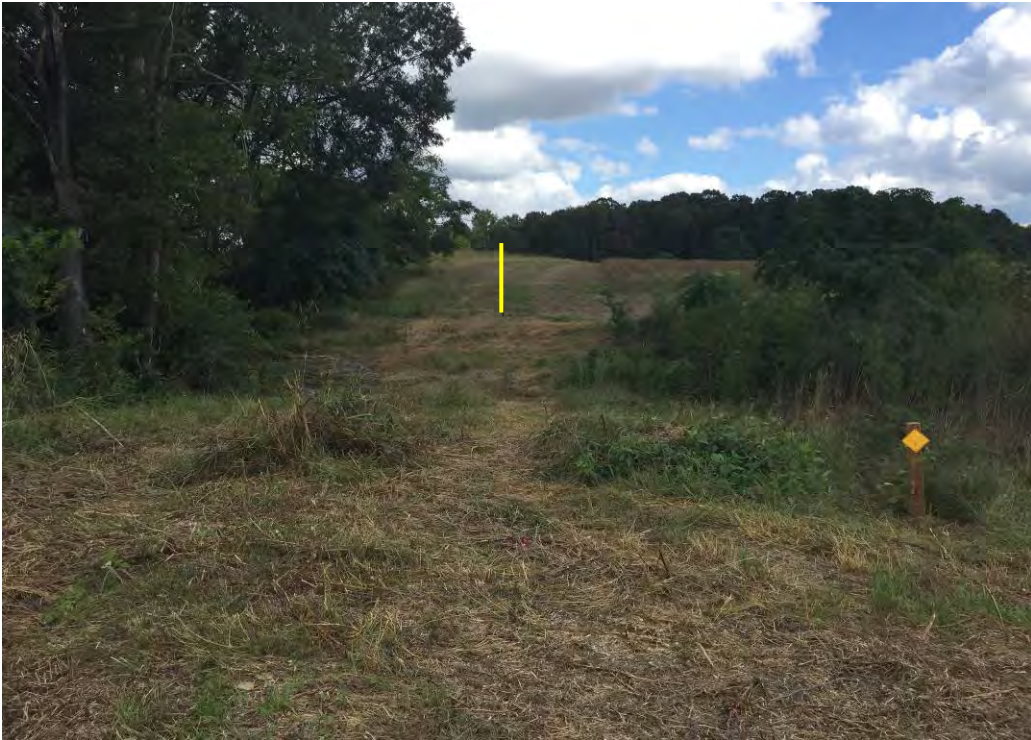
The above photo depicts the location of the corner of the easement at the top of Tributary 2 in relation to the treeline. The Yellow Line is the far (northeast) corner of the easement and the wood post with the sign is the northwest corner. There is sufficient room at the northeast corner but not at the southeast corner. The photo below shows the farm equipment crossing the easement.

Expanding (or clearing) the crossing to the property line to allow for full use of the crossing would require removal of several large trees.

AECOM would like permission to modify the easement to allow adequate room for the equipment. We would work with the farmer to determine the exact distance but anticipate that it would look something like the photo above. The above photo shows reducing the length of the easement by about 35 feet on one side and maintaining it on the other. This would reduce the easement by about 1530 square feet or 0.035 acre. It should be noted that the easement in this area is not actually buffering an asset. Tributary 2 is an ephemeral feature that does not generate any stream credits.

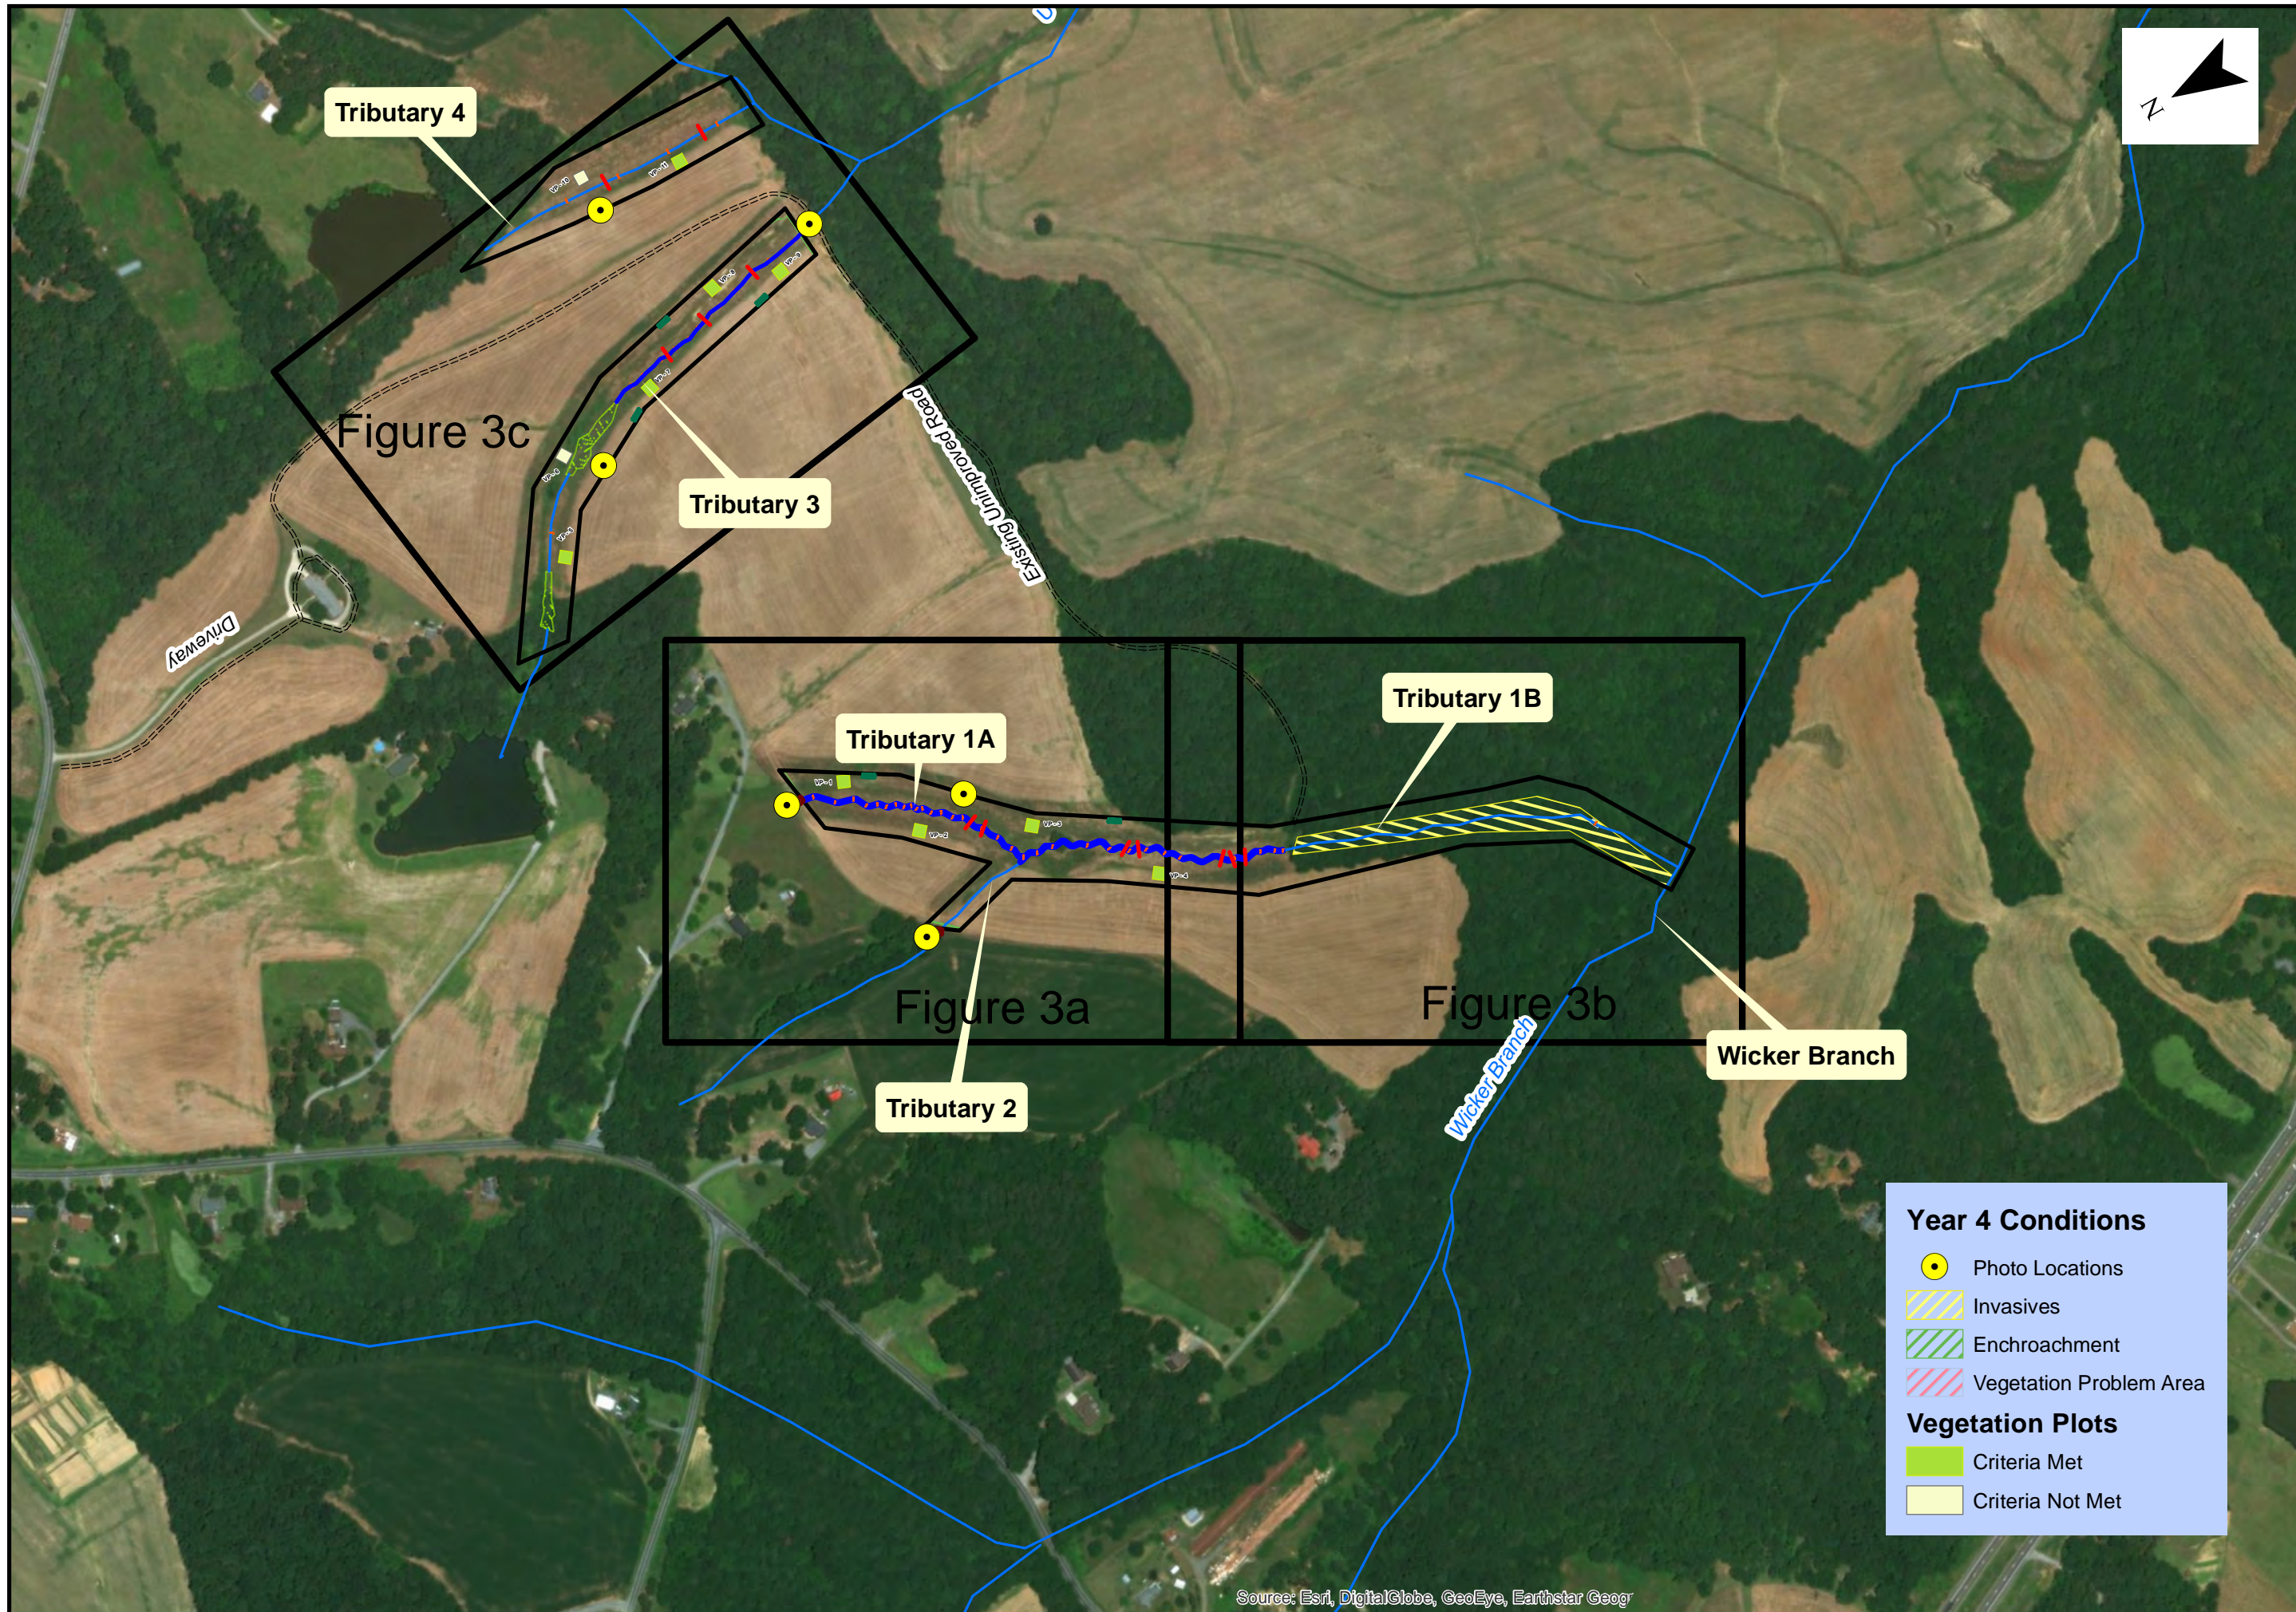
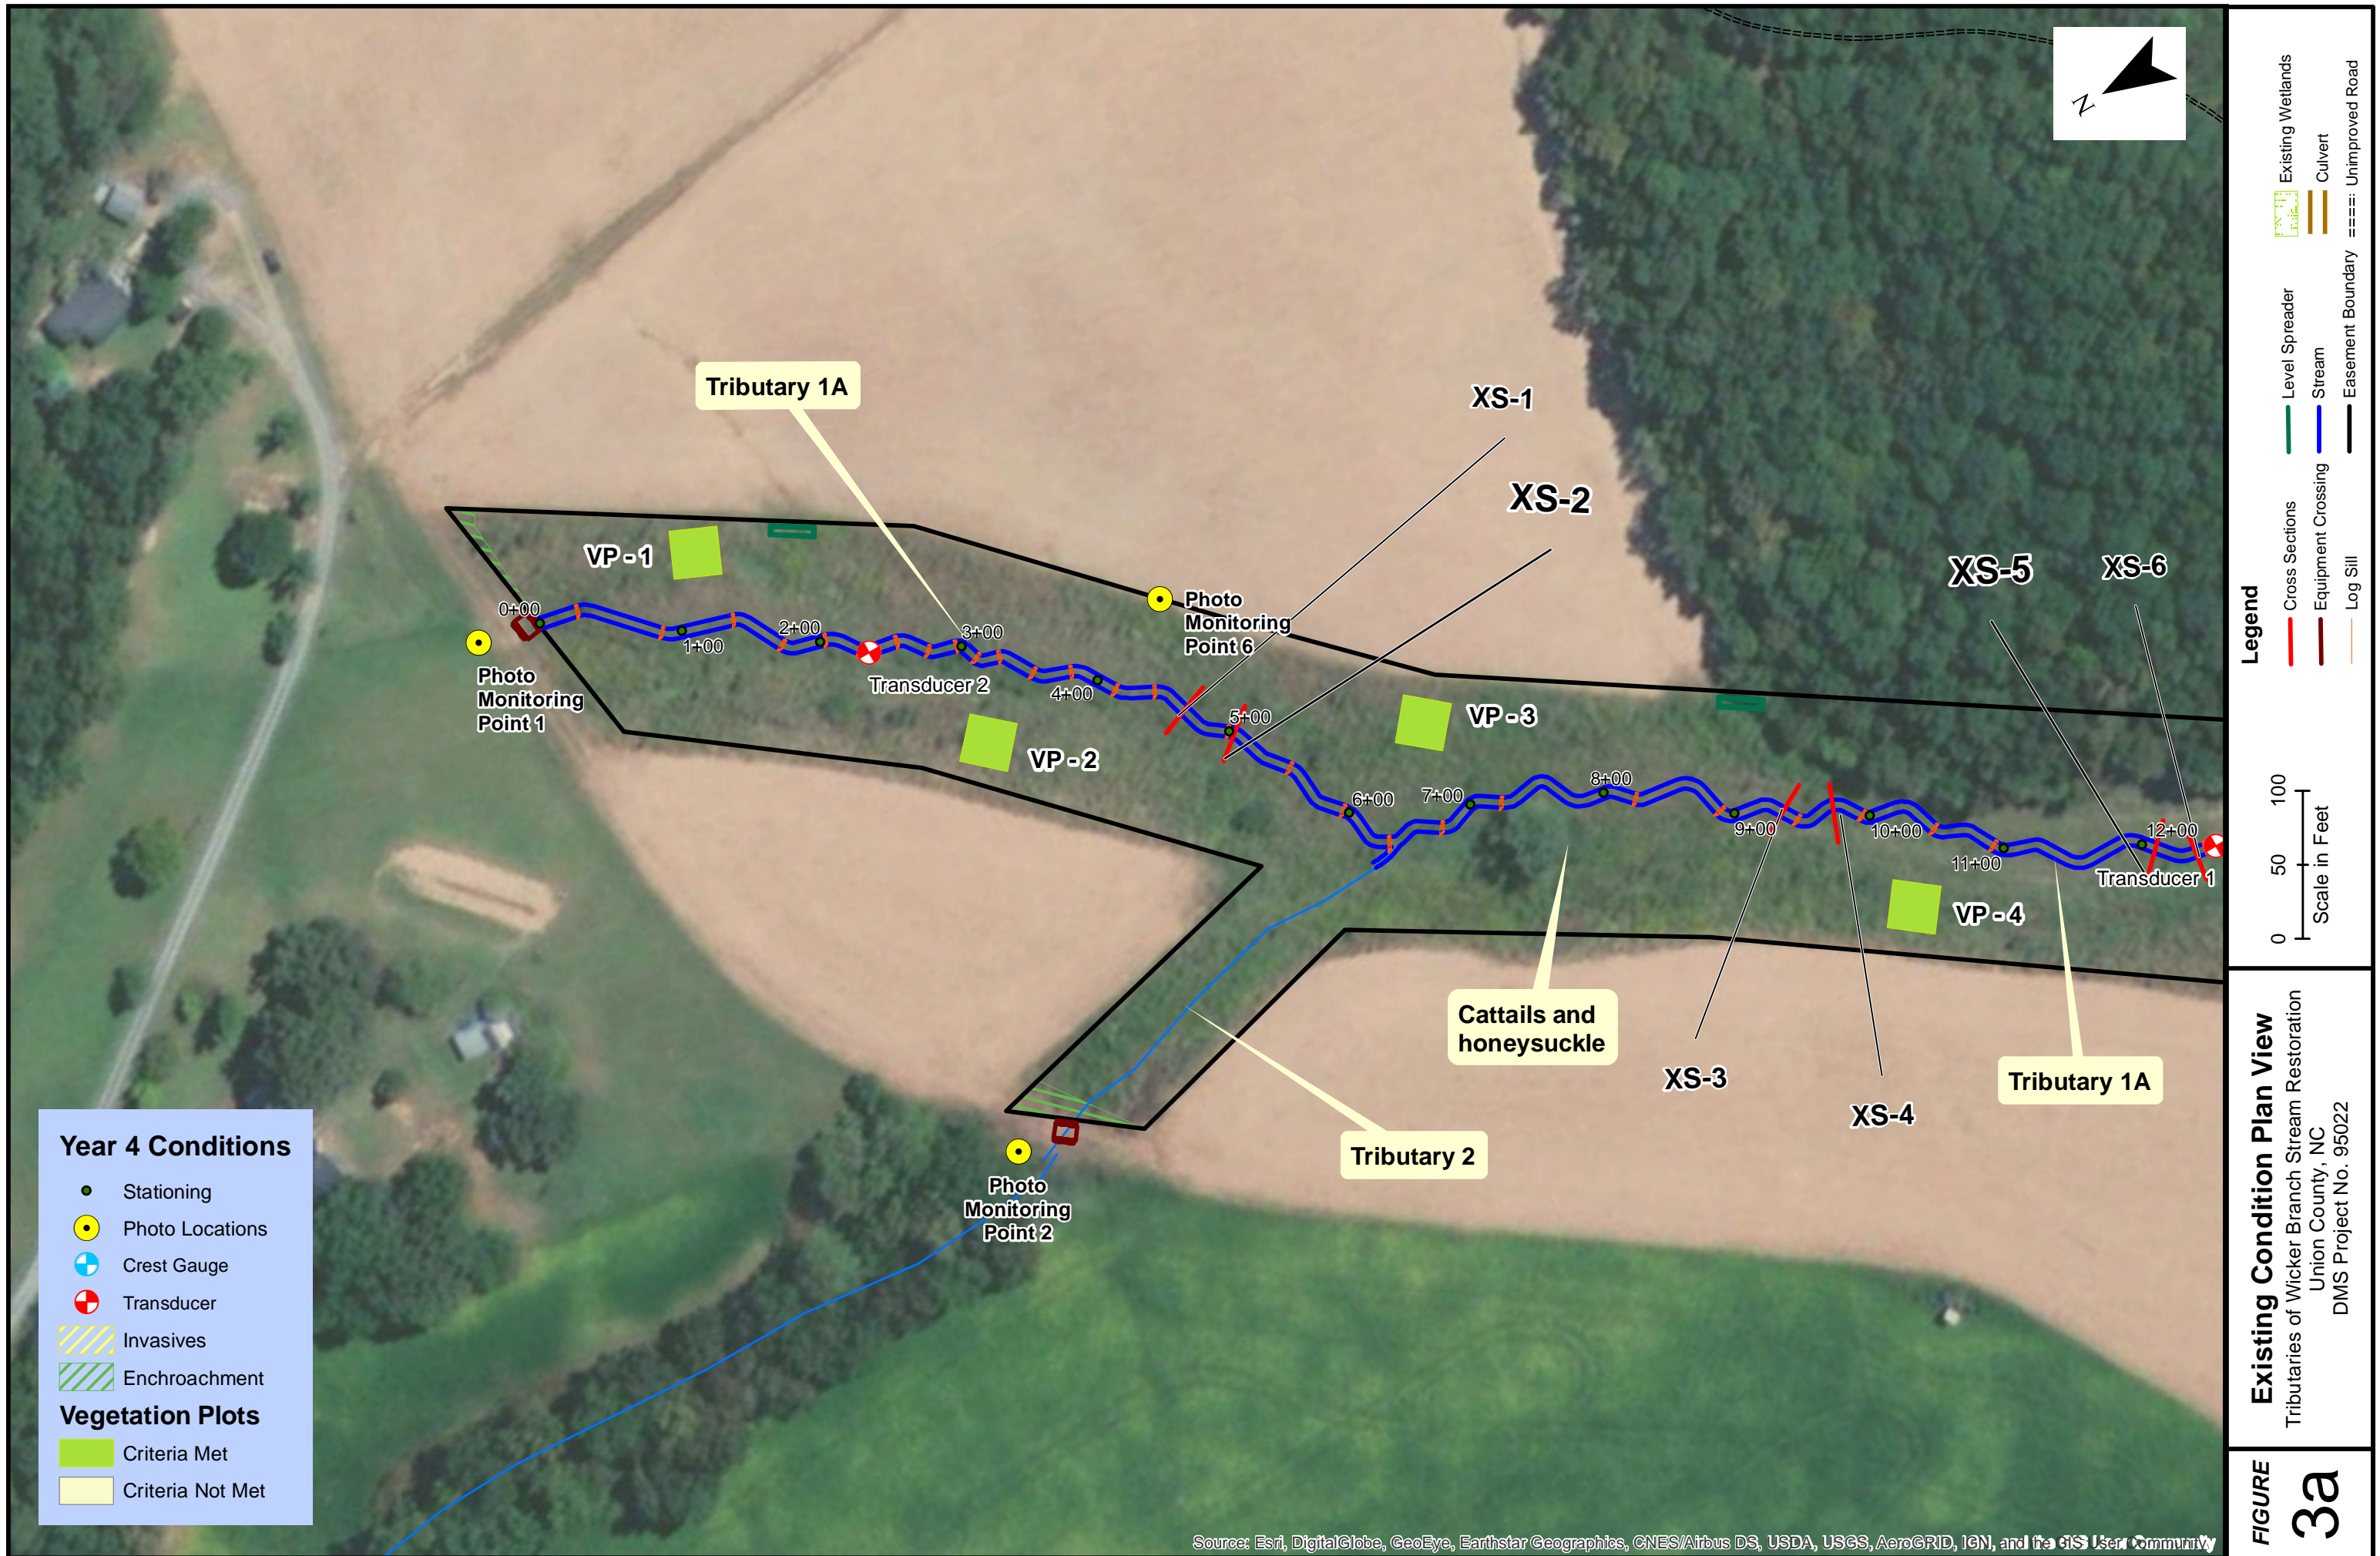
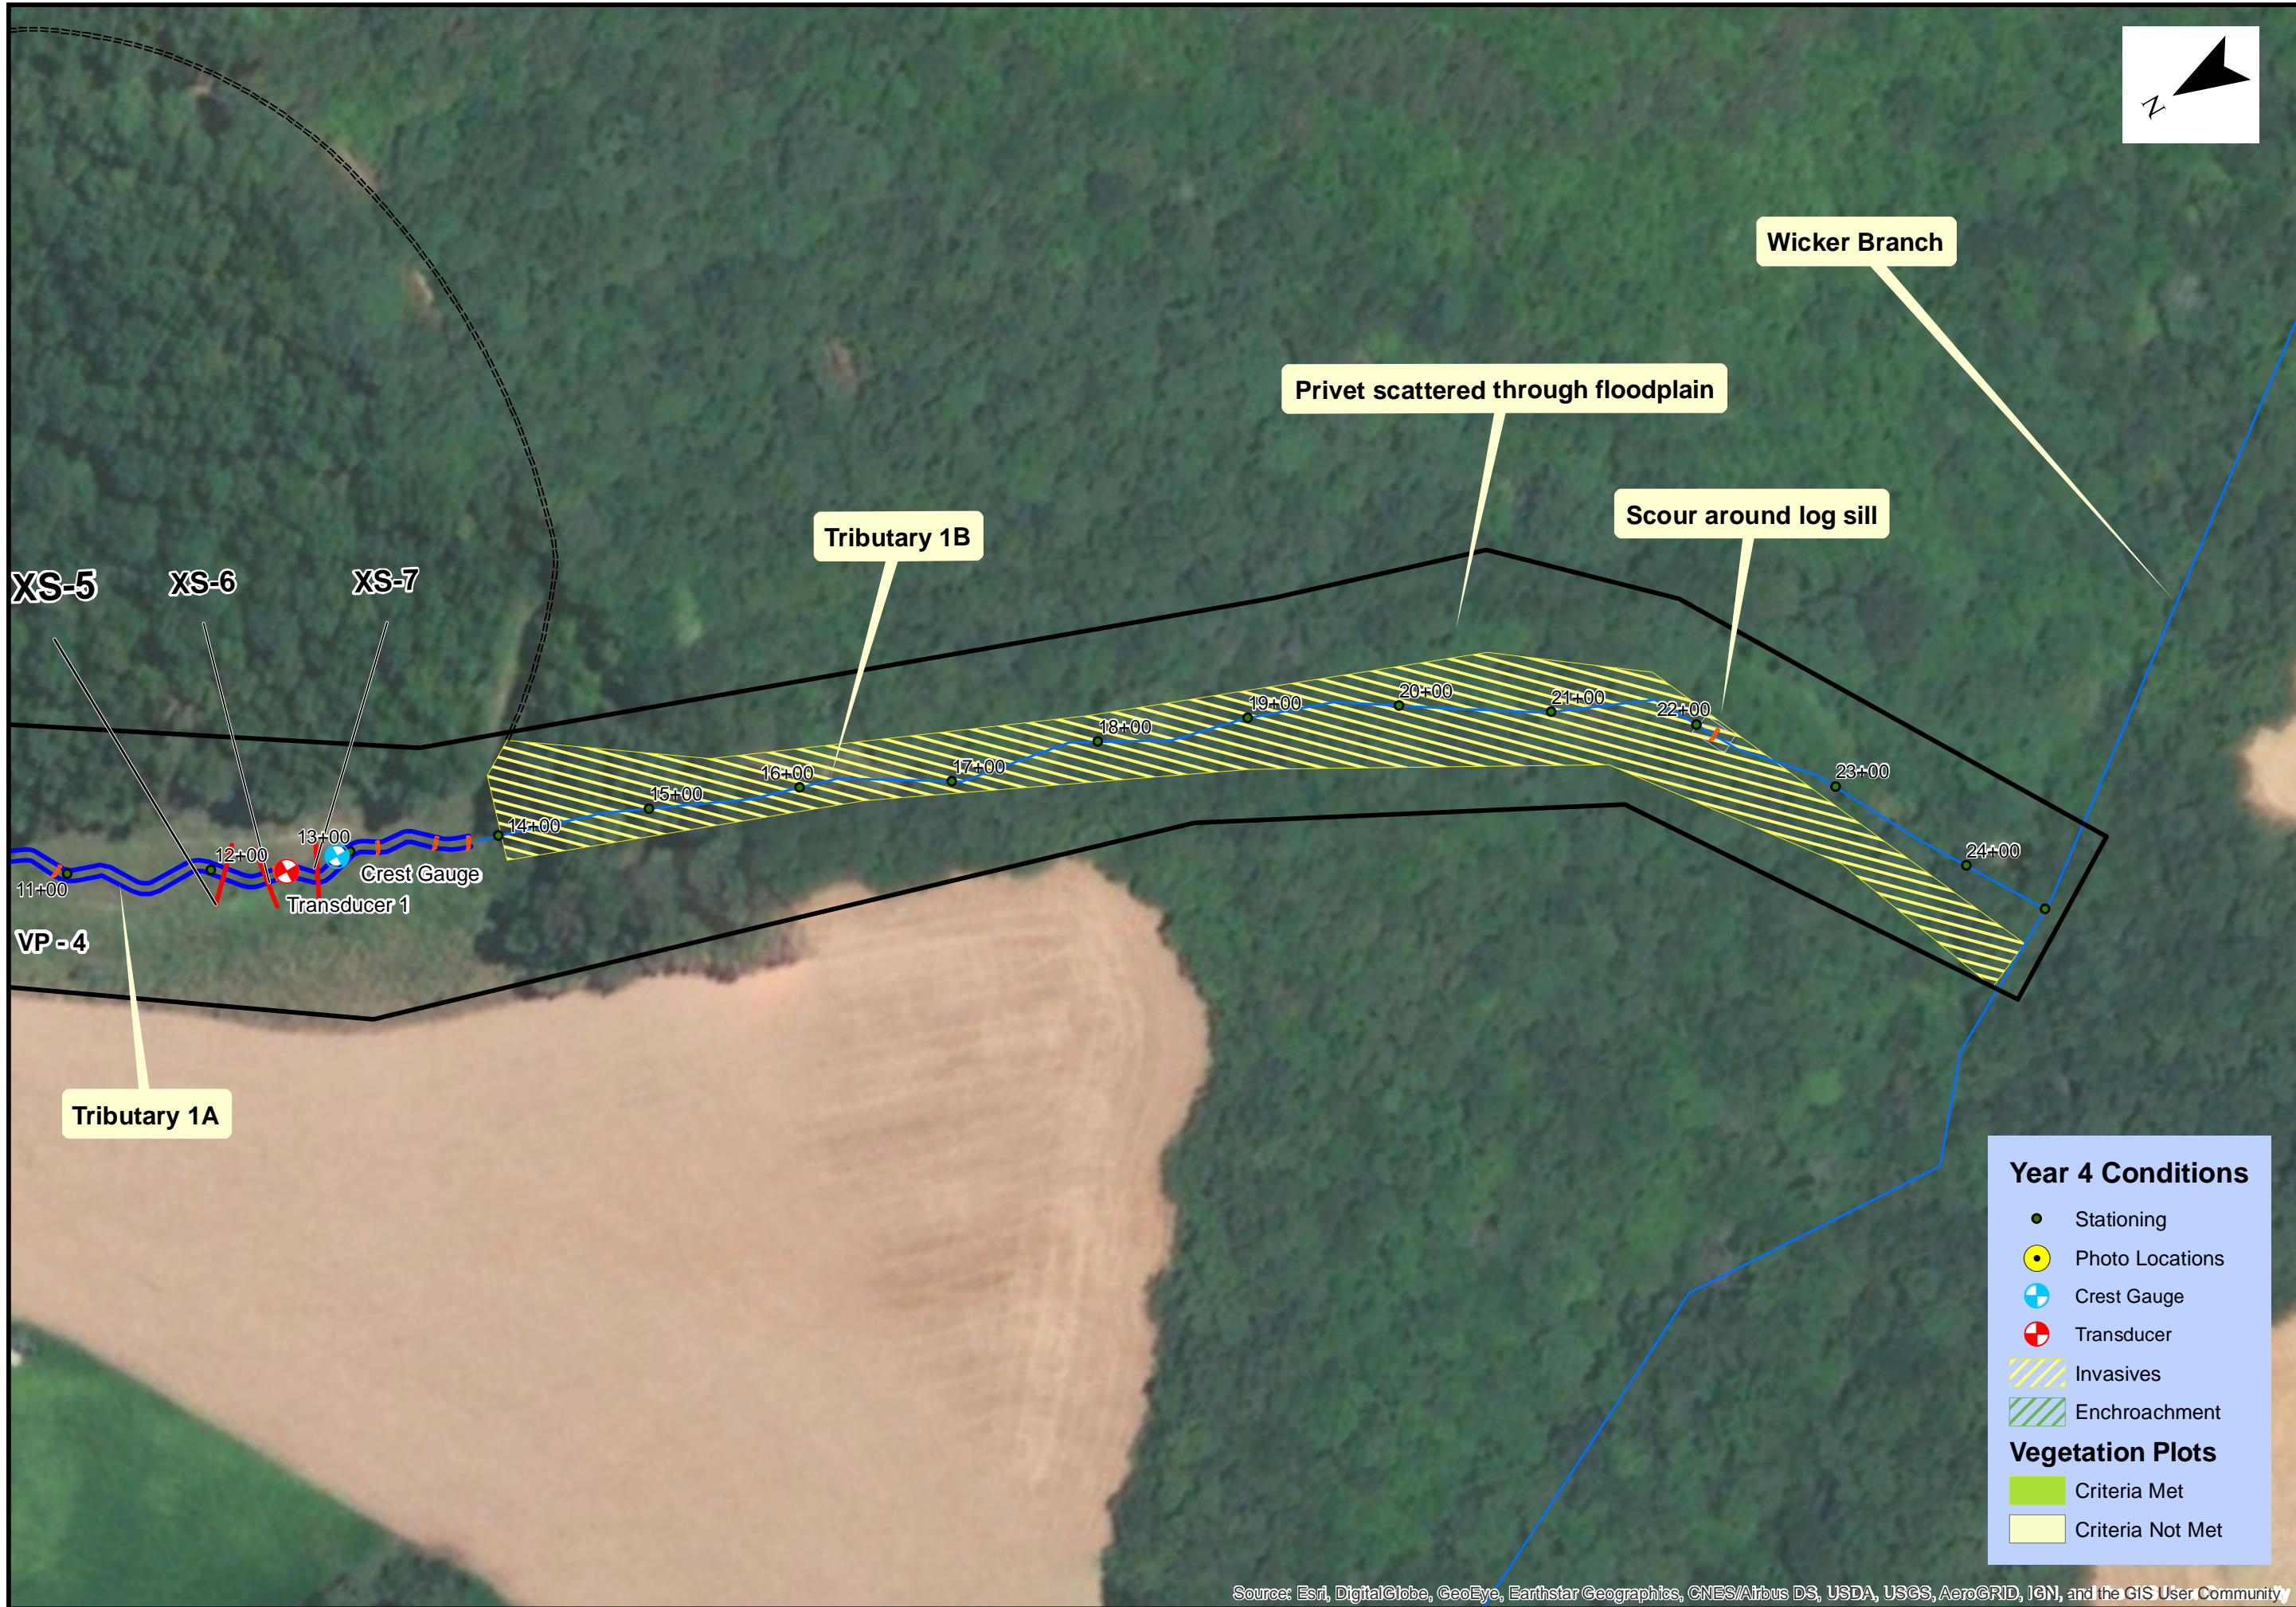
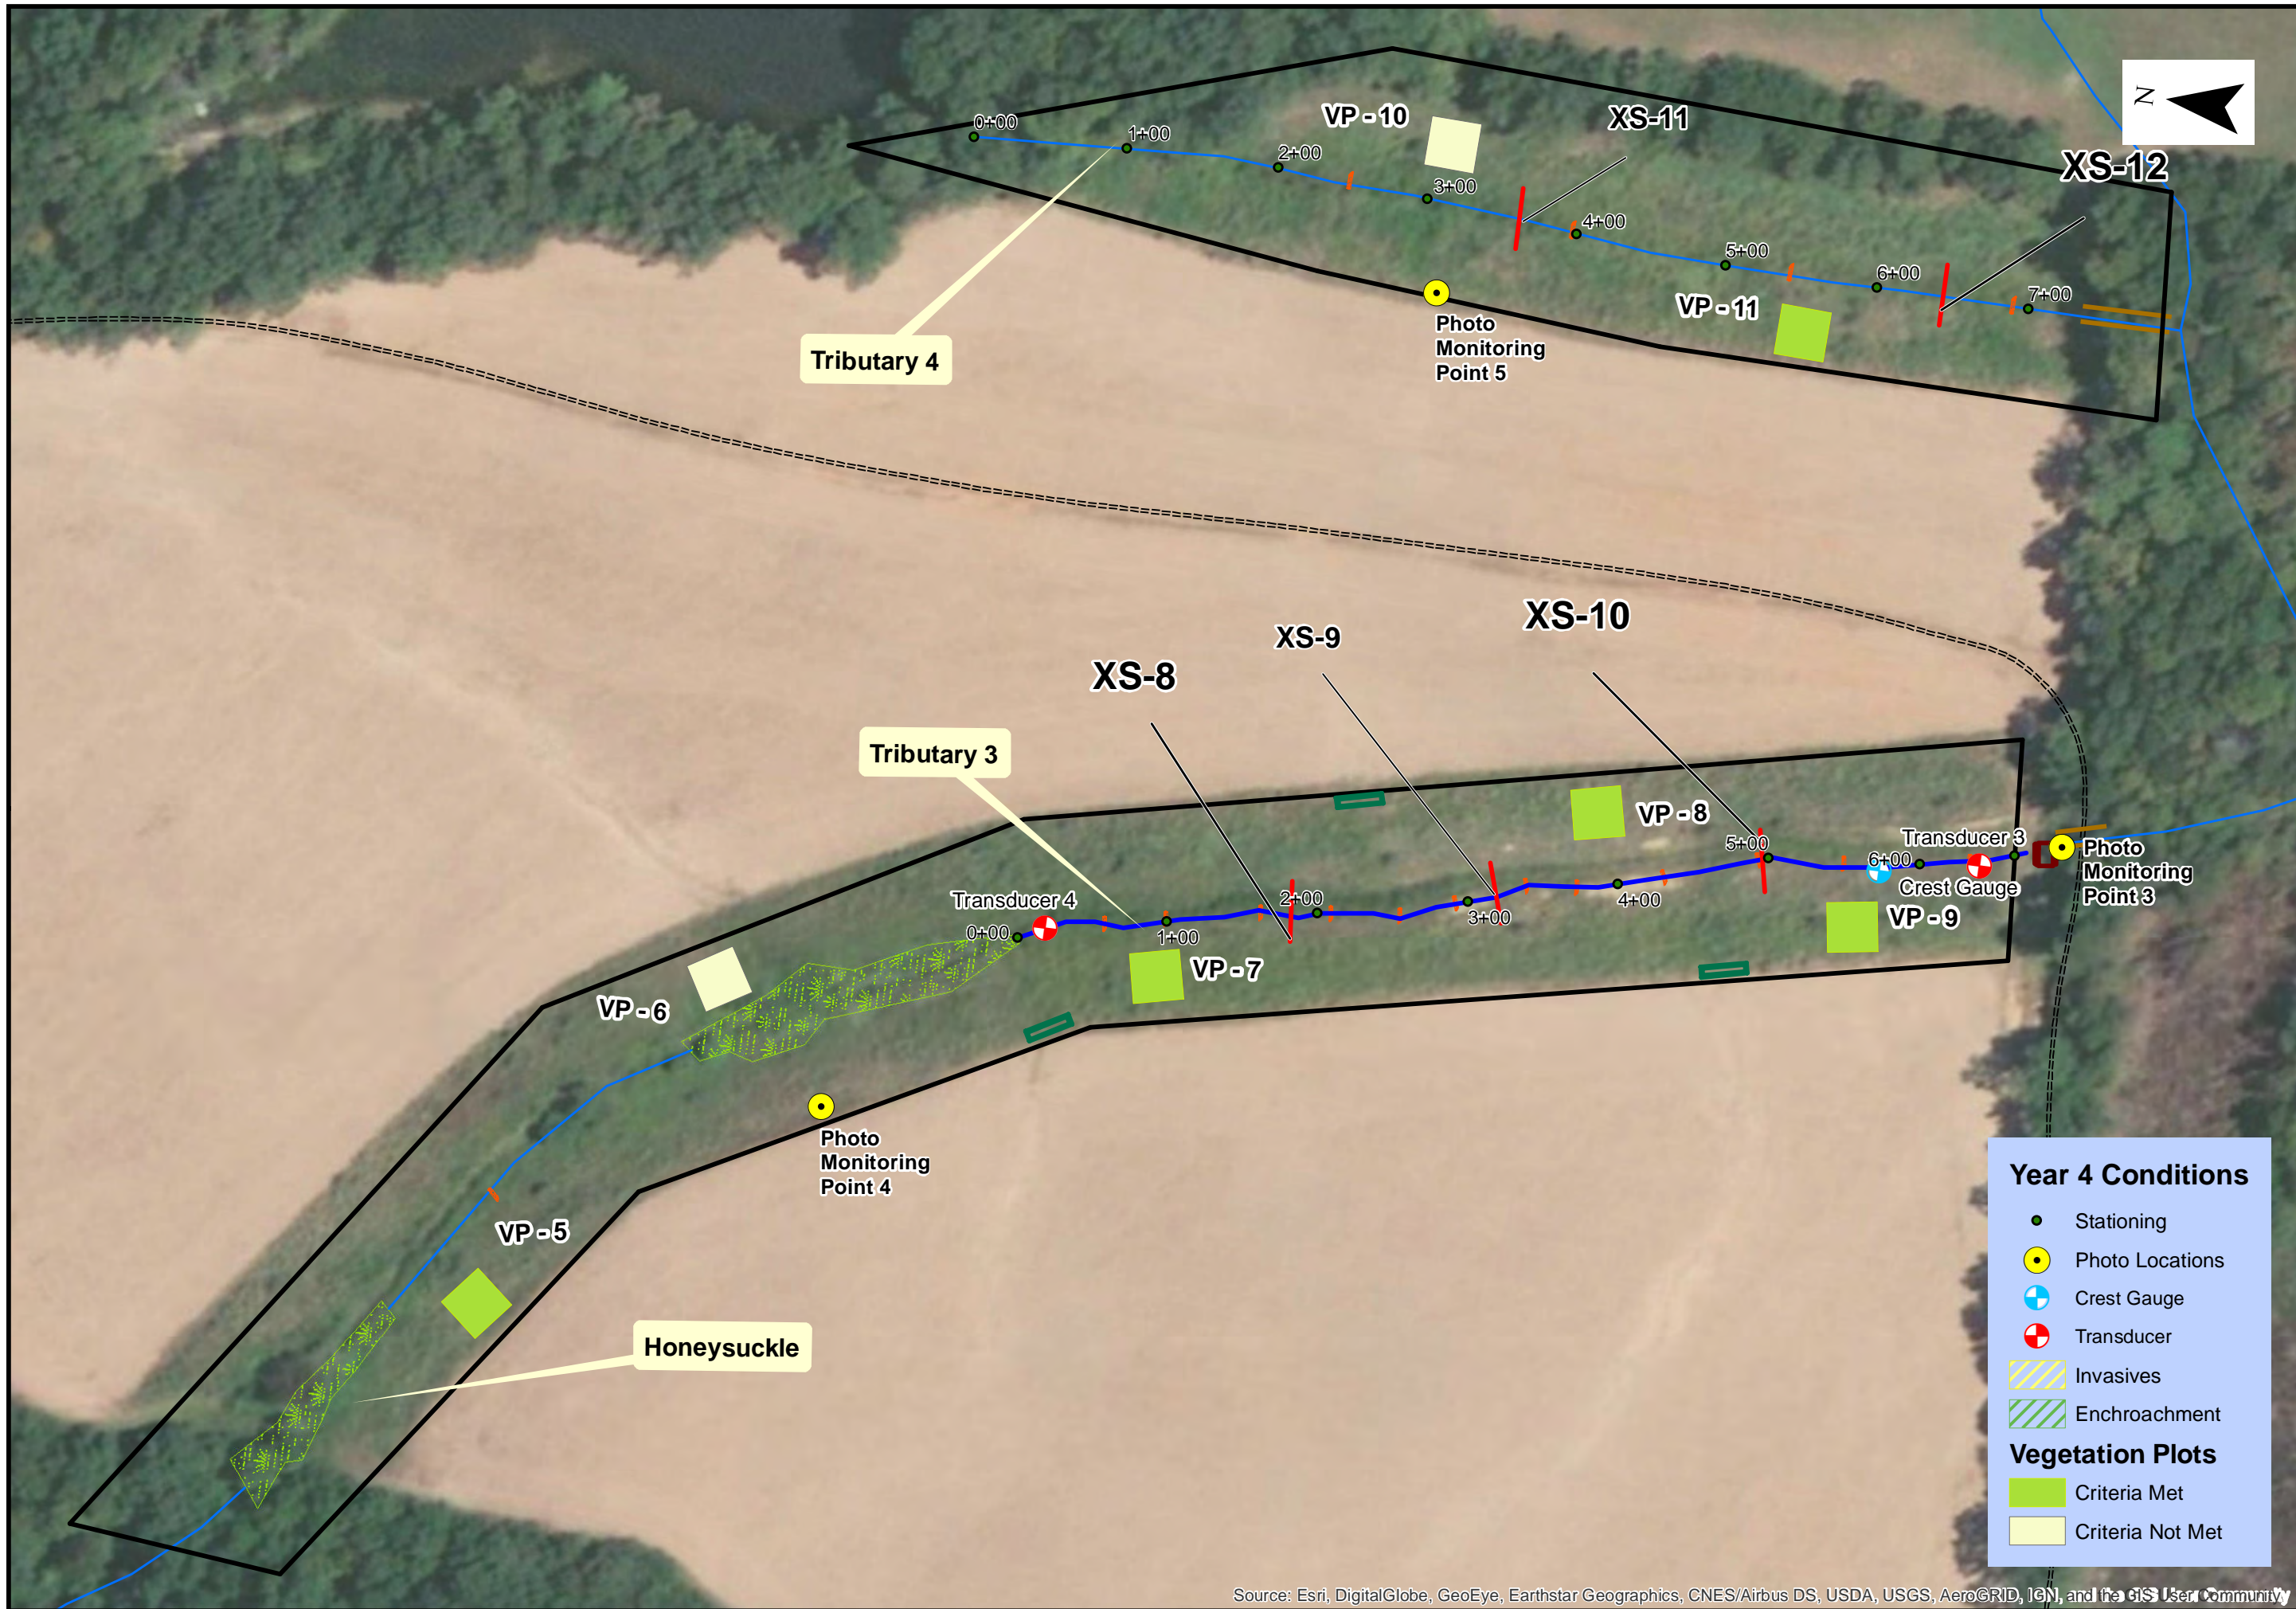
FIGURE 3

AECOM is currently monitoring the stream flow on Tributaries 1 and 3 using Onset HOB0 pressure transducers. Transducers are installed in two separate pools on each of the tributaries for a total of 4 locations. On Tributary 1A a transducer is located on the downstream end of the project and a second is located above the confluence with Tributary 2. On Tributary 3 one transducer is located on the downstream end and a second is located in a pool just below the wetland at the beginning of the Enhancement I reach. The locations of the transducers are shown on Figure 3 Current Condition Plan View in Appendix B.

Transducer locations have been confirmed and updated locations are shown on the CCPV that was submitted with the MY 4 report.

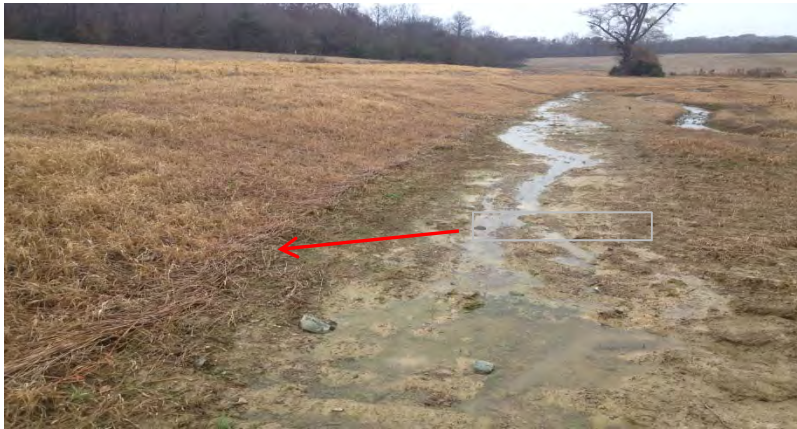
Photo of wrack lines from 11/23/2014 bankfull event
