# Year 1 Monitoring Report

## Trout Cove Stream Restoration

**January 2007**  
**EEP Project No. 388**

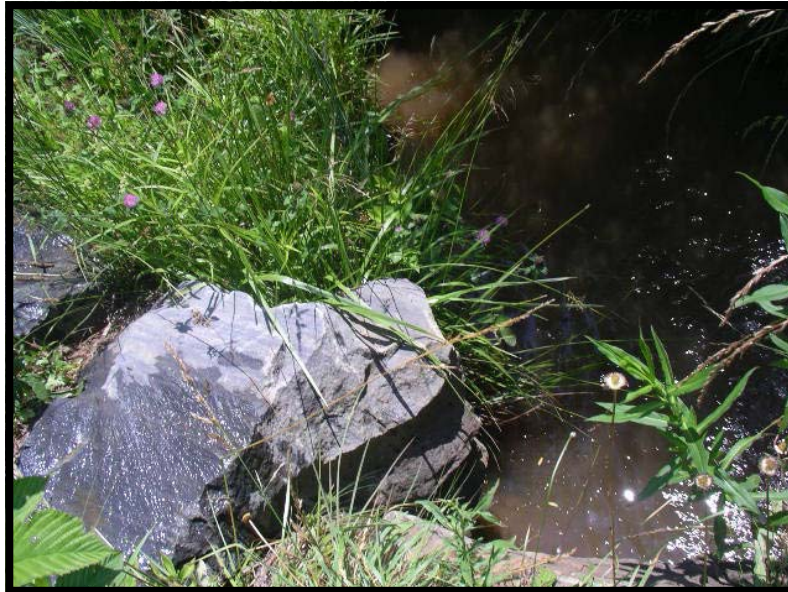
| <b>Table IX: Stream Problem Areas<br/>Trout Cove Stream Restoration Site (EEP Project # 388)</b> | | | |
|--|---|---|---|
| Structure<br>(Rock Shift) | 1 (0+25 – 0+38) | Erosion/Undercutting | 1-3 |

Figure 1— Typical Rock Shift

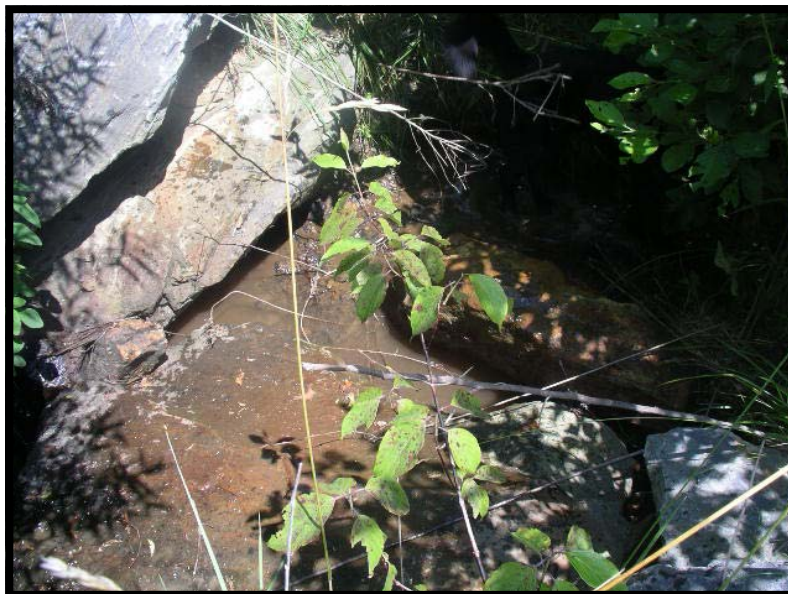
Figure 2—Typical Rock Shift

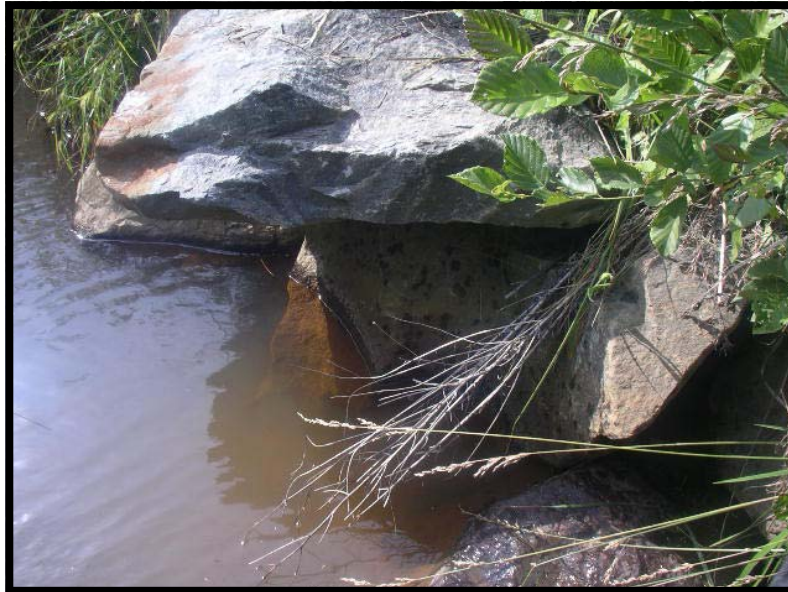
Figure 3— Typical Rock Shift

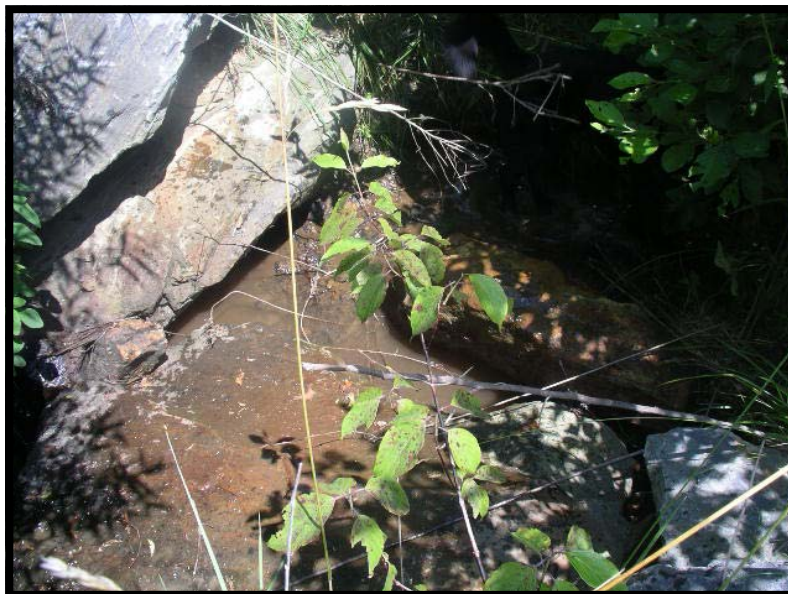
| <b>Table IX: Stream Problem Areas<br/>Trout Cove Stream Restoration Site (EEP Project # 388)</b> | | | |
|--|---|---|---|
| Structure<br>(Rock Piping) | 1 (0+25 – 0+38) | Erosion | 4 |

Figure 4—Typical Rock Piping

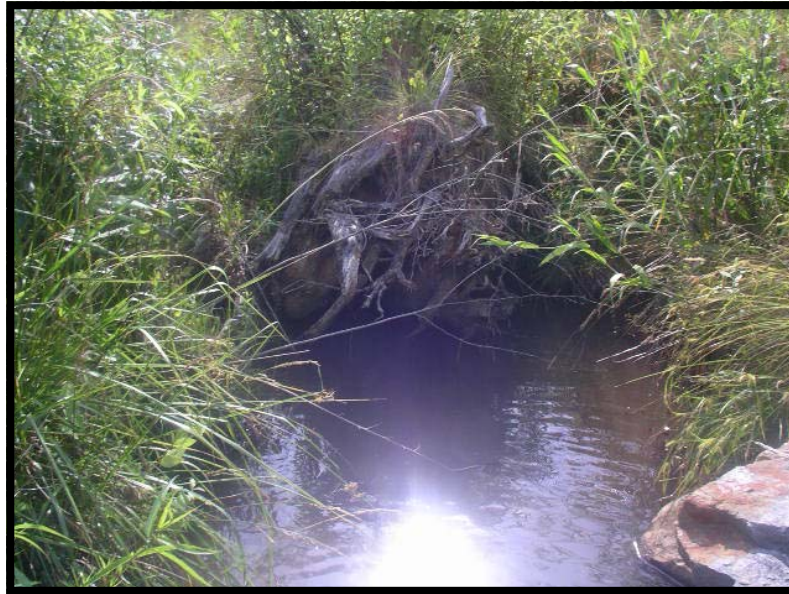
| <b>Table IX: Stream Problem Areas<br/>Trout Cove Stream Restoration Site (EEP Project # 388)</b> | | | |
|--|---|---|---|
| Bank Scour | 1 (2+50 – 2+60) | Erosion/Undercutting Banks | 5-6 |

Figure 5—Typical Bank Scour

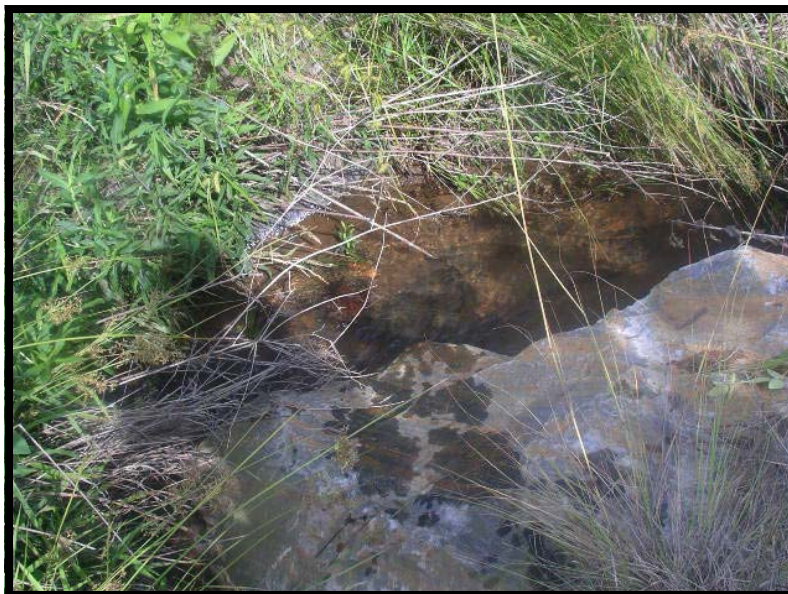
Figure 6—Typical Bank Scour
