Year 2 Monitoring Report

Trout Cove Stream Restoration

March 2008
EEP Project No. 388

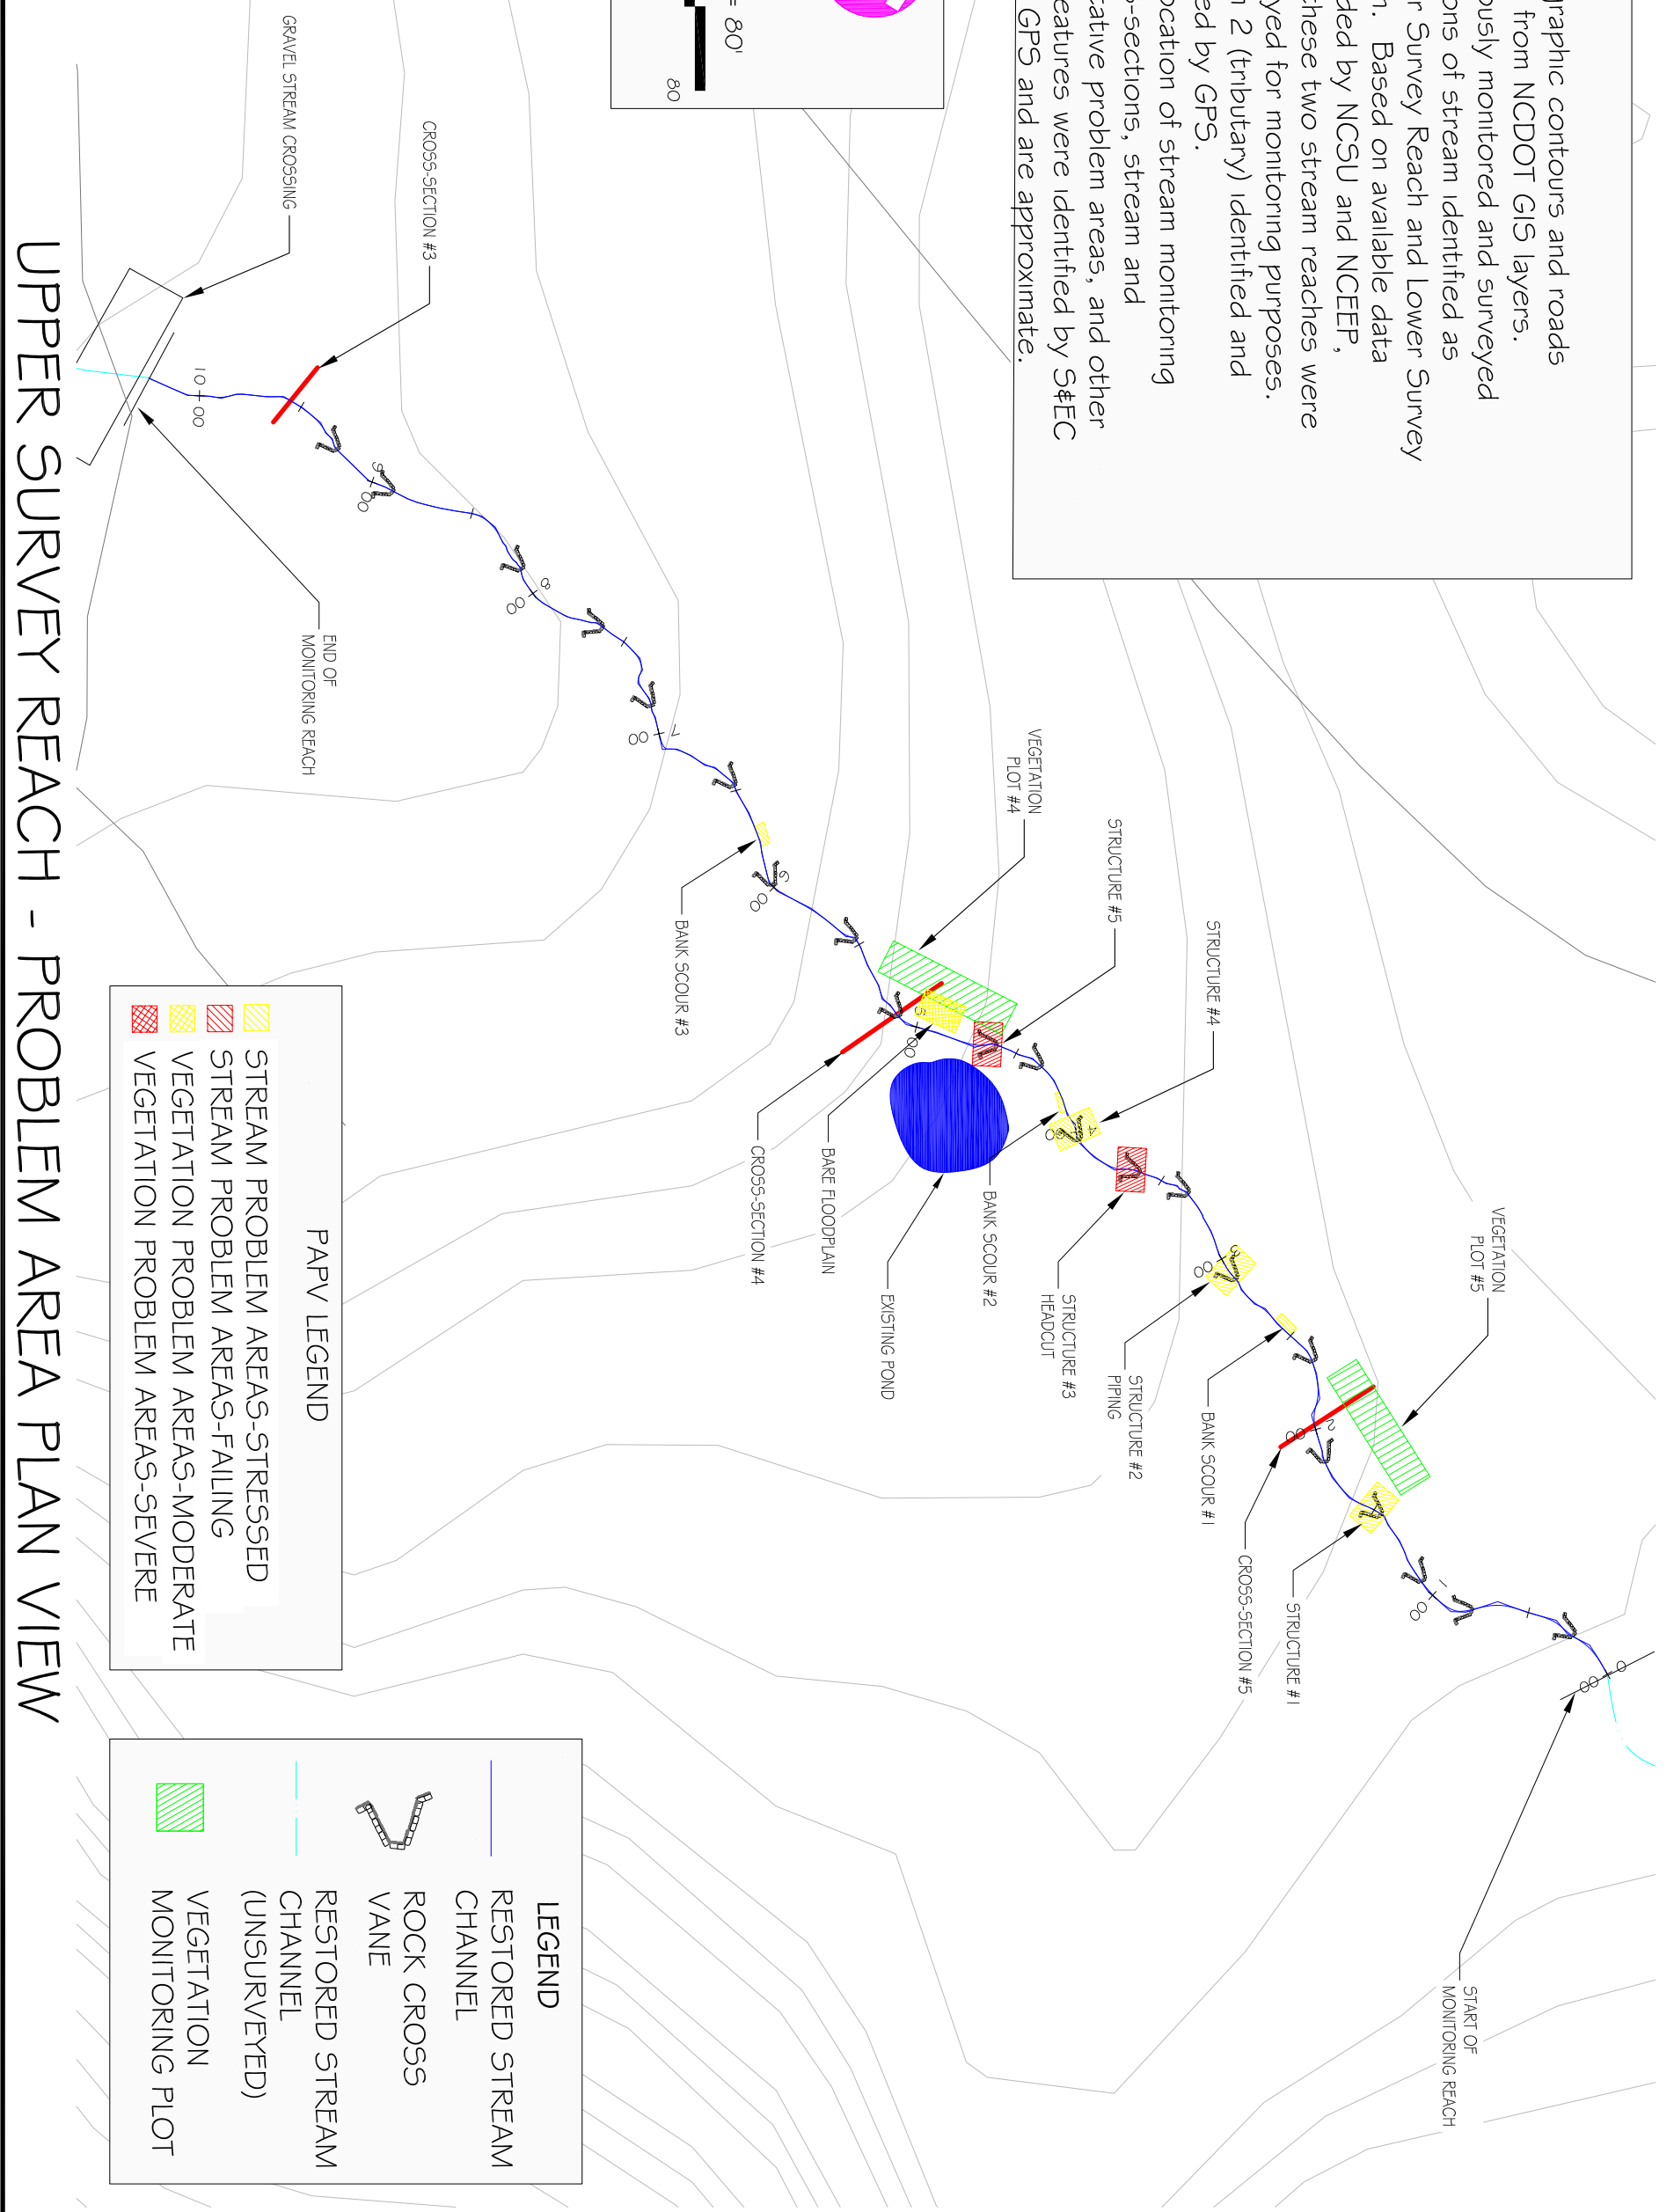
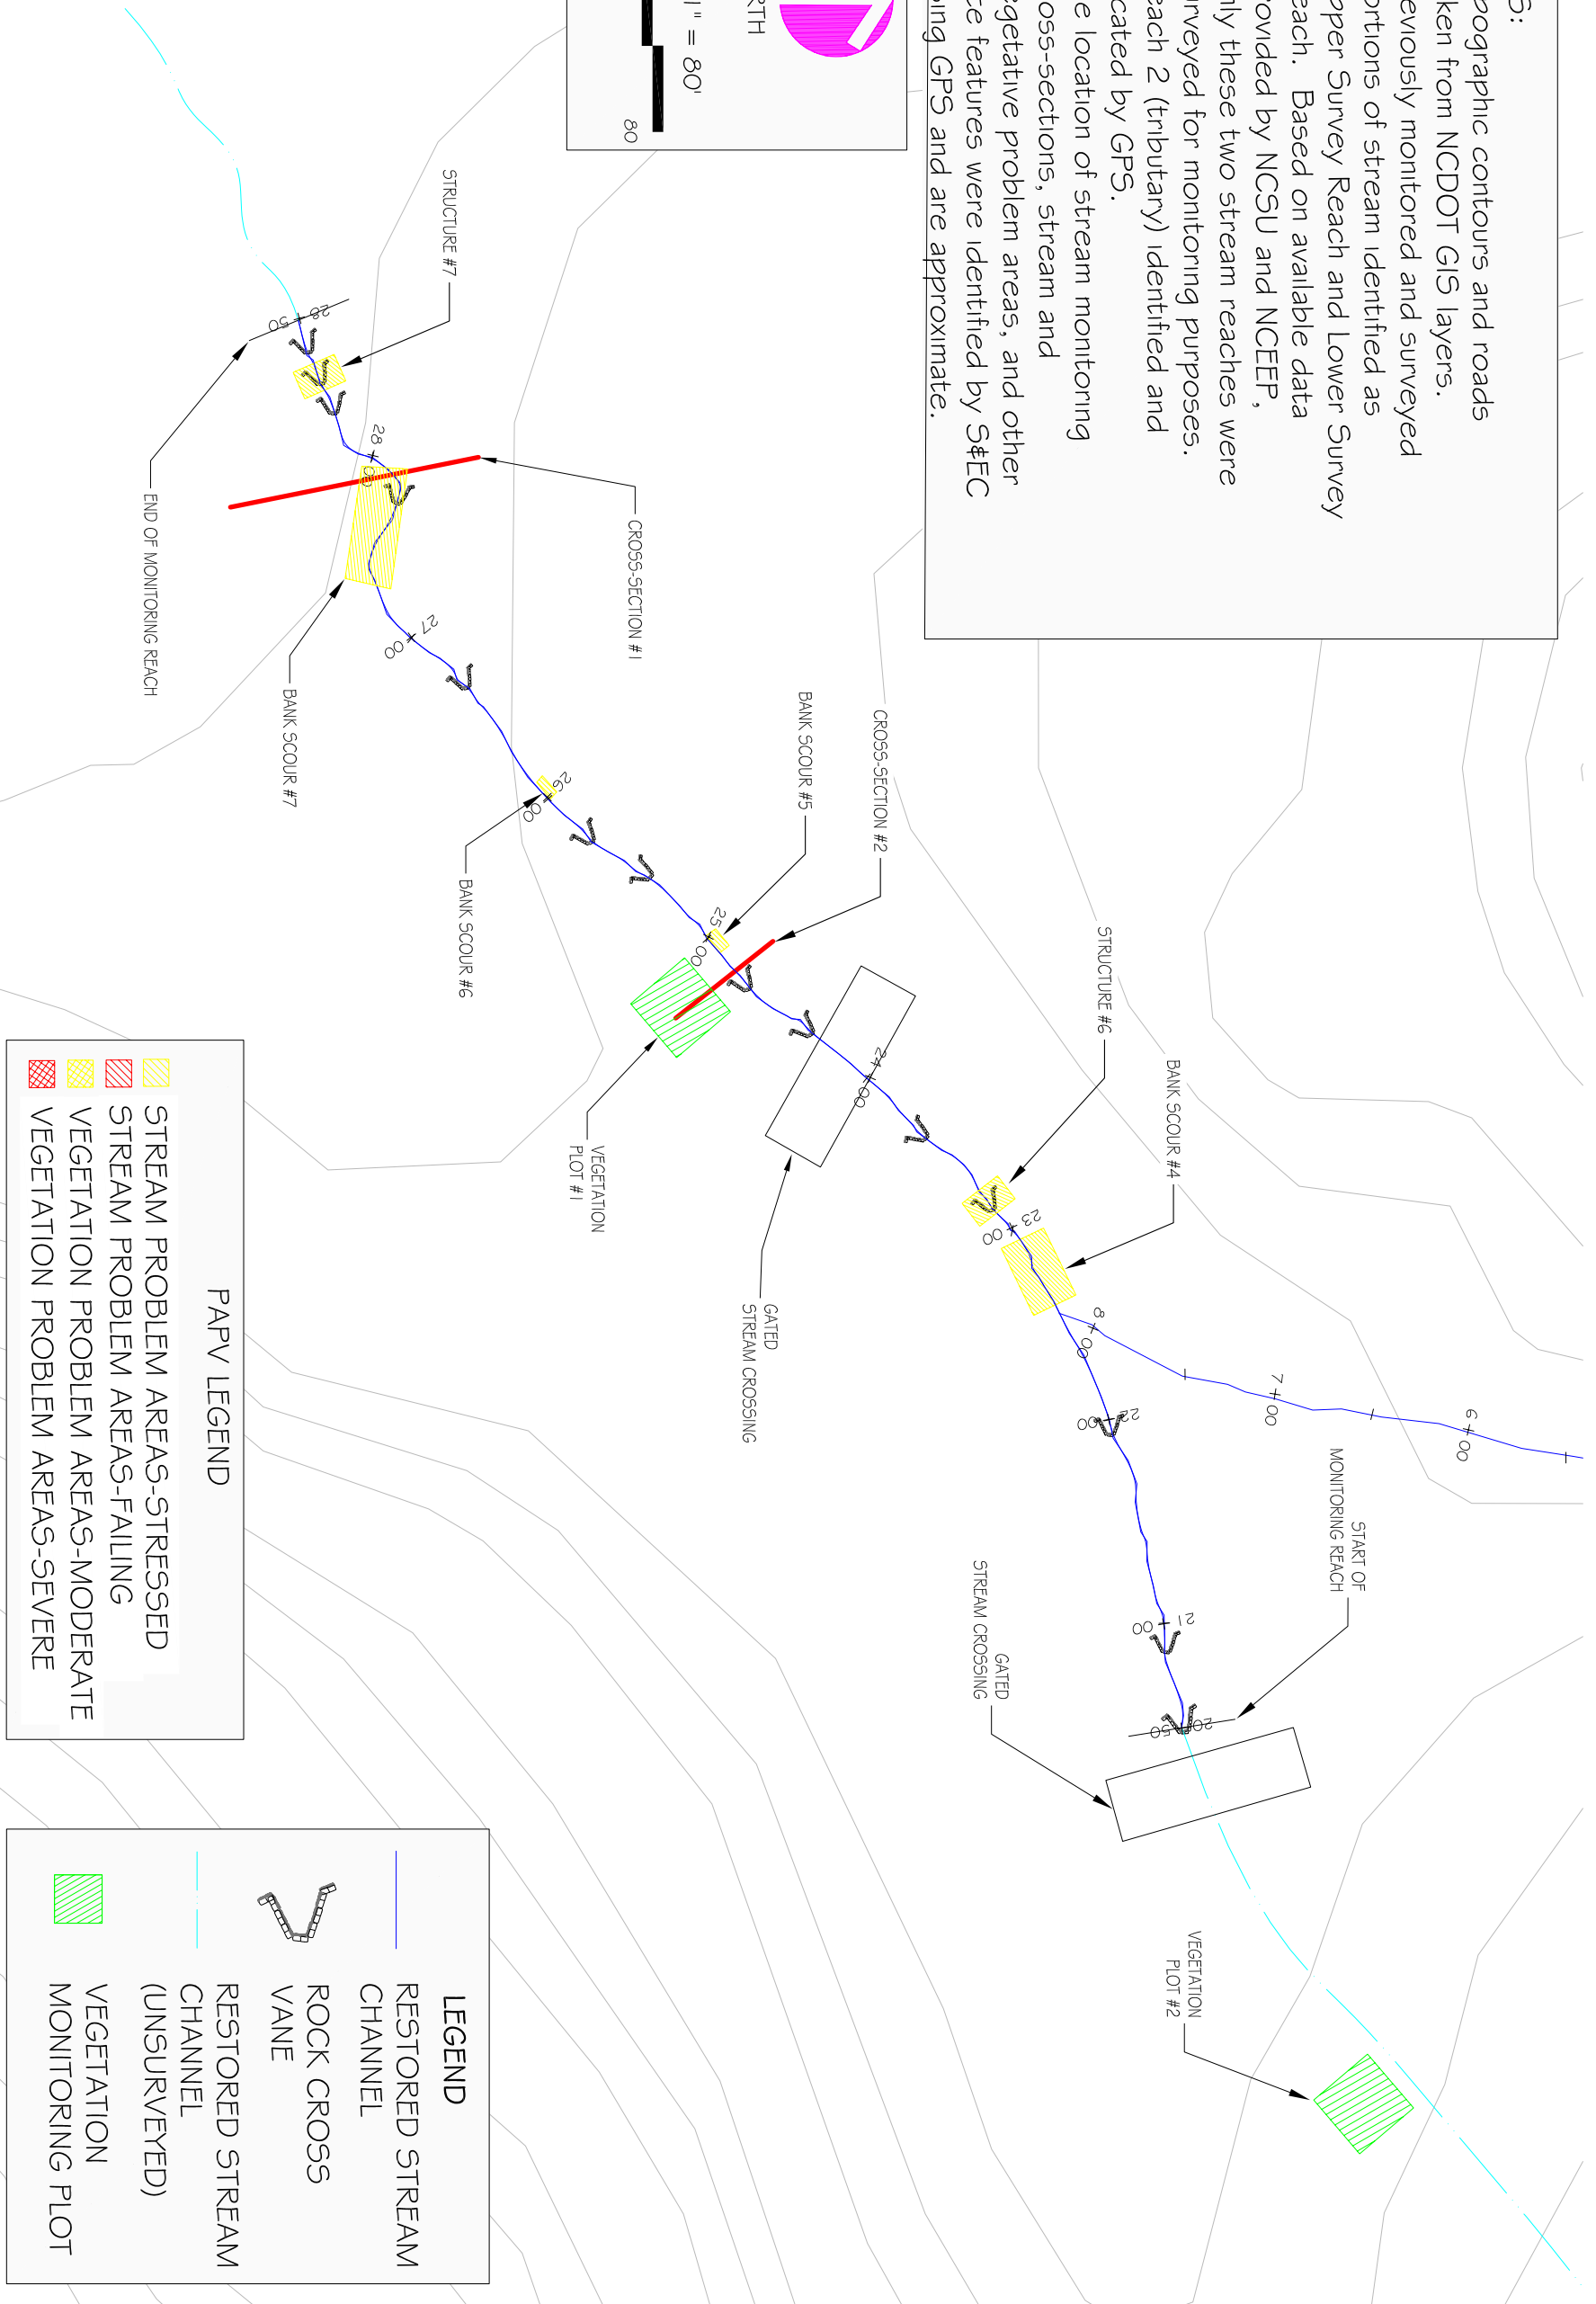
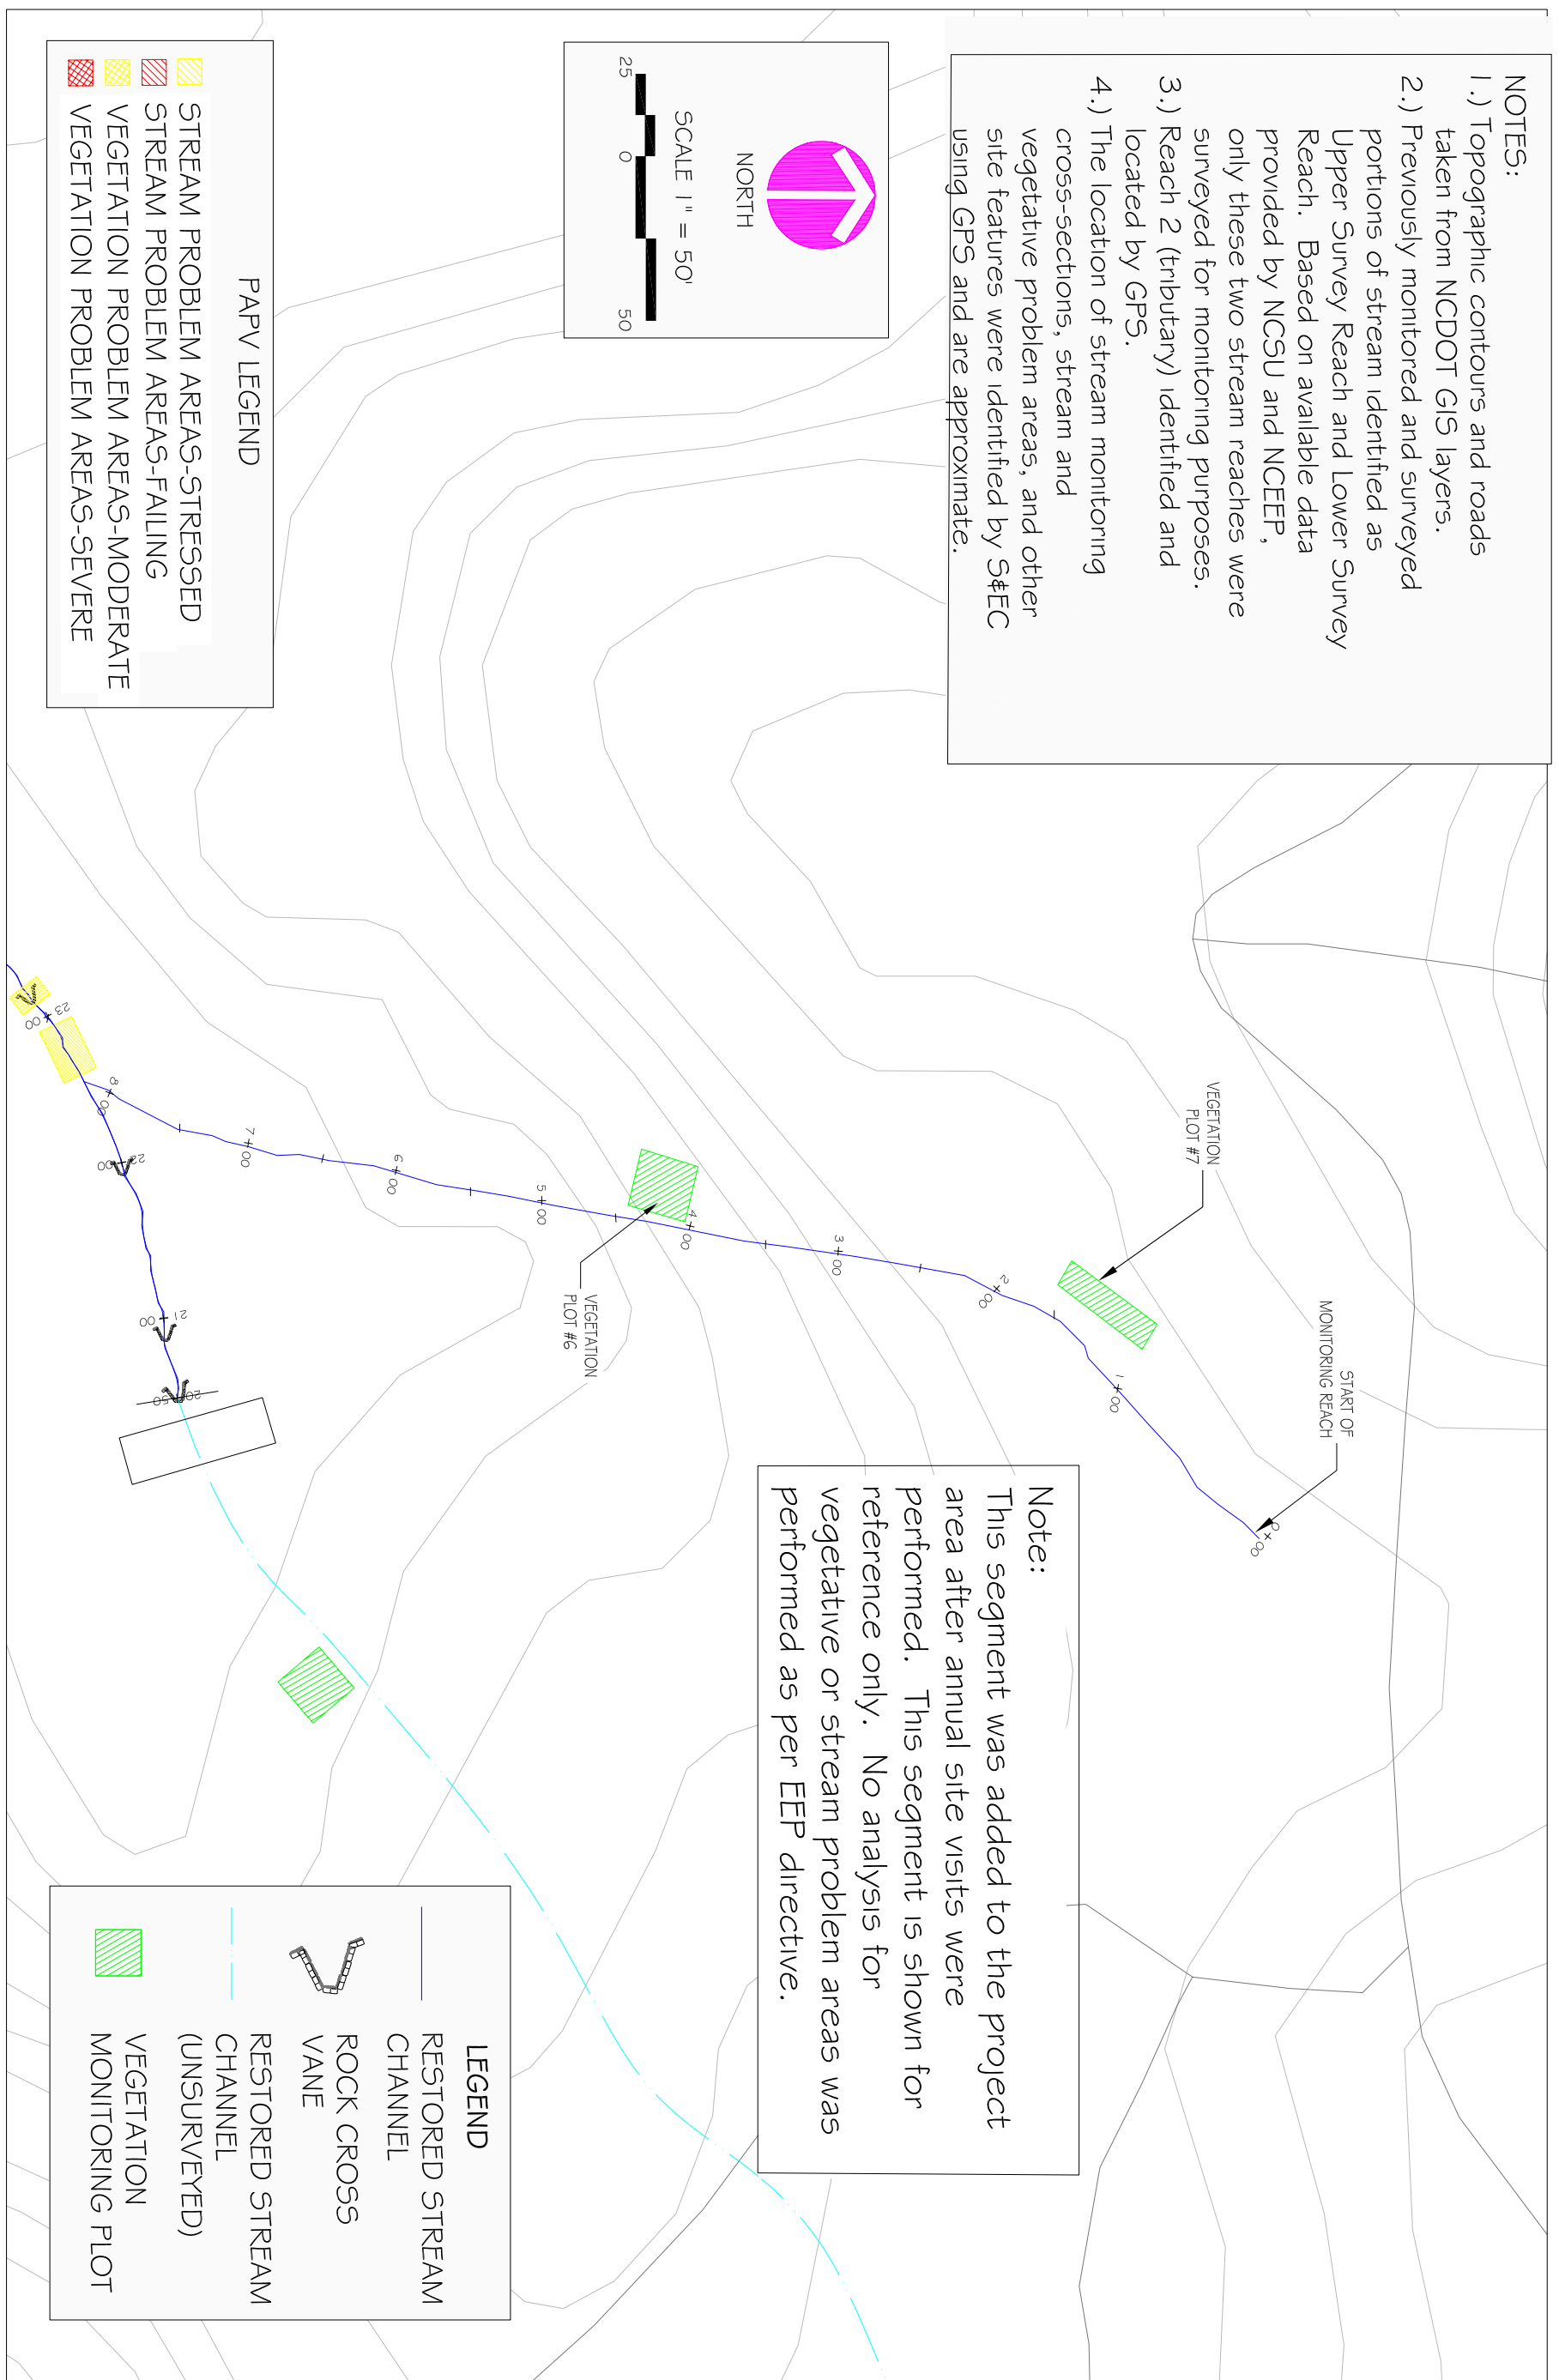
An assessment of channel stability was performed on June 12, 2007, by S&EC. Areas of concern that were observed and documented included localized bank scour, and stressed or failing structures. These problem areas are shown on Sheets 5 through 7 (Problem Area Plan View) and described in Table IX.

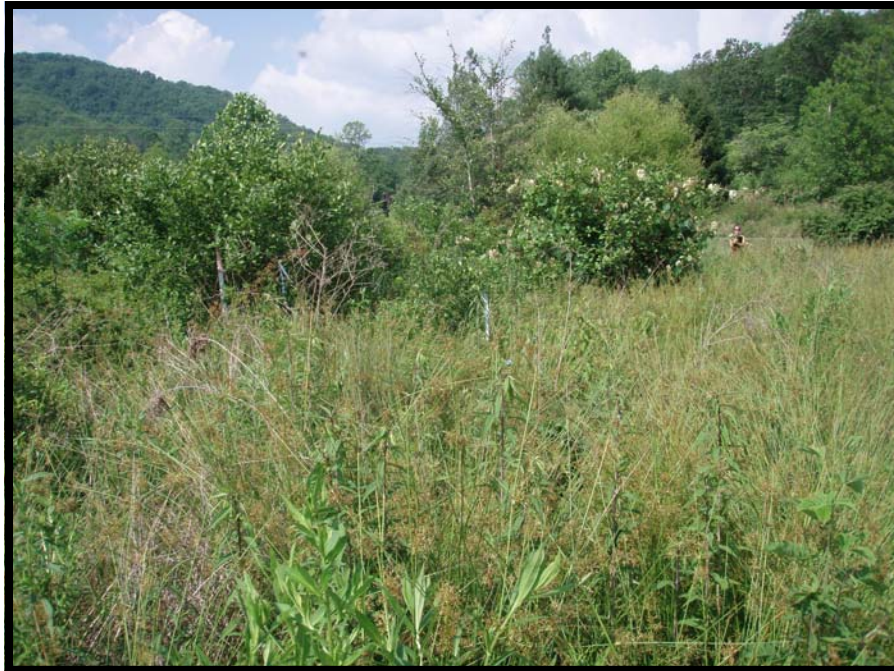
Vegetation Monitoring Plot #3—Year 2 (June 12, 2007)

As shown in Table VIII, one plot (Plot 3) has shown a stem density of less than the desired 320 stems per acre. However, while not quantified in the above table, each plot has shown a large number of volunteers in addition to the original planted stems including additional species such as Red Oak and

Pepperbush. If these new plants are taken into consideration, stem density would likely be much higher than 320 stems per acre in that plot.

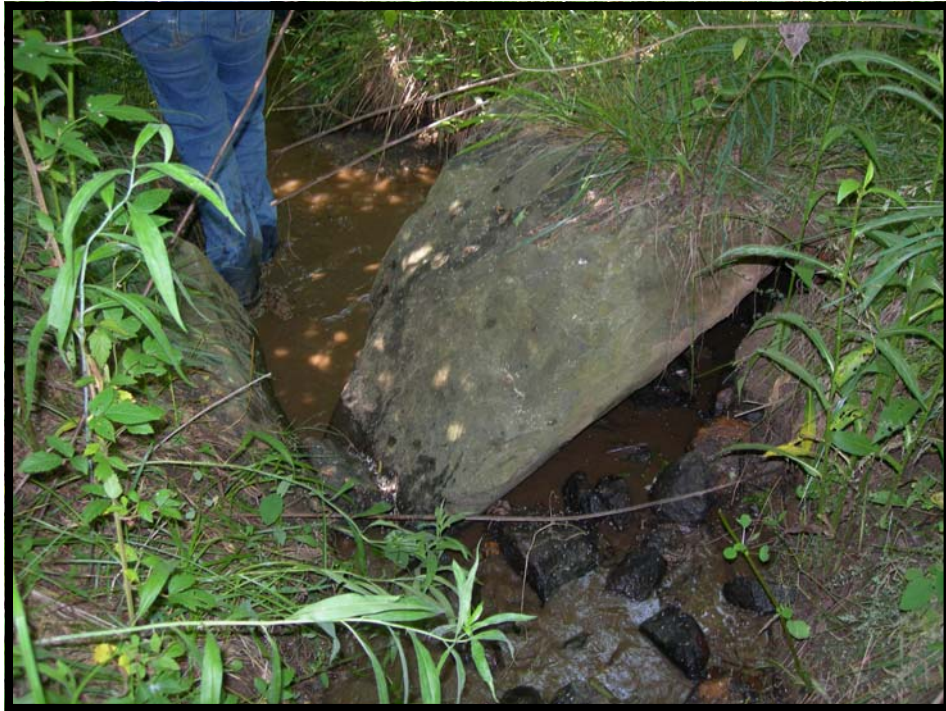
Table IX: Stream Problem Areas Trout Cove Stream Restoration Site (EEP Project # 388)			
Feature Issues	Number	Suspected Cause	Photo number
Structure (Rock Shift)	1 (1+40 – 1+55)	Erosion/Undercutting	1-2
	3 (3+60 – 3+70)	Erosion/Undercutting	
	4 (3+95 – 4+05)	Erosion/Undercutting	
	5 (4+60 – 4+70)	Erosion/Undercutting	
	6 (23+05 – 23+15)	Erosion/Undercutting	
	7 (28+30 – 28+40)	Erosion/Undercutting	
Structure (Rock Piping)	2 (2+90 – 3+00)	Erosion	3
Bank Scour	1 (2+50 – 2+60)	Erosion/Undercutting Banks	4-5
	2 (4+10 – 4+18)	Erosion/Undercutting Banks	
	3 (6+20 – 6+27)	Erosion/Undercutting Banks	
	4 (22+55 – 22+95)	Erosion/Undercutting Banks	
	5 (24+96 – 25+00)	Erosion/Undercutting Banks	
	6 (26+00 – 26+05)	Erosion/Undercutting Banks	
	7 (27+40 – 27+95)	Erosion/Undercutting Banks

Figure 1—Typical Rock Shift (June 12, 2007)

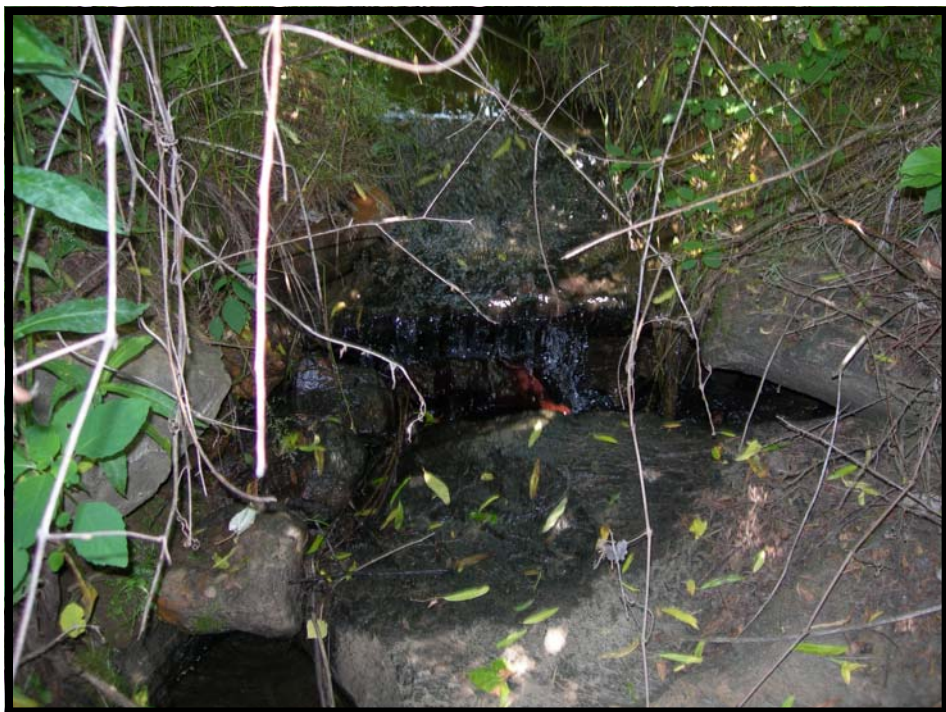
Figure 2—Typical Rock Shift (June 12, 2007)

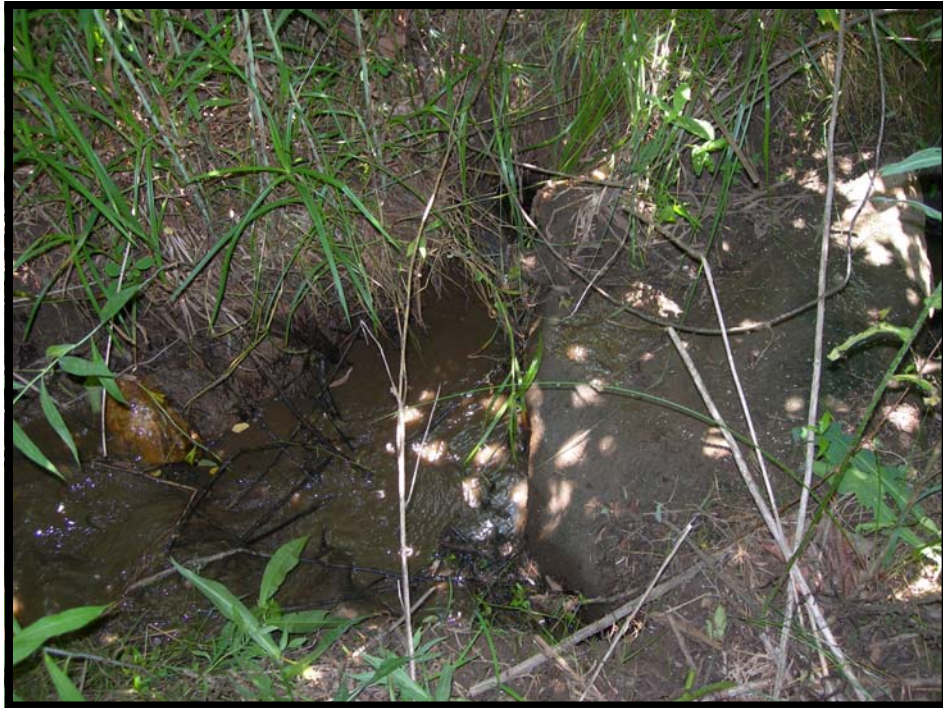
Figure 3—Typical Rock Piping (June 12, 2007)

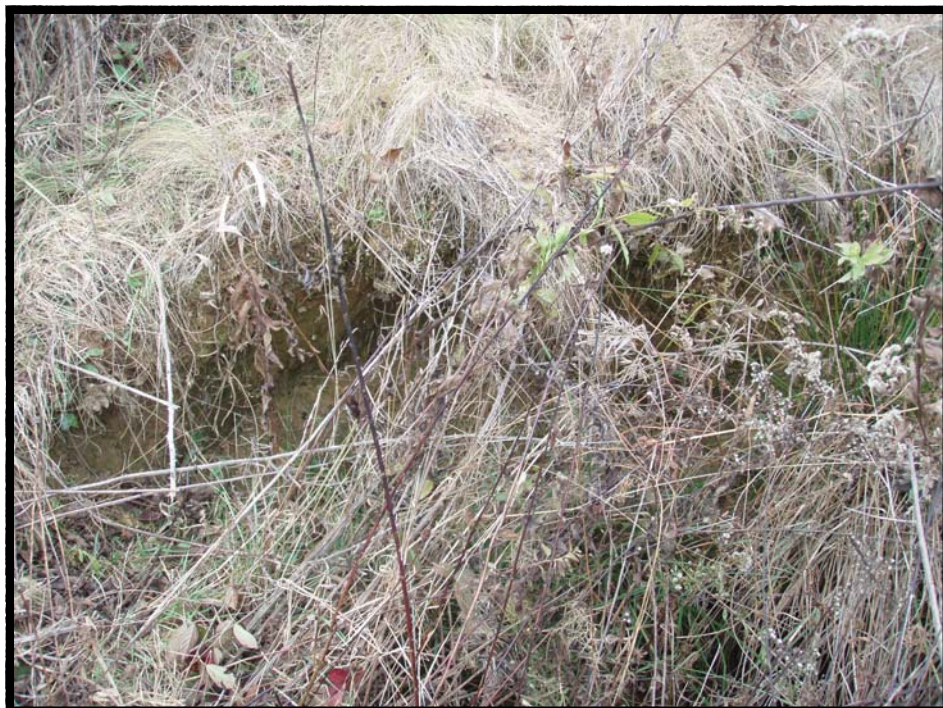
Figure 4—Typical Bank Scour (November 13, 2007)

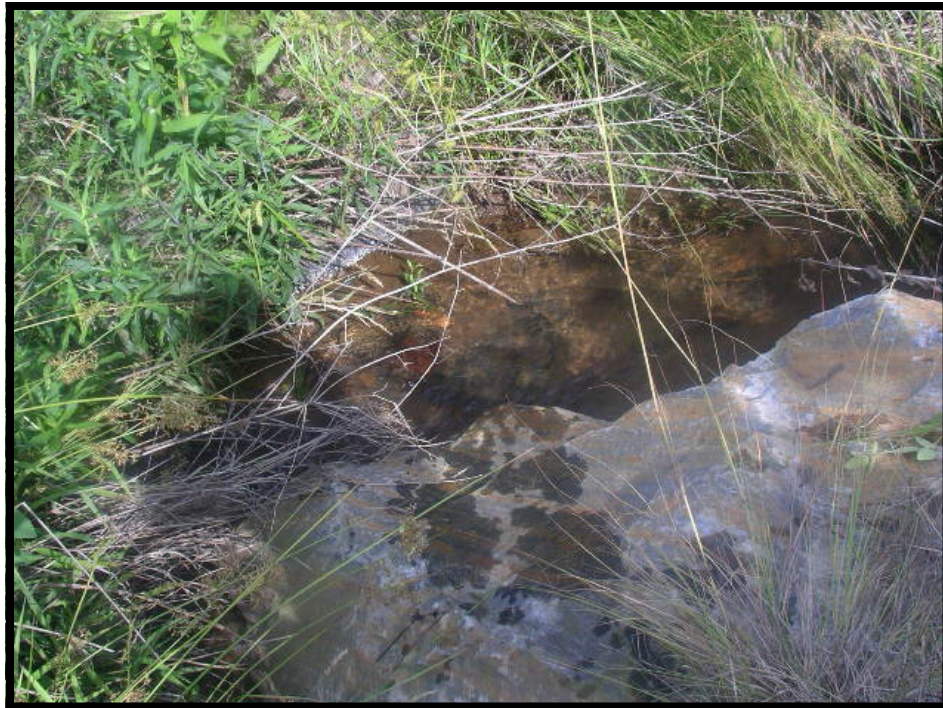
Figure 5—Typical Bank Scour (June 12, 2007)
