Trout Cove Branch and Tributary Stream Restoration

NCEEP Project Number: 388

Monitoring Year 4

2008 Final Report

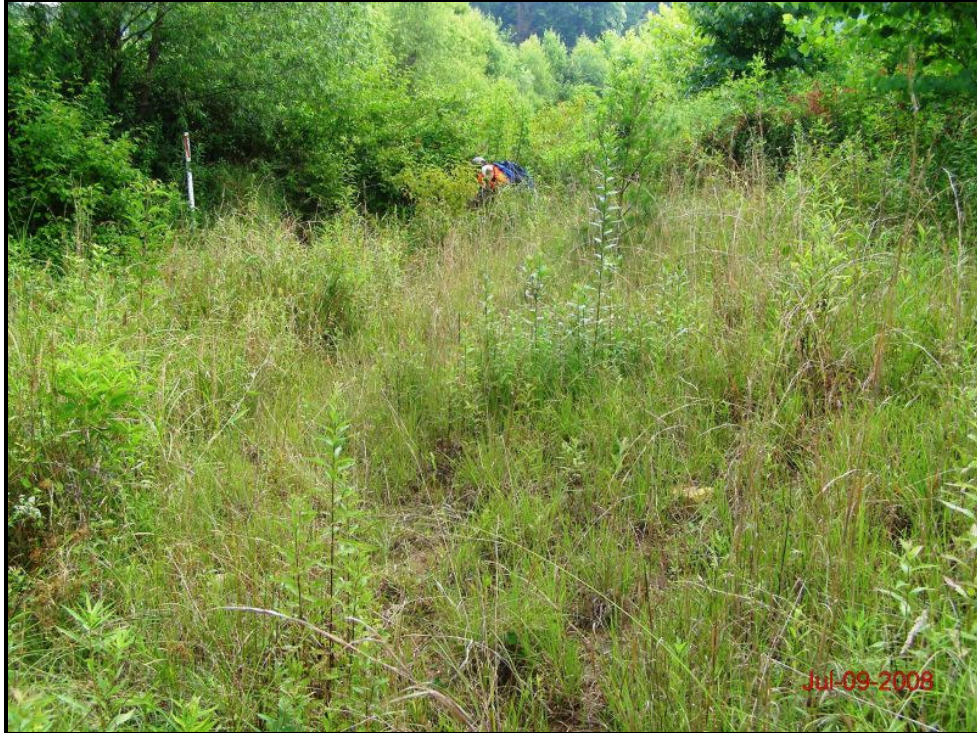
Vegetative growth at four stream bench locations is stunted and appears to be related to poor soil

Vegetation Problem Area (VPA 1) – Bare Bench
Monitoring Year 4 – July 9, 2008

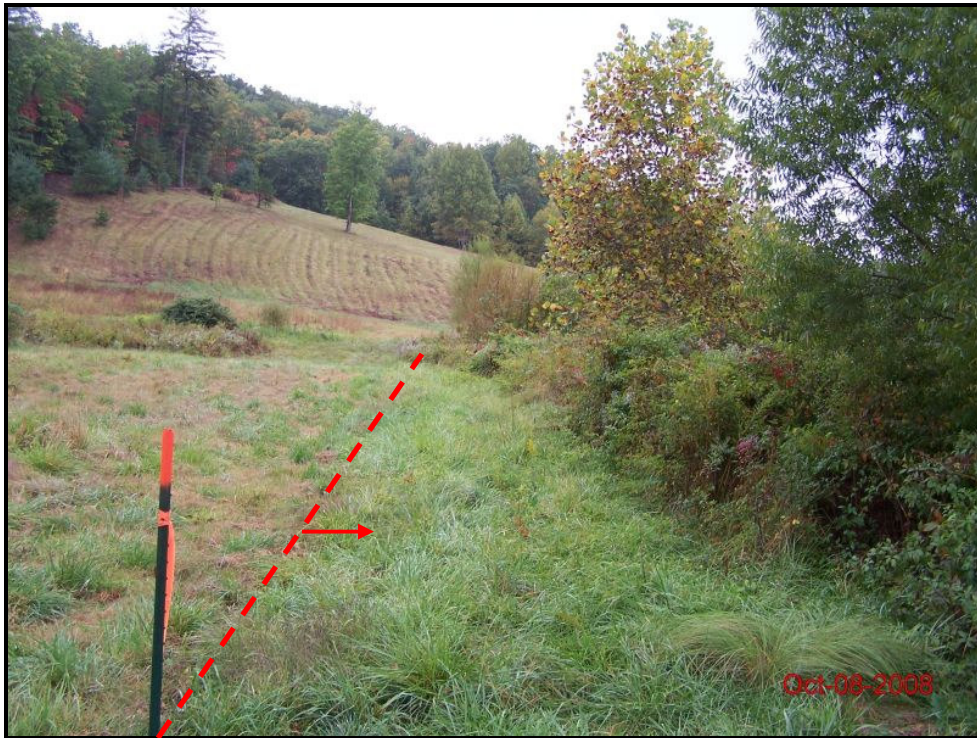
substrate. The bare floodplain problem areas noted are the result of unauthorized mowing and livestock fencing extending into the easement area. An additional problem was identified during the final site visit in November 2008. Mary Jo Deck, one of the existing landowners, indicated that the electrical company recently attempted to mow the existing power line crossings along the upper portion of the project site. A small area was mowed within the easement area prior to the landowners stopping progress. This issue will need to be resolved to prevent potential impacts to the riparian vegetation in proximity to the existing power line crossings. The most significant change in vegetation problem areas between MY 4 and previous monitoring efforts is associated with the extent of invasive/exotic species noted in 2008. The MY 4 efforts documented isolated, dense patches of Japanese honeysuckle (*Lonicera japonica*) and Multiflora rose (*Rosa multiflora*). In particular, Japanese honeysuckle largely accounted for the vine strangulation reported in four of the seven monitoring plots. The species most negatively affected by vine strangulation were Silky dogwood (*Cornus amomum*) and Tag alder.

Vegetation Problem Area (VPA 2) – Mowed Floodplain
Monitoring Year 4 – October 8, 2008

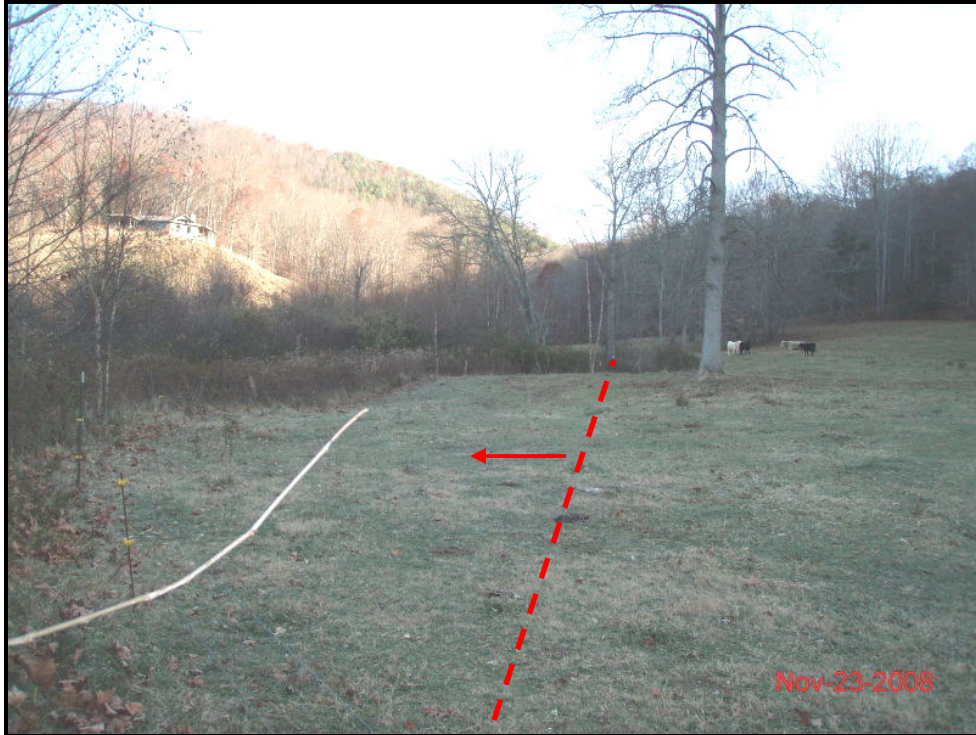
Vegetation Problem Area (VPA 3) – Livestock Encroachment
Monitoring Year 4 – November 23, 2008

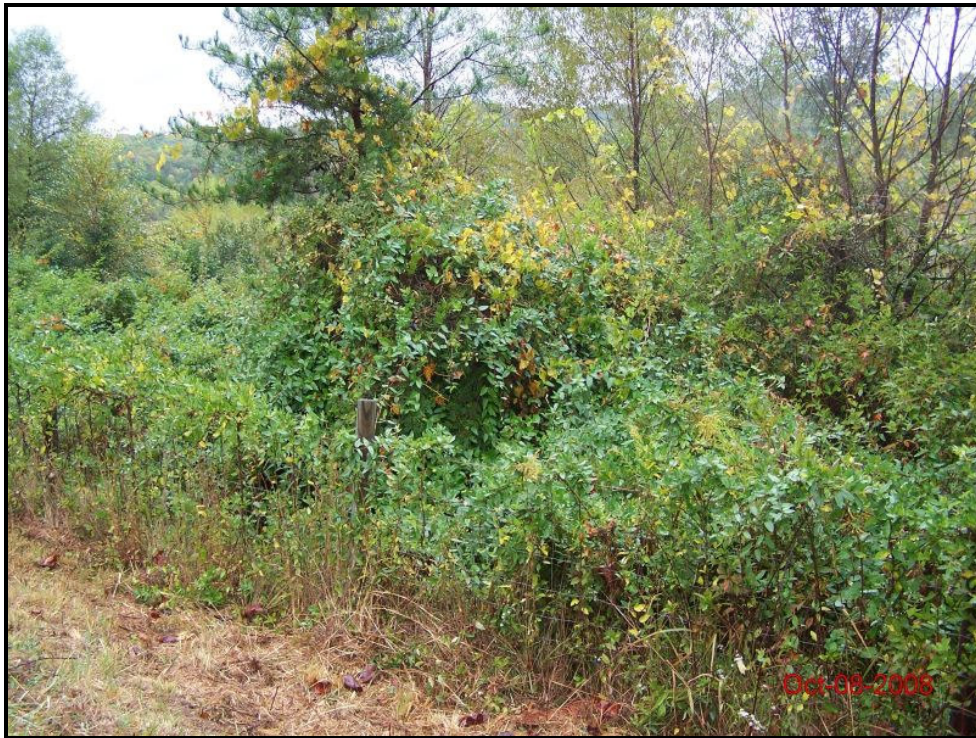
Vegetation Problem Area (VPA 4) – *Lonicera japonica*
Monitoring Year 4 – October 8, 2008

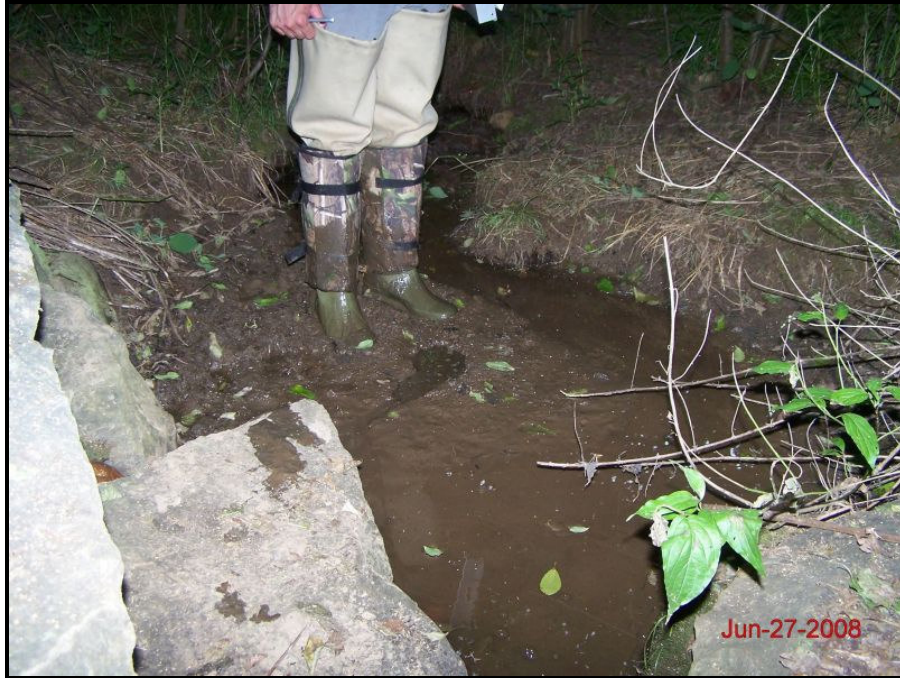
Stream Problem Area (SPA 1) – Pool aggradation
Monitoring Year 4 – June 27, 2008

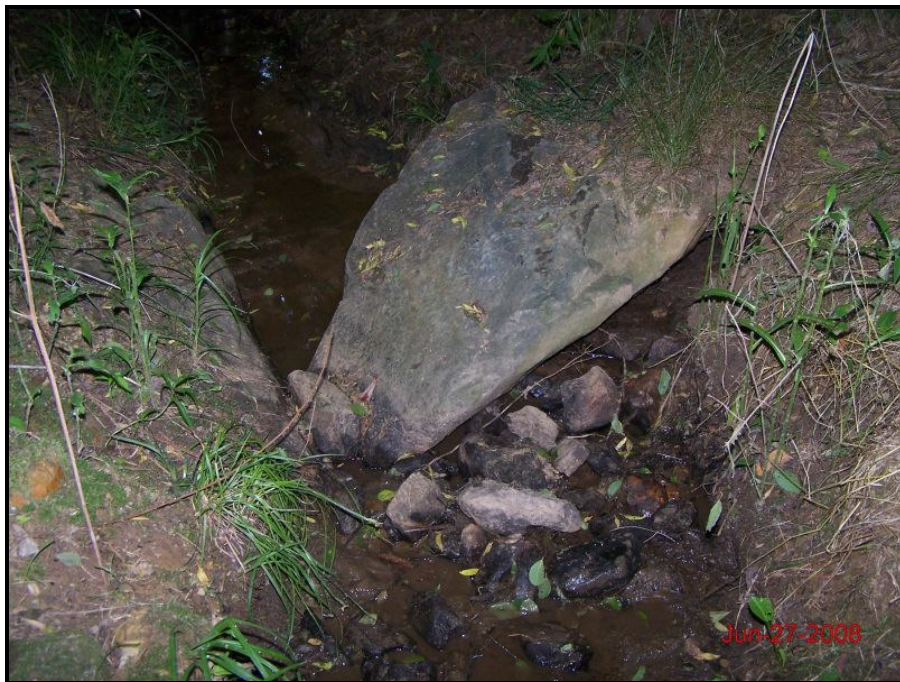
Stream Problem Area (SPA 2) – Failed structure
Monitoring Year 4 – June 27, 2008

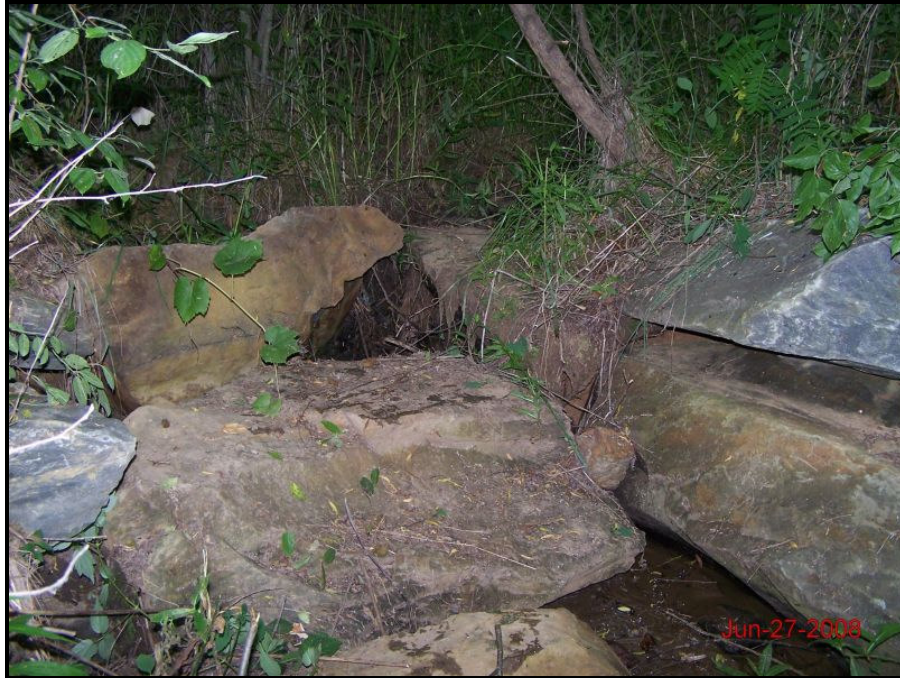
Stream Problem Area (SPA 3) – Failed structure
Monitoring Year 4 – June 27, 2008

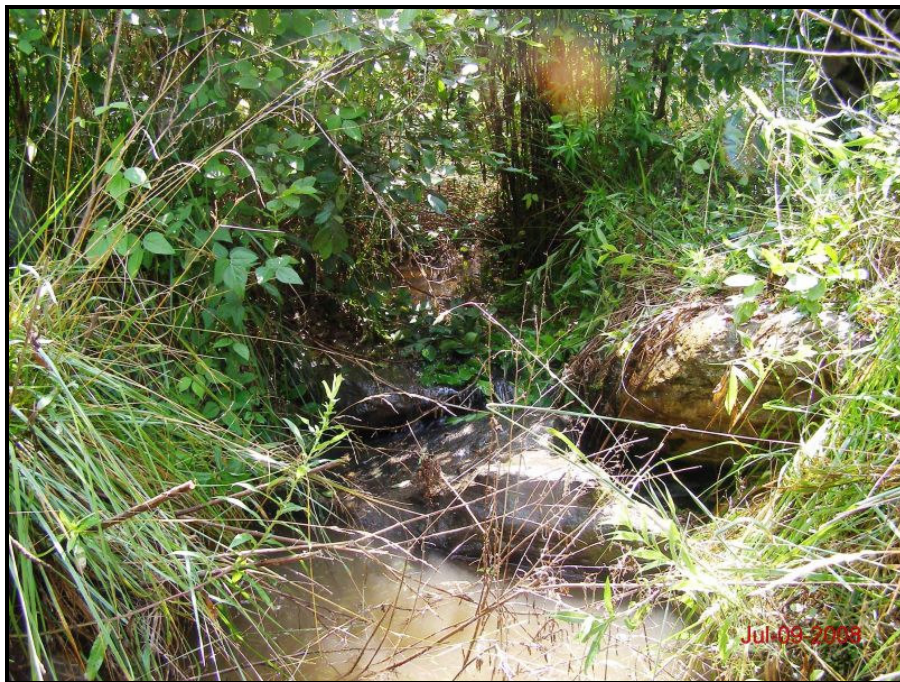
Stream Problem Area (SPA 4) – Stressed structure
Monitoring Year 4 – July 9, 2008
