Trout Cove Branch and Tributary Stream Restoration

NCEEP Project Number: 388

Monitoring Year 5

2009 Final Report

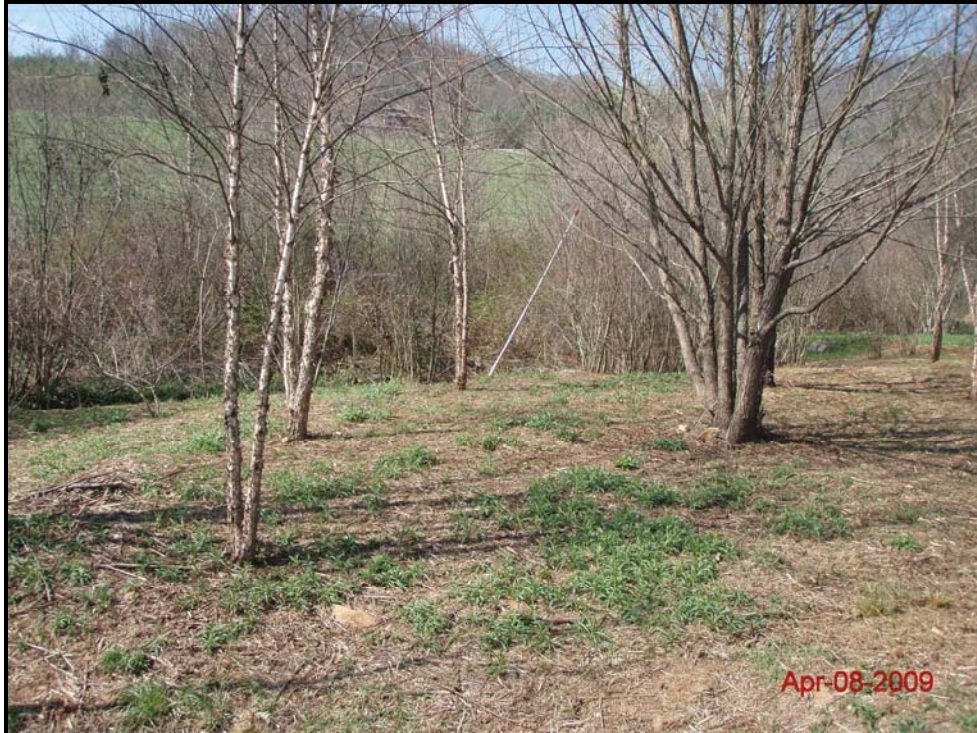
Vegetation Problem Area (VPA 1) – Mowed Floodplain
Monitoring Year 5 – April 8, 2009

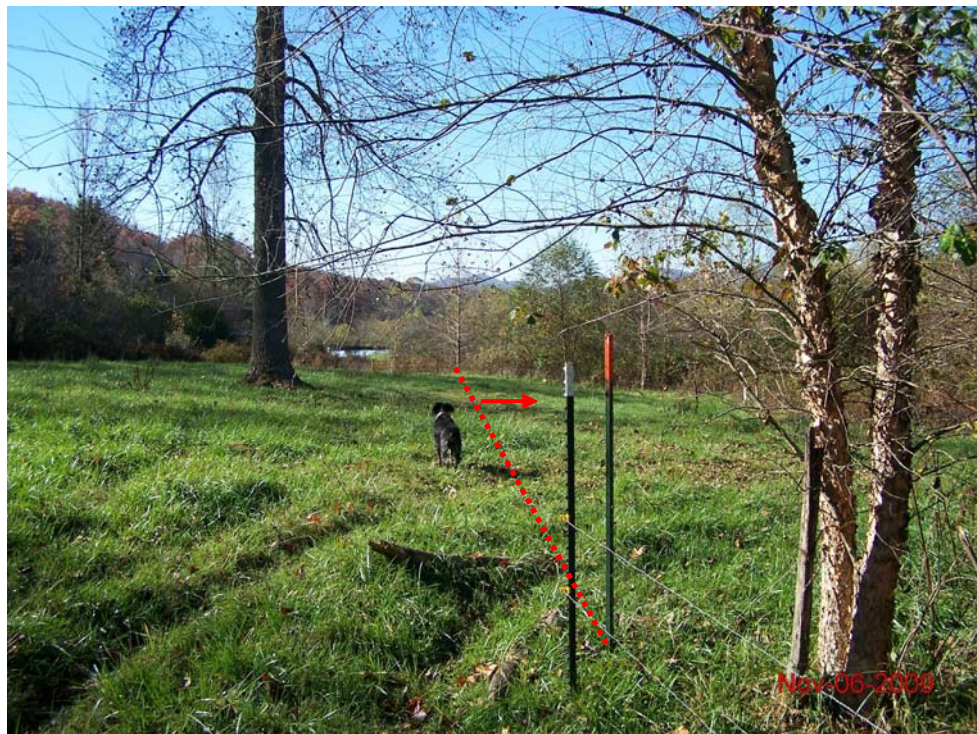
Vegetation Problem Area (VPA 2) – Livestock Encroachment
Monitoring Year 5 – November 6, 2009

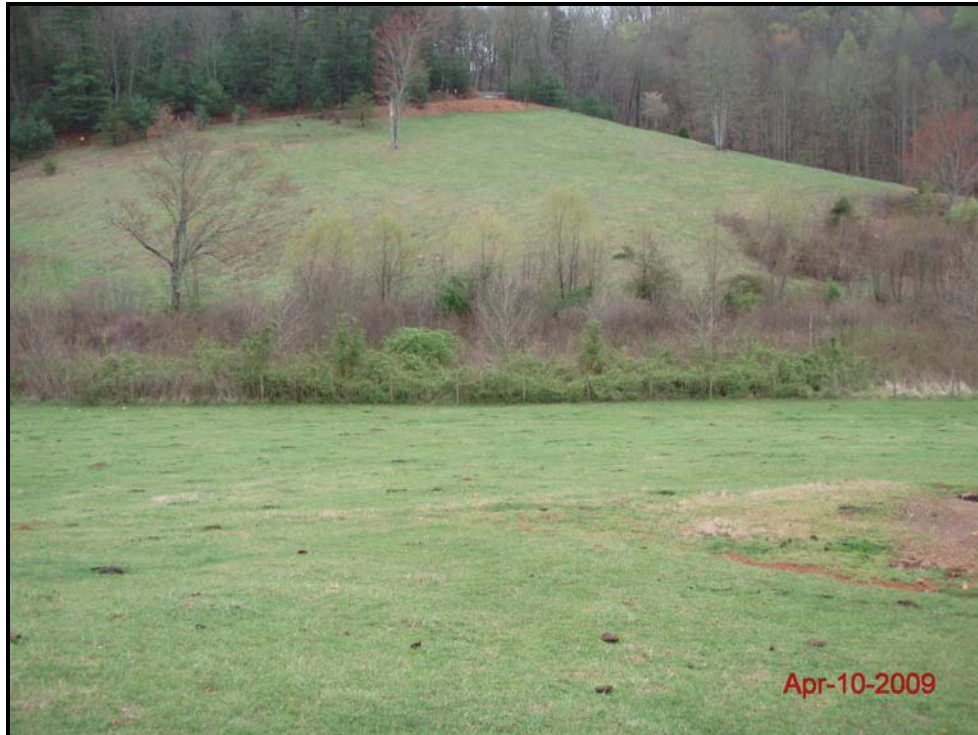
Vegetation Problem Area (VPA 3) – Invasive / Exotic Population
Monitoring Year 5 – April 10, 2009

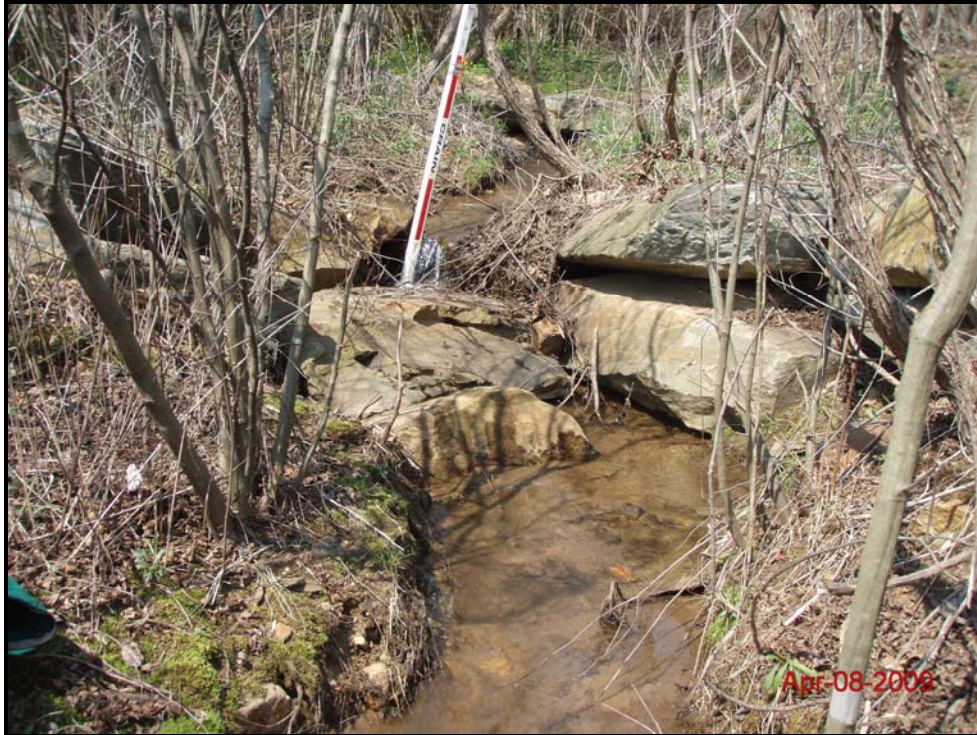
Stream Problem Area (SPA 1) – Pool Aggradation Associated with Stressed Structure
Monitoring Year 5 – April 8, 2009

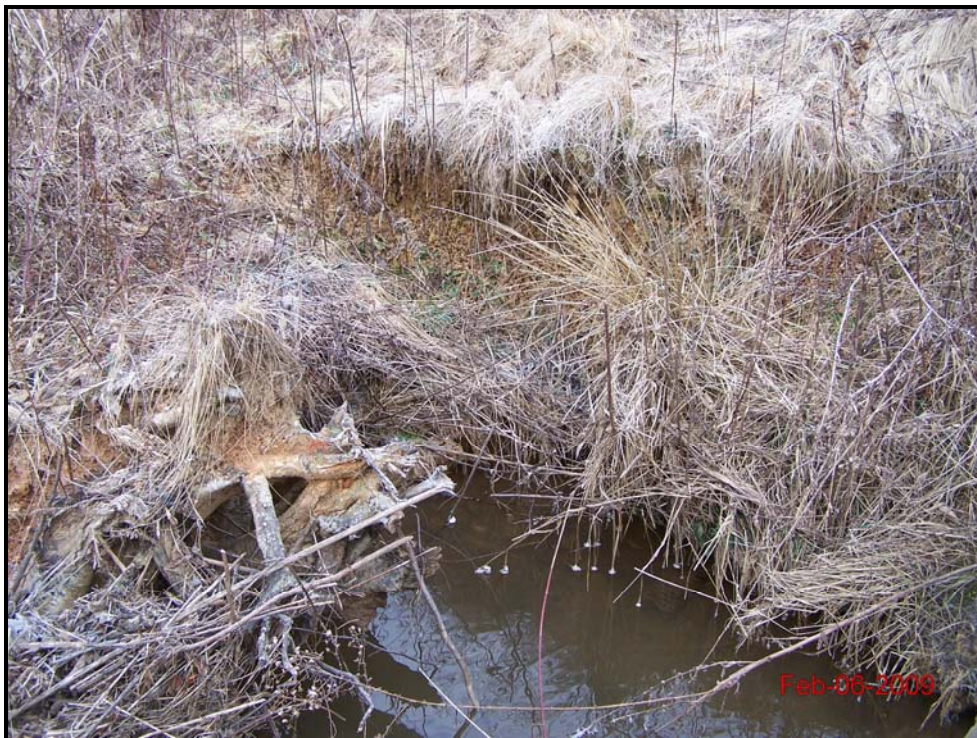
Stream Problem Area (SPA 2) – Bank Erosion
Monitoring Year 5 – February 6, 2009

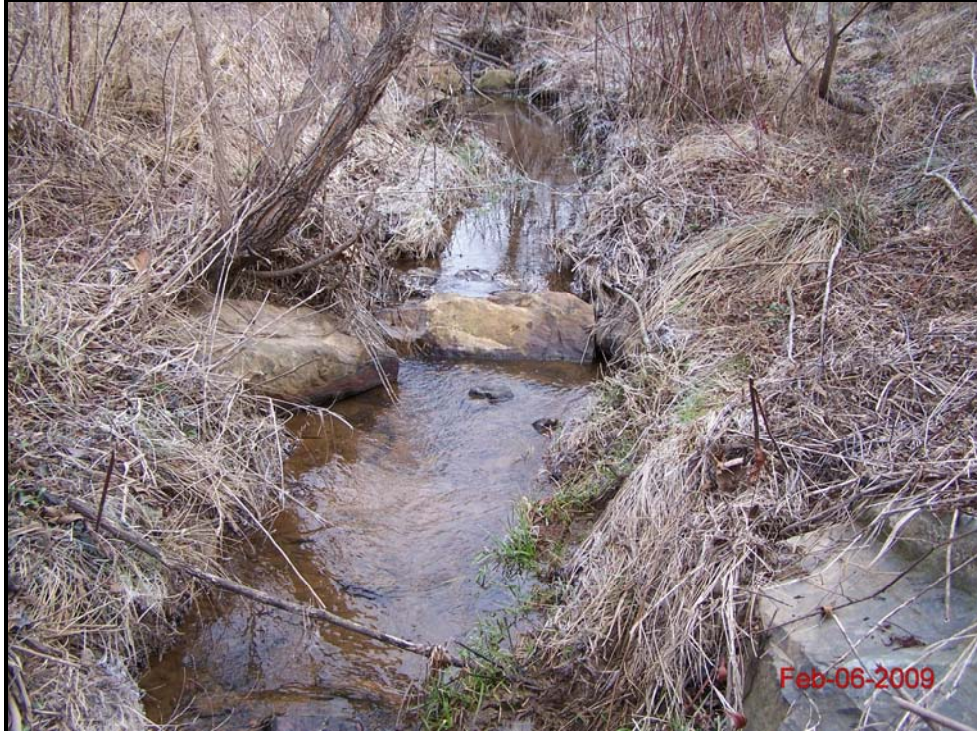
Stream Problem Area (SPA 3) – Stressed Structure
Monitoring Year 5 – February 6, 2009

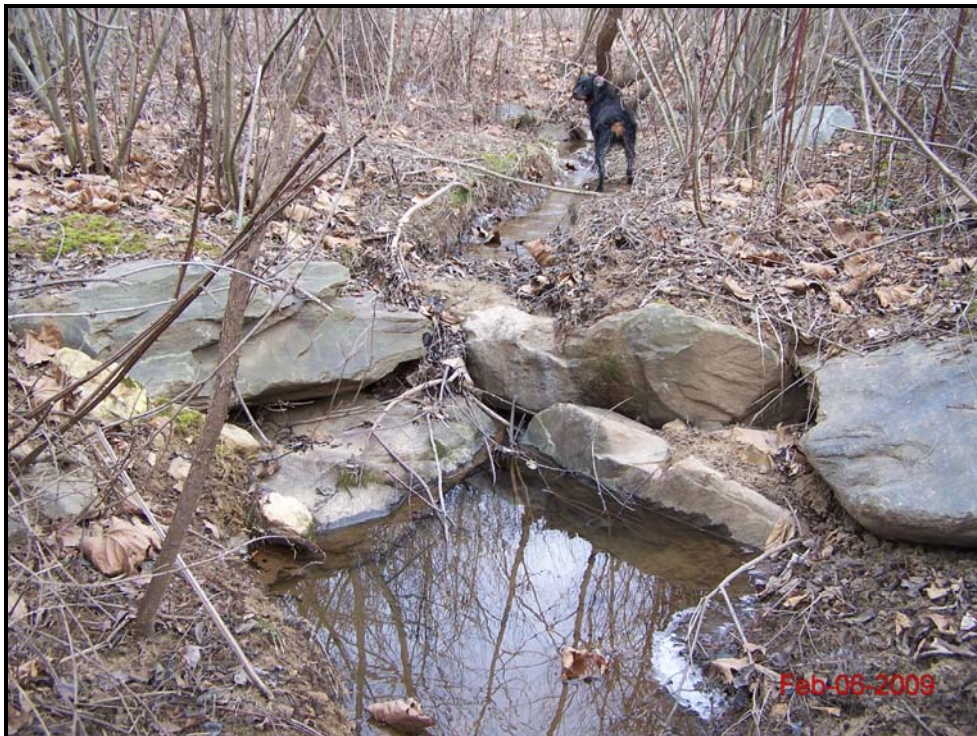
Stream Problem Area (SPA 4) – Stressed Structure
Monitoring Year 5 – February 6, 2009

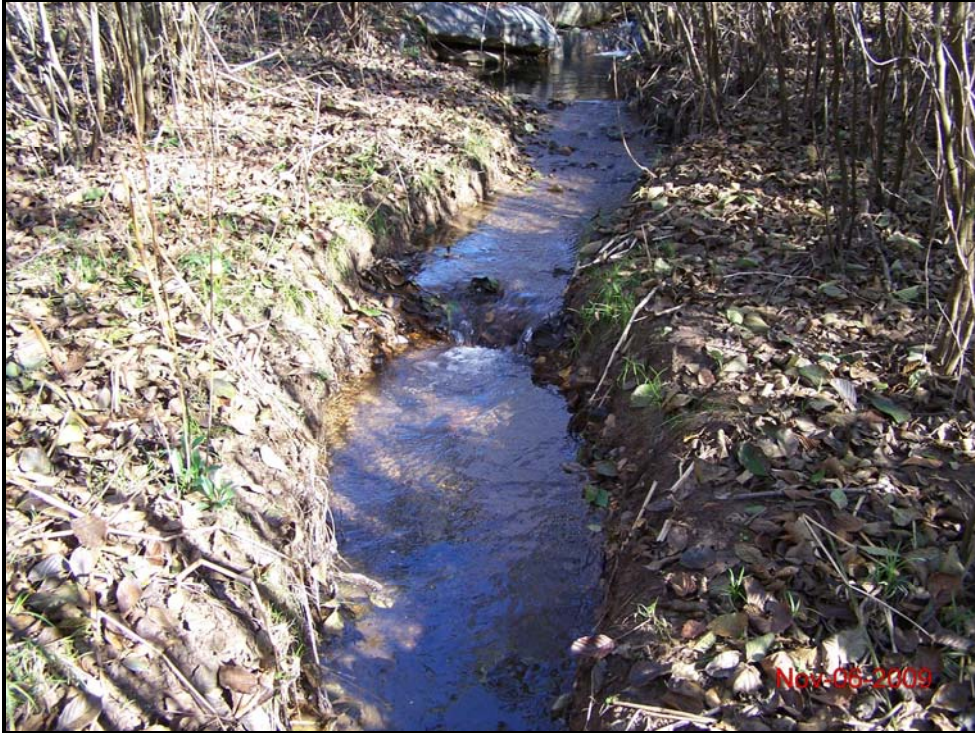
Stream Problem Area (SPA 5) – Small Headcut on Mainstem
Monitoring Year 5 – November 6, 2009

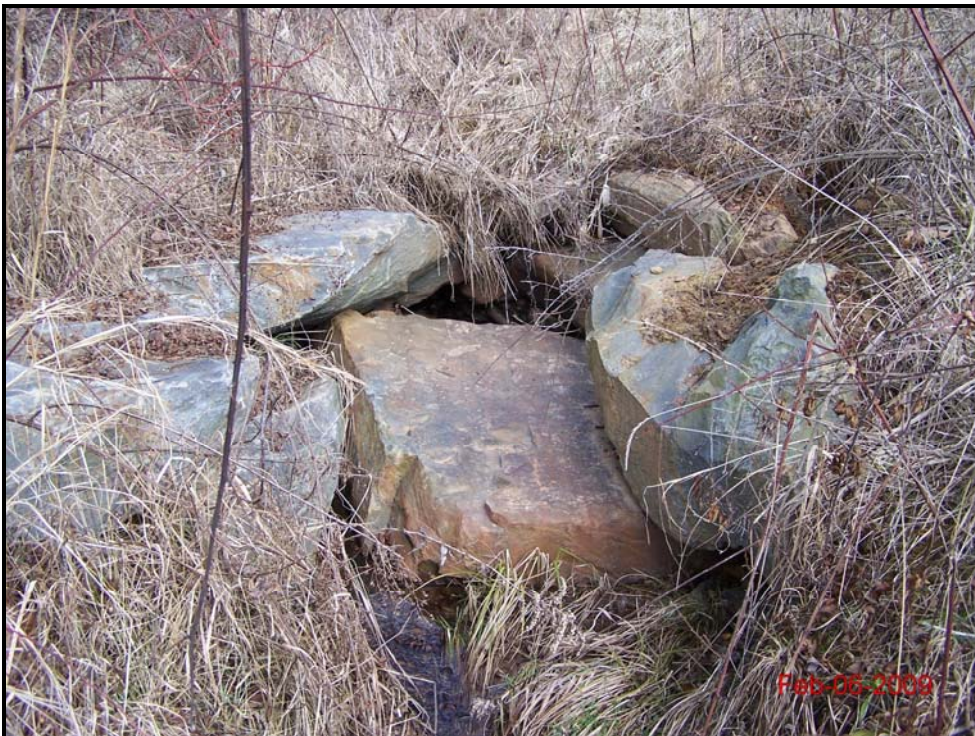
Stream Problem Area (SPA 6) – Failed Structure on Unnamed Tributary
Monitoring Year 5 – February 6, 2009

Stream Problem Areas			
Trout Cove Branch / Project No. 388			
Unnamed Tributary / Reach 2 (888 feet)			
Feature Issue	Station Numbers	Suspected Cause	Photo Number
Engineered Structure	0+90	Structure piping	SPA 6
	2+35	Structure piping	
	3+85	Structure piping	
	4+58	Structure piping	
	4+87	Structure piping	
Headcut	3+60	Unknown	SPA 7
	7+14	Unknown

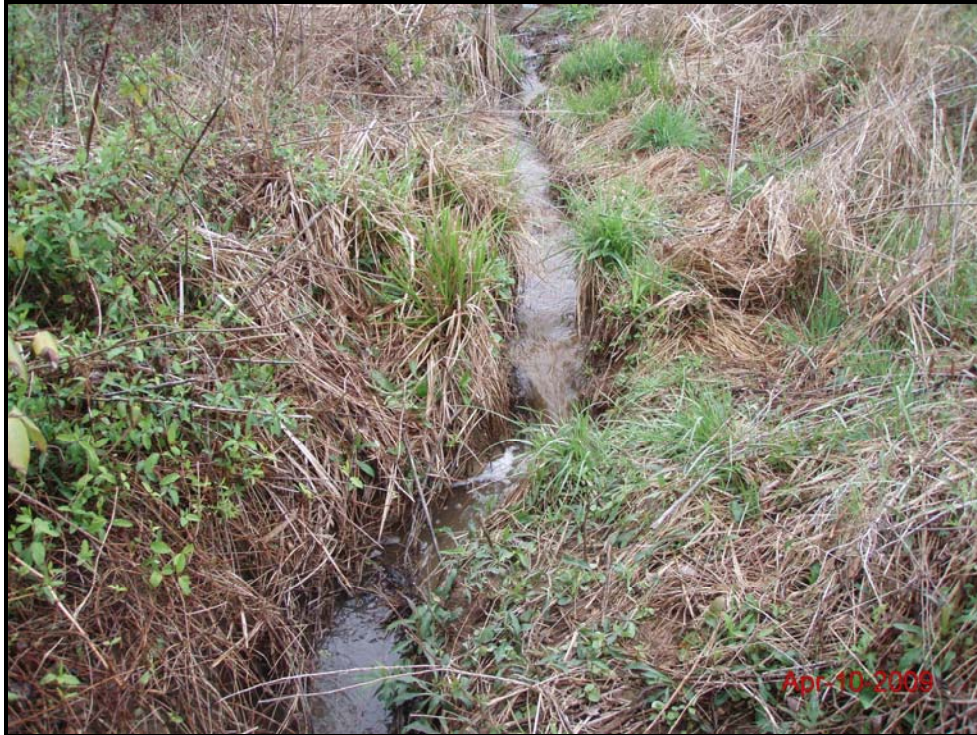
Stream Problem Area (SPA 7) – Small Headcut on Unnamed Tributary
Monitoring Year 5 – April 10, 2009
