Year 3 Monitoring Report

Tulula Stream & Wetland Restoration

February 2006
S&EC Project No. 9444.D1
EEP Project No. 00035

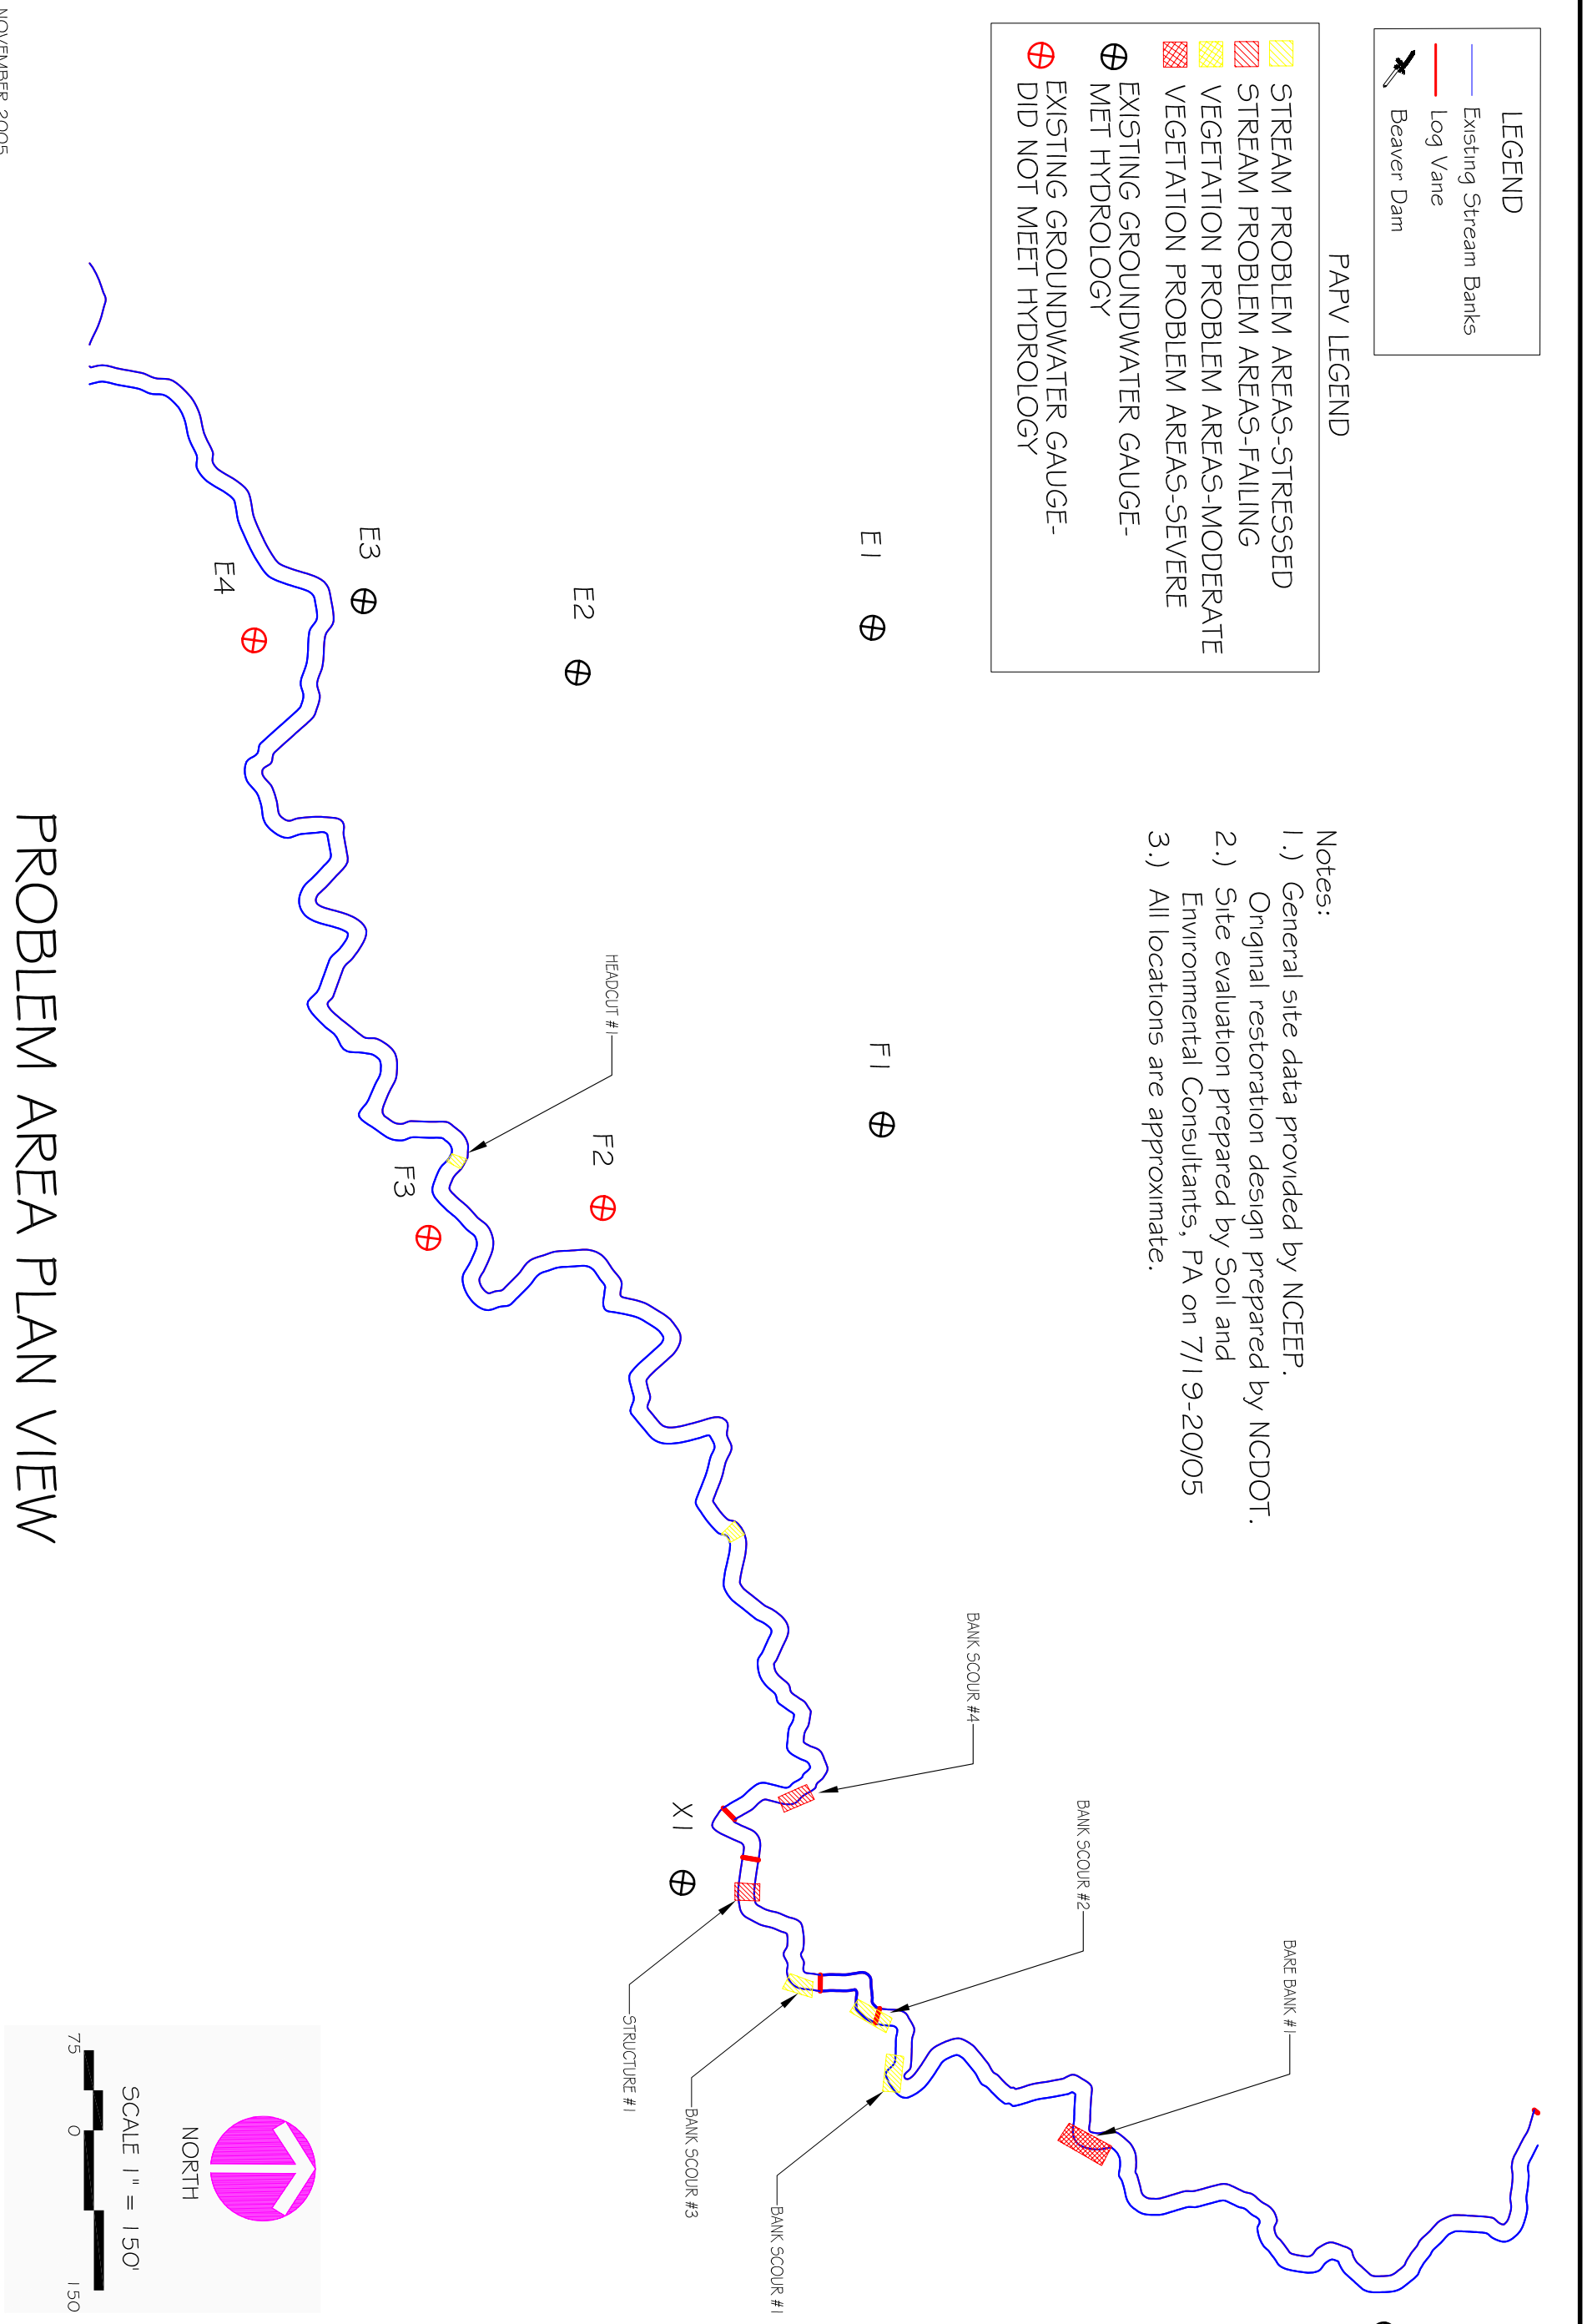
PROBLEM AREA PLAN VIEW

An assessment of channel stability was performed on July 19 and 20, 2005, by S&EC. Areas of concern that were observed and documented included localized bank scour, debris and beaver dams, and stressed or failing structures. These problem areas are shown on Sheets 5 through 8 (Problem Area Plan View).

As shown on the Problem Area Plan View (Sheets 5 through 8), twenty (20) of the twenty-nine (29) gauges on-site achieved wetland success criteria of saturation for 12.5% of the growing season (29 days). The nine (9) gauges that did not meet criteria were consistent with those failing to meet hydrology in 2004.
