# **Year 4 Monitoring Report**

## **Tulula Stream & Wetland Restoration**

**January 2007**  
**EEP Project No. 392**

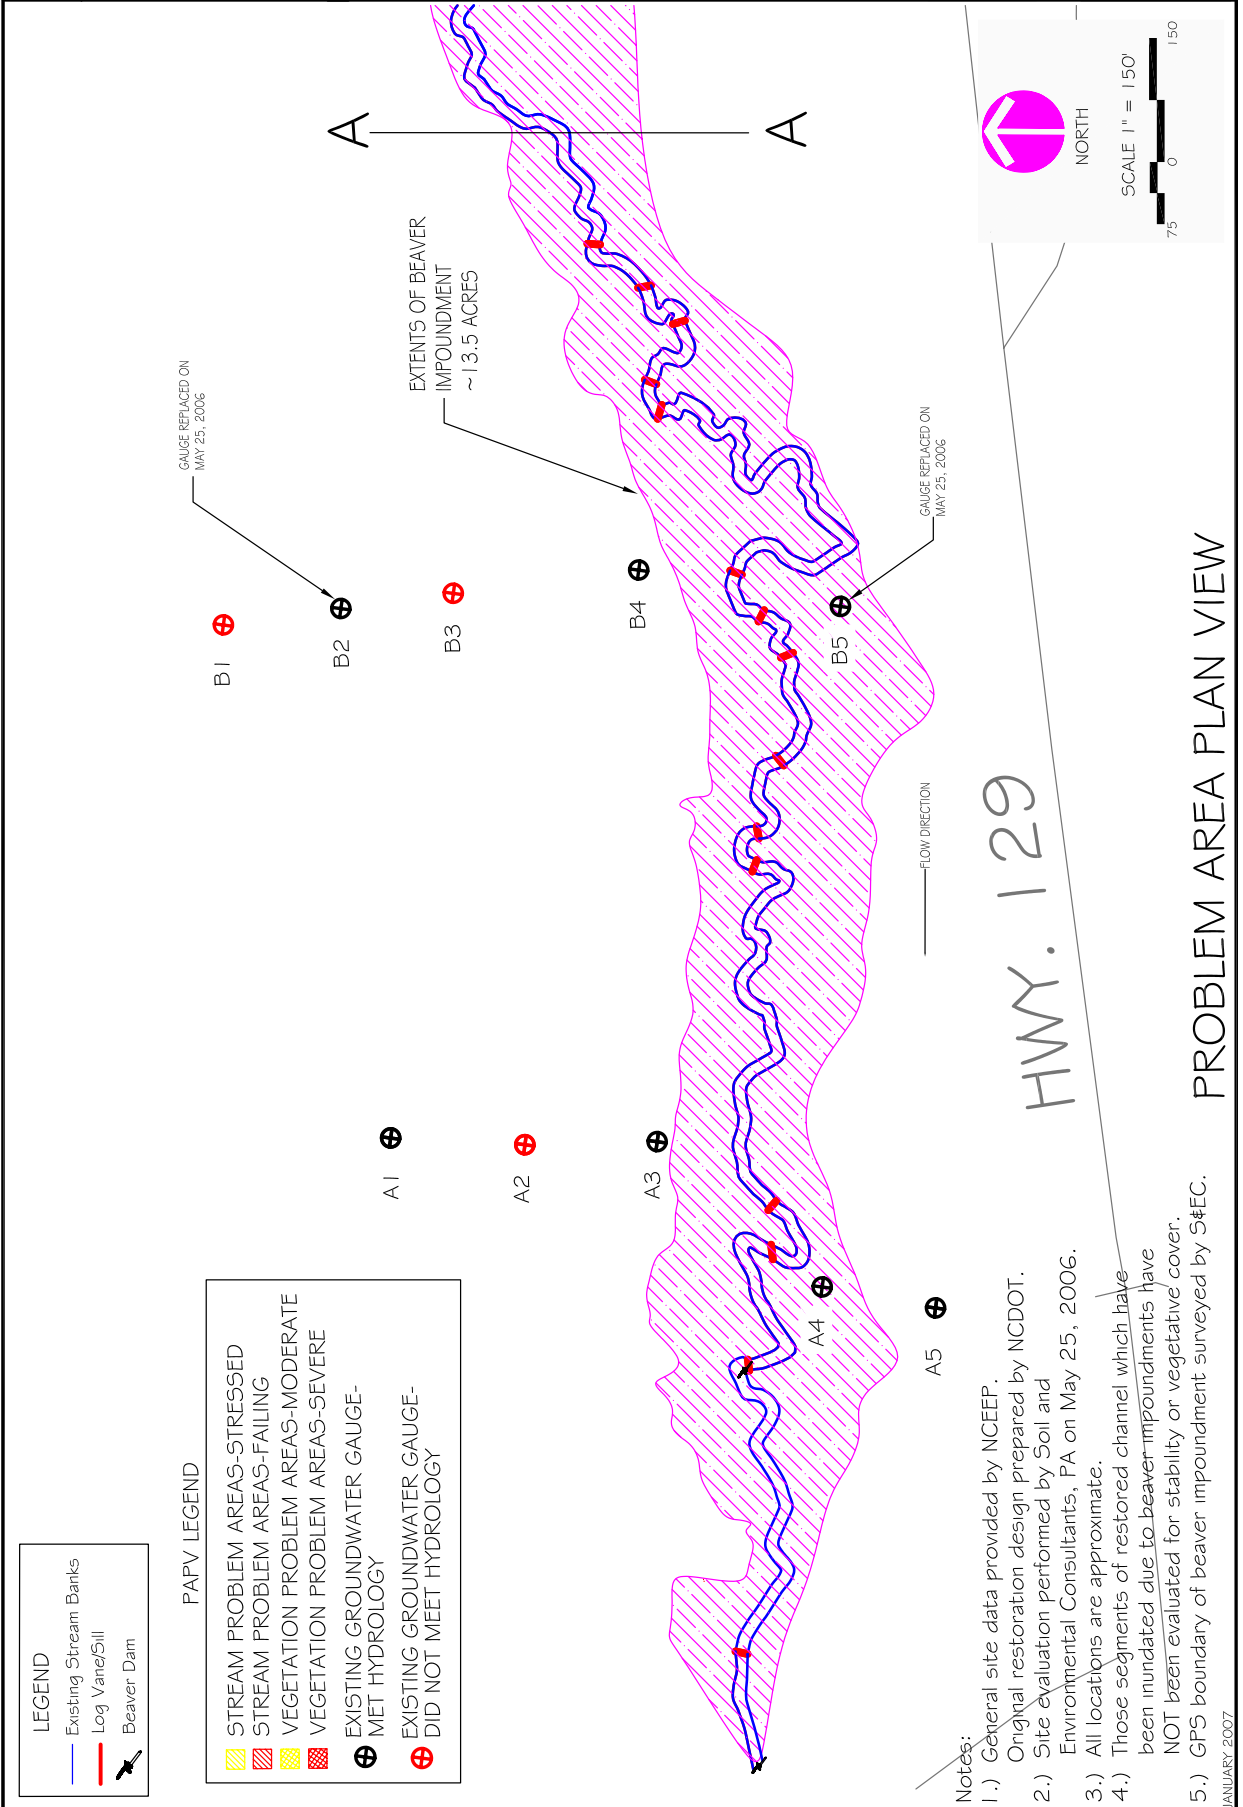
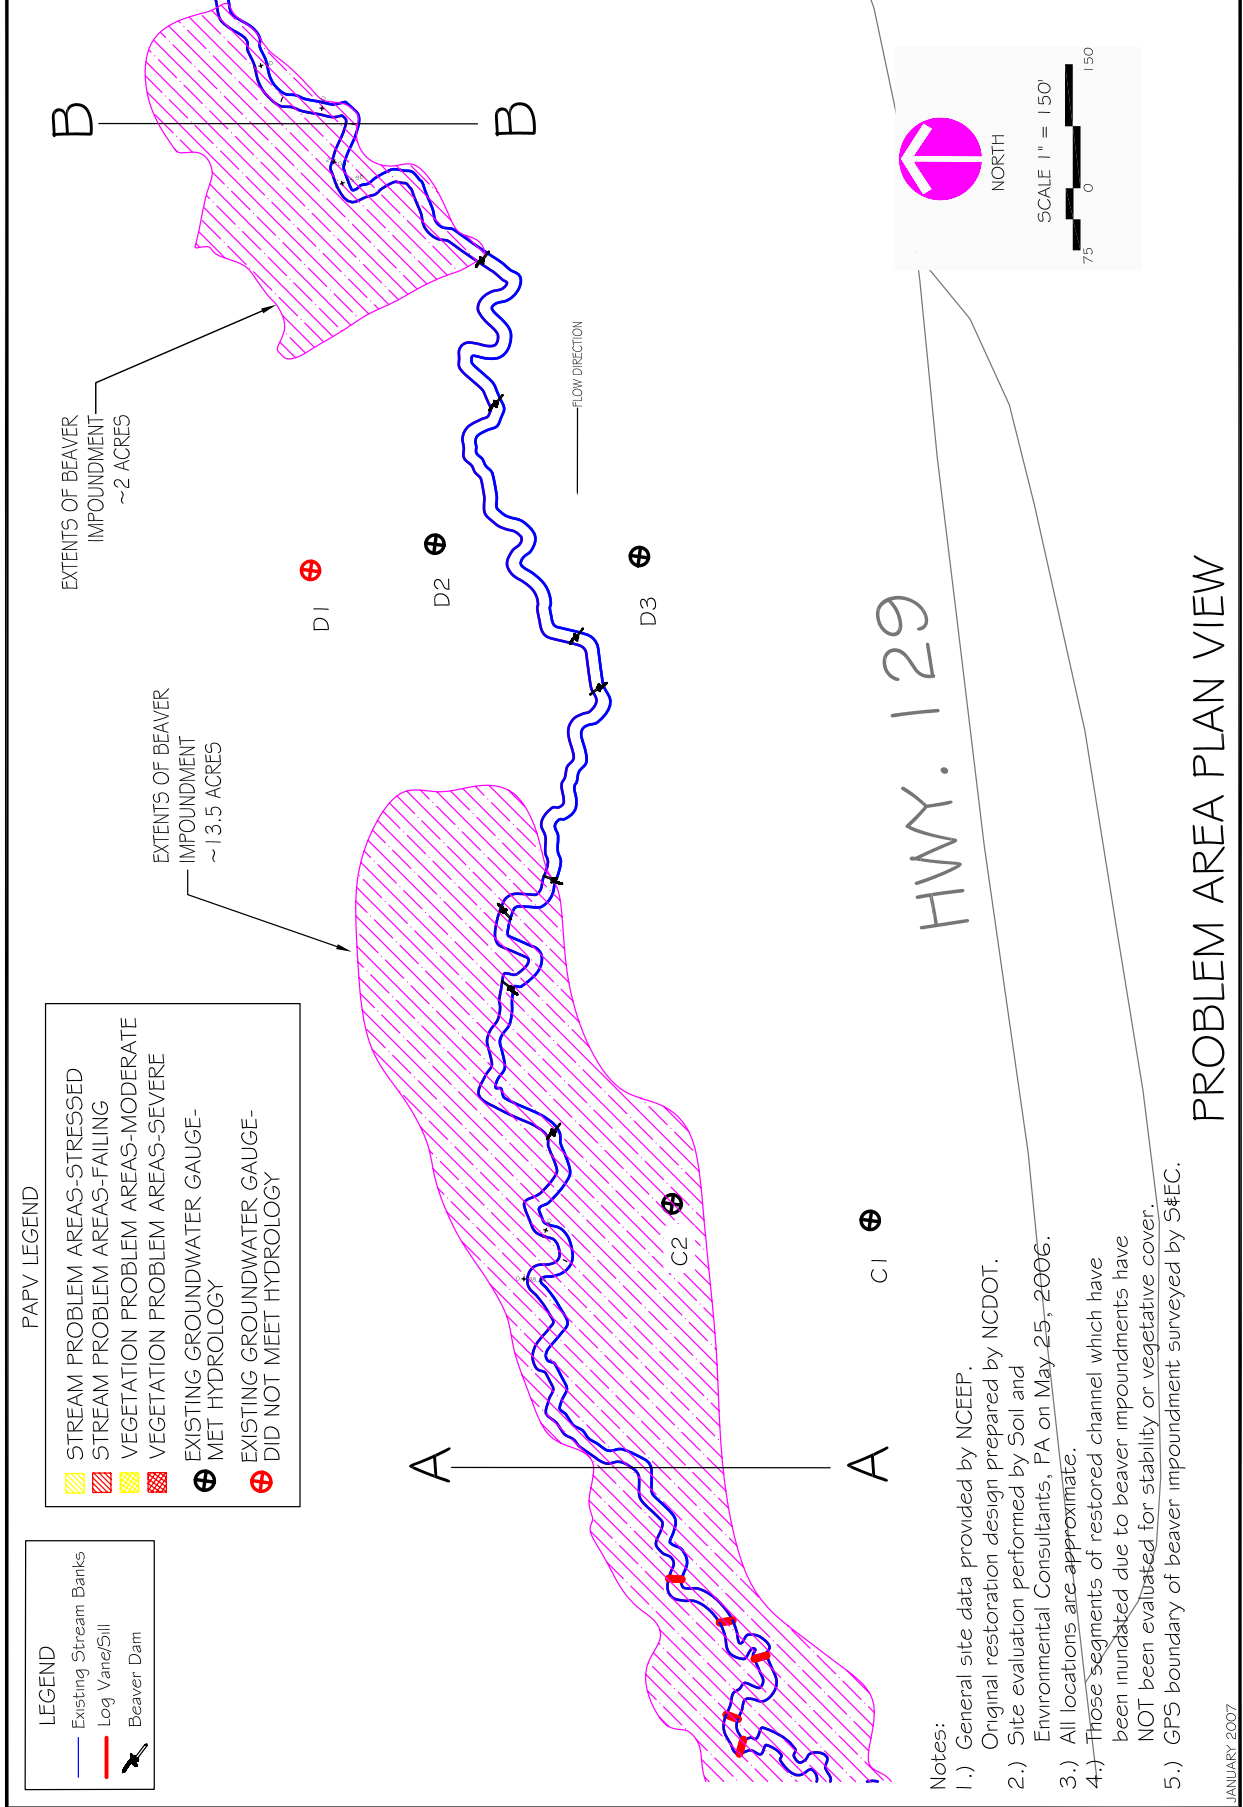
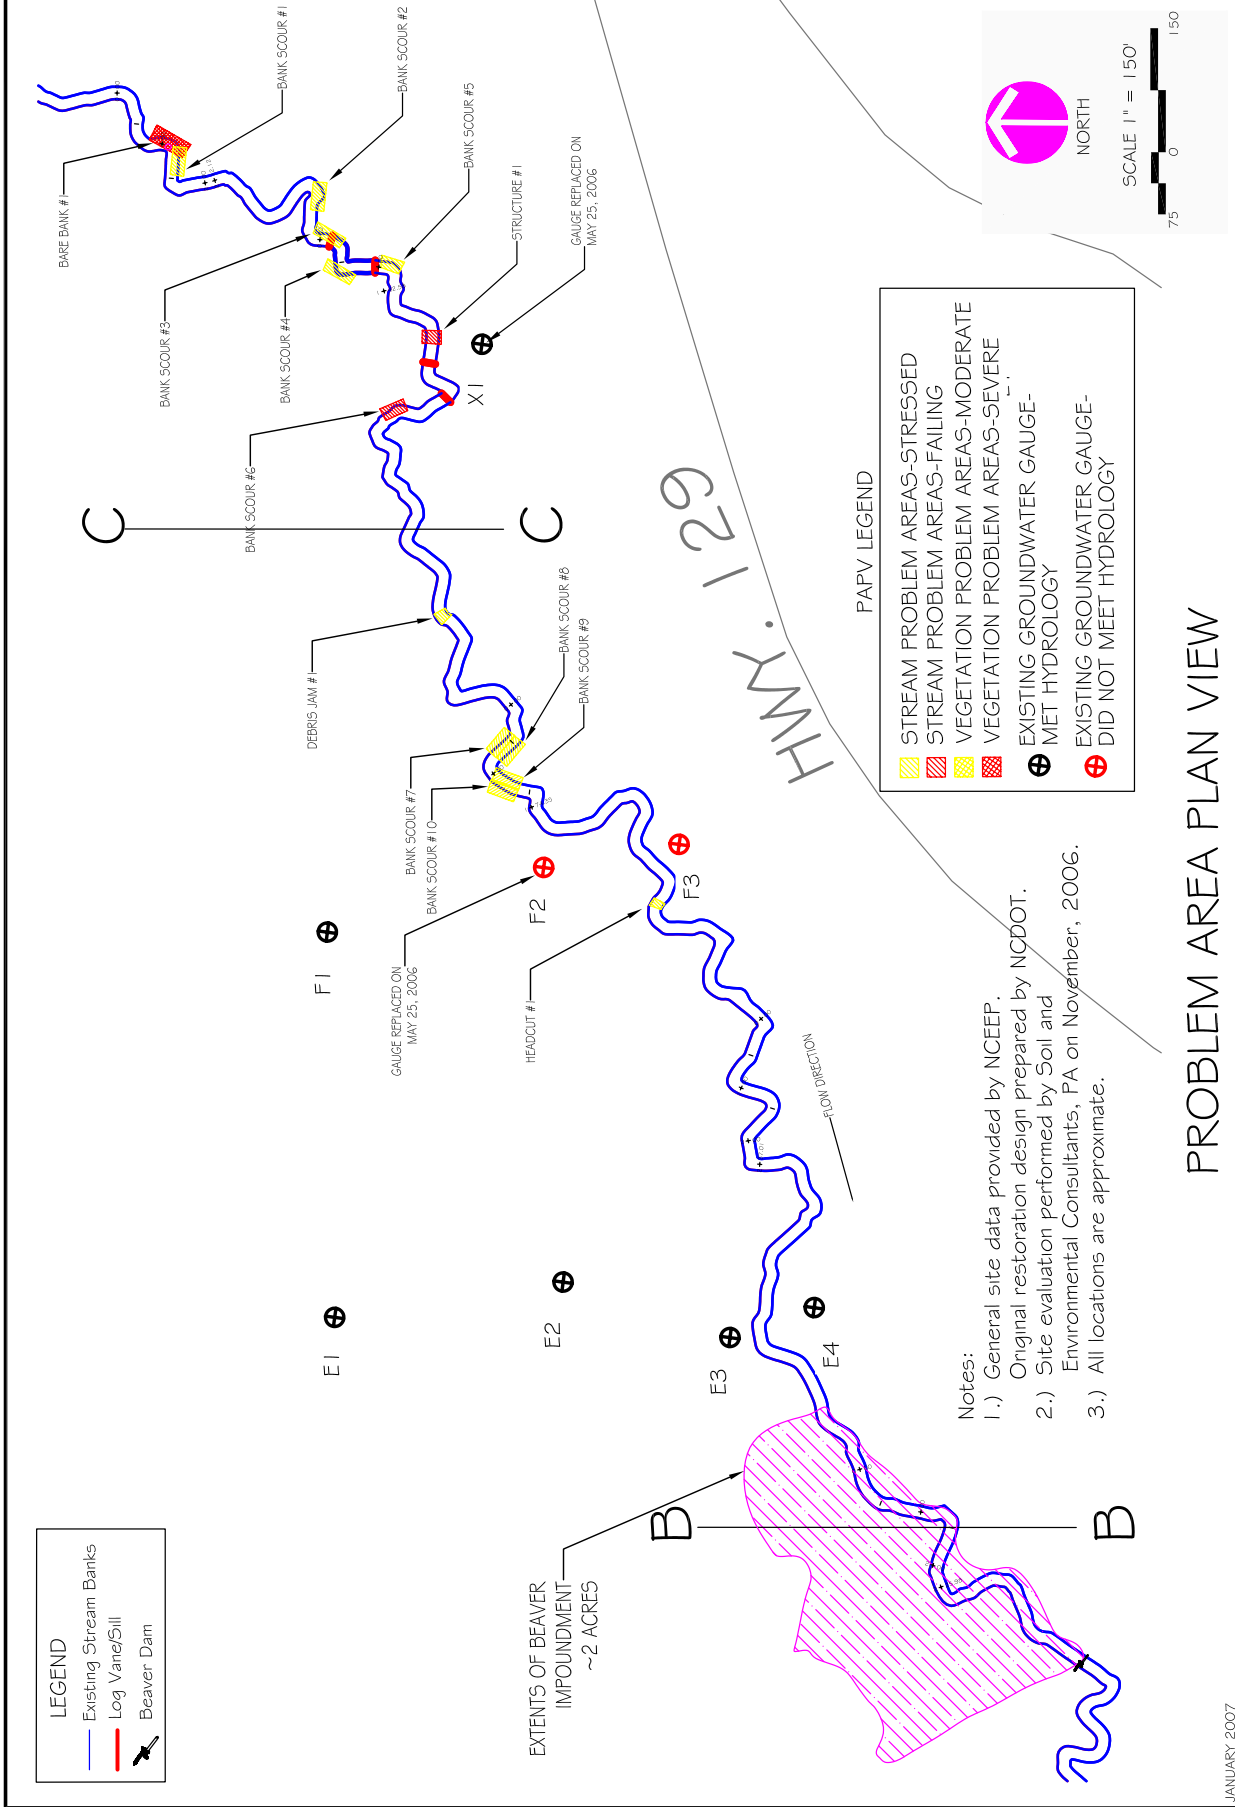
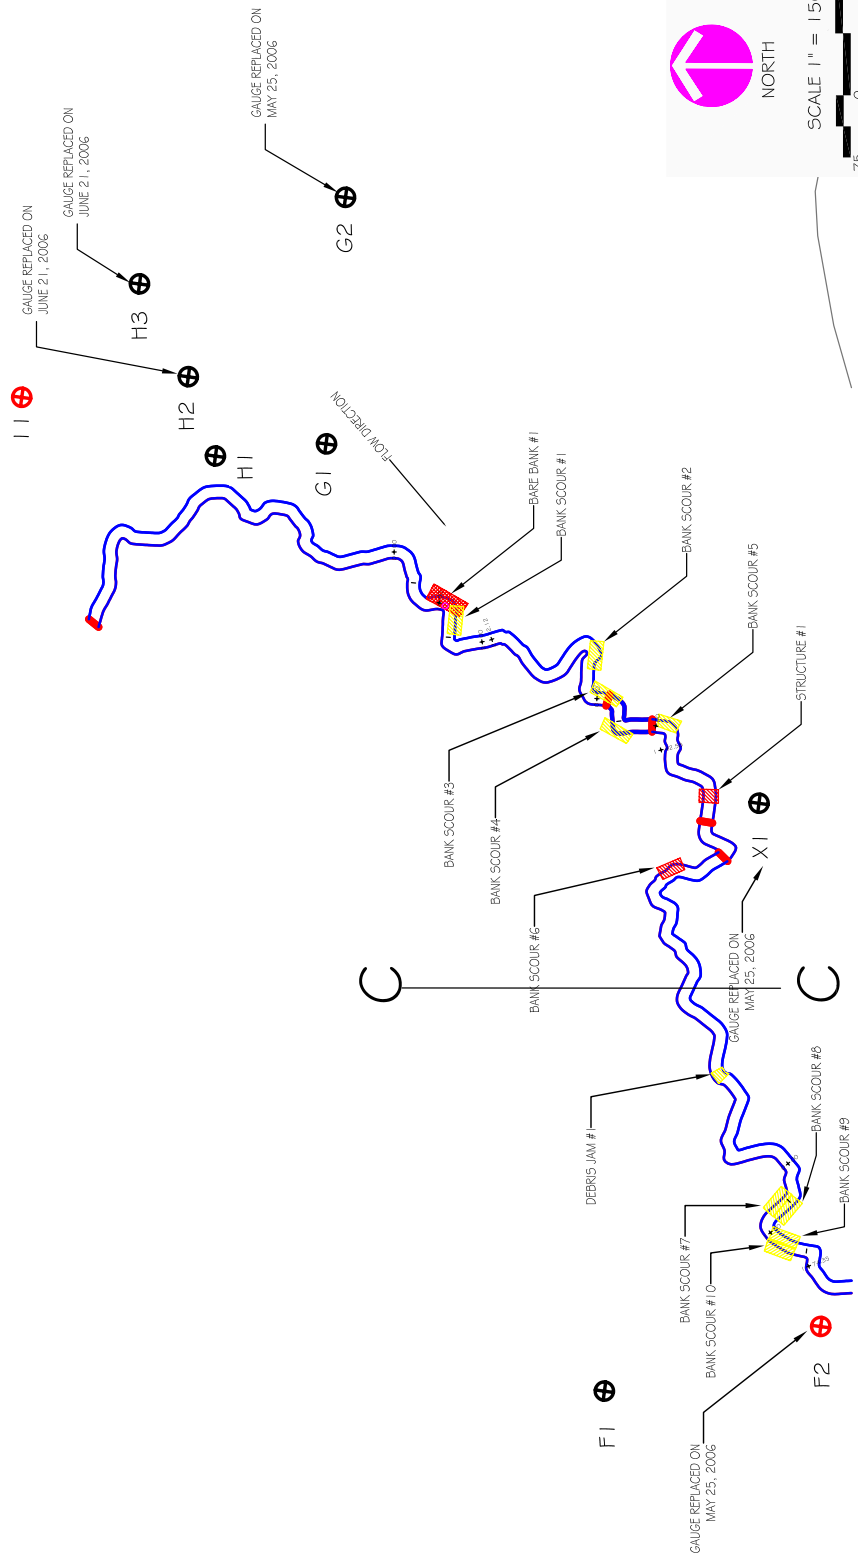
PROBLEM AREA PLAN VIEW

An assessment of channel stability was performed in November, 2006, by S&EC. Areas of concern that were observed and documented included localized bank scour, debris and beaver dams, and stressed or failing structures. These problem areas are shown on Sheets 5 through 8 (Problem Area Plan View).

As shown on the Problem Area Plan View (Sheets 5 through 8), twenty-two (22) of the twenty-nine (29) gauges on-site achieved wetland success criteria of saturation for 12.5% of the growing season (29 days). The seven (7) gauges that did not meet criteria were consistent with those failing to meet hydrology in 2005 and 2004.
