Year 5 Monitoring Report

Tulula Stream & Wetland Restoration

March 2008
EEP Project No. 392

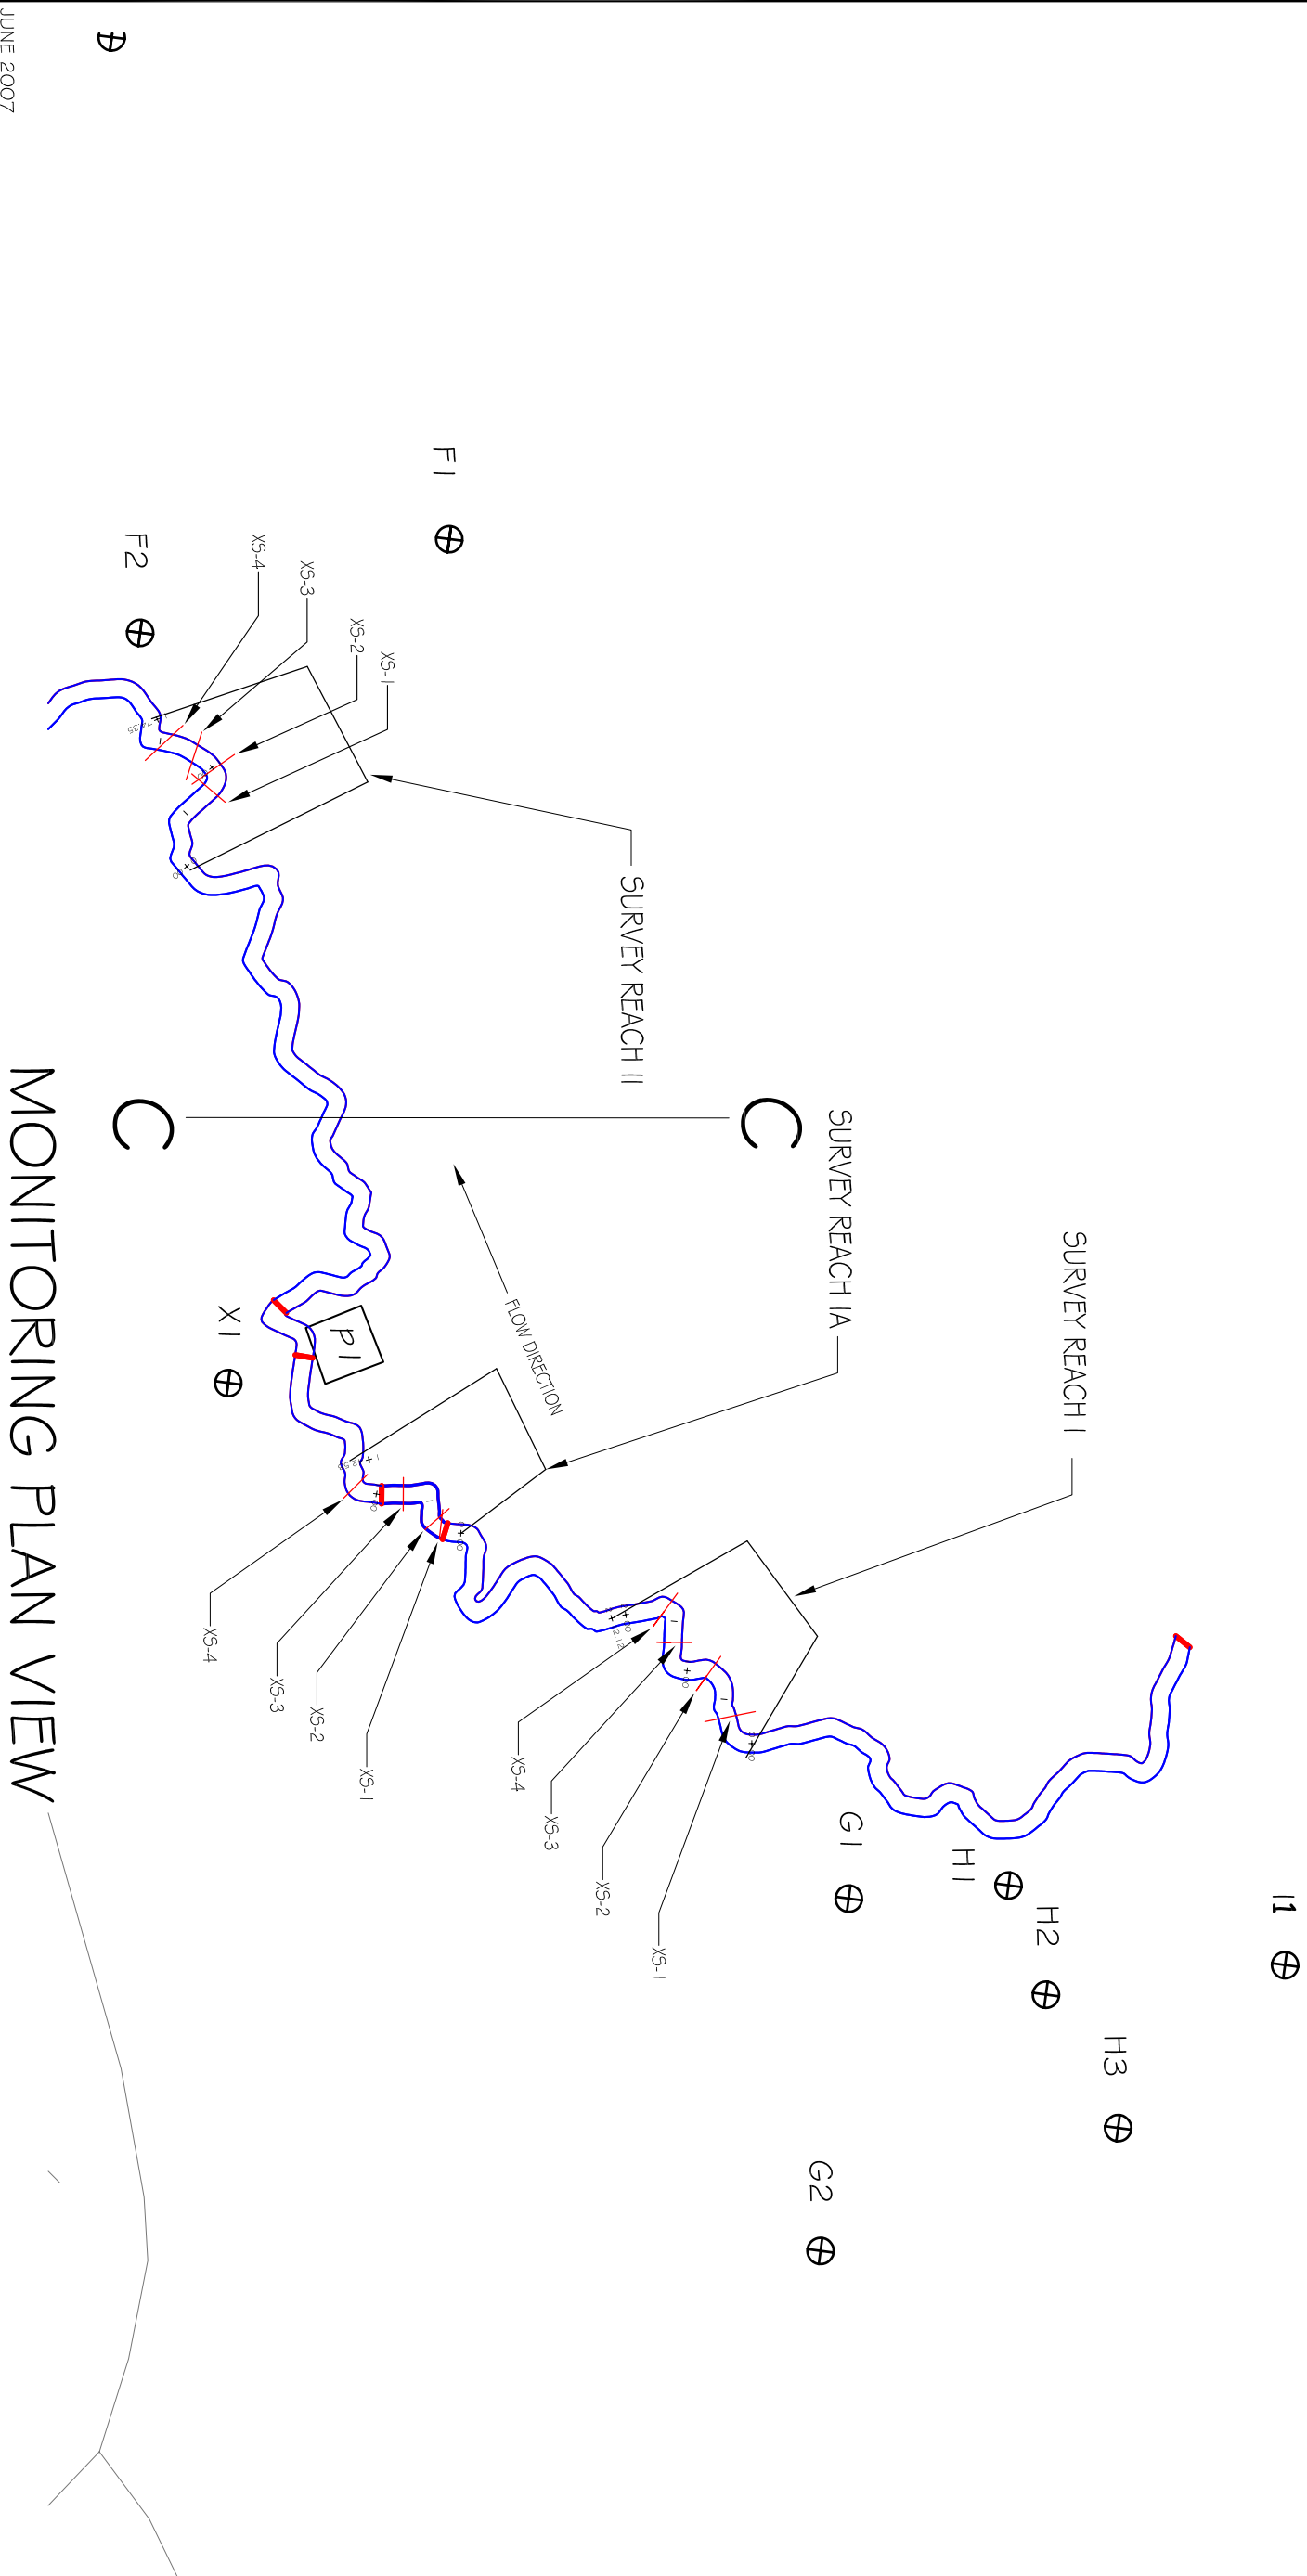
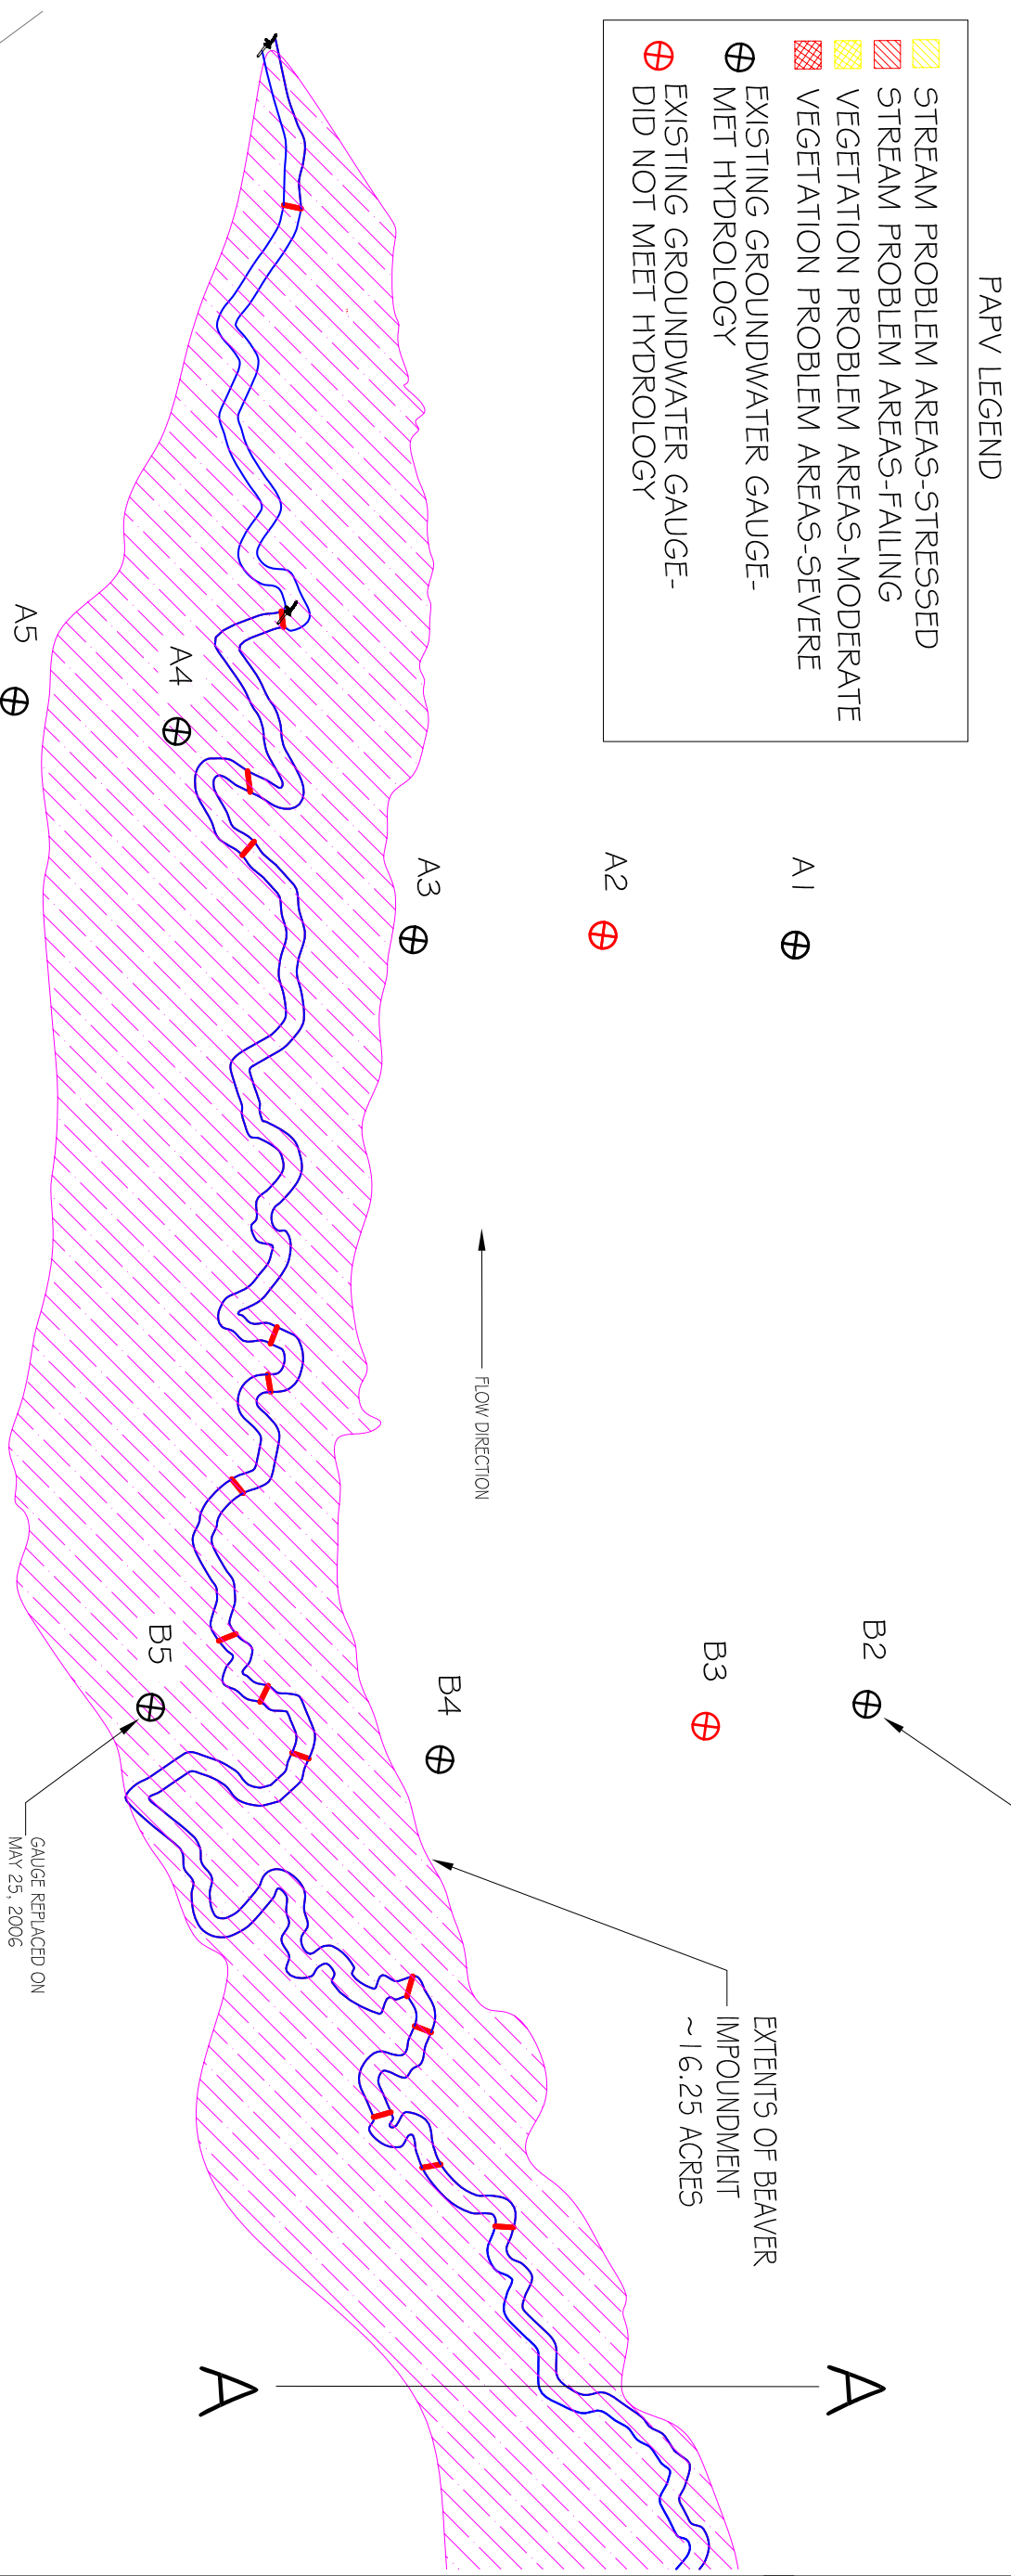
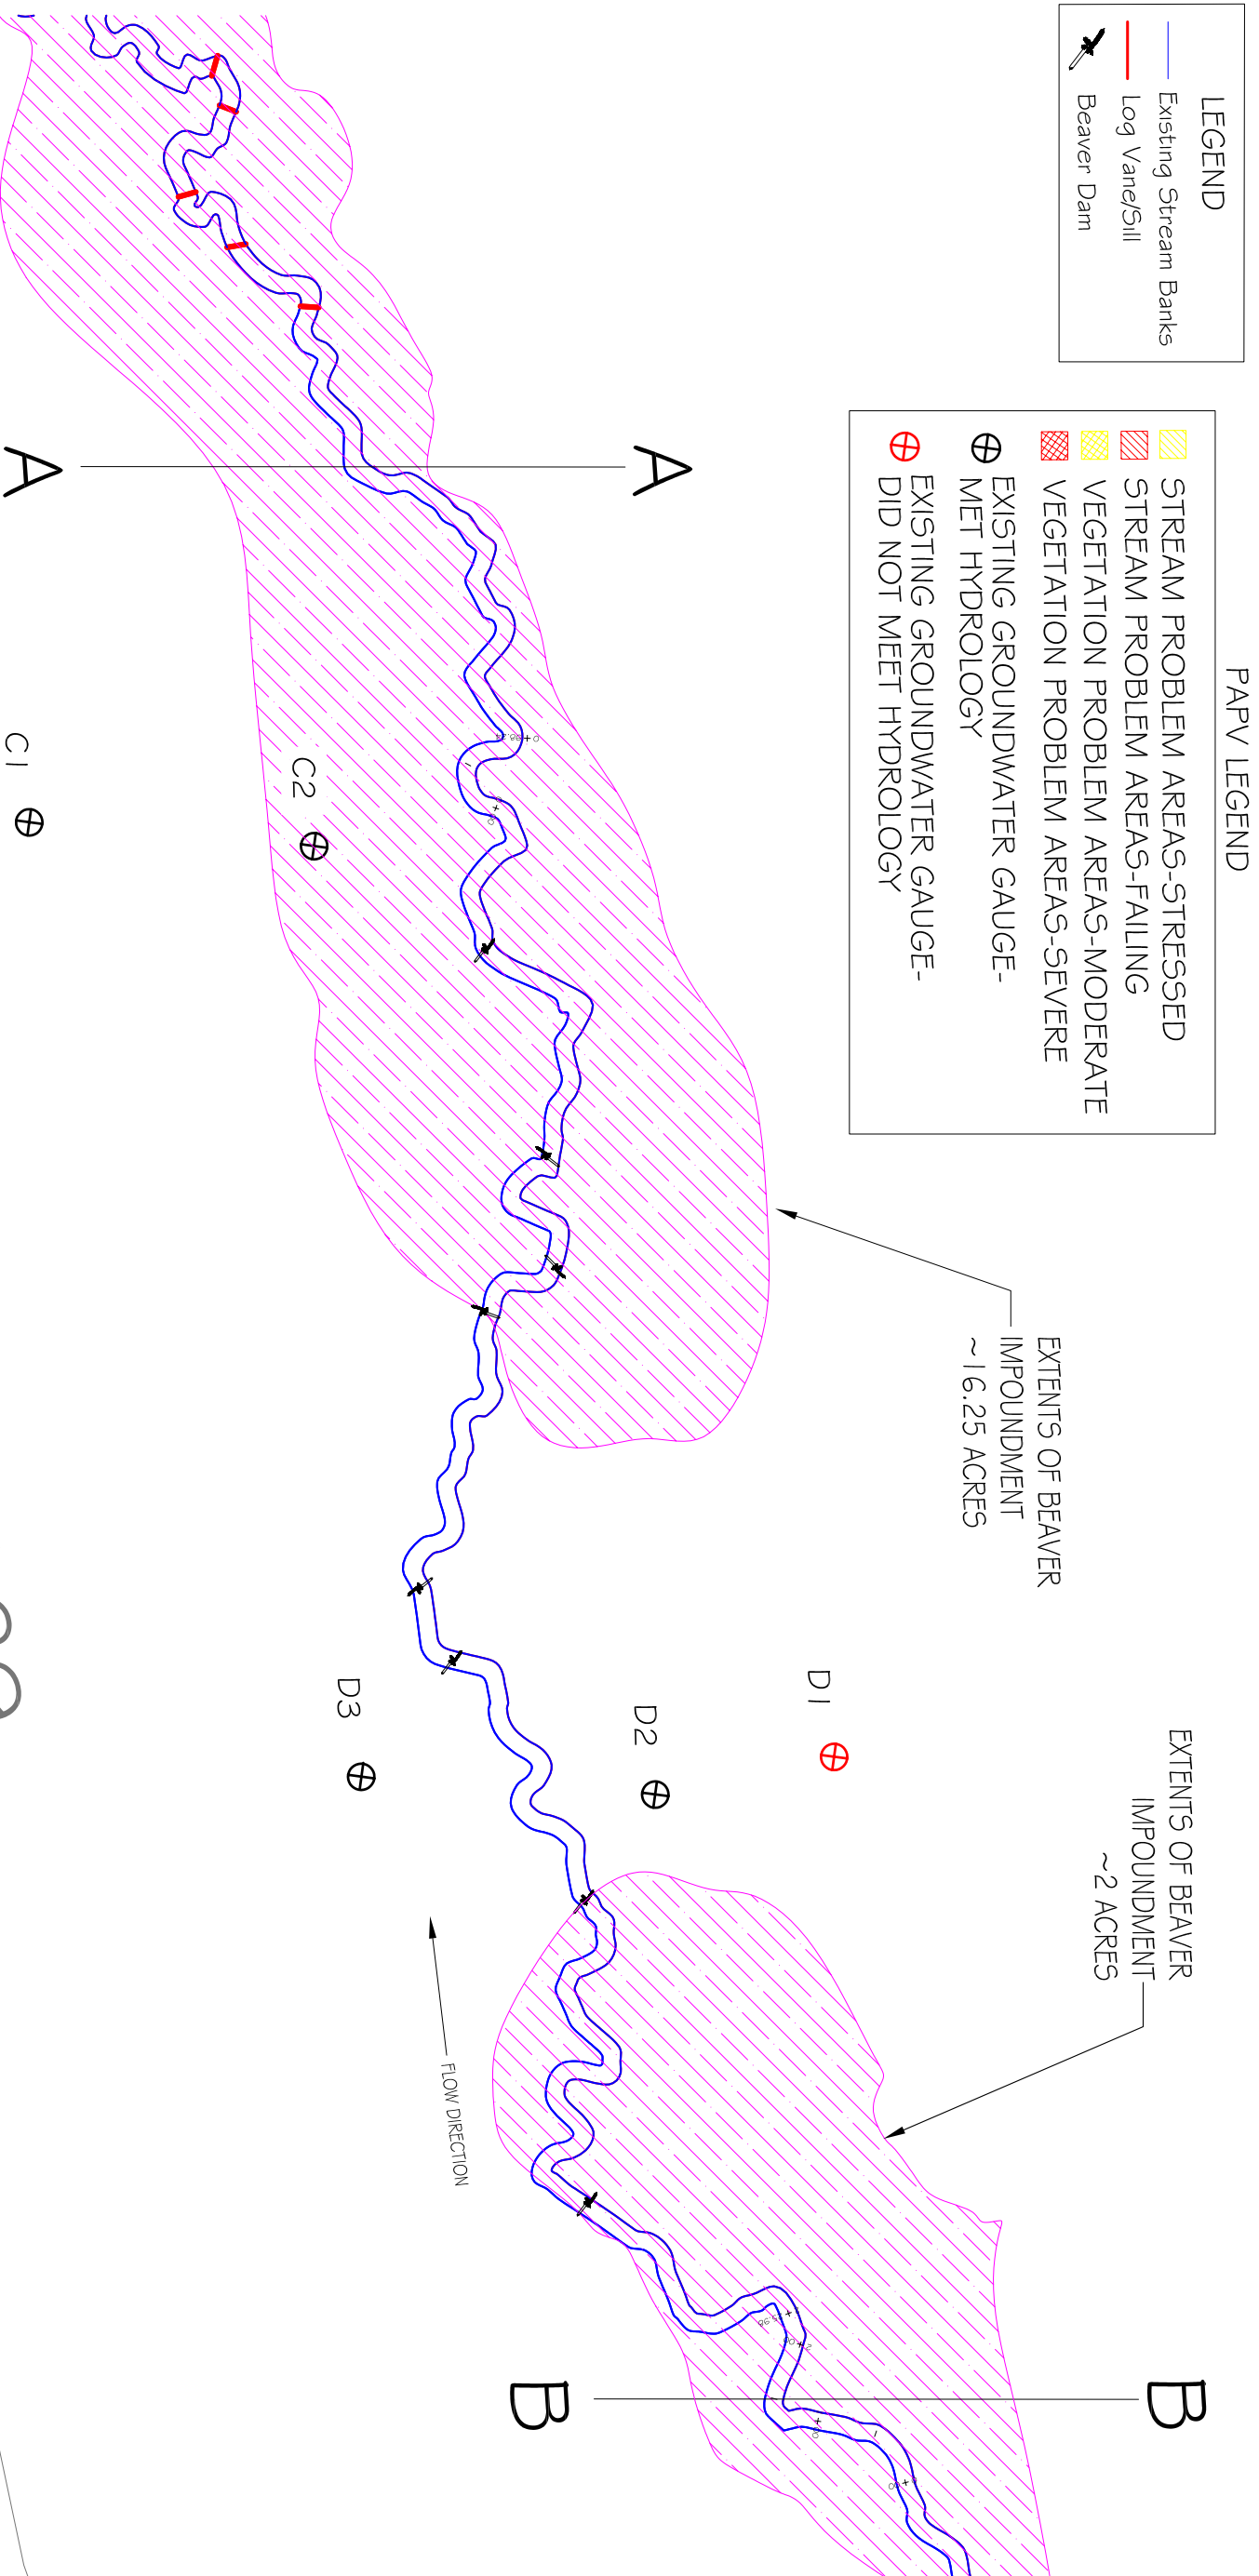
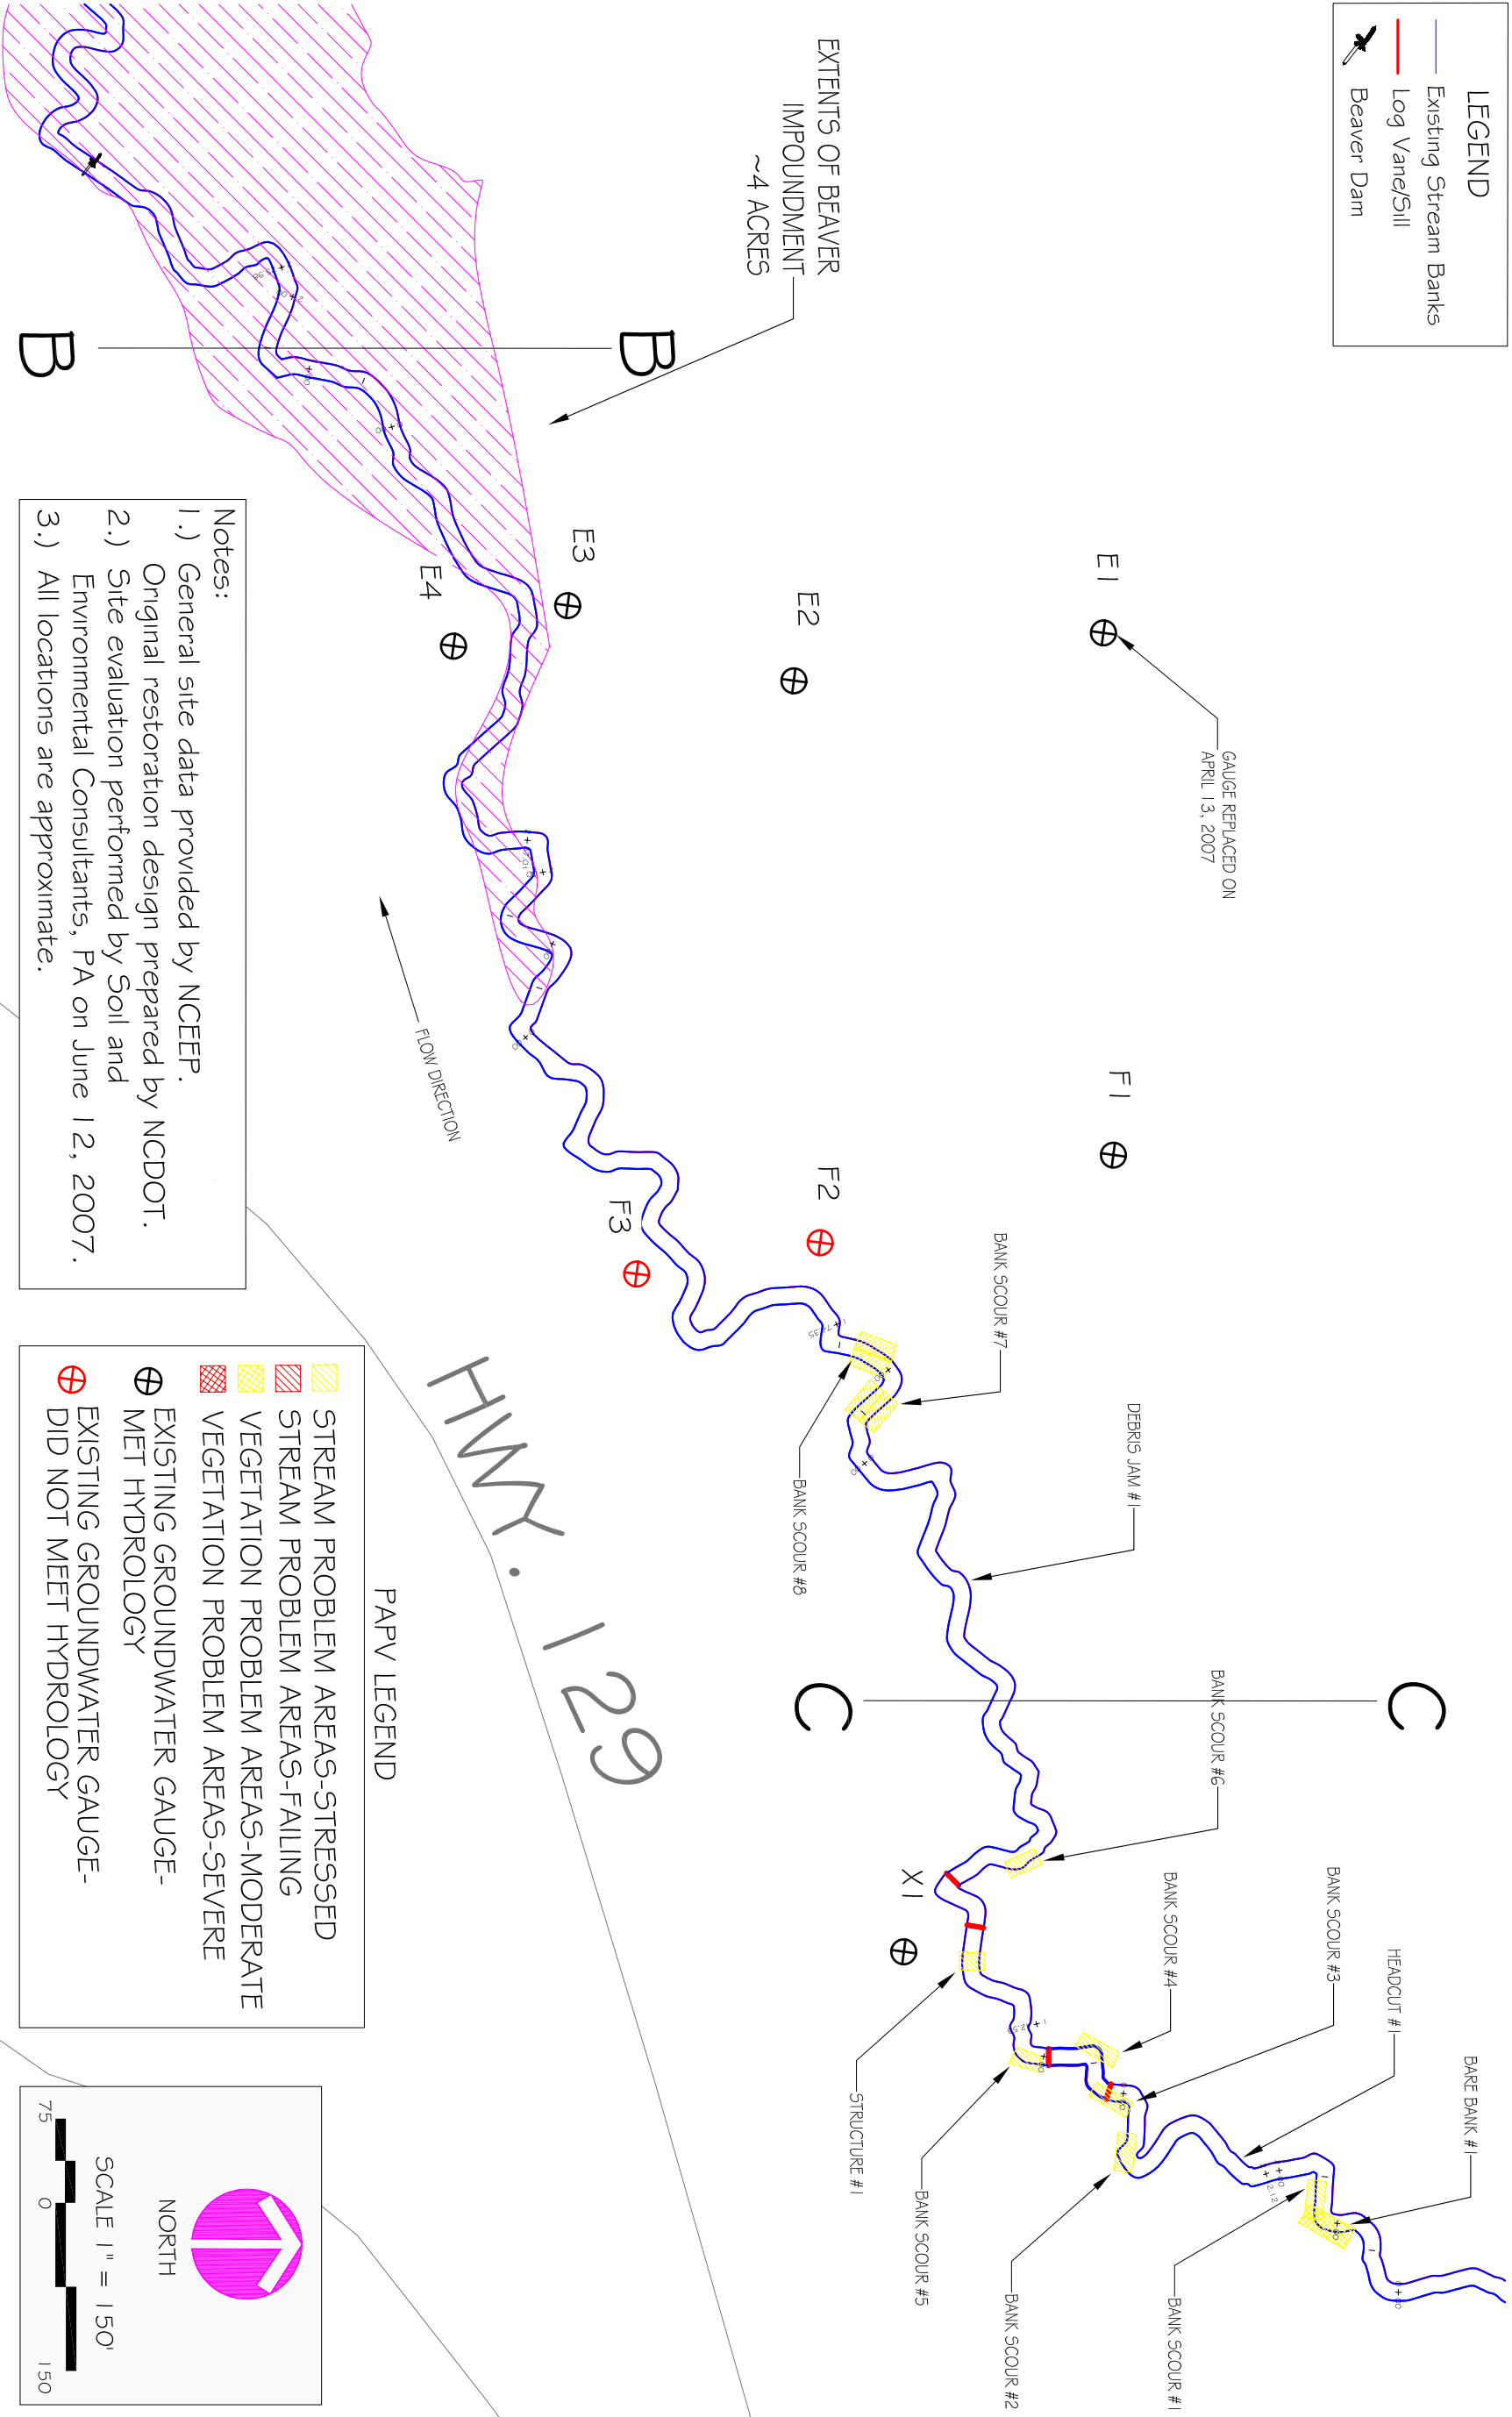
An assessment of channel stability was performed in June, 2007, by S&EC. Areas of concern that were observed and documented included localized bank scour, debris and beaver dams, and stressed or failing structures. These problem areas are shown on Sheets 5 through 8 (Problem Area Plan View). According to EEP, additional control and dam removal efforts are being implemented by the agencies wildlife control contractor to remove beaver from the site and remove remnant dam materials.

As shown on the Problem Area Plan View (Sheets 5 through 8), twenty (20) of the twenty-nine (29) gauges on-site achieved wetland success criteria of saturation for 12.5% of the growing season (29 days). Nine (9) gauges did not meet hydrology in 2007, to include gauges: A2, B1, B3, D1, F2, F3, G2, H3, and I1. The nine (9) gauges that did not meet criteria were consistent with those failing to meet hydrology in 2006 and 2005.

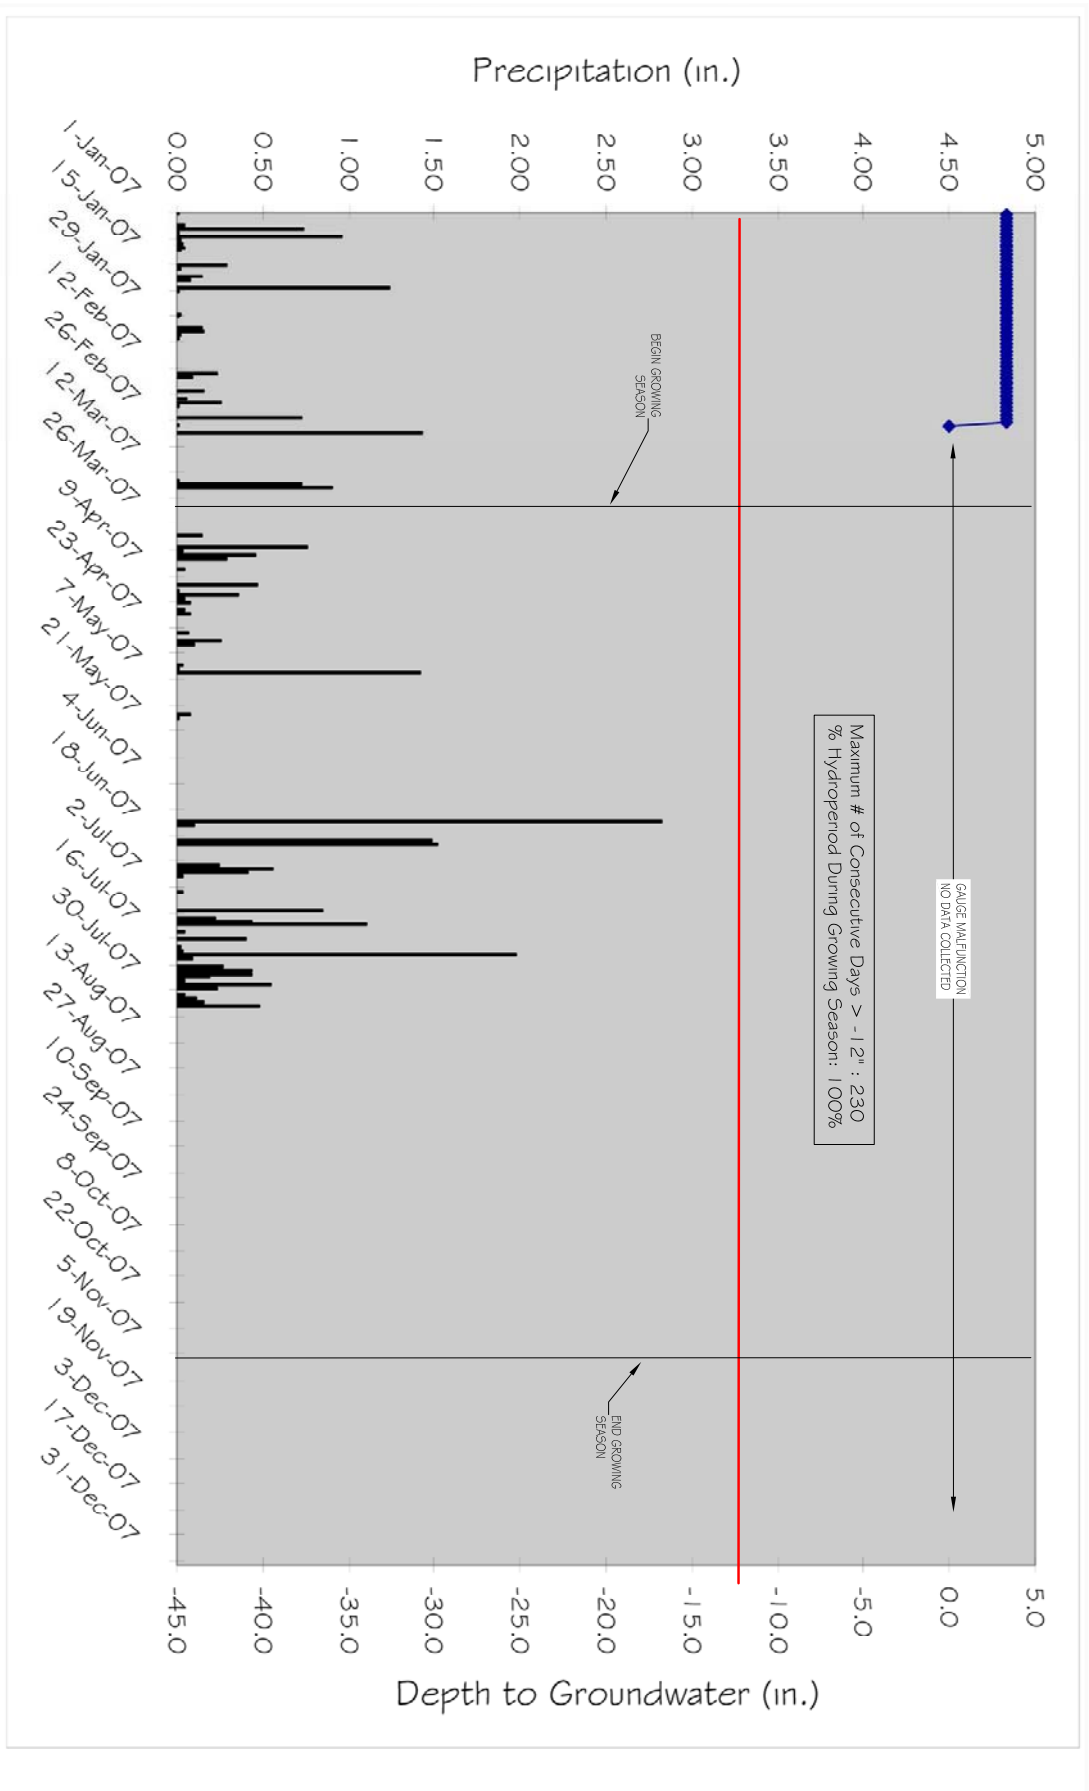
Tulula Stream and Wetland Restoration Site Groundwater Gauge A4

It should be noted that gauge A4 has met hydrology requirements, although no data has been collected from the gauge since March 2007. Due to frequent inundation due to the beaver activity observed onsite, this gauge has also been damaged. Due to the high water levels in this area, we do not recommend that this gauge be replaced.

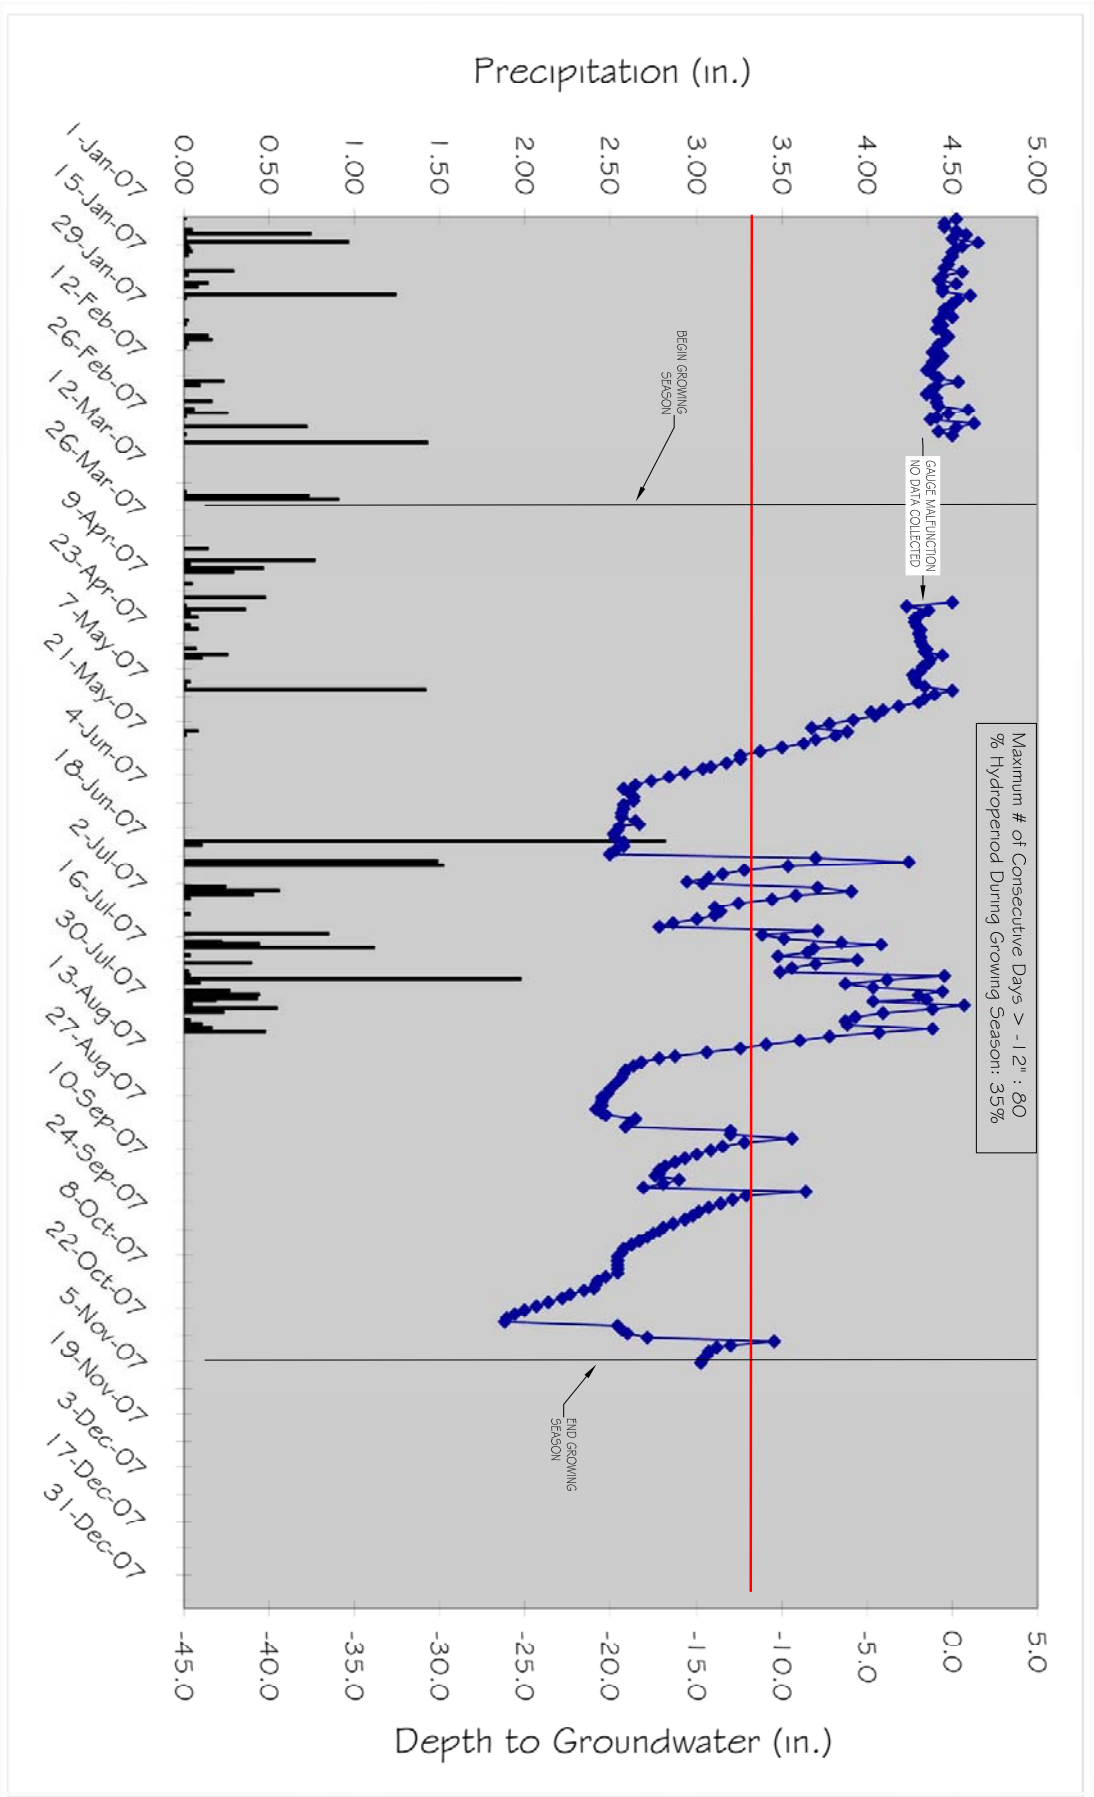
Tulula Stream and Wetland Restoration Site Groundwater Gauge E1

During the site visit on April 13, 2007 gauge E1 was replaced due to damage to the gauge. The cause of the damage is unknown. This gauge was replaced with an EcotoneWM gauge and its' approximate location marked using GPS technology. The locations of all monitoring devices are shown on Sheets 1 through 4 (Monitoring Plan View).

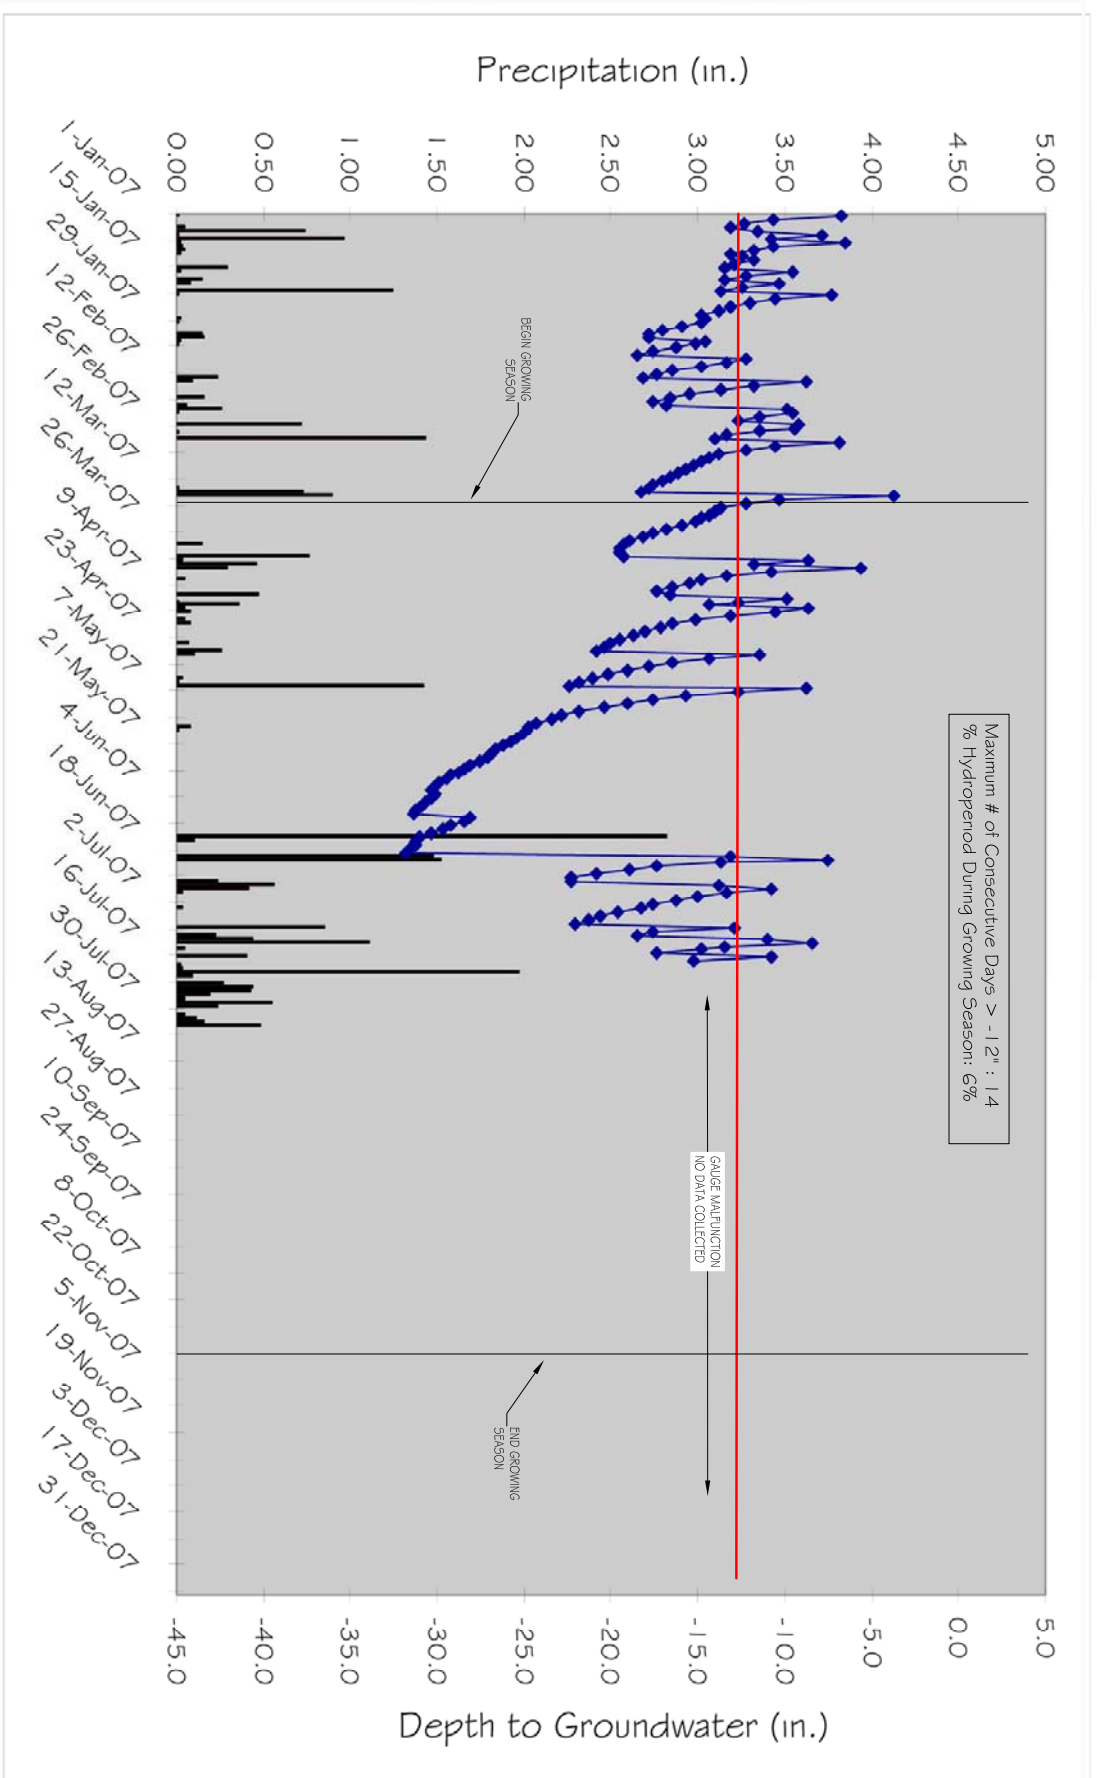
Tulula Stream and Wetland Restoration Site Groundwater Gauge F3

During the November 2007 download it was noted that gauge F3 had sustained some water damage (deteriorated seals allowed water into the battery compartment). Gauge G2 was replaced in 2006, but appears to have sustained damage as well. It is recommended that both these gauges be replaced.
