Tulula Stream & Wetland Restoration
NCEEP Project Number: 392
Monitoring Year 6
2008 Final Report

Submitted to
Ecosystem Enhancement Program
North Carolina Department of Environment and Natural Resources
May 2009

Tulula Stream and Wetland Restoration – 2008 Monitoring Report (MY 6)

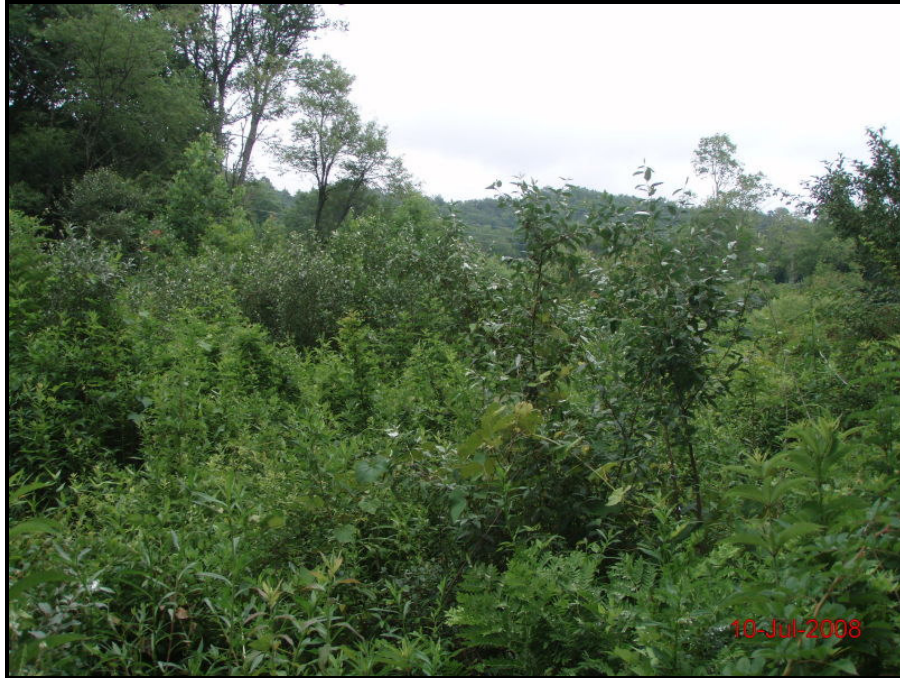
Table A2. Vegetation Problem Areas Tulula Stream & Wetland / Project No. 392			
Feature Issue	Station Numbers	Suspected Cause	Photo Number
Invasive / Exotic Populations	See CCPV	<i>Elaeagnus</i> species: Onsite seed source	VPA 1
	See CCPV	<i>Lespedeza bicolor</i> : Onsite seed source	
	See CCPV	<i>Lespedeza cuneata</i> : Onsite seed source	VPA 2
	See CCPV	<i>Ligustrum</i> species: Onsite seed source	
	See CCPV	<i>Lonicera japonica</i> : Onsite seed and vine source	
	See CCPV	<i>Microstegium vimineum</i> : Onsite seed source	
	See CCPV	<i>Pueraria montana</i> : Onsite seed and vine source	VPA 3
	See CCPV	<i>Rosa multiflora</i> : Onsite seed source

Vegetation Problem Area (VPA 1) – *Elaeagnus* species
Monitoring Year 6 – July 10, 2008

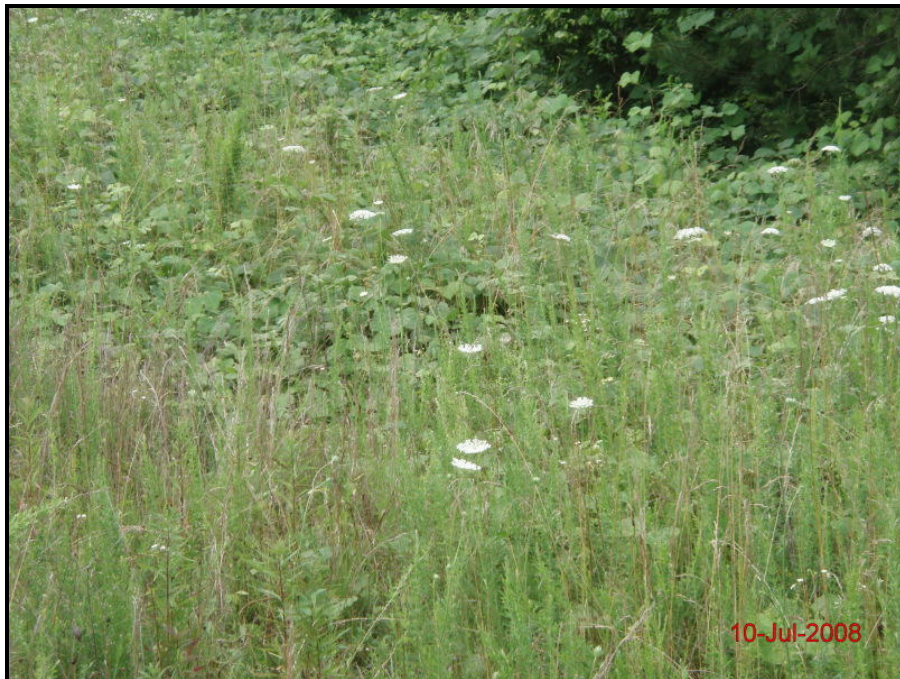
Vegetation Problem Area (VPA 2) – *Lespedeza cuneata*
Monitoring Year 6 – July 10, 2008

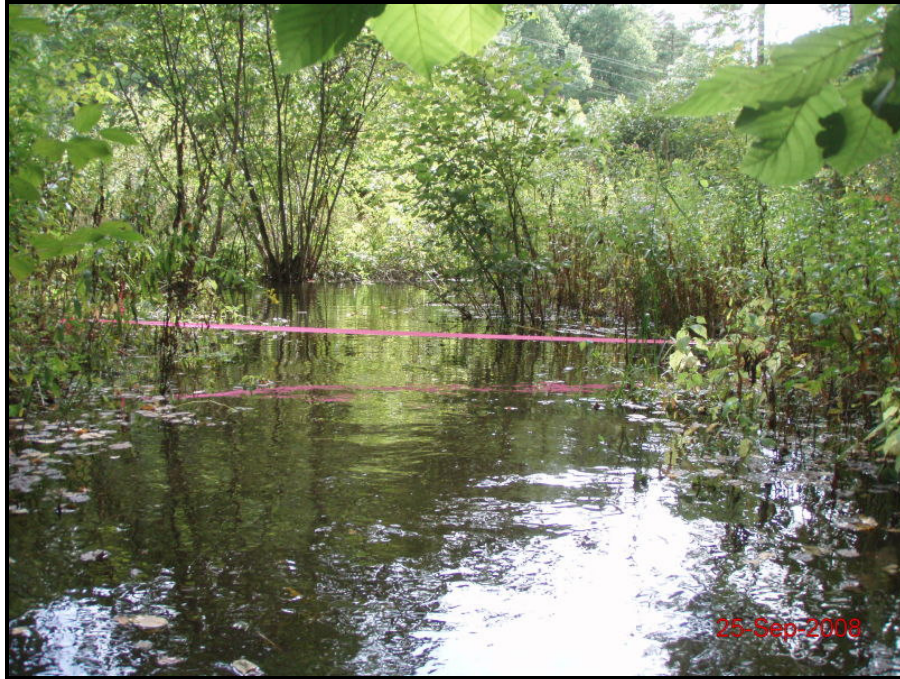
Table B1. Stream Problem Areas Tulula Stream & Wetland / Project No. 392			
Feature Issue	Station Numbers	Suspected Cause	Photo Number
None observed due to beaver inundation	N/A	N/A	SPA 1

Stream Problem Area (SPA 1) – Inundated stream channel due to beaver activity
Monitoring Year 6 – September 25, 2008

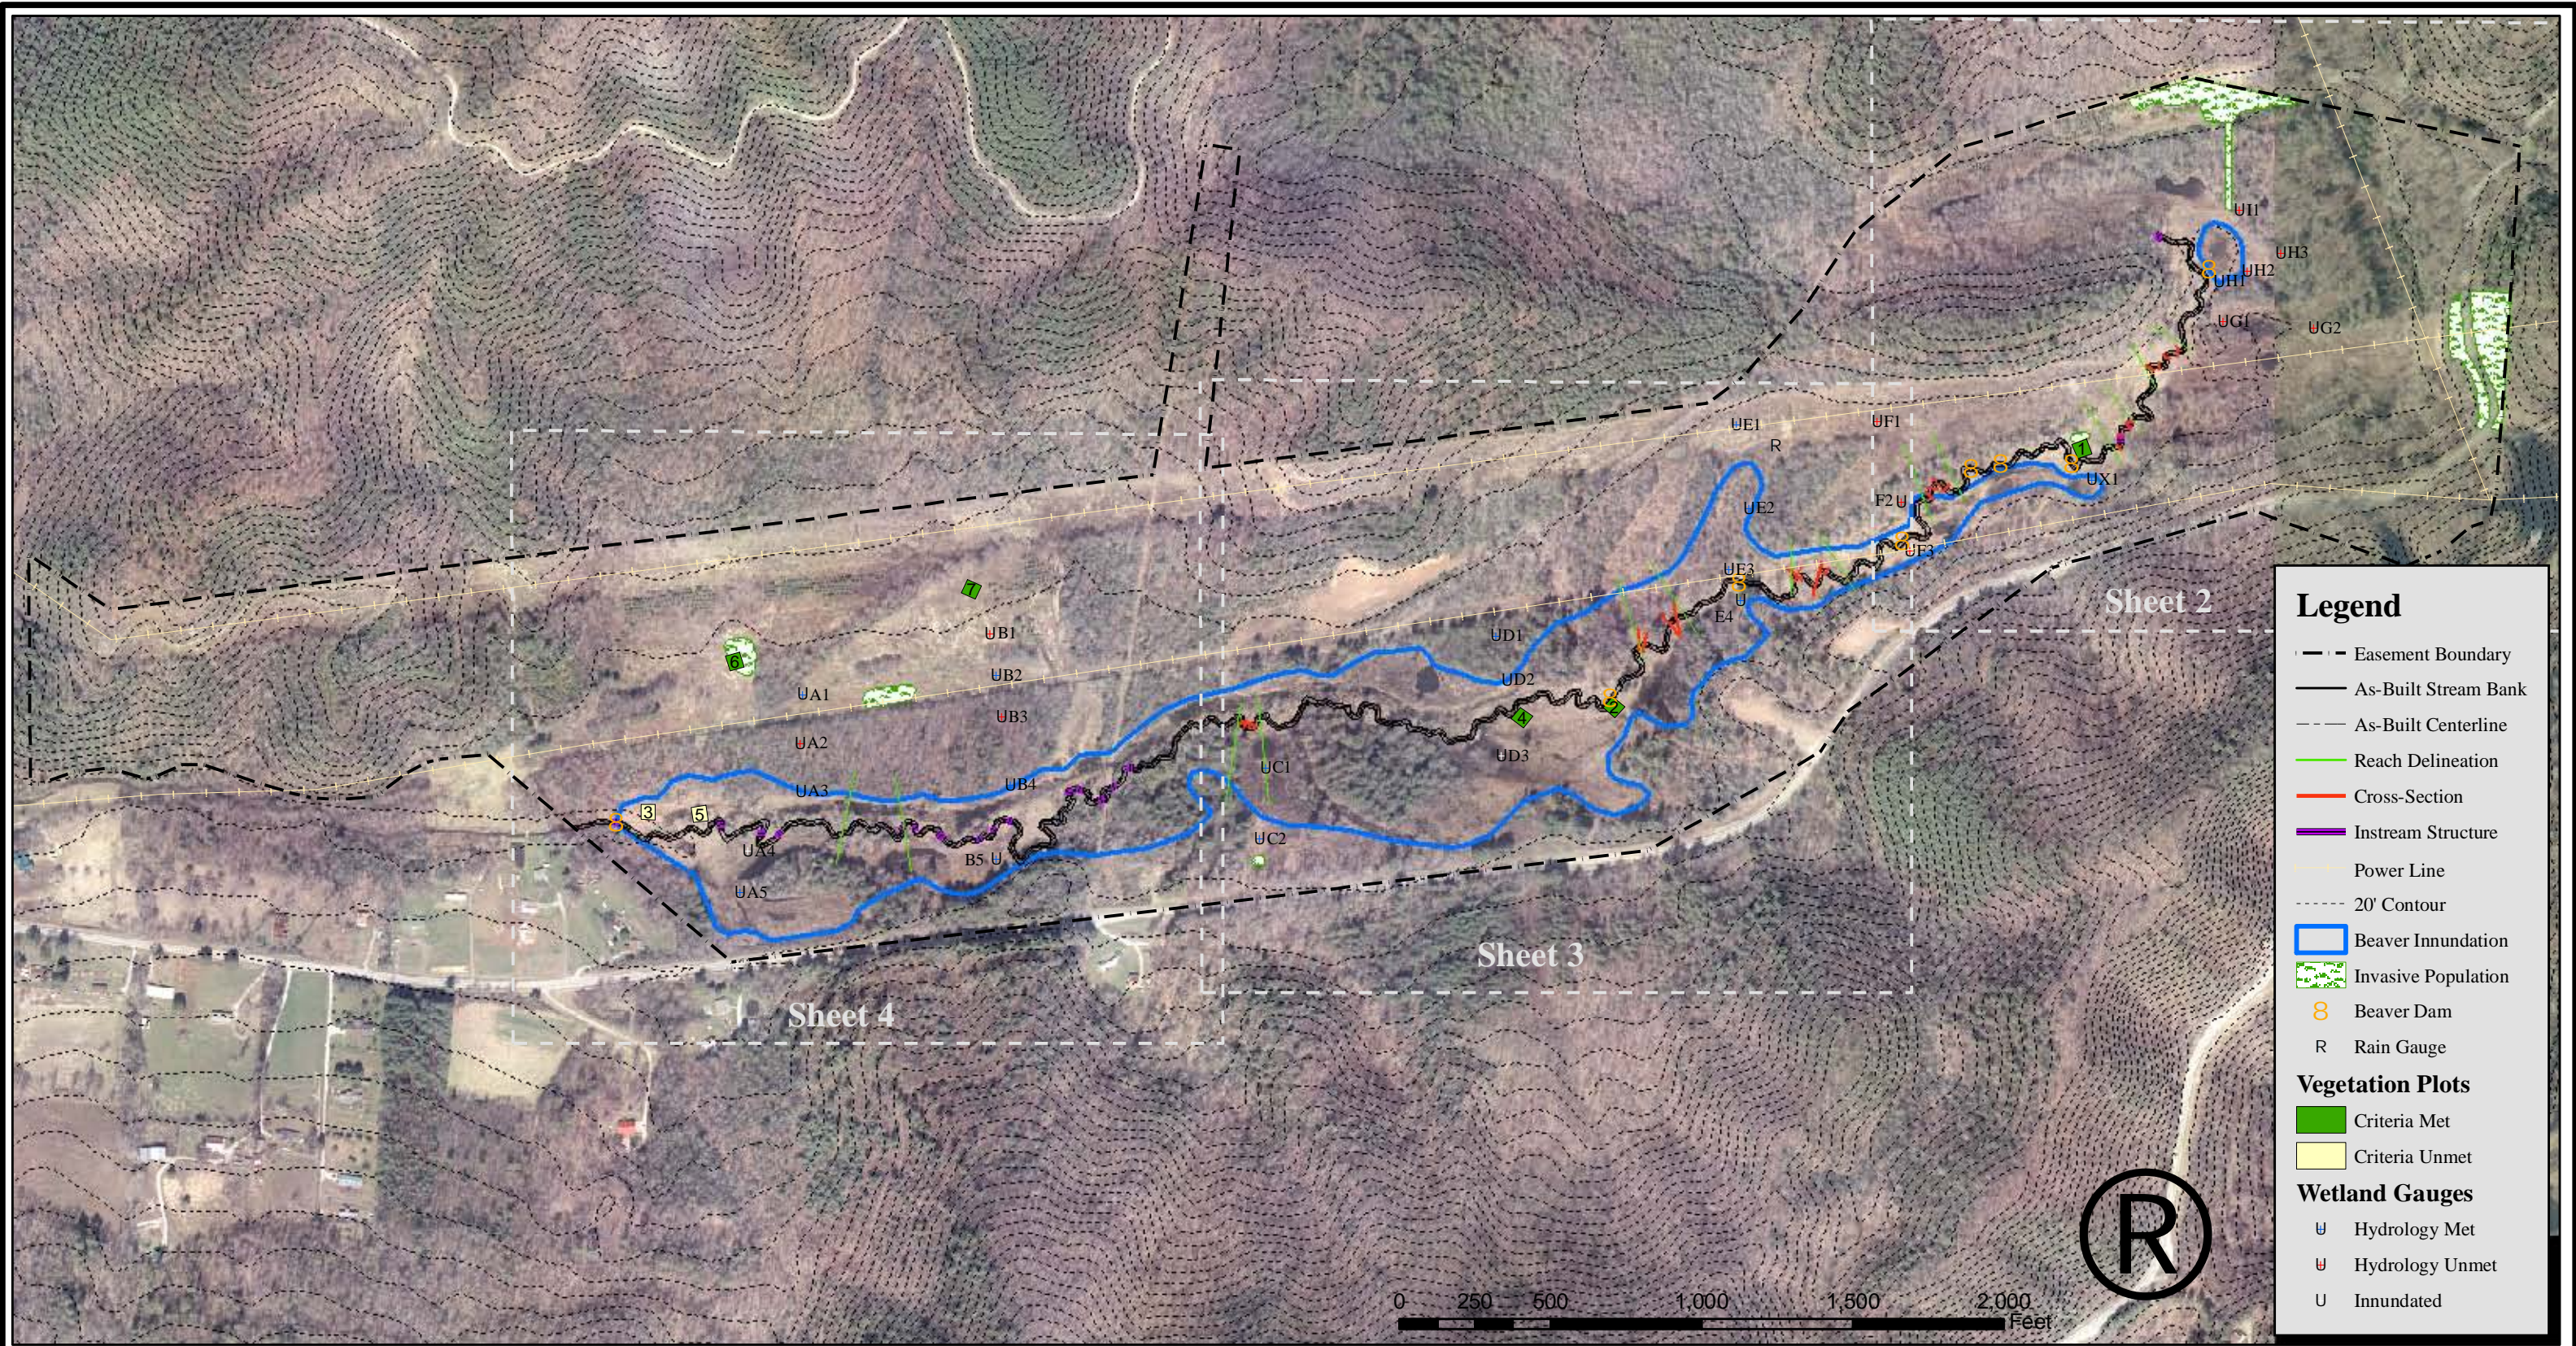
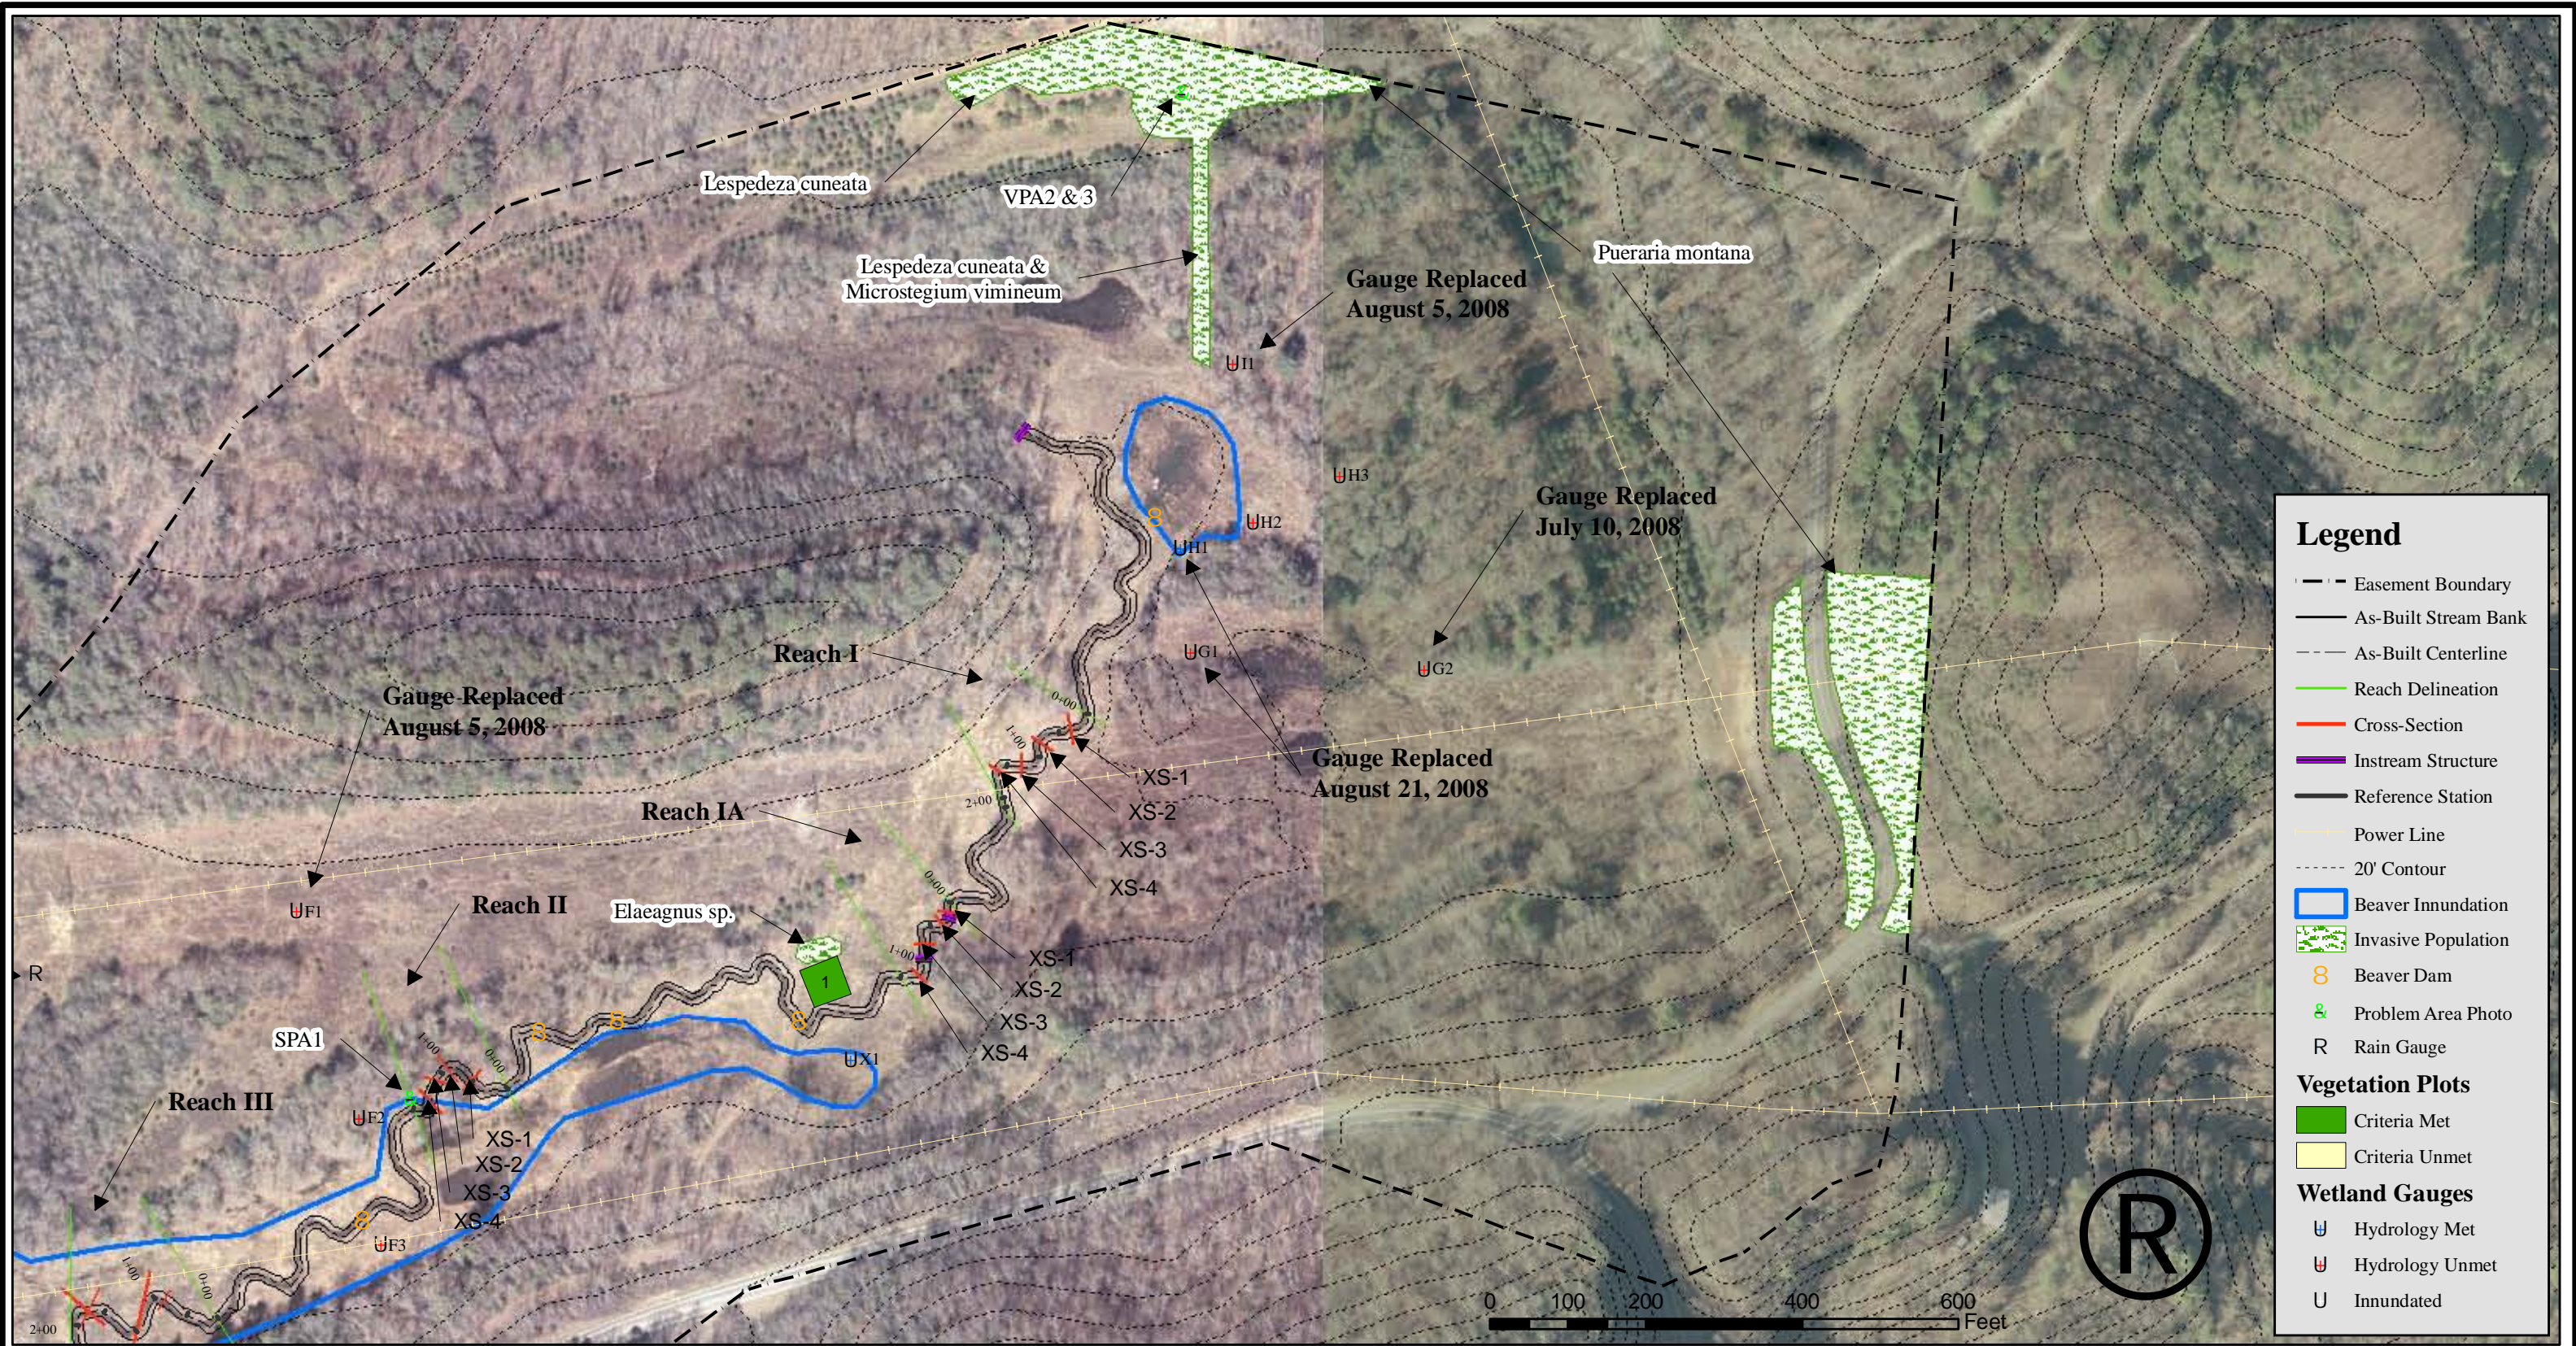
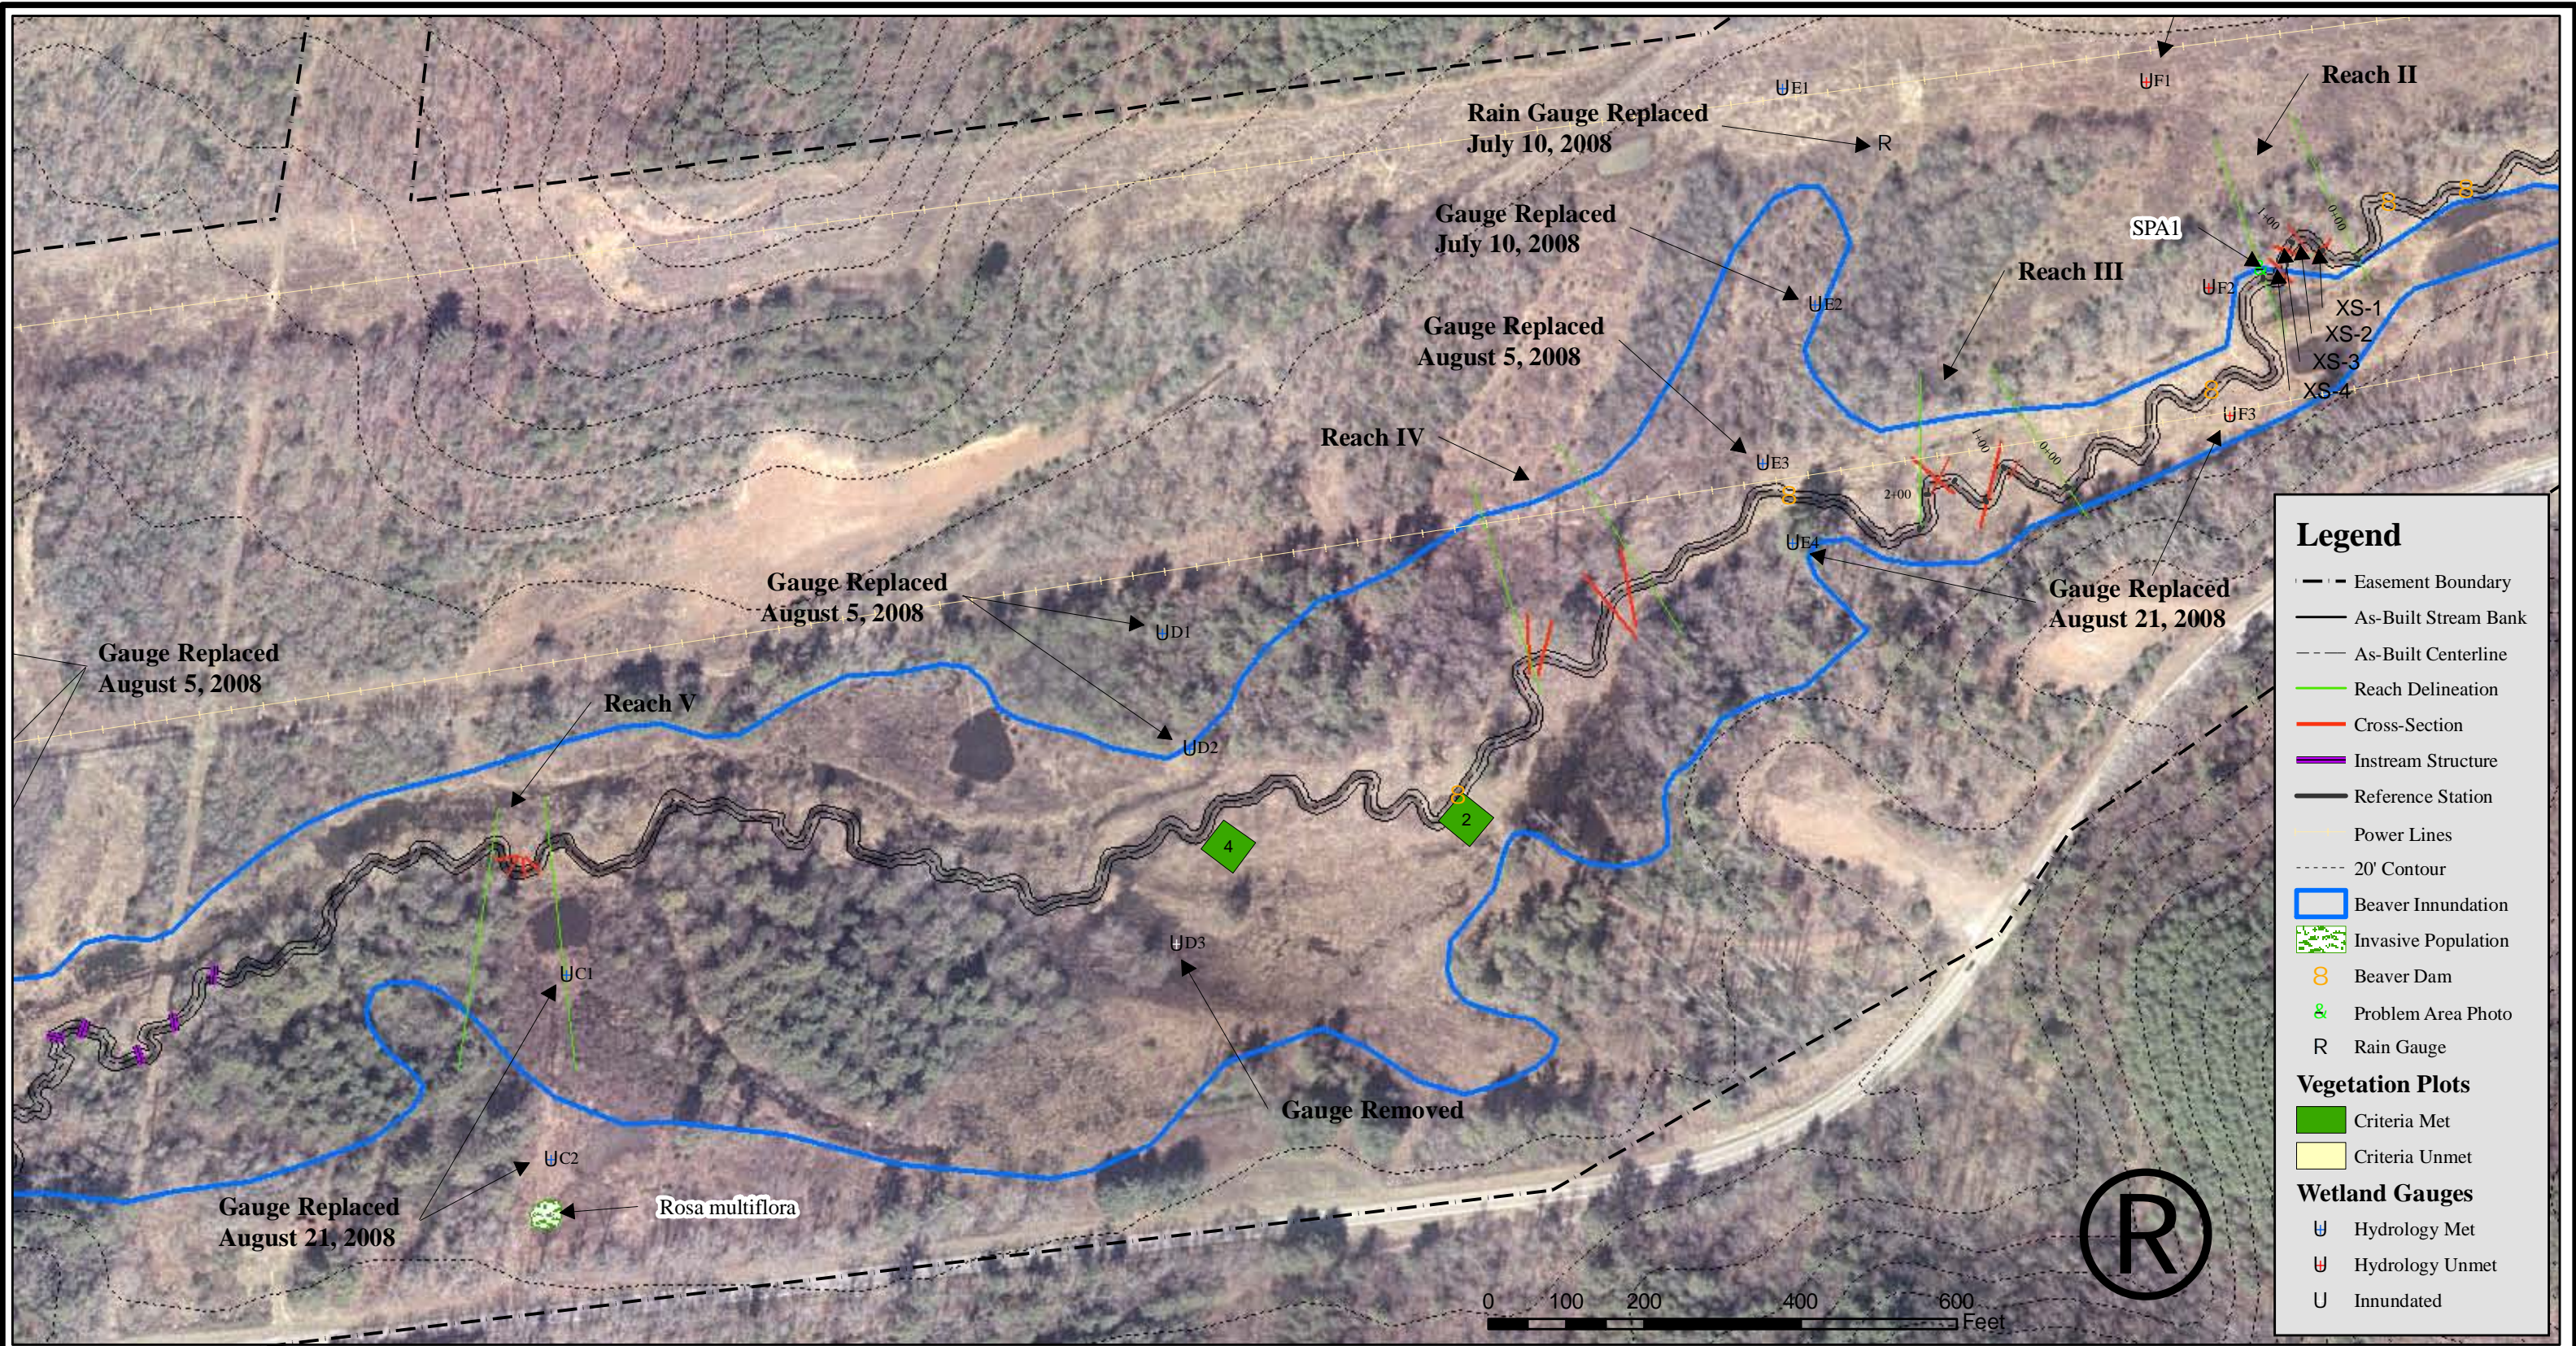
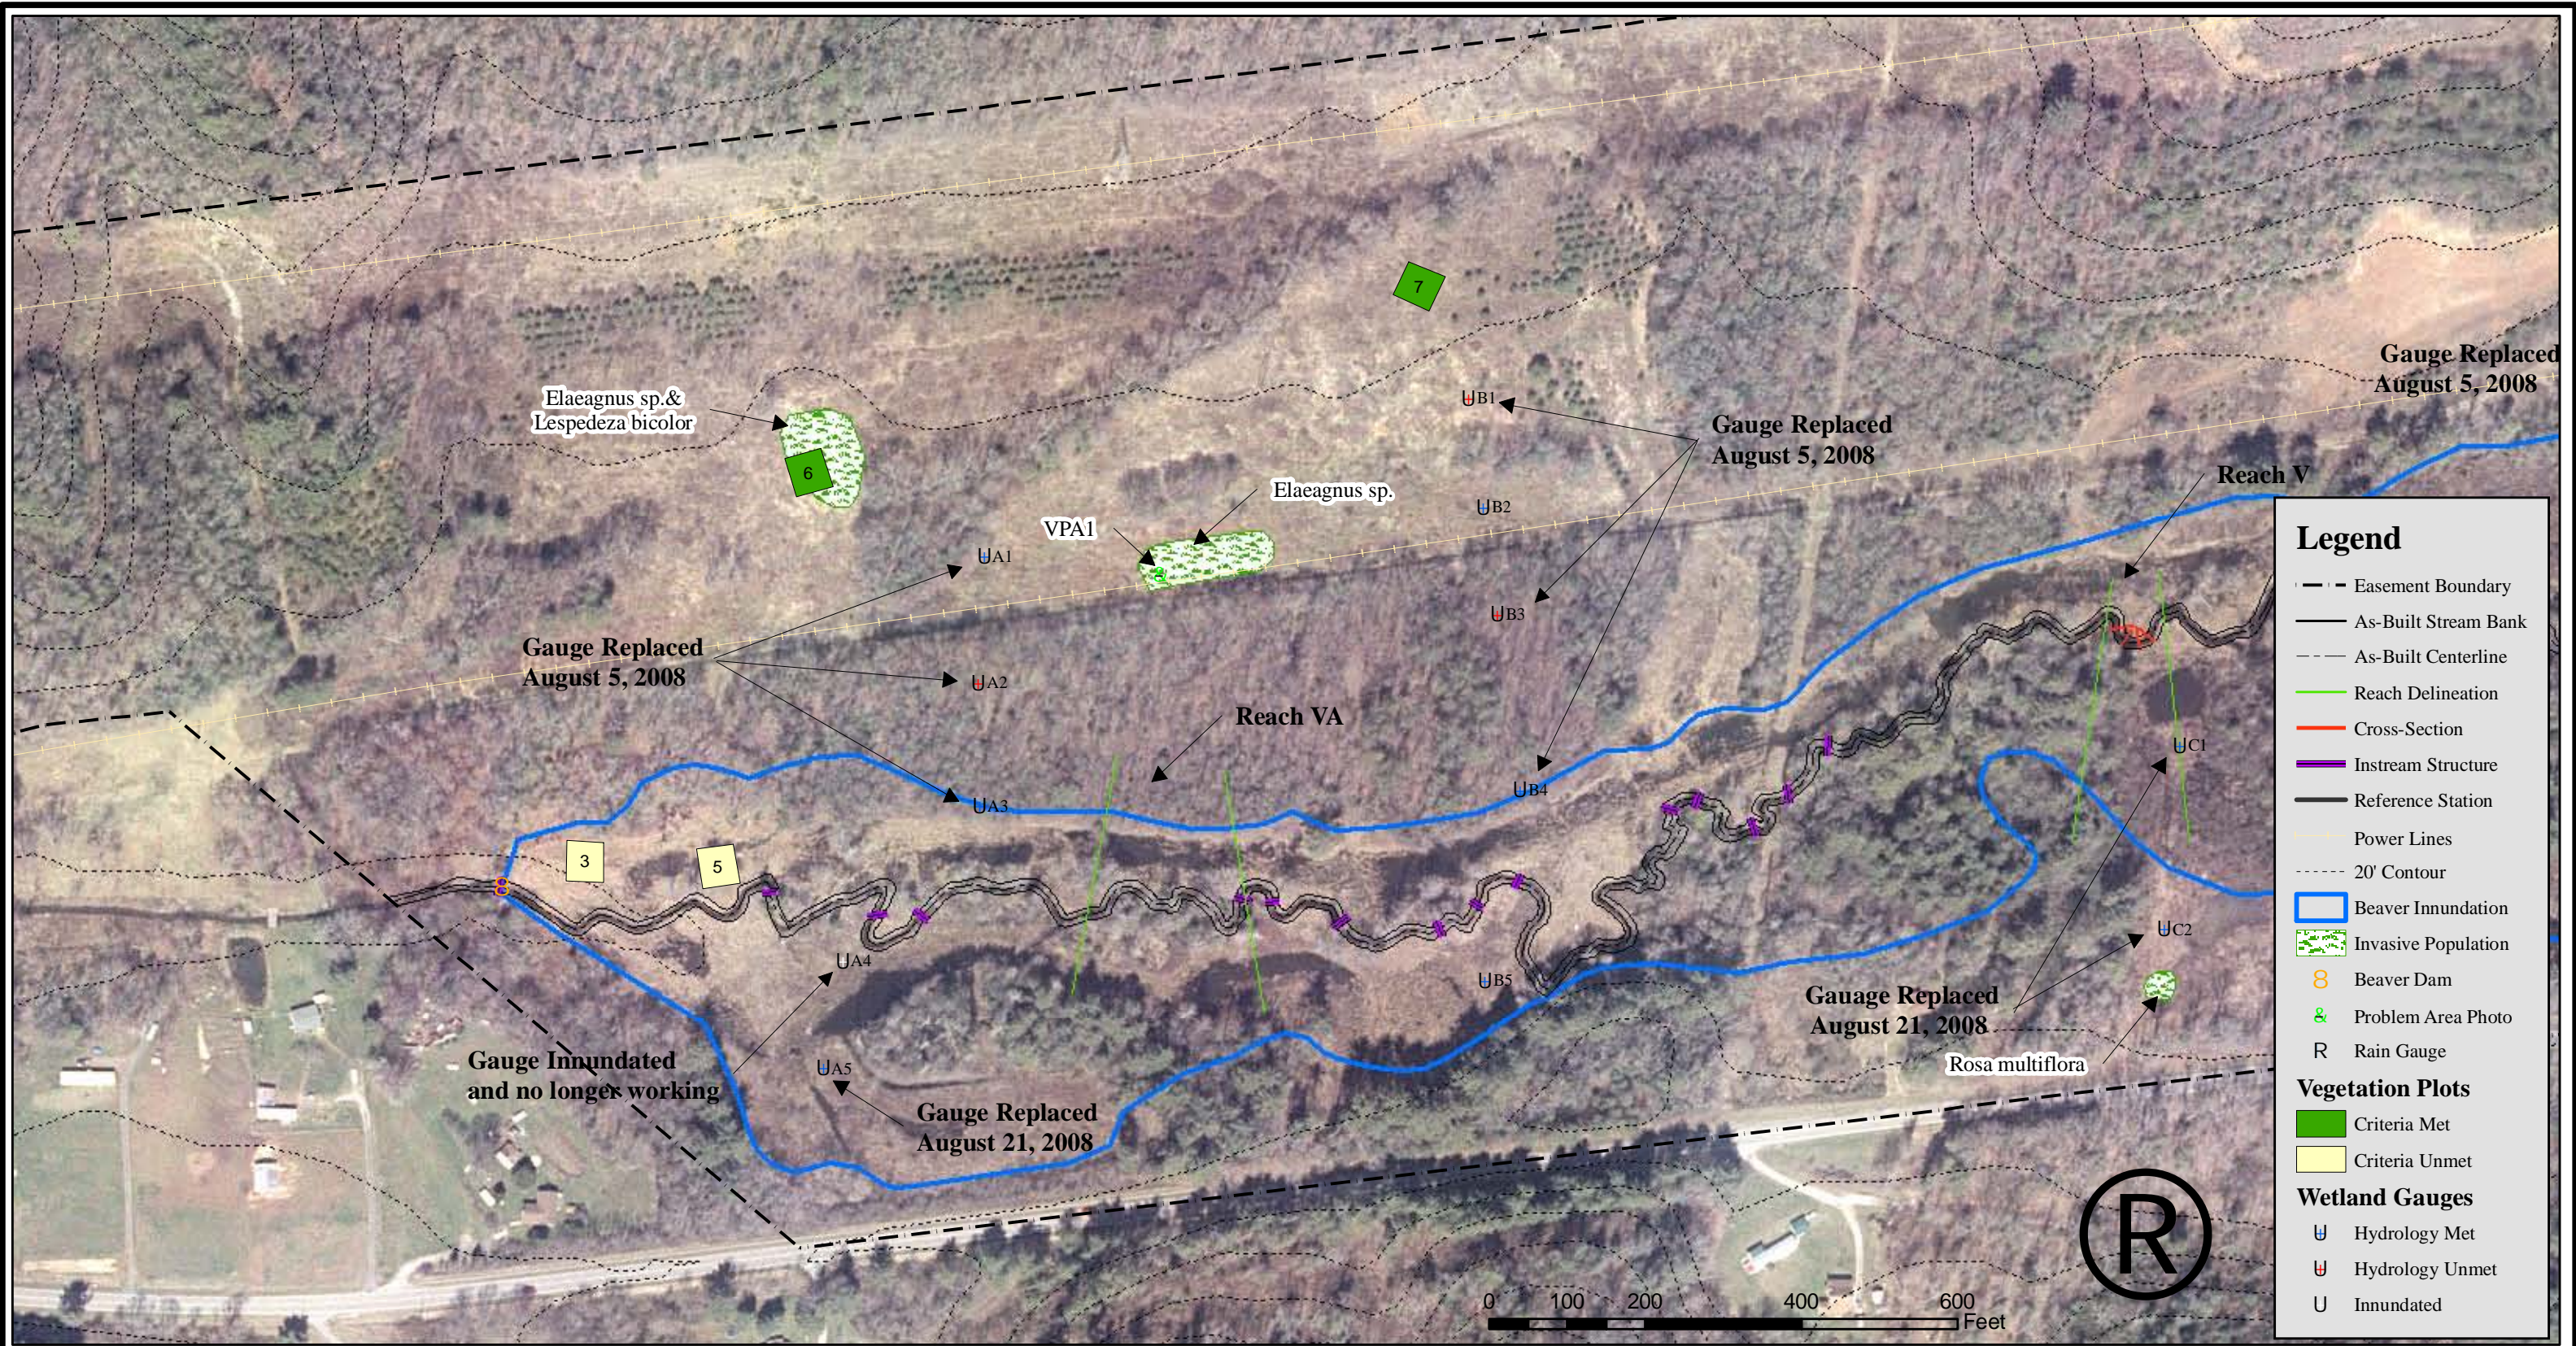
Appendix D
Tulula Stream & Wetland Restoration
Integrated Current Condition Plan View

Vegetation problem areas pertain to the presence of some invasive/exotic species throughout the easement area. A total of eight invasive/exotic species were identified (Appendix A – Table A2). Species are primarily associated with the power-line corridors and other disturbed areas but were also noted within the forested riparian and upland areas.

Stream and upland inundation has increased annually since the MY 3. The inundated area for the project site has increased to 41.6 acres in MY 6 compared to 20.2 acres in MY 5 (Appendix D – Integrated Project Current Condition Plan View).
