# Monitoring Report

**Twin Bays Wetland Restoration Site**

**DMS Project Number 95363**

**Monitoring Year 06**

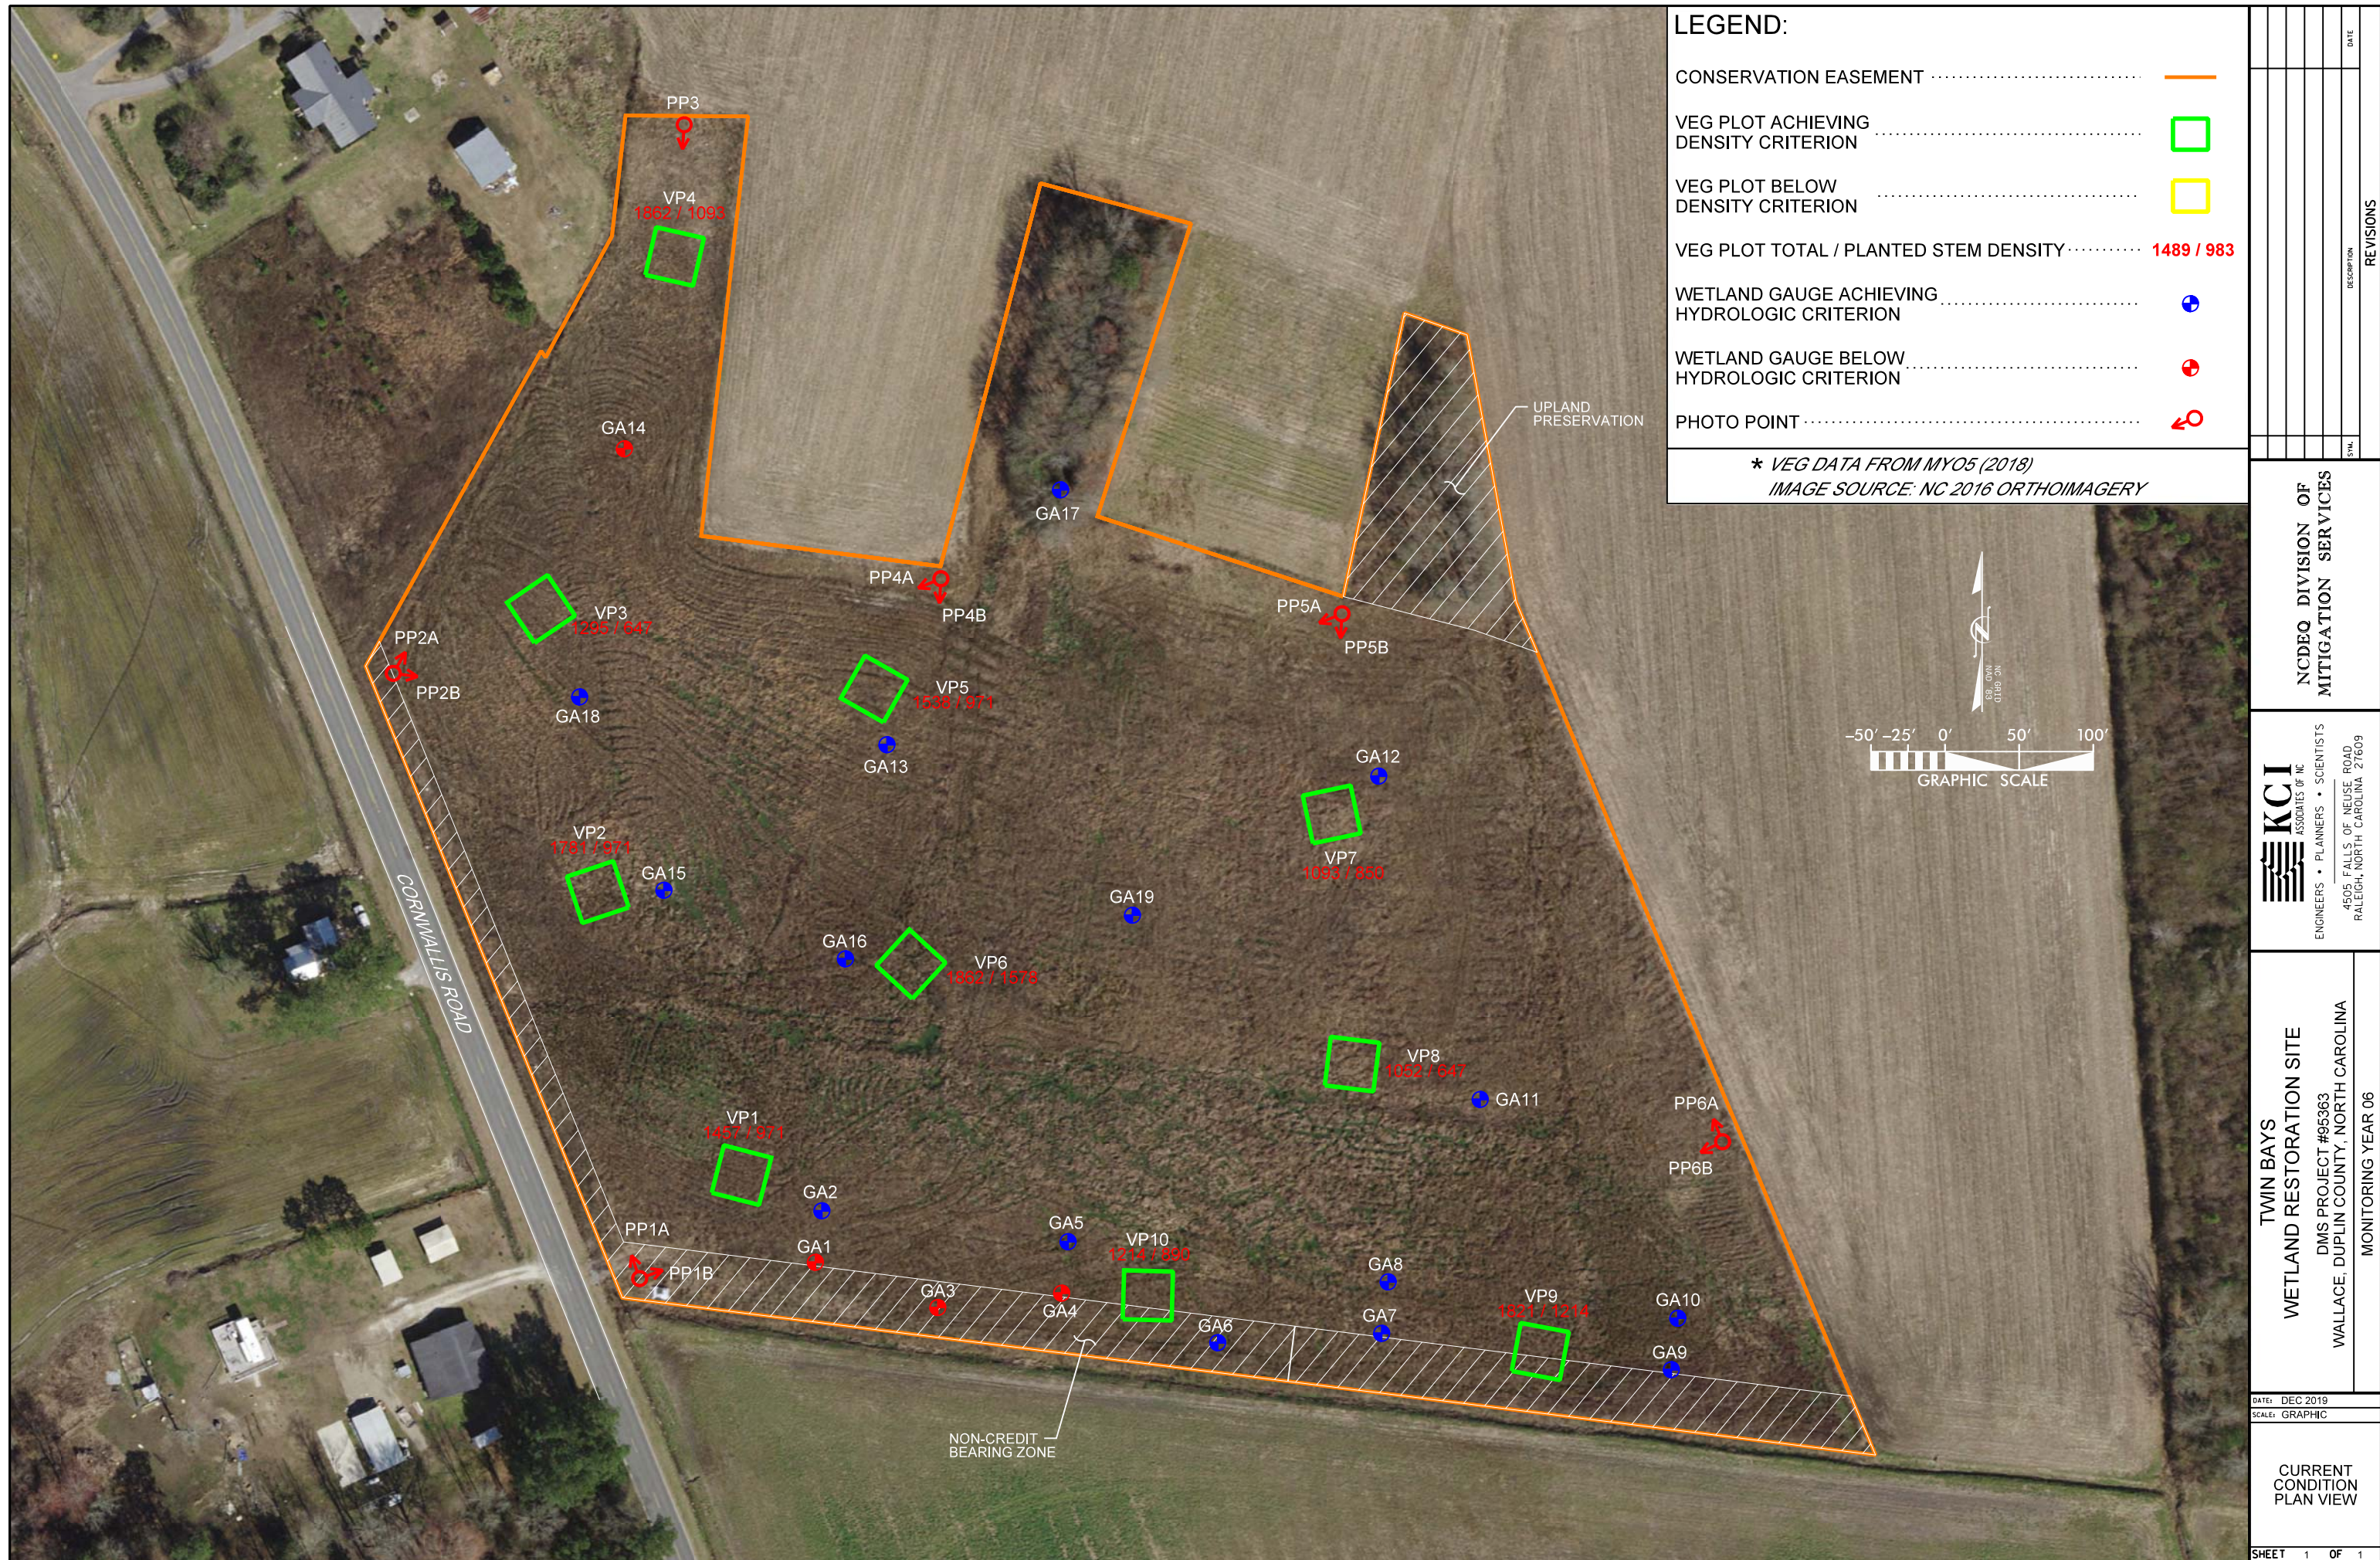
DATE: DEC 2019  
 SCALE: GRAPHIC  
 CURRENT  
 CONDITION  
 PLAN VIEW  
 SHEET 1 OF 1

During the site's sixth growing season, fourteen of the seventeen credit-bearing gauges met the hydrologic success criteria. The three gauges that did not meet the success criteria were 1, 4, and 14. Gauge 1 has met the criteria for three of the previous five growing seasons. Gauge 4 malfunctioned throughout the growing season, and no viable data was collected, although it has had hydrology success in every previous growing season. Gauge 14 only collected data at the beginning of the growing season and then malfunctioned repeatedly for the rest of the growing season. That gauge has had hydrology success in four of the previous five growing seasons. Gauges 1 and 4 are both located right on the credit line and so are generally expected to be drier than other gauges located further into the wetland. KCI believes that the pattern of success seen in MY06 is evidence that the credit line is generally drawn accurately. In addition, one of the two non-credit bearing gauges also achieved the success criteria this year. This gauge (Gauge 6) has met the hydrology success criteria every previous growing season except for the first.

4. DMS recommends that KCI label the gauges with % hydroperiod on the CCPV to show IRT how this line is generally accurate. This is not required for MY6 but may be beneficial for the report and certainly for MY7.  
*KCI Response: This will be added to the CCPV in MY07.*
