UNDERWOOD MITIGATION SITE
Chatham County, NC
DENR Contract 003268
NCEEP Project Number 94641

Monitoring Year 1 Annual Report
FINAL

UNDERWOOD MITIGATION SITE Monitoring Year 1 Annual Report

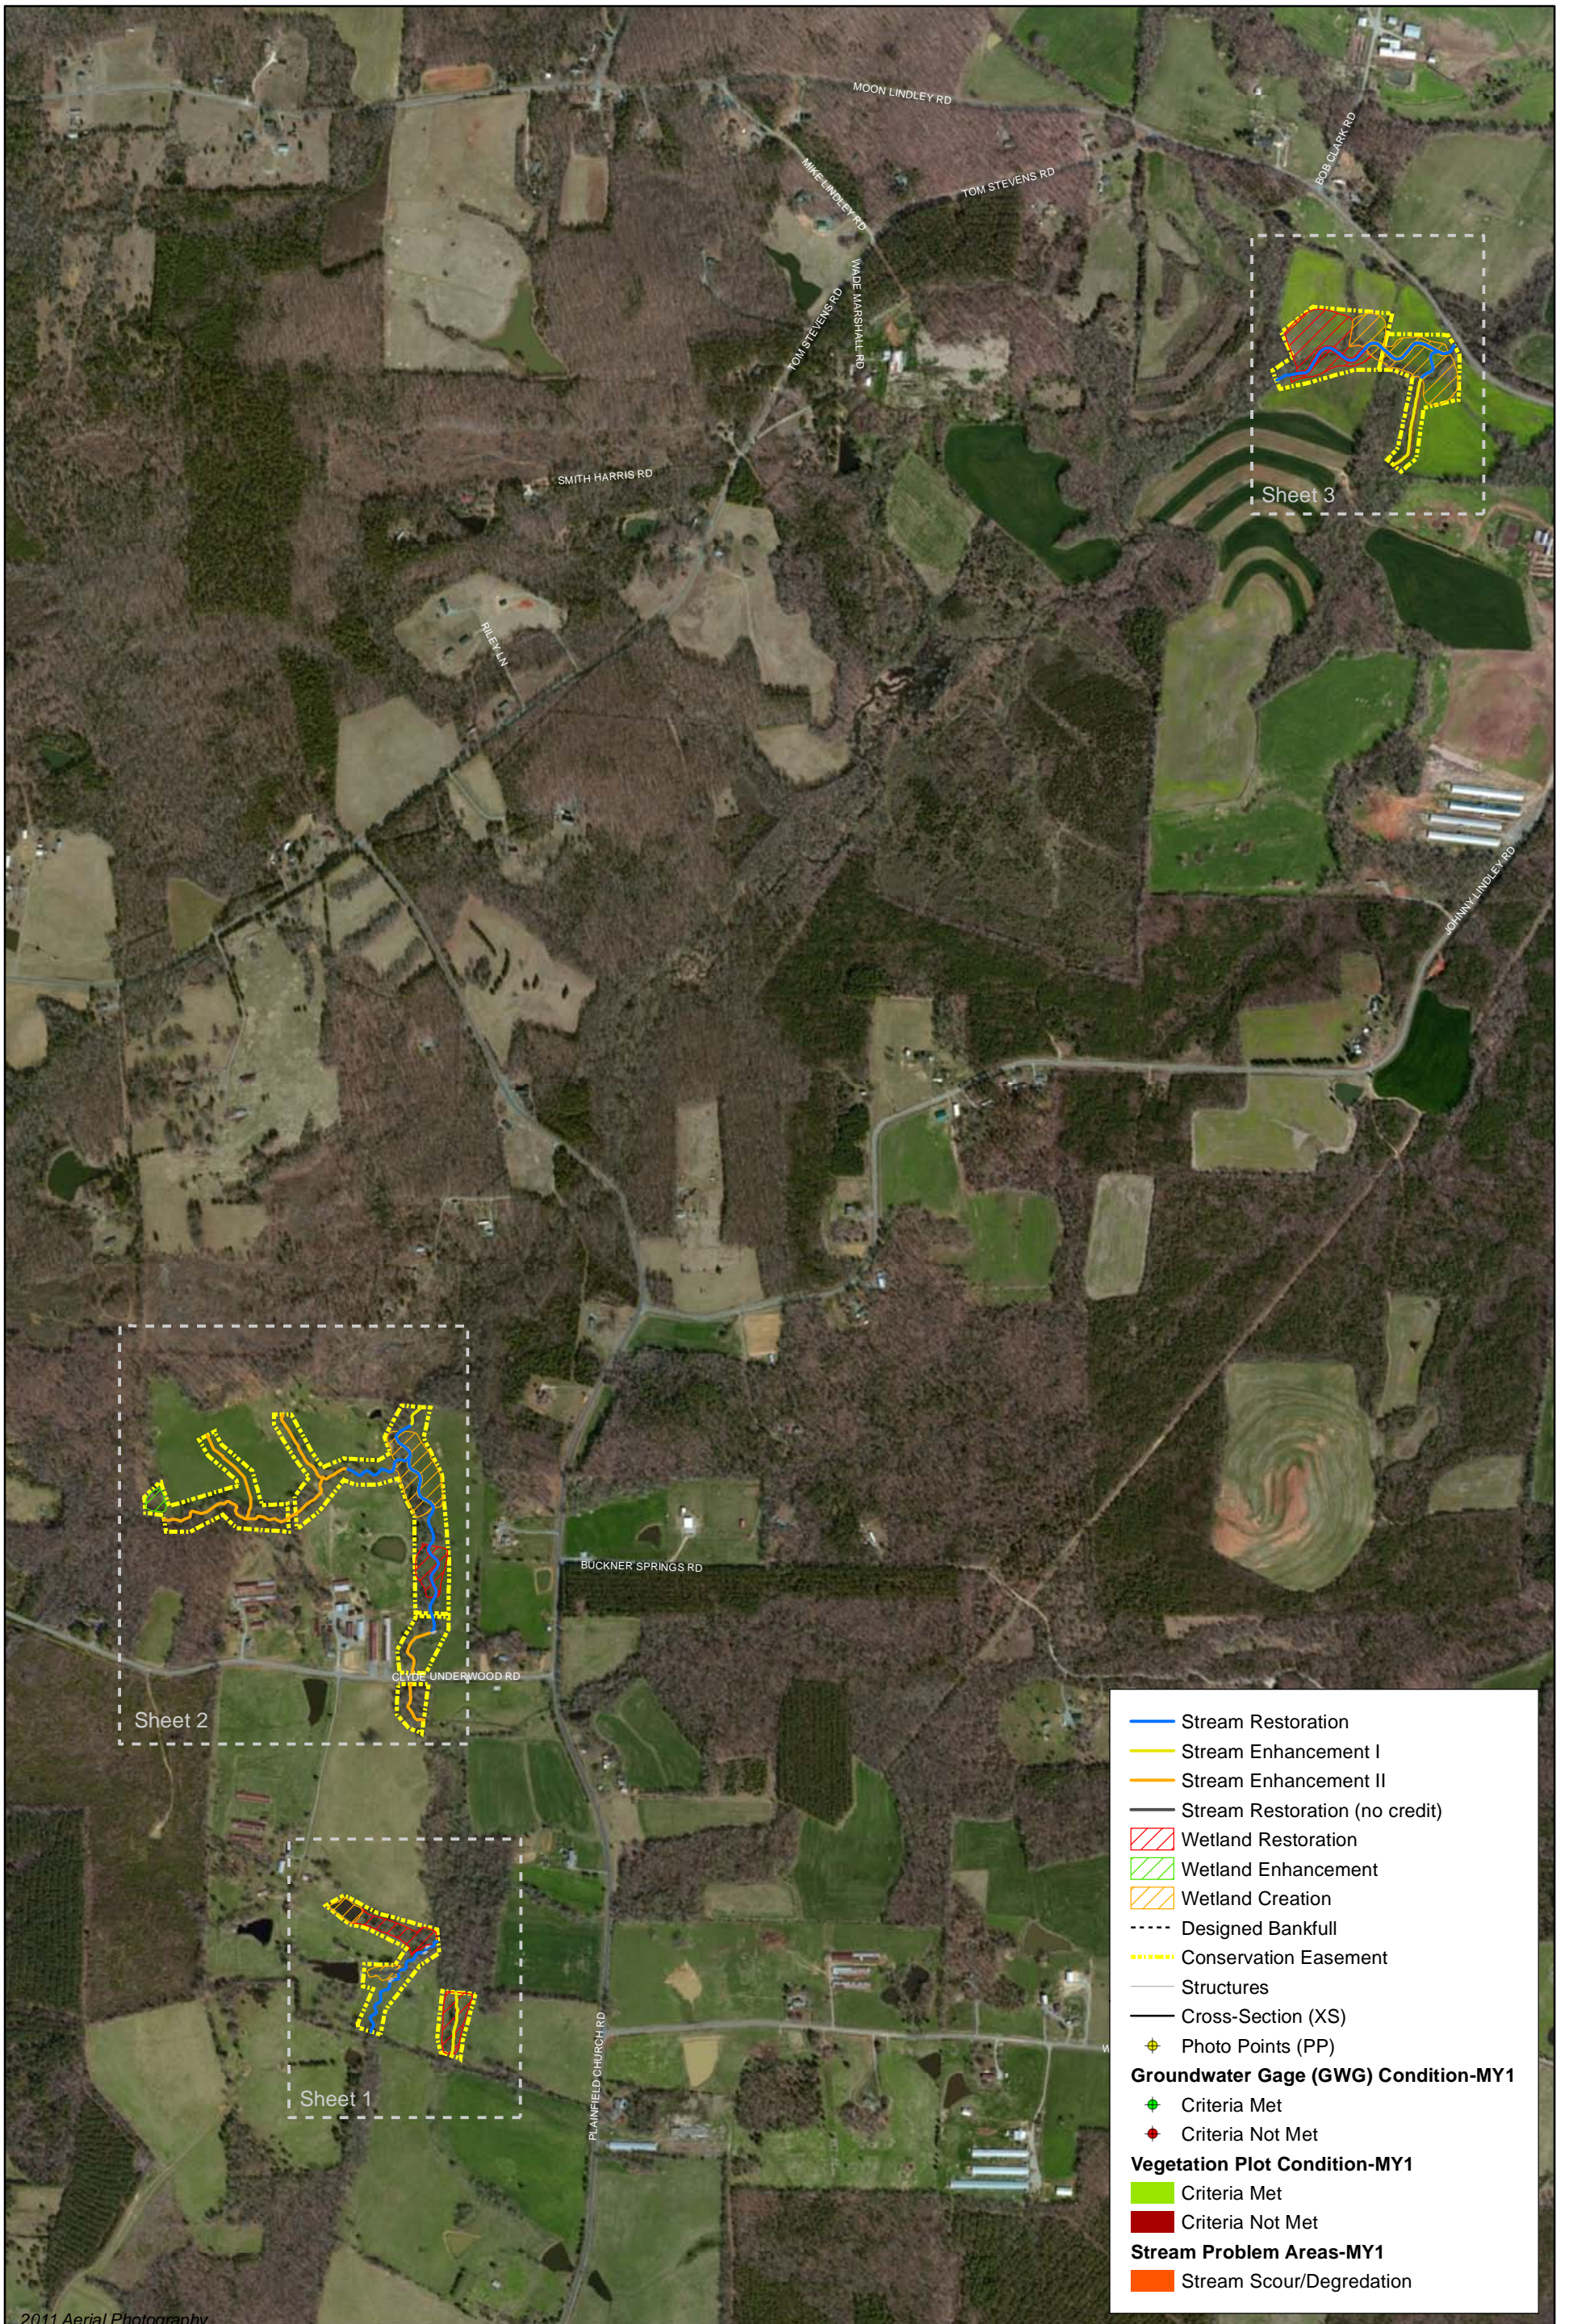
Figure 3.0 Integrated Current Condition Plan View (Key)
 Underwood Mitigation Site
 NCEP Project No. 94641
 Monitoring Year 1
 Chatham County, NC

- Stream Restoration
- Stream Enhancement I
- Stream Enhancement II
- Stream Restoration (no credit)
- Wetland Restoration
- Wetland Enhancement
- Wetland Creation
- Designed Bankfull
- Conservation Easement
- Structures
- Cross-Section (XS)
- ◆ Photo Points (PP)
- Groundwater Gage (GWG) Condition-MY1**
- ◆ Criteria Met
- ◆ Criteria Not Met
- Vegetation Plot Condition-MY1**
- Criteria Met
- Criteria Not Met
- Stream Problem Areas-MY1**
- Stream Scour/Degradation

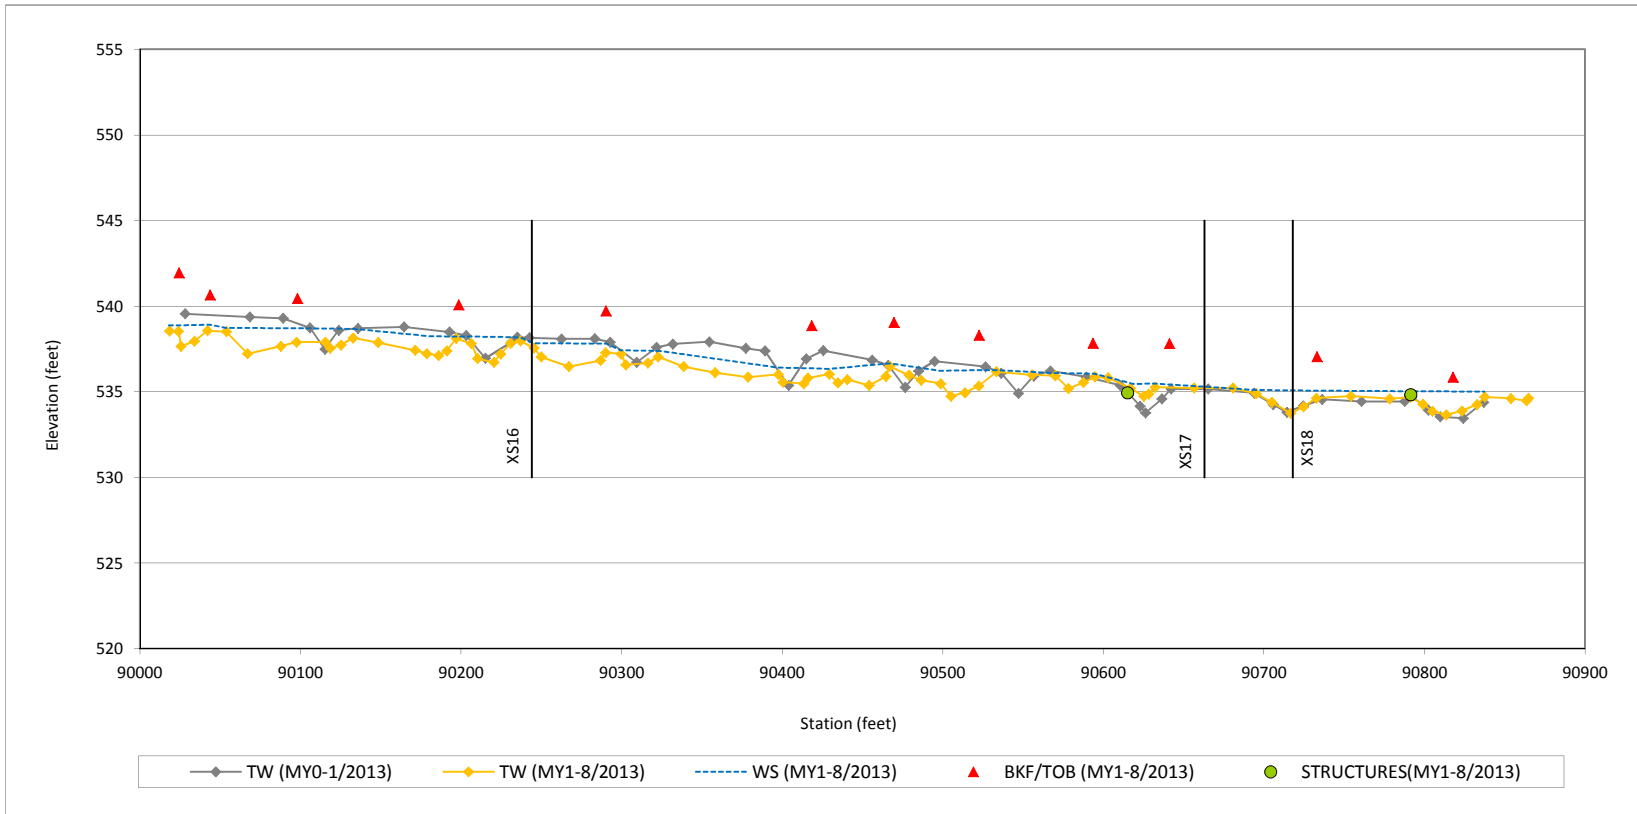
Longitudinal Profile Plots
Underwood Mitigation Site (NCEP Project No. 94641)
Lindley Site; SF4A
Monitoring Year 1

Morphological surveys for the MY-1 were conducted in August and September 2013. With the exception of SF4A, all streams within the Site are stable with little to no erosion and have met the success criteria for MY-1. Please refer to Appendix 2 for the visual assessment table, Current condition plan view (CCPV), and reference photographs. Refer to Appendix 4 for the morphological data and plots.

With the exception of SF4A, all streams within the Site are stable and functioning as designed. Degradation observed on SF4A will be monitored for indications of long term instability. A maintenance plan will be prepared after MY-2 if conditions continue to degrade. The average stem density for the Site is on track to meeting the MY-5 success criteria; however, a few individual vegetation plots did not meet the MY-1 success criteria as noted in the CCPV. There has been one documented bankfull event with the crest gage recorded along UT1, SF2, SF3, SF4, and SF4A since construction commenced along with visual verifications such as wrack lines. The MY-5 stream hydrology attainment requirement has been partially met for the Site at this time. All groundwater gages met the MY-1 success criteria.

¹Number of riffles and pools are determined based on the as-built survey along Restoration and Enhancement Level I reaches. Approximately 533 LF of the stream bed has downcut along SF4A and riffles and pools shifted have shifted downstream. Although these conditions were not intended in the design, the stream has maintained a stable bedform with riffles and pools at a lower elevation.

degradation continues along SF4A, Wildlands will prepare a maintenance plan to address the problem areas. Details regarding the tentative maintenance plan are discussed below in section 1.2.3. Pattern data will be collected in MY-5 only if there are indicators from the profile or dimensions that significant geomorphic adjustments have occurred. No changes were observed during MY-1 that indicated a change in the radius of curvature or channel belt width.
