MONITORING YEAR 2 ANNUAL REPORT Final

UNDERWOOD MITIGATION SITE

Chatham County, NC
DENR Contract 003268
NCEP Project Number 94641

Data Collection Period: June 2014-November 2014
Draft Submission Date: December 1, 2014
Final Submission Date: January 9, 2014

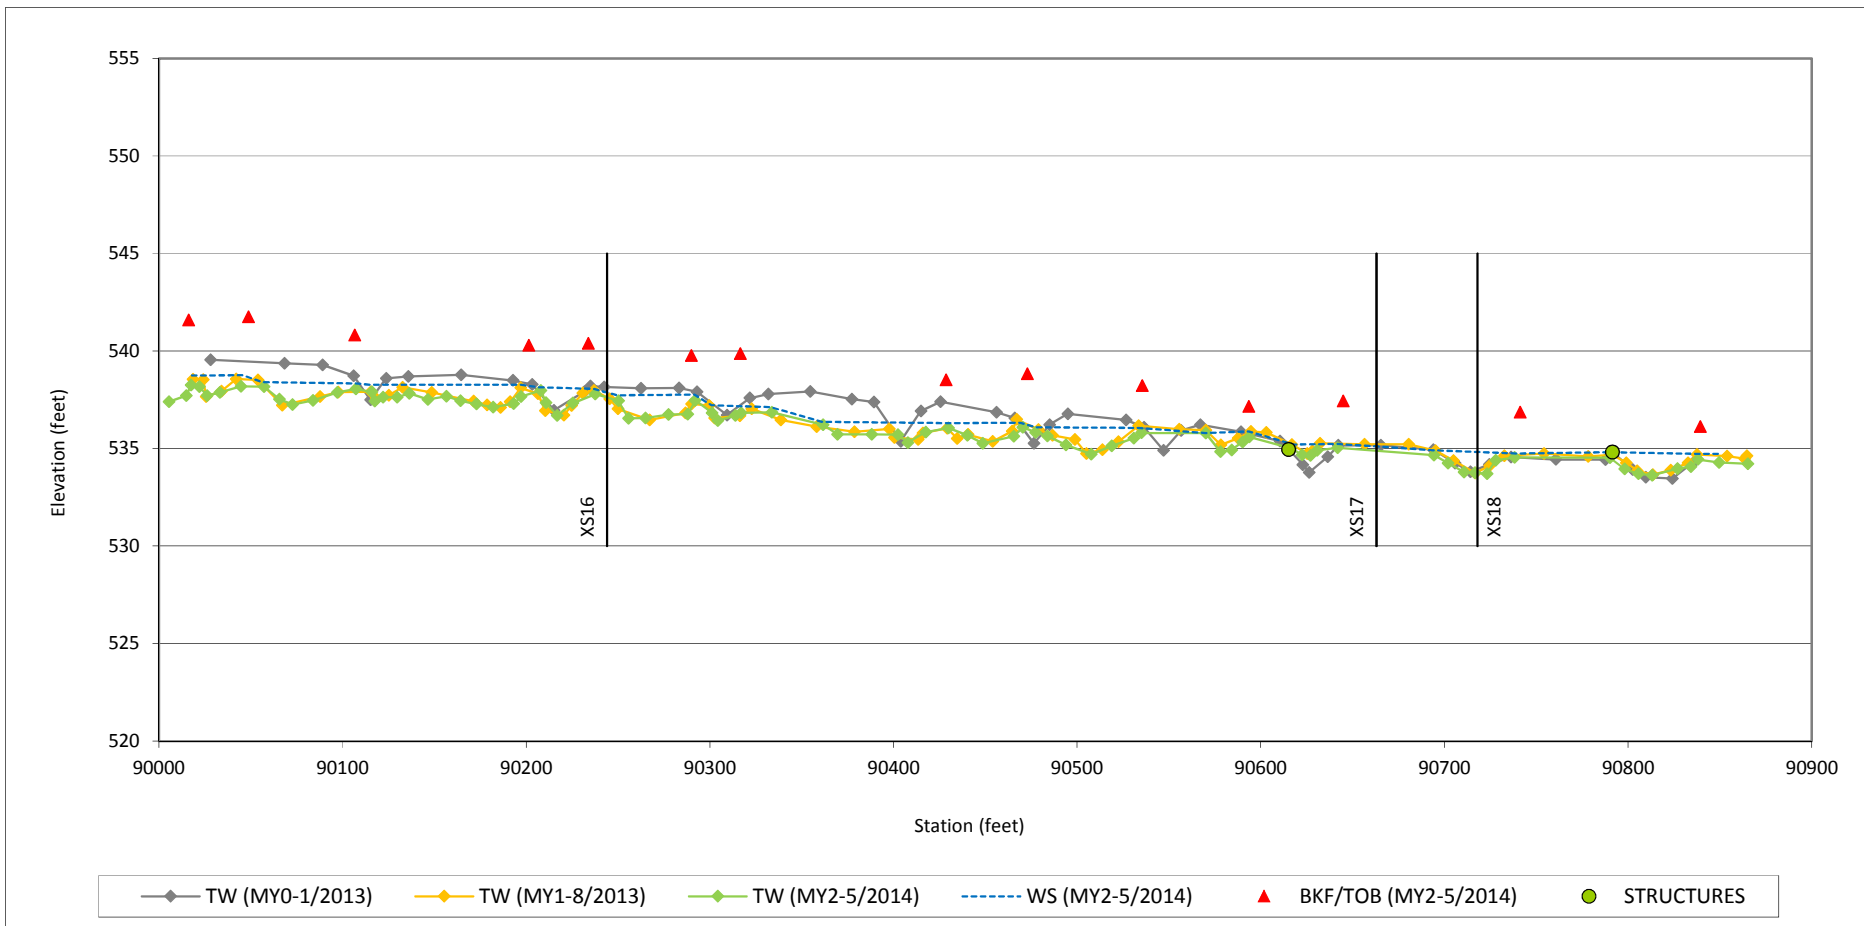
Longitudinal Profile Plots
Underwood Mitigation Site (NCEEP Project No. 94641)
Lindley Site; SF4A
Monitoring Year 2

With the exception of SF4A, all streams within the Site are stable and functioning as designed. Degradation observed on SF4A will be monitored for indications of long term instability. A maintenance plan will be prepared after MY-3 if conditions continue to degrade. The average stem density for the Site is on track to meeting the MY-5 success criteria; however, some individual vegetation plots did not meet the MY-3 success criteria as noted in the Integrated Current Condition Plan View. With the exception of UT2, there have been multiple documented bankfull events with the crest gage recordings along UT1, SF2, SF3, SF4, and SF4A since construction completion. The MY-5 stream hydrology attainment requirement has been partially met for the Site at this time. With the exception of one gage, the MY-2 hydrology success criteria has been met.

¹Number of riffles and pools are determined based on the as-built survey along Restoration and Enhancement Level I reaches. Approximately 533 LF of the stream bed has downcut along SF4A and riffles and pools shifted have shifted downstream. Although these conditions were not intended in the design, the stream has maintained a stable bedform with riffles and pools at a lower elevation.

Wildlands is proposing a supplemental planting in the winter of 2015 to address areas noted with low planted stem survivability. Additionally, Wildlands will continue to monitor SF4A and will develop a maintenance plan if it becomes apparent that the stream continues to downcut or otherwise destabilize. A maintenance plan to correct this problem would likely consist of installation of sills at the downstream end of riffles to stabilize those features, add additional grade control, and backfill over time to raise the bed through the riffle sections.
