MONITORING YEAR 3 ANNUAL REPORT Final

UNDERWOOD MITIGATION SITE

Chatham County, NC
NCDEQ Contract 003268
DMS Project Number 94641

Data Collection Period: June 2015- October 2015
Draft Submission Date: December 1, 2015
Final Submission Date: December 14, 2015

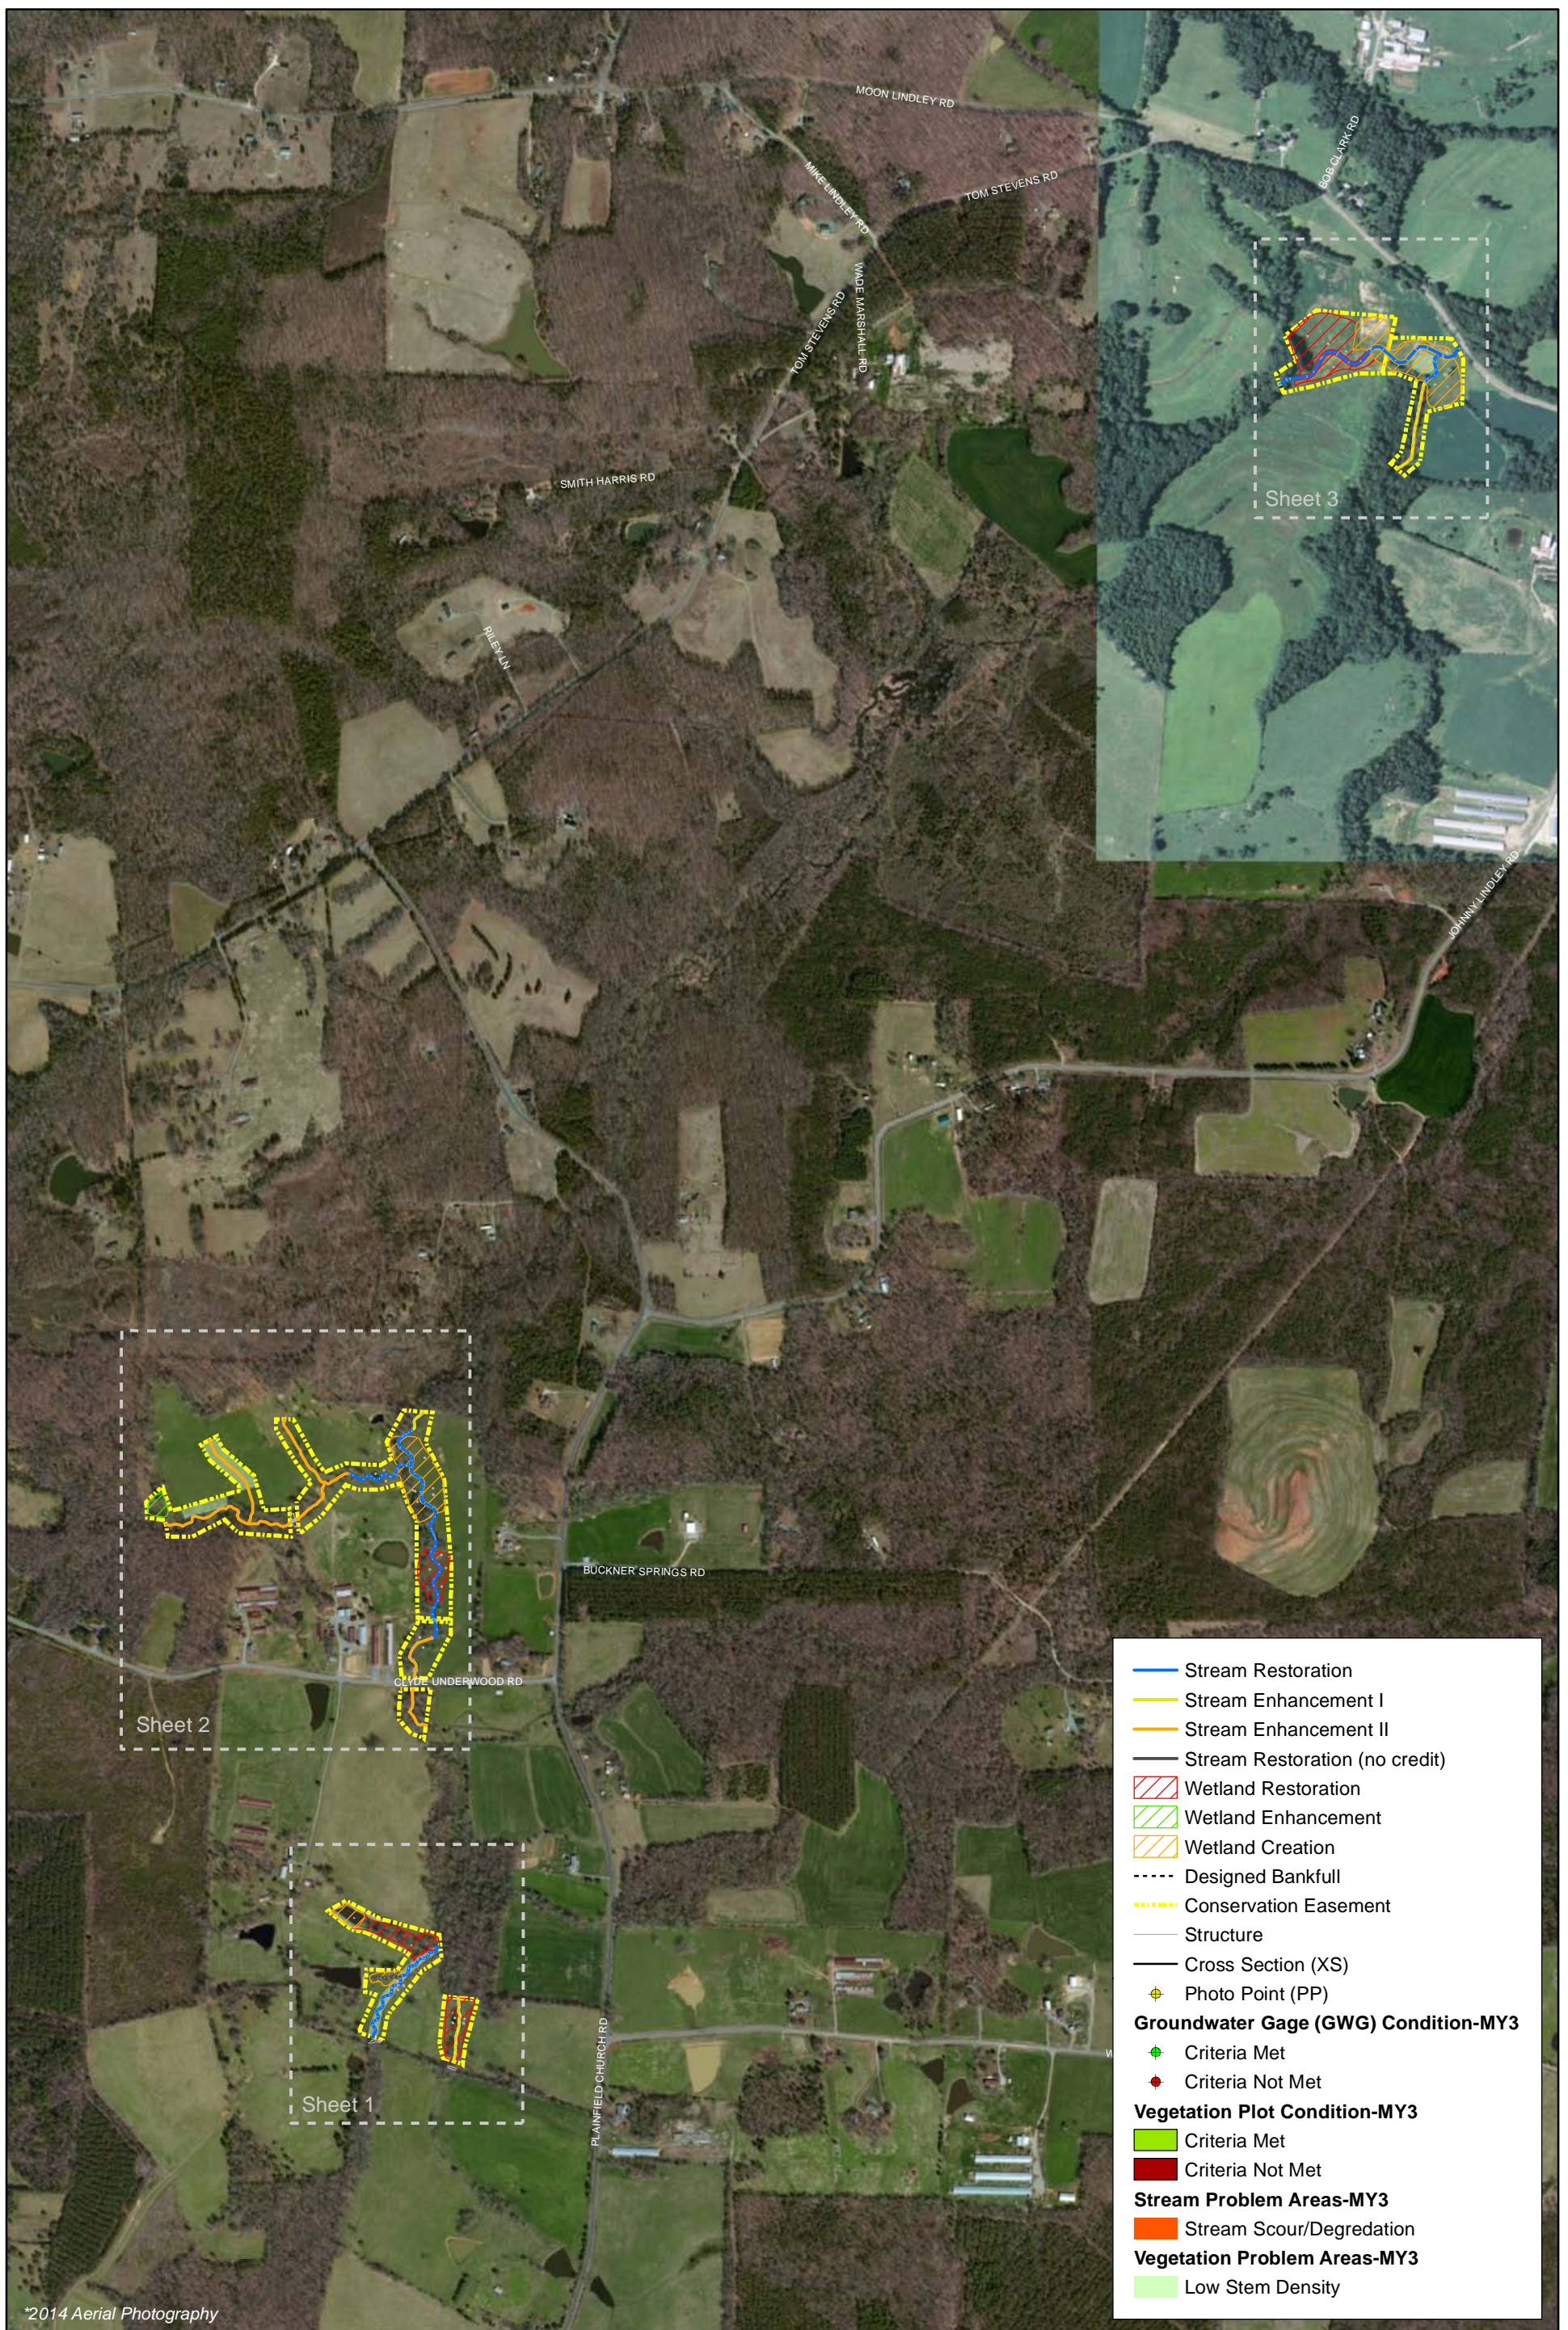
Figure 3.0 Integrated Current Condition Plan View (Key)
 Underwood Mitigation Site
 NCDMS Project No. 94641
 Monitoring Year 3 - 2015
 Chatham County, NC

During MY3 a few isolated areas were observed to have low tree densities. These areas are shown on the CCPV maps (Figures 3.0-3.3). These areas will be supplemented with additional trees during the beginning of MY4. Some of these areas were graded down several feet during construction and are believed to have poor soil conditions due to the removal of the nutrient rich top soil. Soil samples will be taken in these graded areas and appropriate actions, such as lime or fertilizer application, will be taken to help improve soil growing conditions. Also, most of these areas have limited herbaceous cover growing on them. A native grass seed mix will be applied to these areas to create a well-established herbaceous ground cover.

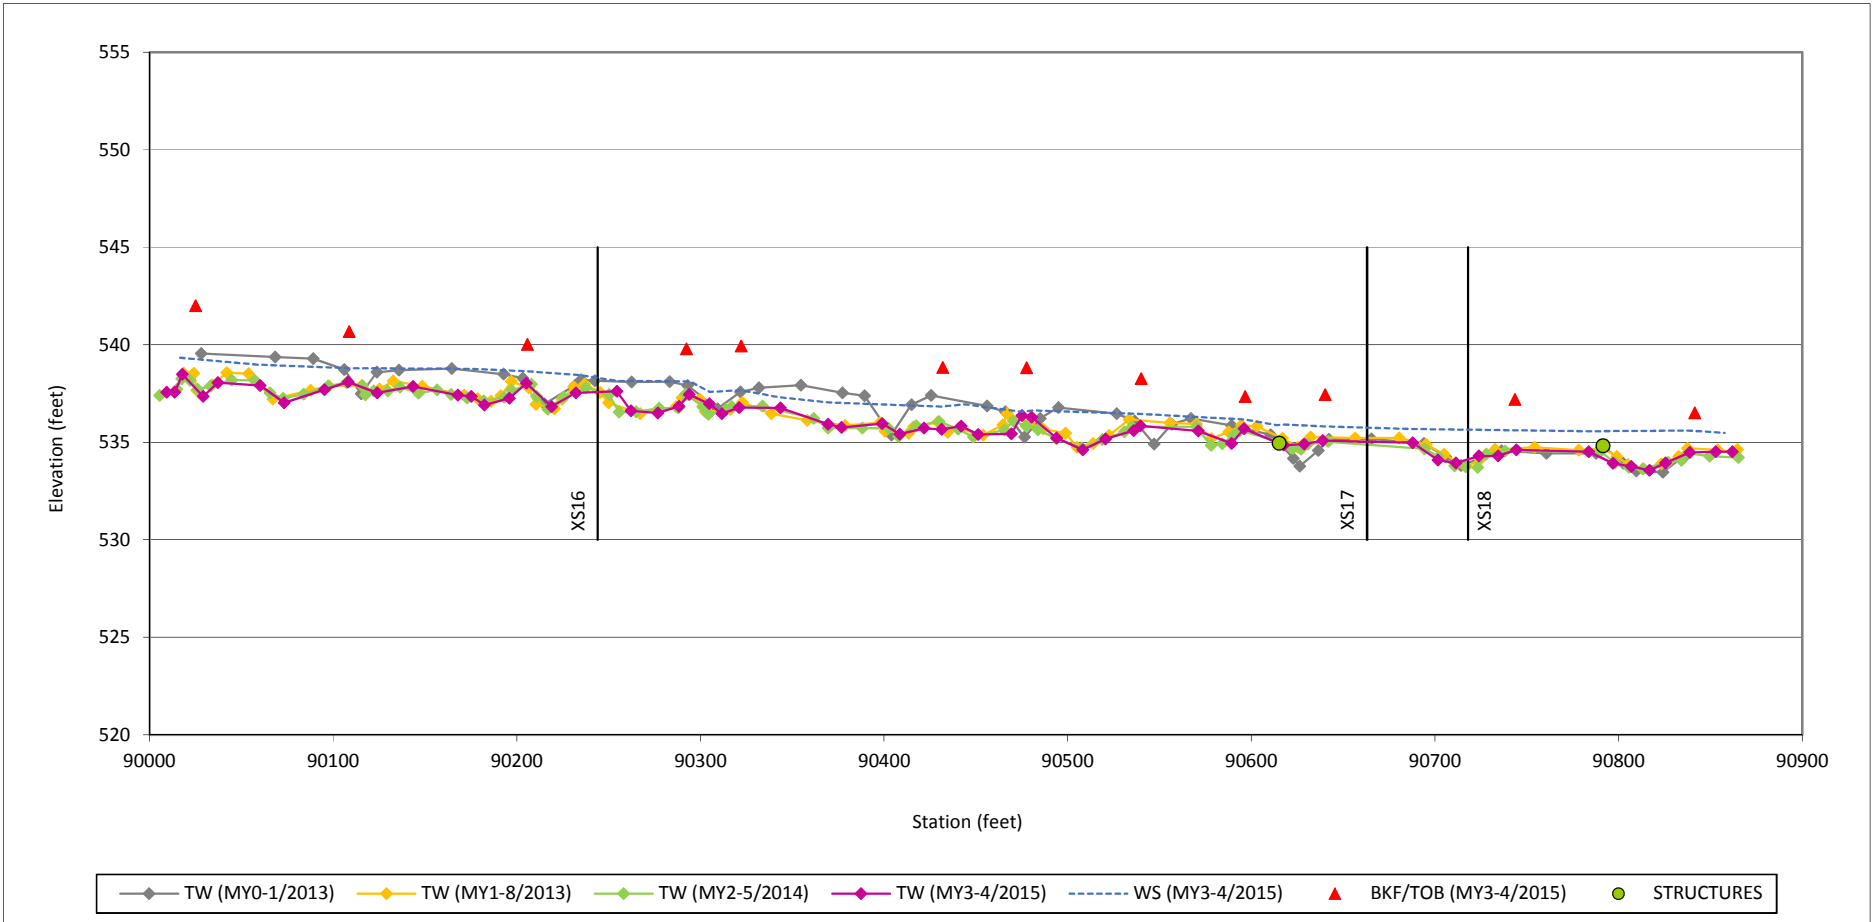
Lindley Site; SF4A

Degradation was documented in the enhancement section on SF4A (approximate STA 900+00-905+33) between MY0 and MY1. This section of the stream has down cut in several locations. The adjustments in SF4A's profile were not intended in the design, but the stream has not down cut to a lower elevation since MY1. The profiles show that SF4A bed has had little change in bed elevation since MY1. During MY3 the decision was made to repair SF4A at the beginning MY4. Details regarding the repair work are discussed below in section 1.2.7.

During MY1 SF4A incised up to two feet in areas. During MY2 and MY3 SF4A seemed to be stable and the incision had ceased. At the end of MY3 it was determined that SF4A's banks had active erosion and the stream needed to be repaired. The repair work will be completed during the beginning of MY4. Constructed riffles were originally built without sills and most of the rock from these riffles washed away during MY1. The repair work will incorporate log and rock sills in the constructed riffles to raise the elevation of the stream bed. Minor stream bank grading will be performed as necessary and native grass seed and live stakes will be planted in disturbed areas.

¹Number of riffles and pools are determined based on the as-built survey along Restoration and Enhancement Level I reaches. Approximately 533 LF of the stream bed has downcut along SF4A and riffles and pools have shifted downstream. Although these conditions were not intended in the design, the stream has maintained a stable bedform with riffles and pools at a lower elevation.

SF4A will have repair work performed at the beginning of MY4. Details regarding the repair work are discussed below in section 1.2.7.
