MONITORING YEAR 4 ANNUAL REPORT

UNDERWOOD MITIGATION SITE

Chatham County, NC
NCDEQ Contract 003268
DMS Project Number 94641

Data Collection Period: May 2016- November 2016
Draft Submission Date: December 1, 2016
Final Submission Date: January 11, 2017

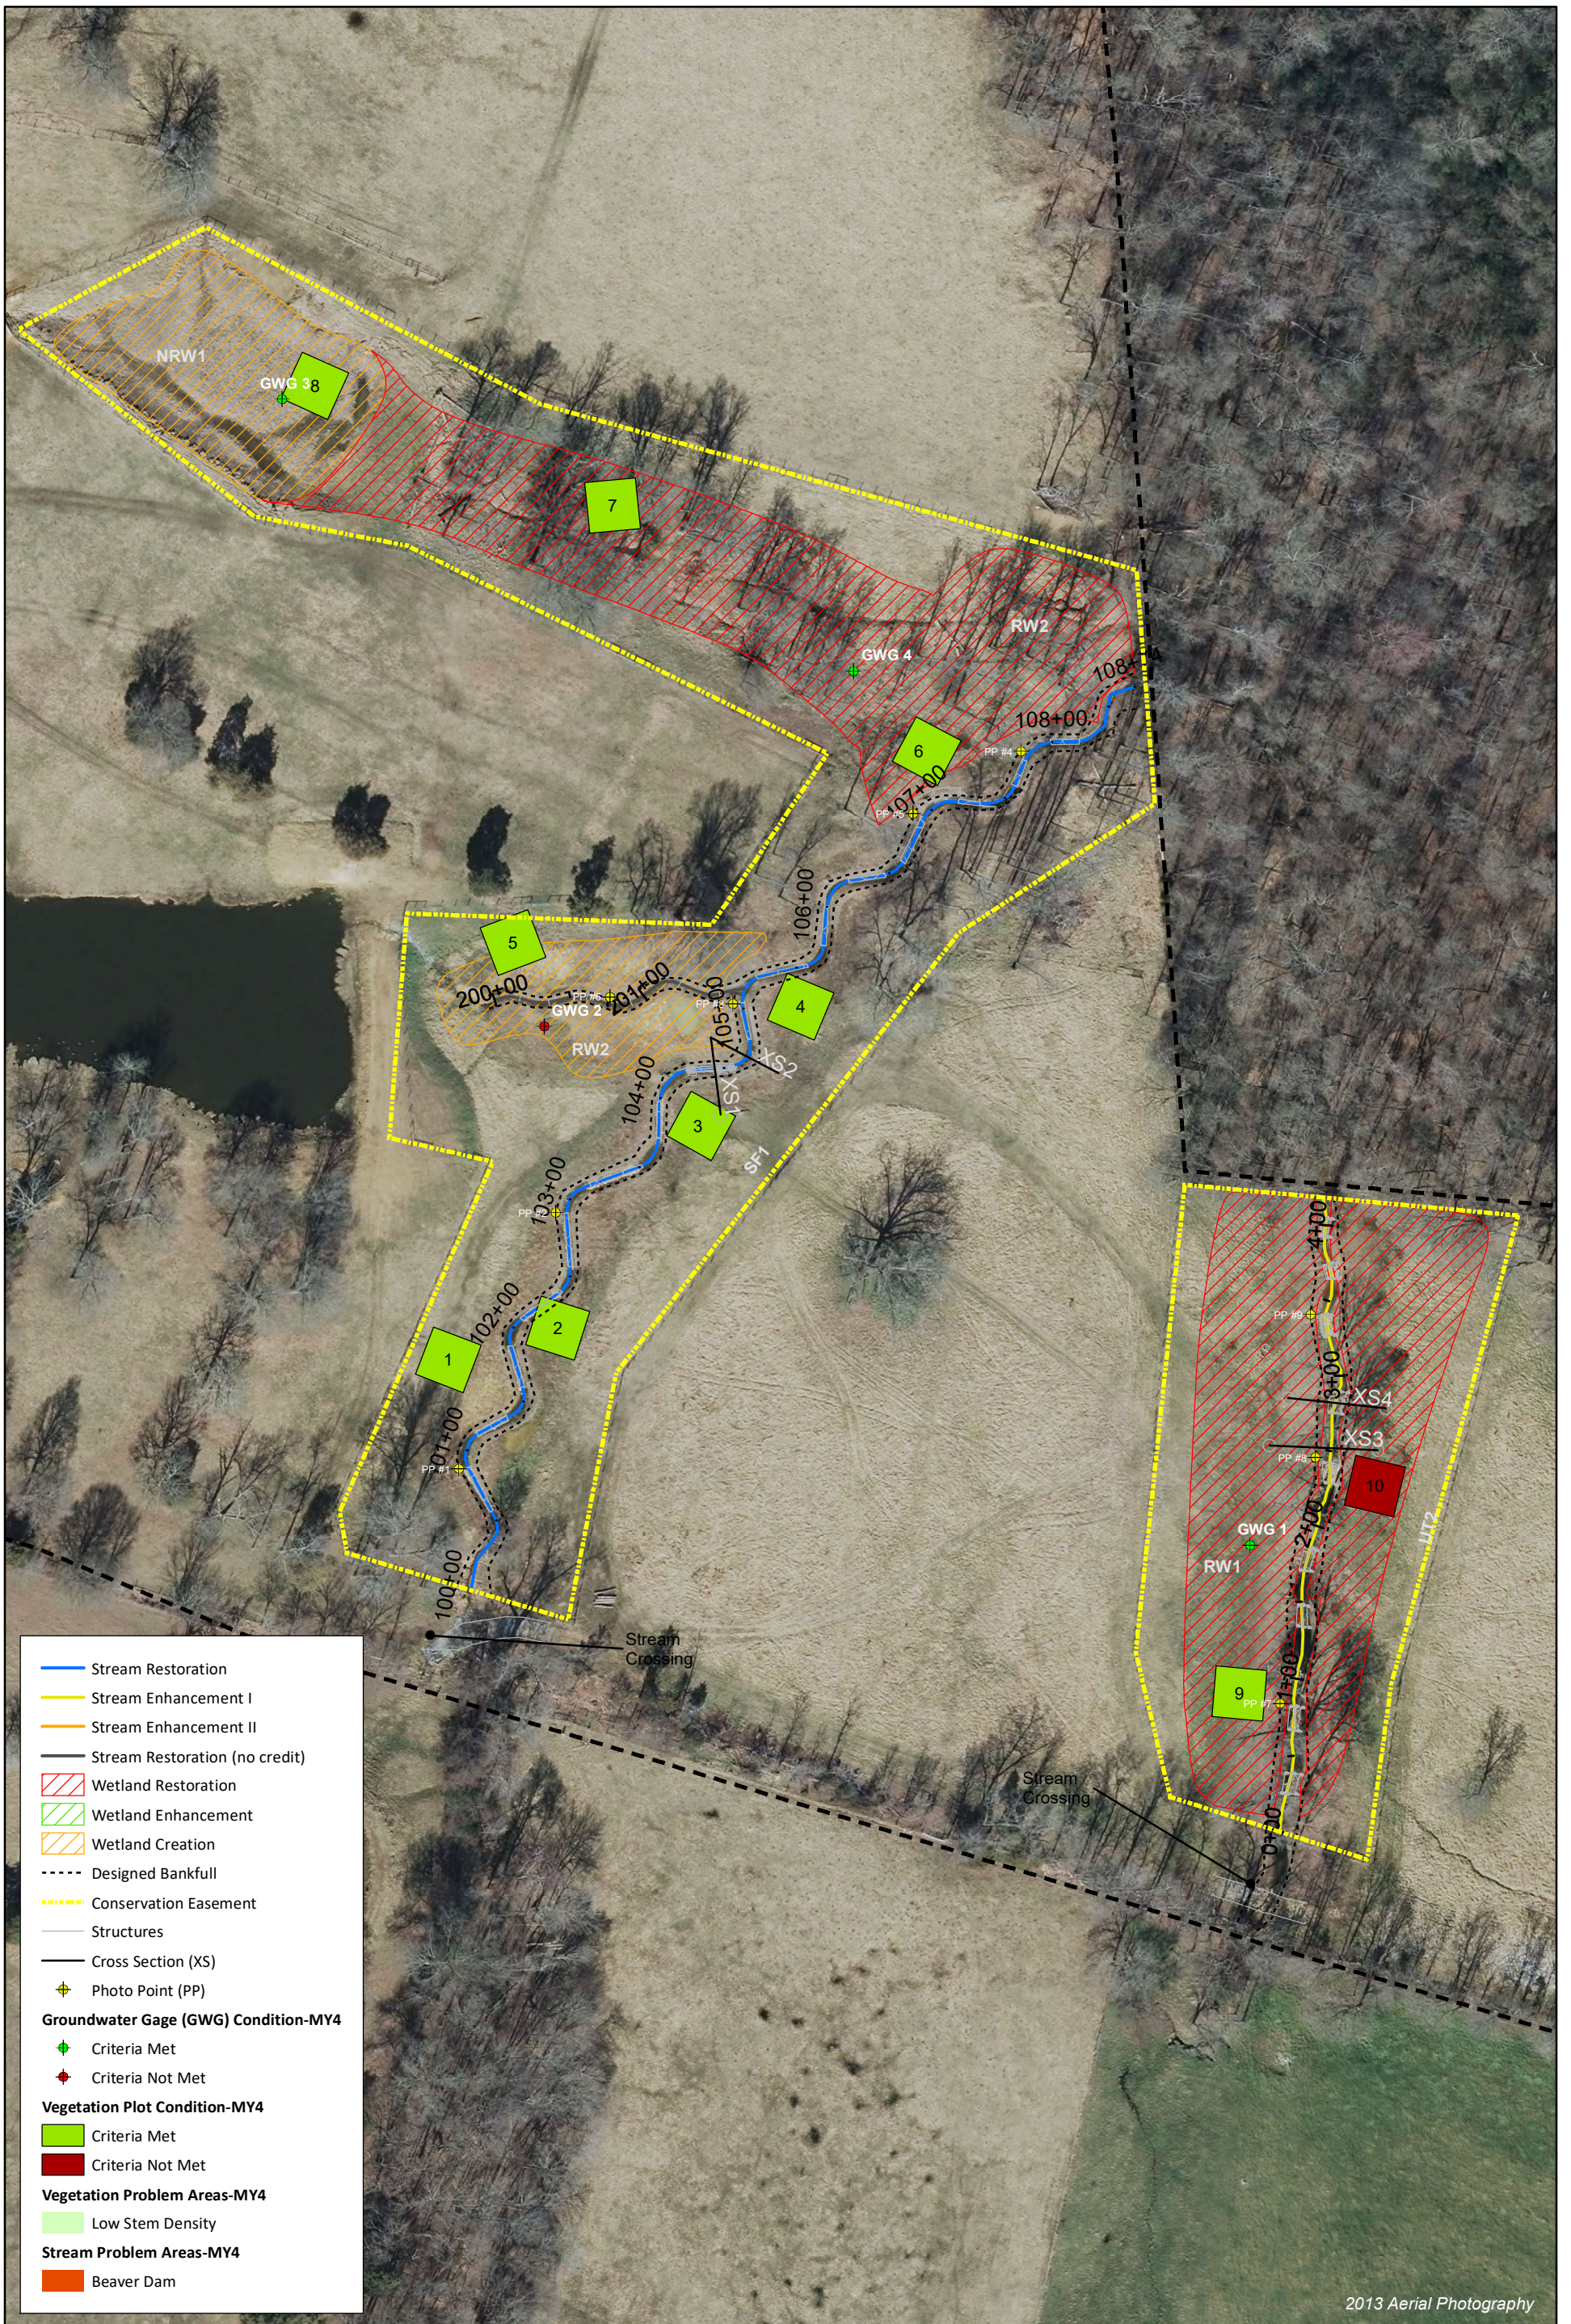
Figure 3.1 Integrated Current Condition Plan View
(Sheet 1 of 3)

During MY4 a few isolated areas were observed to have low tree densities. These areas are shown on the CCPV maps (Figures 3.0-3.3 in Appendix 2). Vegetation plots 19, and 23 did not meet the MY4 success criteria as noted above in section 1.2.1. Plot 19 is in a shaded area dominated by mature trees, and plot 23 is in a wet area which has resulted in poor growth of planted stems. Isolated areas with low tree densities will be monitored during subsequent monitoring years.

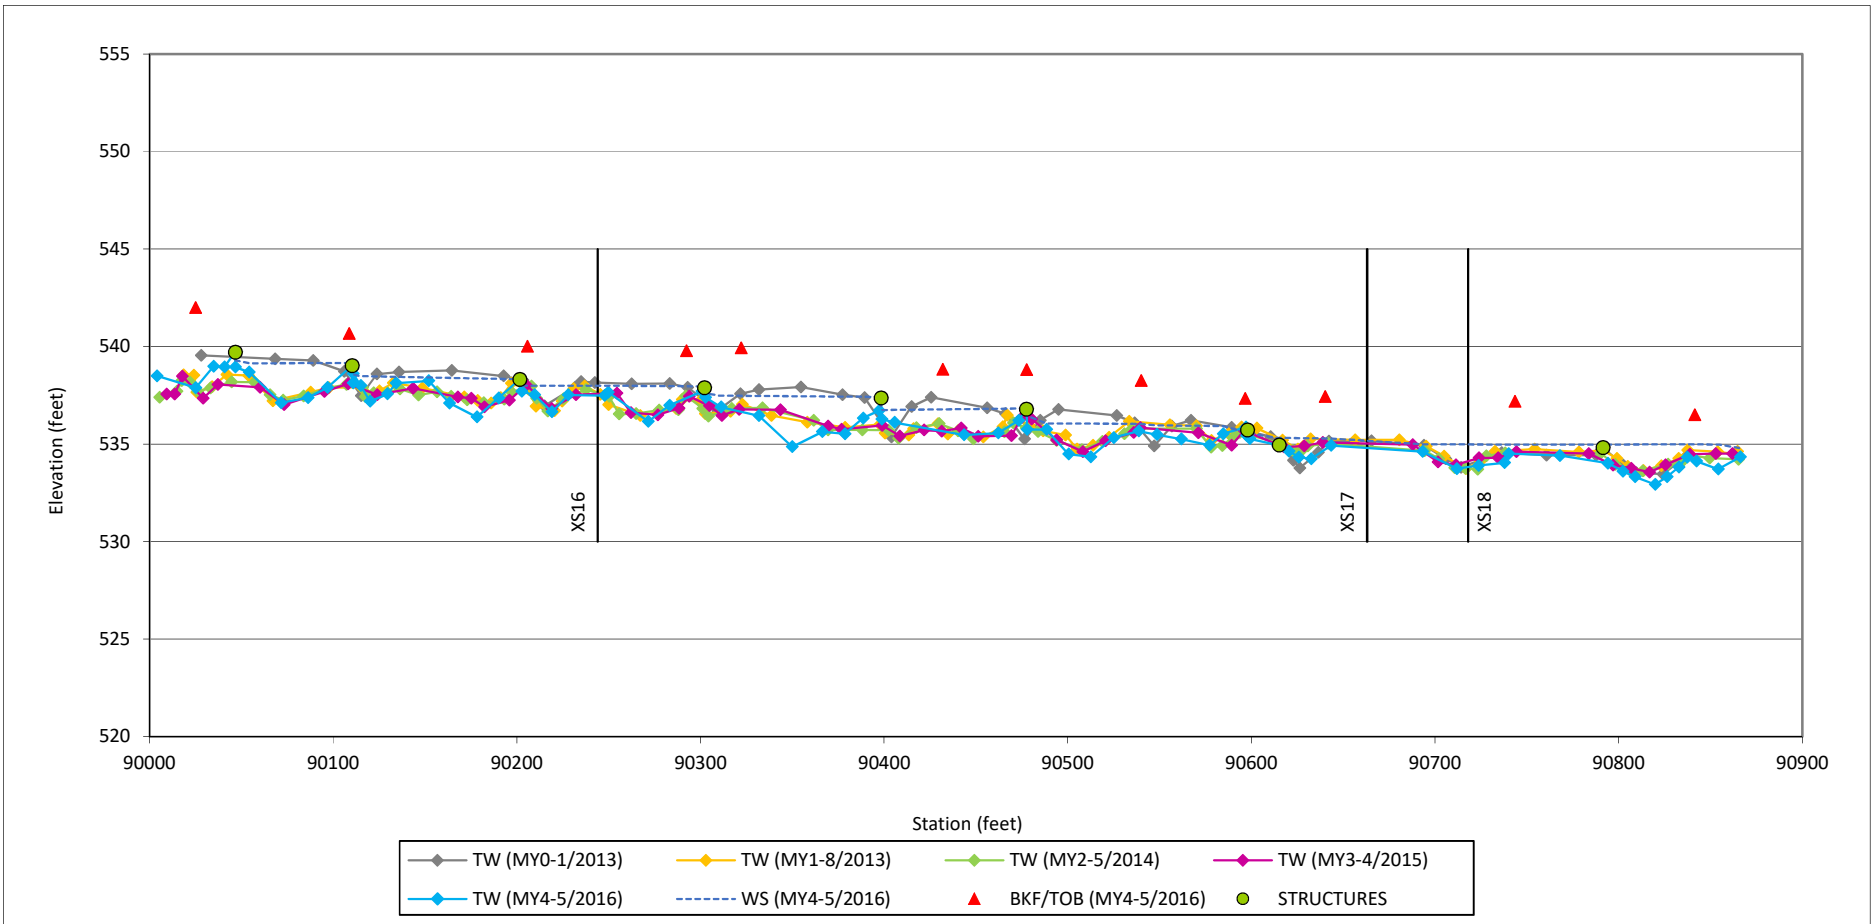
Lindley Site; SF4A

Degradation was documented in the enhancement section on SF4A (approximate STA 900+00-905+33) between MY0 and MY1. At the beginning of MY4, SF4A was repaired and the stream has remained stable since. Details regarding the repair work are discussed below in section 1.2.7.

¹Number of riffles and pools are determined based on the as-built survey along Restoration and Enhancement Level I reaches. Approximately 533 LF of the stream bed has downcut along SF4A and riffles and pools have shifted downstream. Although these conditions were not intended in the design, the stream has maintained a stable bedform with riffles and pools at a lower elevation.

As mentioned in Section 1.2.3, SF4A repair work was completed early in MY4. The repair work consisted of installing seven constructed riffles with log sills to raise the elevation of the stream bed back to the design elevation. Minor stream bank grading was also performed as necessary and native grass seed and live stakes were planted in disturbed areas. SF4A has remained stable since repairs were performed.
