# MONITORING YEAR 5 ANNUAL REPORT

## UNDERWOOD MITIGATION SITE

Chatham County, NC  
NCDEQ Contract 003268  
DMS Project Number 94641

Data Collection Period: March 2017 - November 2017  
Draft Submission Date: December 5, 2017  
Final Submission Date: January 5, 2018

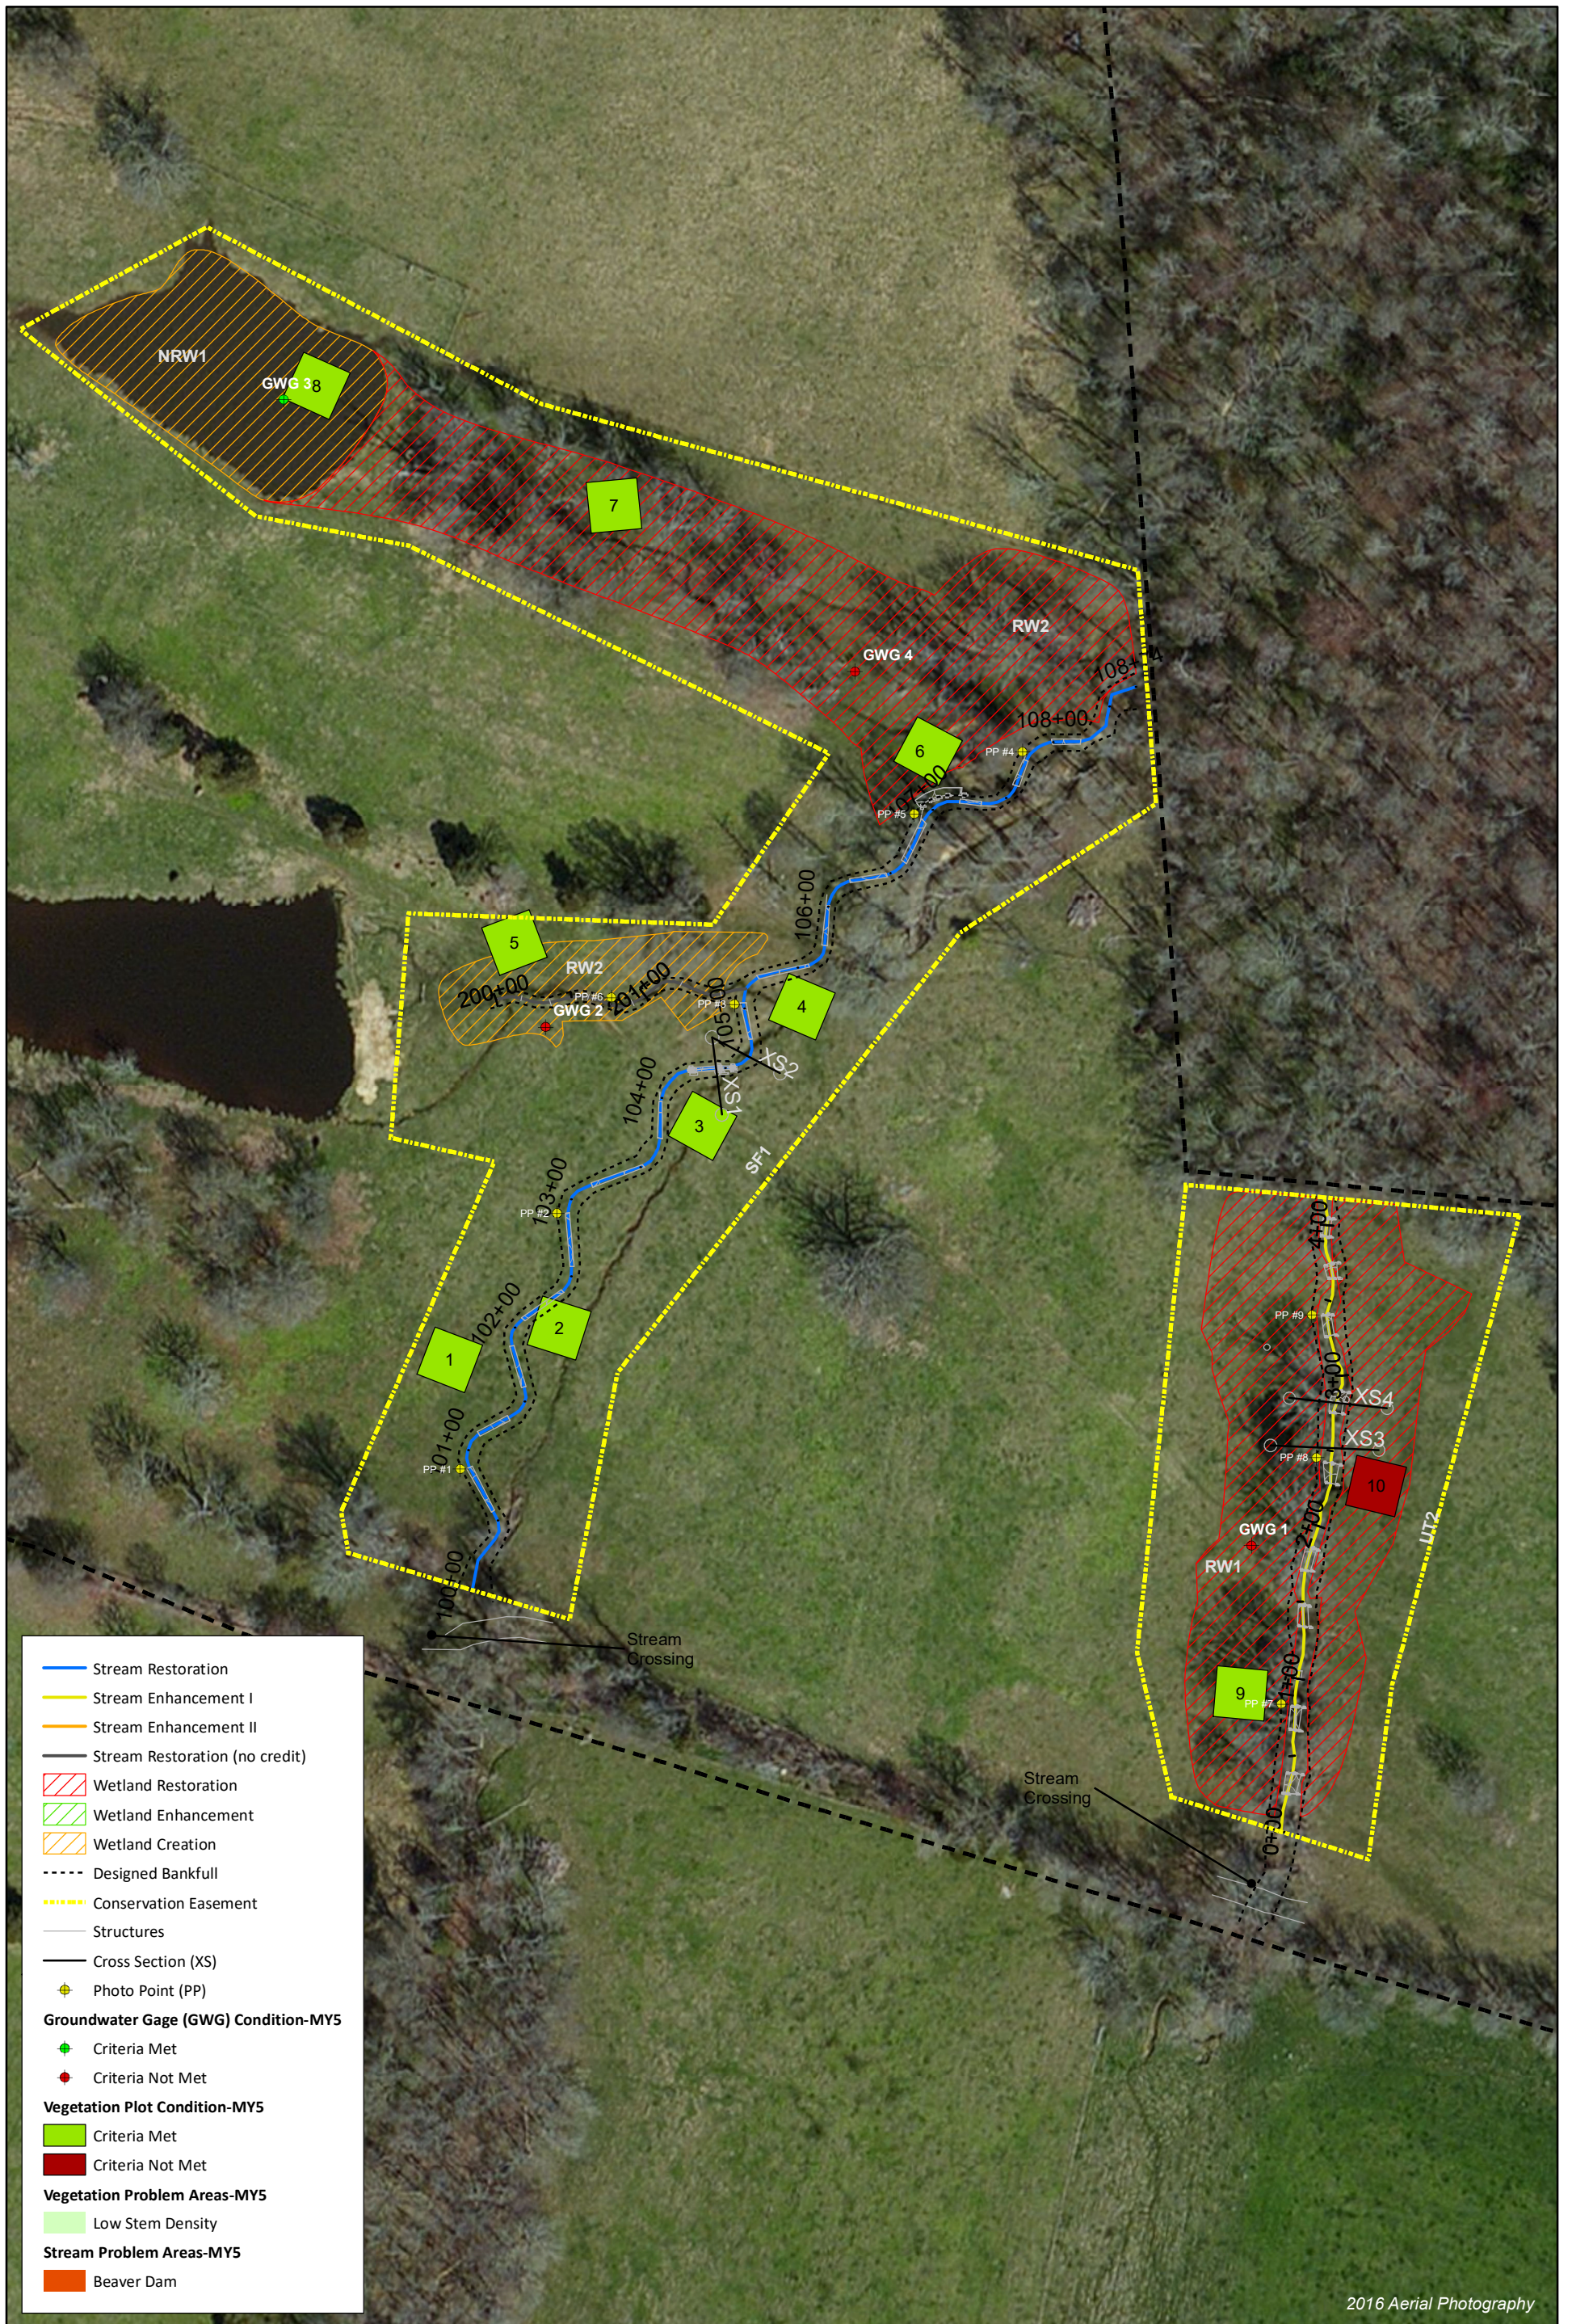
Figure 3.1 Integrated Current Condition Plan View (Sheet 1 of 3)

During MY5, vegetation plot 23 was observed to have a low stem density due to frequent standing water. As mentioned above in section 1.2.1, this isolated area (0.08 acres) is located in a low spot with dense herbaceous cover. Even though trees have not become well established in this area, no remedial actions are recommended at this time due to the small size. This area is shown on the CCPV maps (Figures 3.0-3.3 in Appendix 2).

During MY5 two beaver dams were located on SF3 during different times of the year. The beaver dams caused backwater, sediment build up in constructed riffles, and loss of some plant species on the stream banks due to girdling. Details regarding beaver and dam removal is discussed further in section 1.2.7.

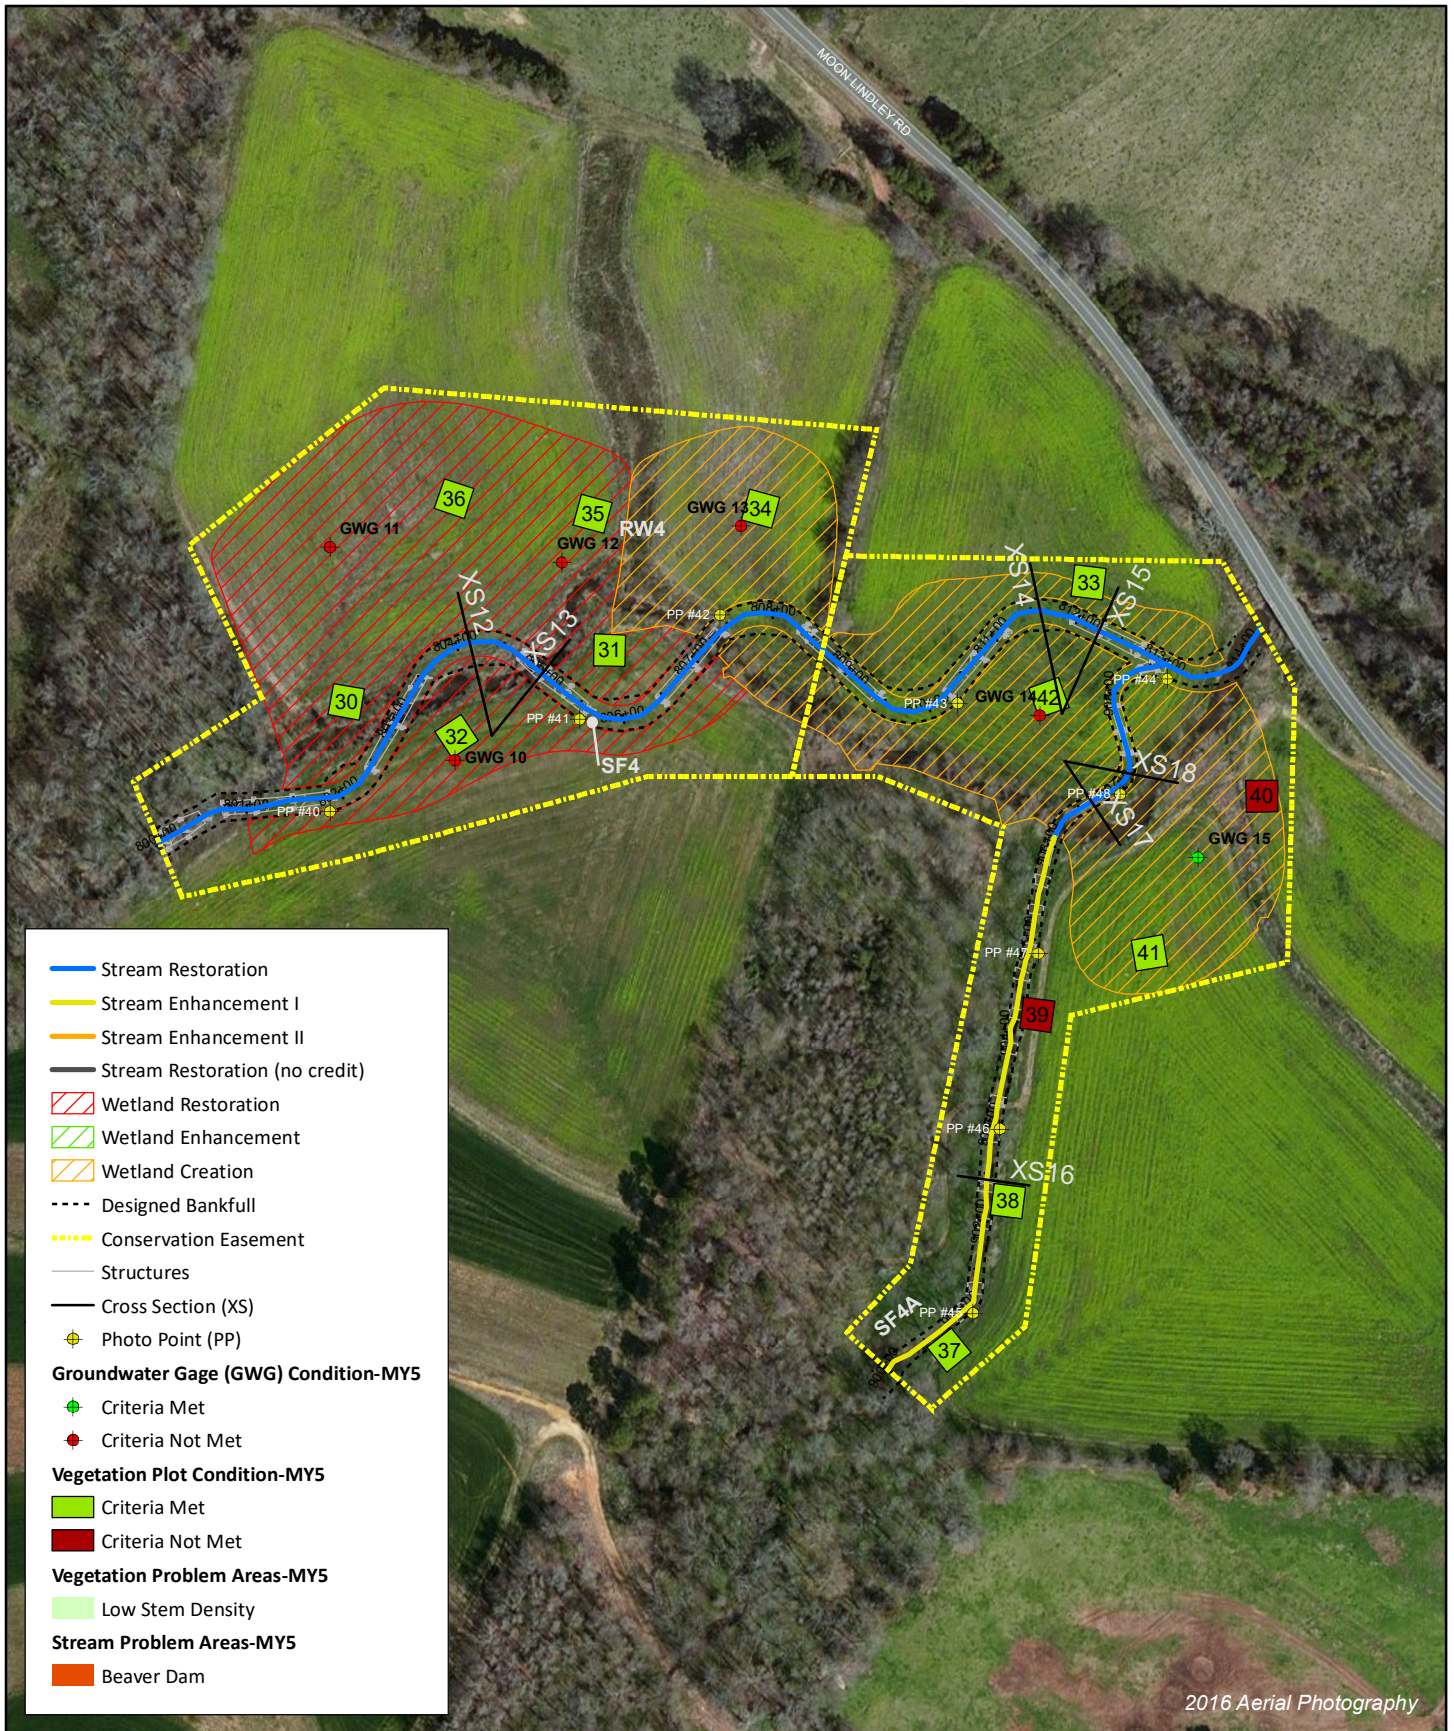
Figure 3.3 Integrated Current Condition Plan View  
(Sheet 3 of 3)

Sporadic areas of minor erosion were repaired along the outer boundary of wetland RW4 creation zone. Runoff from the agricultural field had caused some minor rilling. These areas were graded, matted, and seeded to prevent future erosion.
