Upper Silver Creek Restoration Project Year 1 Monitoring Report

NCDMS Project ID Number – 94645

Submission Date: April 2016

Report Prepared and Submitted by Michael Baker Engineering, Inc.
797 Haywood Road, Suite 201
Asheville, NC 28806

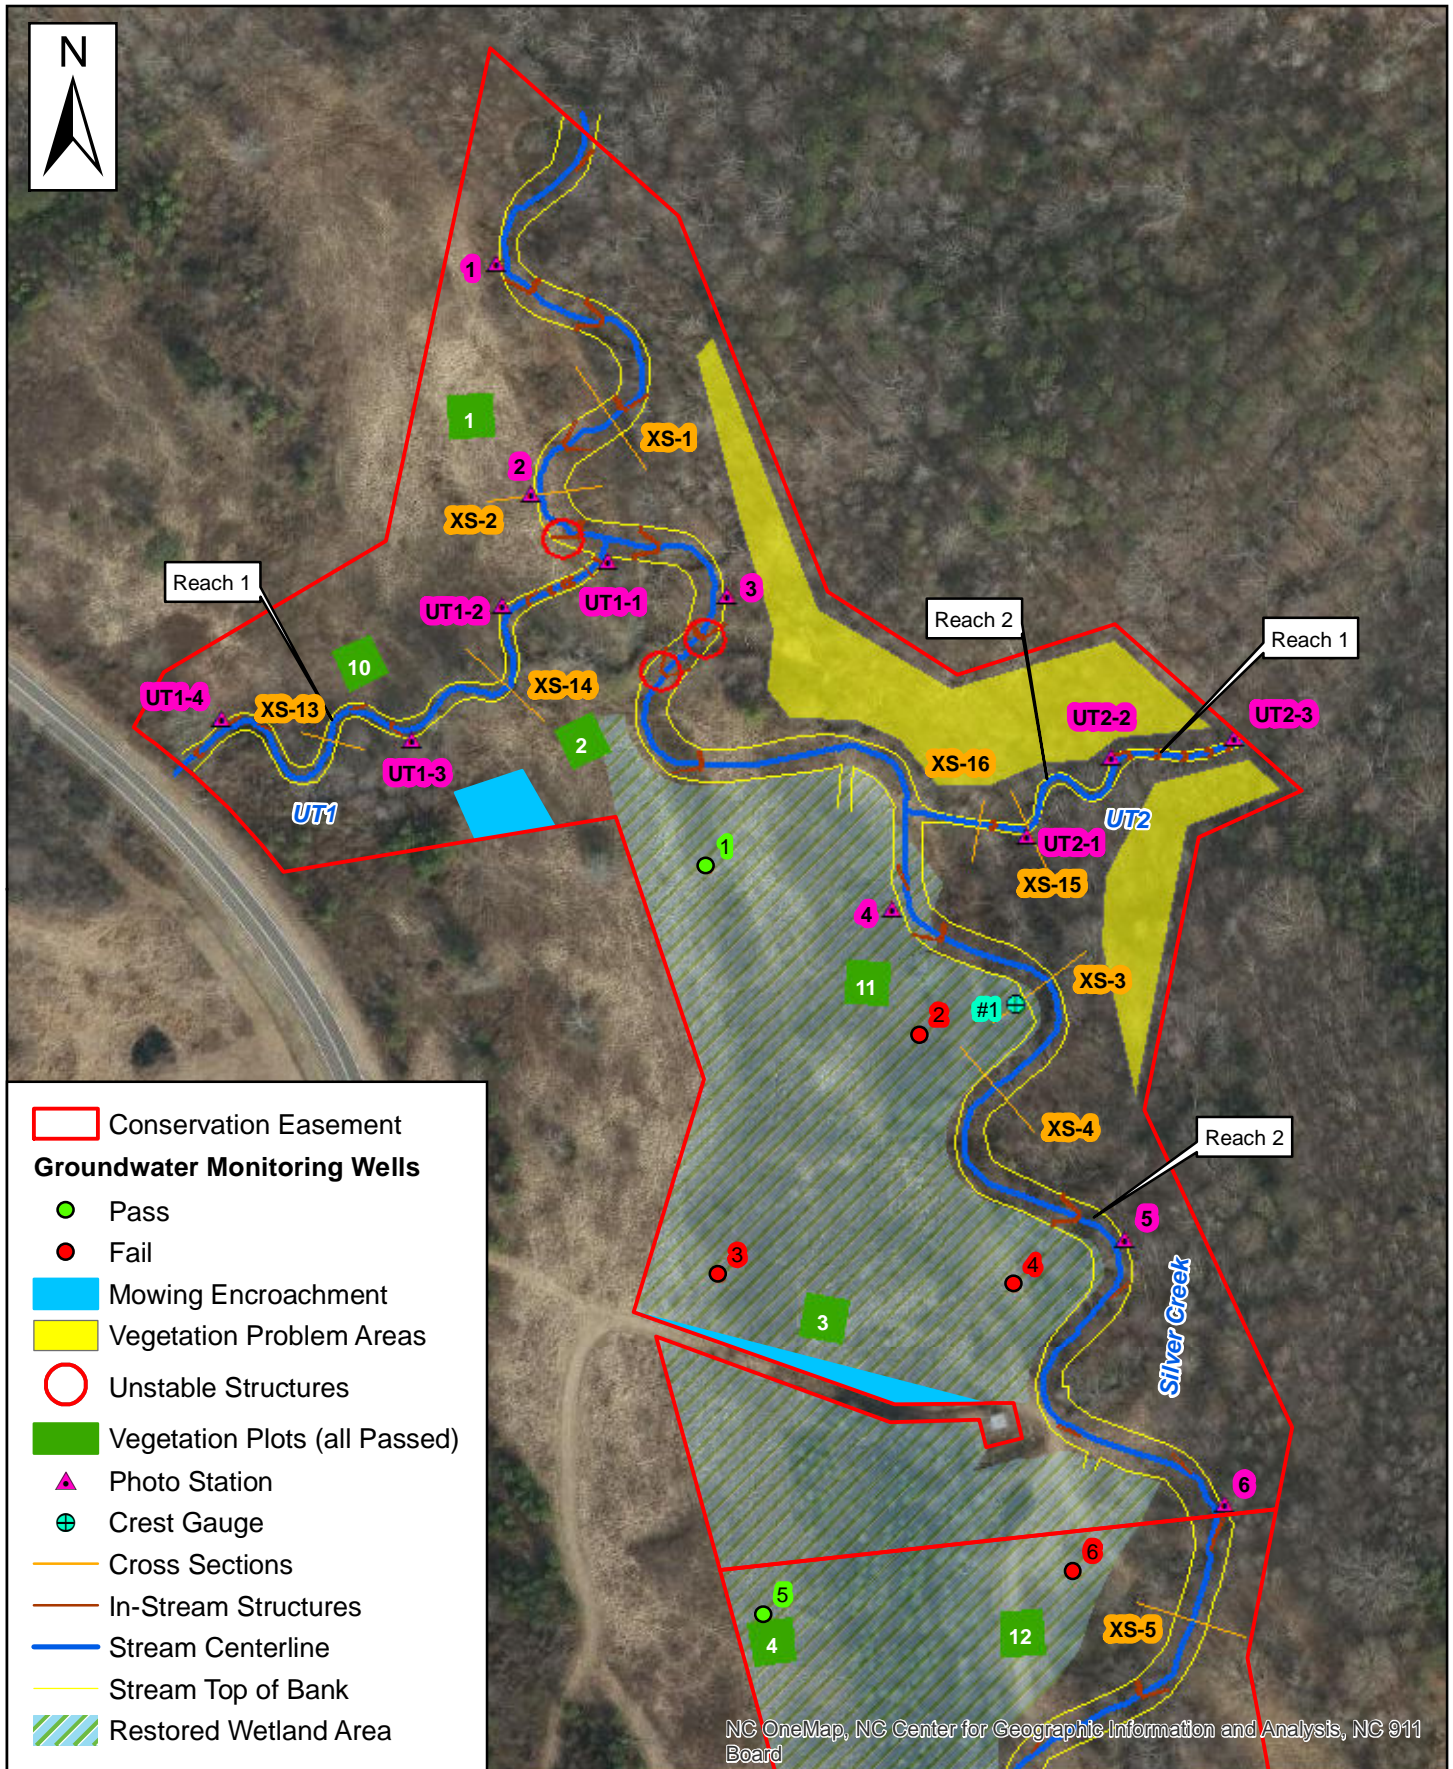
Figure 2A
Current Conditions Plan View
Monitoring Year 1
Upper Silver Creek Site

Invasive species areas of concern were observed and documented accordingly during Year 1. Monitoring indicated that there were two areas found to contain the invasive species, Chinese privet. To control this invasive species, these areas are scheduled to be treated in 2016 during the appropriate treatment window by use of the herbicide Glyphosate. There were six areas along the easement line where the landowner encroached into the easement while attempting to mow the area outside of the easement line. The easement line in these areas will be better marked with witness posts to make clear the line location.
