Subject: Response to DMS comments on the Year 3 Monitoring Report Review for the Upper Silver Creek Stream and Wetland Restoration Project; Catawba River Basin - CU# 03050101; Burke County, North Carolina; NCEEP Project # 94645; Contract No. 003270

Burke County, North Carolina
NCDMS Project ID Number – 94645

Figure 2 - Overview
Current Conditions Plan View
Monitoring Year 3
Upper Silver Creek Site

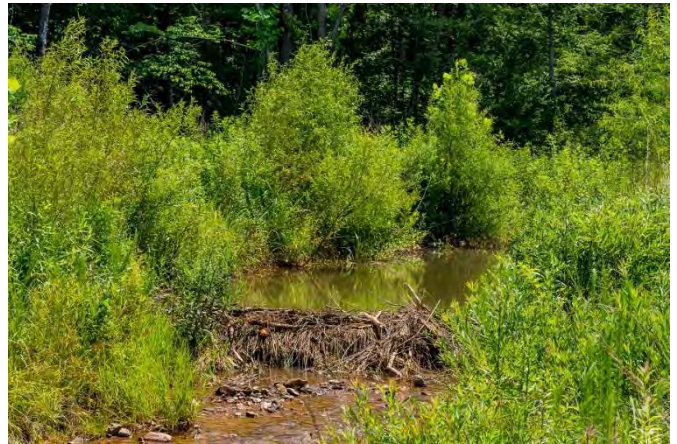
done permanent damage to streambanks or structure. Photos of the dams can be found in the Photolog.

Beaver dam located at Station 25+50 (6/28/2017)

Beaver dam located at Station 22+50 (6/28/2017)

- Please add June 2017 invasive treatment to table.
 - *Invasive treatment was added to Table 2.*
- Please add July 2017 beaver dam removal to table
 - *Beaver dam removal was added to Table 2.*
