Subject: Response to DMS comments on the Year 5 Monitoring Report Review for the Upper Silver Creek Stream and Wetland Restoration Project; Catawba River Basin - CU# 03050101; Burke County, North Carolina; NCEEP Project # 94645; Contract No. 003270

Figure 2 - Overview
Current Conditions Plan View
Monitoring Year 5
Upper Silver Creek Site

**Figure 4. Vegetation Monitoring Plot Photos
Upper Silver Creek - DMS Project #94645**

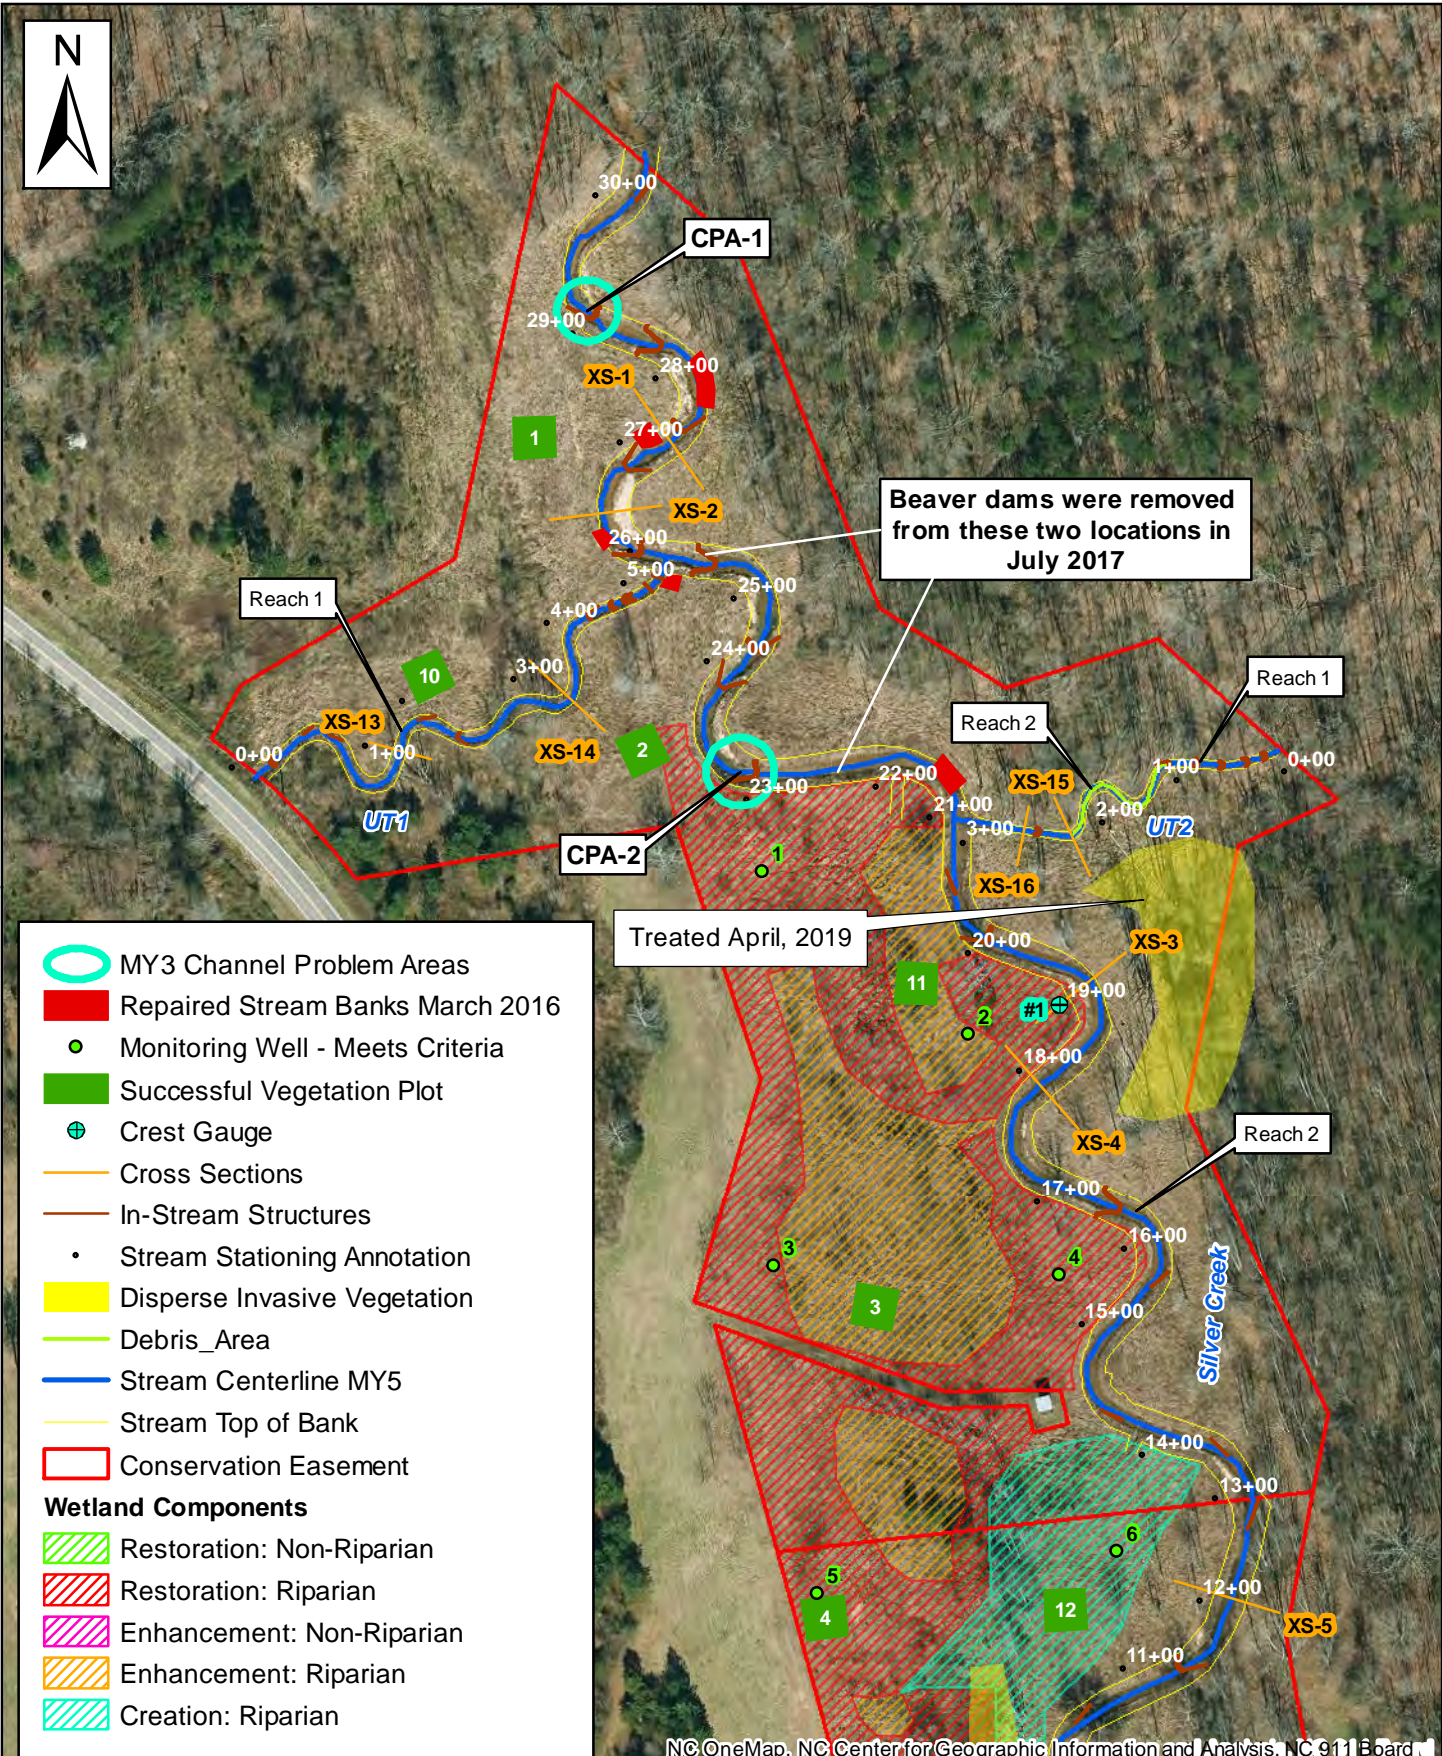
Fig 2A

Location of debris/obstruction removal has been added.

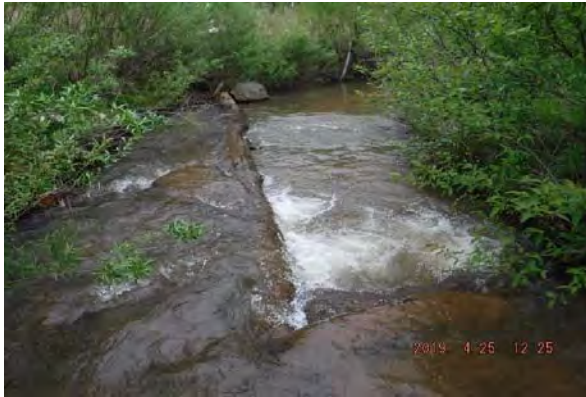
Table 8a. Stream Problem Areas			
Upper Silver Creek Mitigation Project, NCDMS Project No. 94645			
Sink Hole Creek and Uts			
Feature Issue	Station No.	Suspected Cause	Photo Number
J-hook Arm Piping.	23+00	Loss of back fill and fabric that seals the arm. This problem area was first noted in MY3 and has continued during MY5. While not fully functioning as a vane it is providing good habitat, is turning water to the thalweg and is stable.	Photo #1
Bank Erosion	6 + 50	Bank erosion along outside of menader bend. Not completely stable but significantly better than first noted in MY3 and gradually revegetating.	Photo #2 & #3

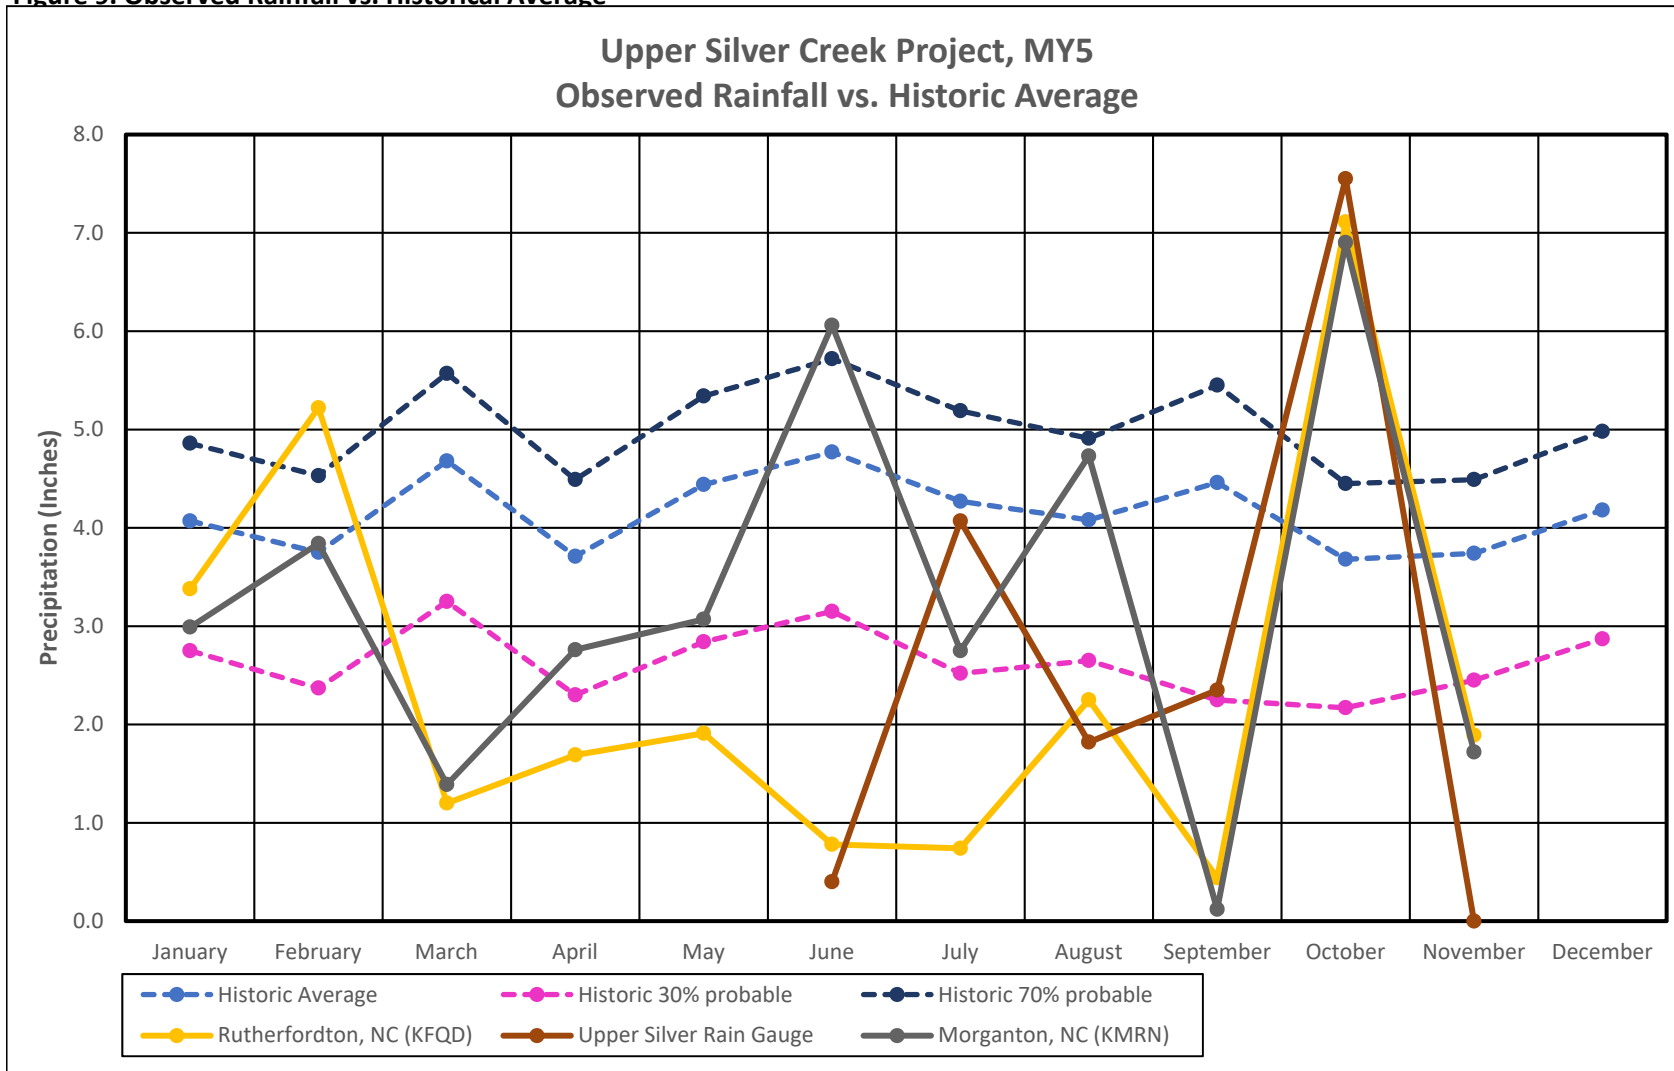
Figure 9. Observed Rainfall vs. Historical Average

1. Upper Silver Rain Gauge malfunctioned and began recording on 6-10. KMRN gauge accounts for rainfall prior to June 10.
2. Historic rainfall data from Burke County Soil Survey, NRCS, pg. 420
3. Rainfall data source for Upper Silver Rain Gauge: Onsite HOBO tipping bucket rain gauge with Pendant Data Logger
4. Rainfall data source for Rutherfordton, NC: <http://climate.ncsu.edu/cronos?station=KFQD&temporal=hourly>
5. Rainfall data source for Morganton, NC: <http://climate.ncsu.edu/cronos?station=KMRN&temporal=hourly>
6. Rainfall data source for historic averages: Morganton, NC WETS Table (1971-2016)
