**Baseline Monitoring Document
and
As-built (MY0) Baseline Report**

**Upper South Hominy Mitigation Site,
South Hominy Creek, French Broad River Basin,
Buncombe County, North Carolina**

EEP Project Number: 92632
Contract Number: D06082; Task Order: 08 FB05-1b-d

Data Collected: November 2011-February 2012
Submitted: 30 April 2013

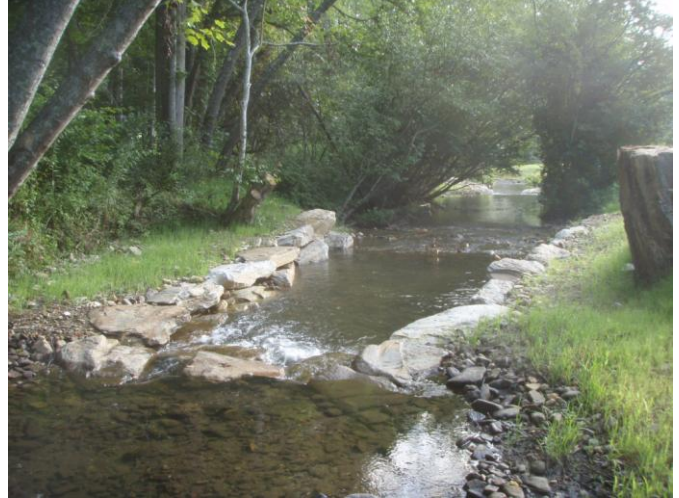
Mid channel bar, sta. 0+50, facing downstream, pre-construction. 30 September 2008.

Cross vane, sta. 0+50, facing downstream, 14 August 2011.

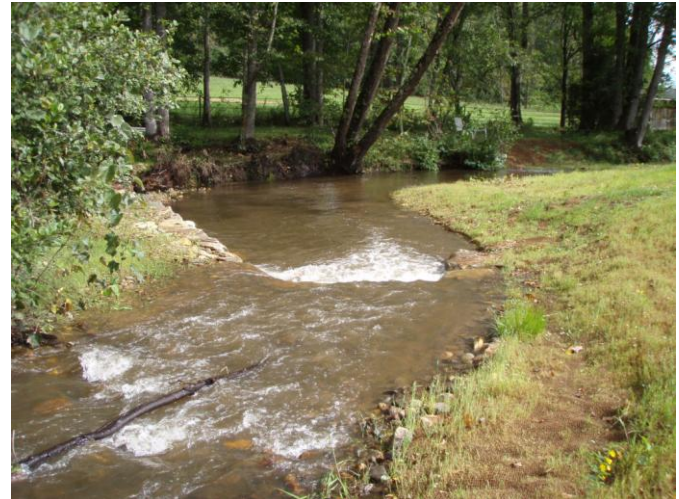
Photo Station 2

Channel blockage, sta.2+50, facing downstream, pre-construction, 30 September 2008.

J-hook, sta. 2+50, facing downstream, 5 September 2011.

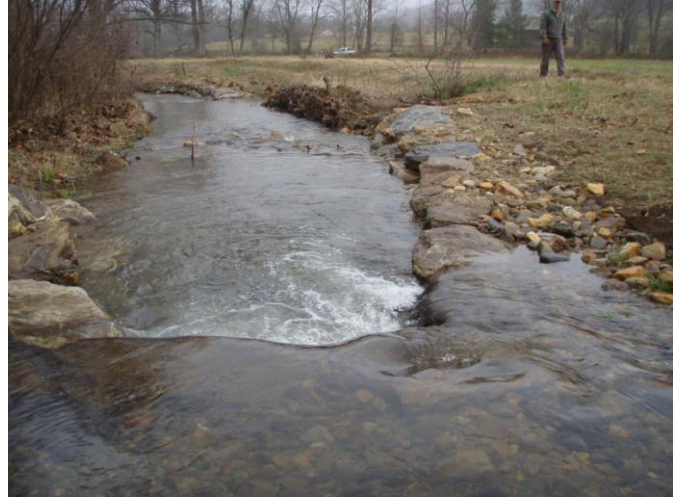
Photo Station 3

Right bank erosion, sta. 5+50, pre-construction, 30 September 2008.

J-hook, sta. 5+00, facing downstream, 5 December 2011.

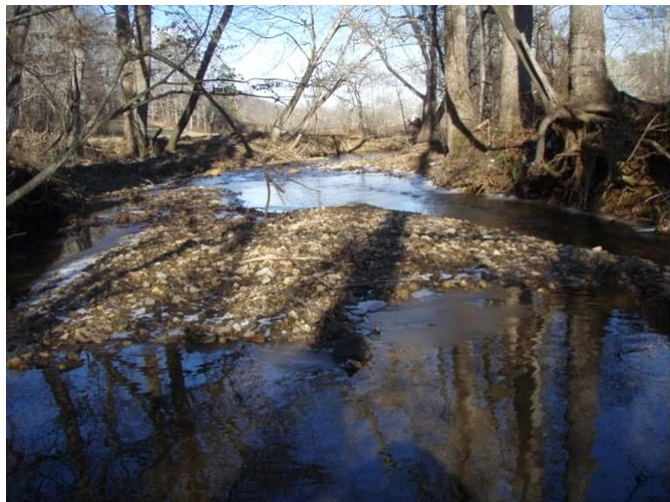
Photo Station 12

Mid channel aggradation, sta. 1+50 to 2+50, facing downstream.
22 January 2009.

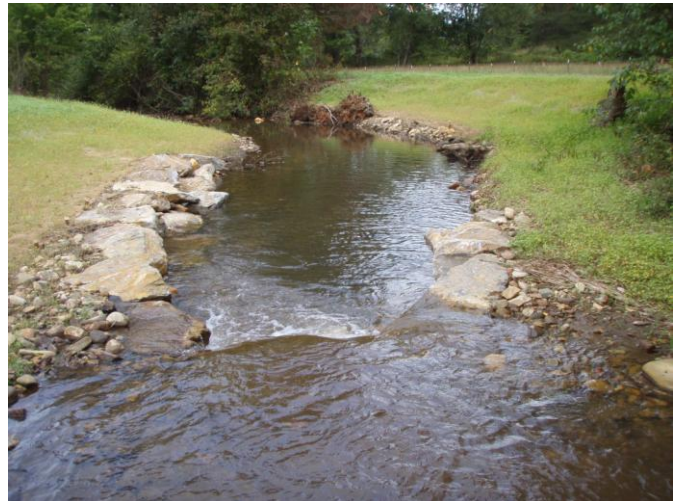
Bed aggradation and transverse bar, sta. 9+50 to 10+00, facing downstream, 22 January 2009.

Bank sloping and J-hook, sta. 9+25 to 10+00, 22 September 2011.

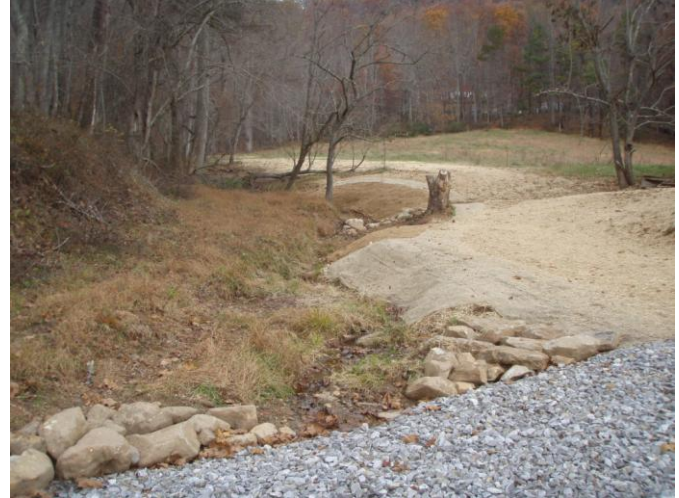
UT3 above ford, channel incision, facing downstream, 25 July 2008.

UT3 above ford, invasive removal, cattle exclusion, and bank shaping, facing upstream, 9 November 2011.

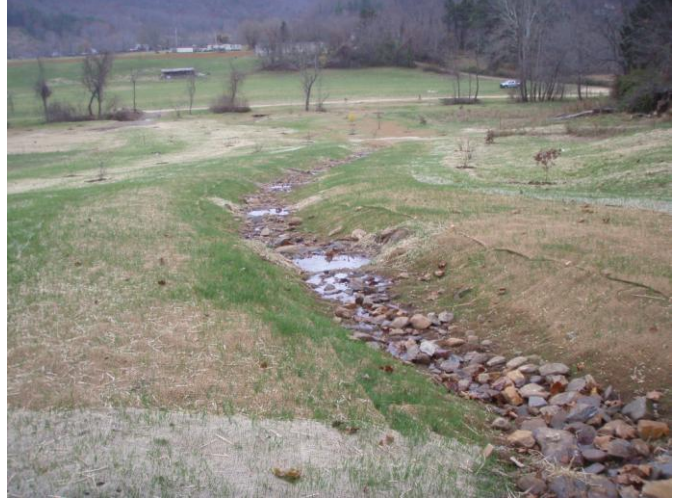
UT3 below ford, severe entrenchment and head cutting, 25 July 2008.

UT3 below ford, Priority I channel restoration, facing downstream, sta. 0+00, 15 November 2011.

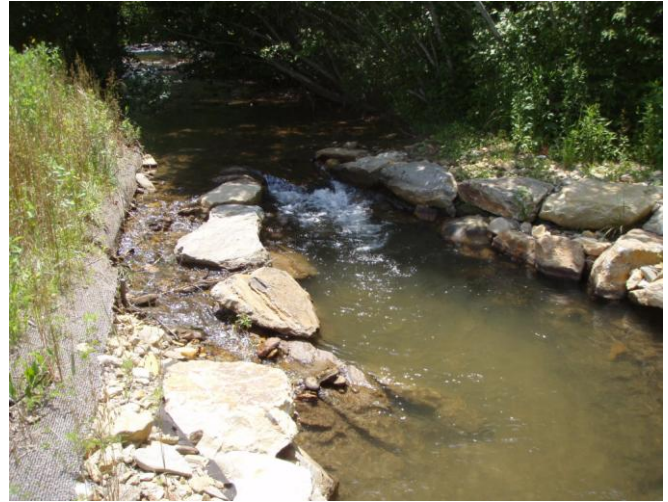
Rock vane after construction, sta. 1+50, facing upstream, 5 September 2011.

Rock vane after flood damage, sta. 1+50, 5 December 2012.

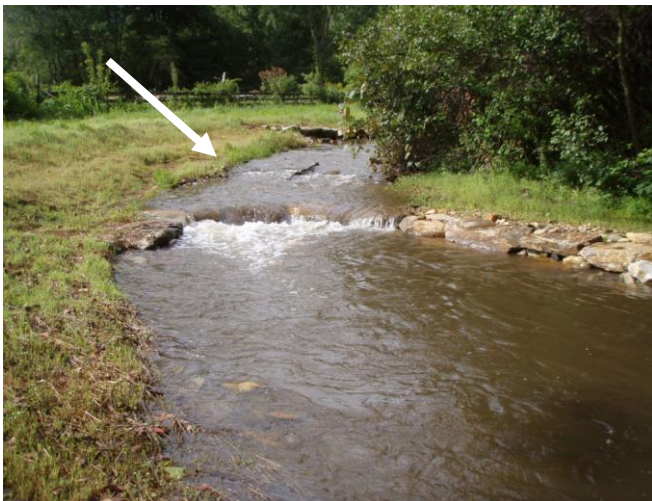
Problem Area 2

Left channel bank under stable condition, sta. 2+00, facing upstream, 5 September 2011.

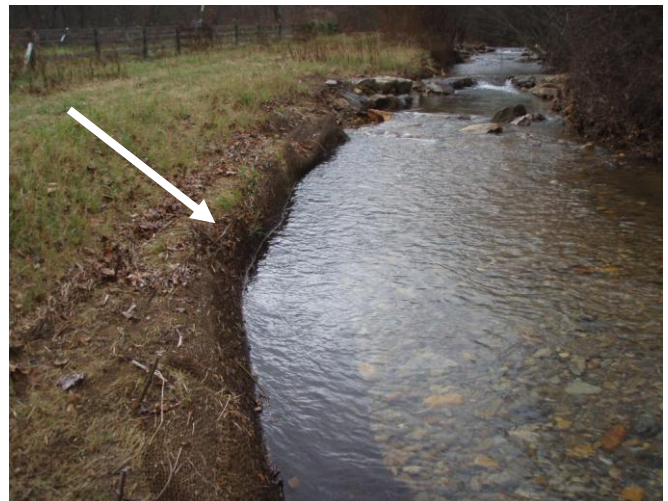
Left channel bank instability after flood damage, sta. 1+75 to 2+25, 5 December 2012.
