# Monitoring Year 1 Report

## Upper South Hominy Mitigation Site, South Hominy Creek, French Broad River Basin, Buncombe County, North Carolina

EEP Project Number: 92632  
Contract Number: D06082; Task Order: 08 FB05-1b-d

Data Collected: October 2012-November 2012  
Submitted: 7 February 2014

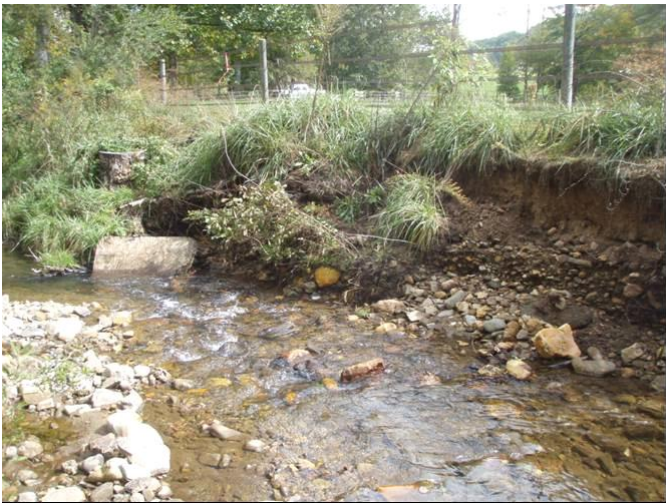
Photo Station 3

Right bank erosion, sta. 5+50, pre-construction, 30 September 2008.

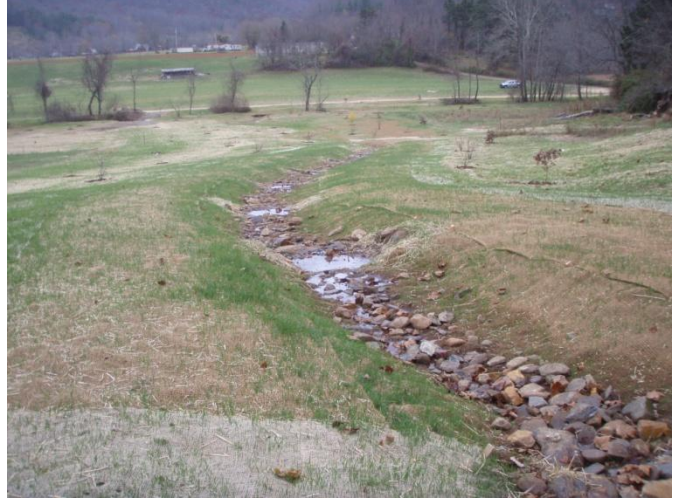
UT3 below ford, severe entrenchment and head cutting, 25 July 2008.

UT3 below ford, Priority I channel restoration, facing downstream, sta. 0+00, 15 November 2011.

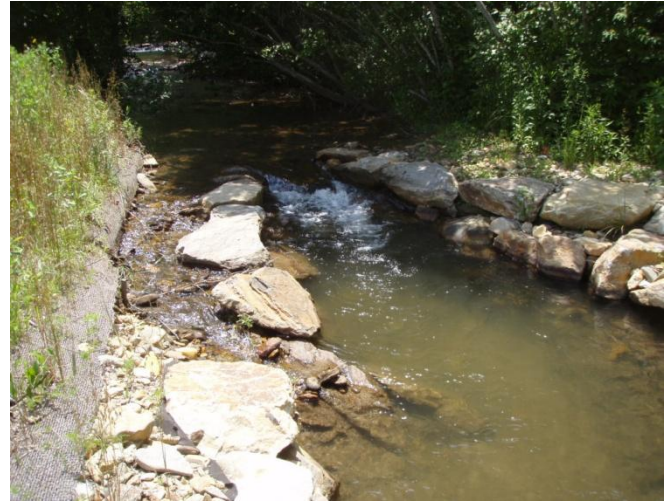
Rock vane after flood damage, sta. 1+50, facing upstream, 14 June 2012.

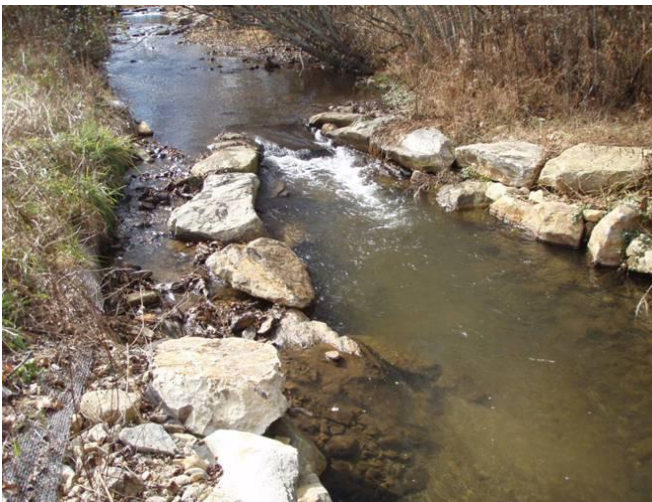
Rock vane, sta. 1+50, facing upstream, 20 November 2012.

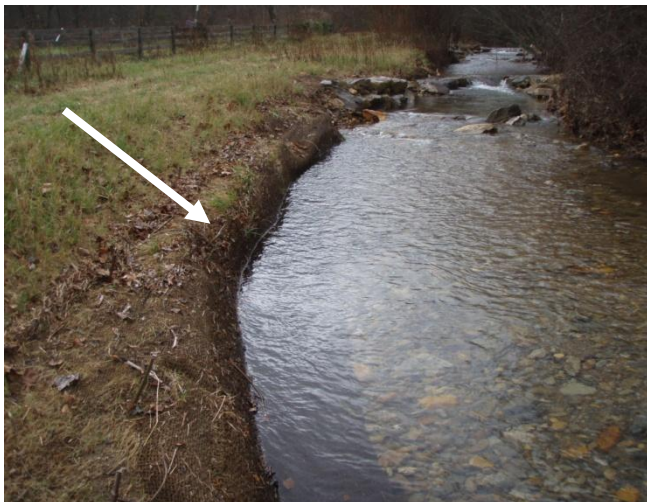
Problem Area 2

Problem areas resulting from the storm event on 28 November 2011 were again noted in the MY1 survey. Right channel bank sloughing, J-hook arm scour, and bar formation was observed in the Mainstem 1 reach from sta. 1+50 to 3+00. A second problem area was observed on Mainstem 2, sta. 9+25 to 9+75, where a large amount of bed material formed a mid-channel bar below a J-hook stream structure. Aggradation of bed material was also observed directly below 4 of the last five rock structures on SHC. Although the structures are intact and stable, habitat

Right channel bank instability after flood damage, sta. 1+75 to 2+25, facing upstream, 5 December 2011.

that existed after construction has been lost due to significant filling of the pools. Repair plans and Scope of Work will be developed and presented to NCEEP to address the needed modifications to the problem areas. Repair work will likely occur in the summer of 2014. Overall, the MY1 survey found the majority of the 2,820 ft of mainstem channel was stable and performing as designed.

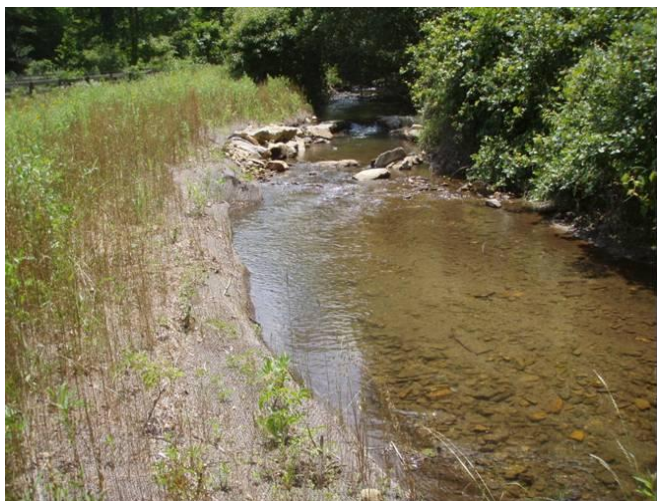
Right channel bank instability after flood, sta. 1+75 to 2+25, facing upstream, 14 June 2012.
