Monitoring Year 2 Report

Upper South Hominy Mitigation Site, South Hominy Creek, French Broad River Basin, Buncombe County, North Carolina

EEP Project Number: 92632
Contract Number: D06082; Task Order: 08 FB05-1b-d

Data Collected: October 2013-November 2013
Submitted: 30 May 2014

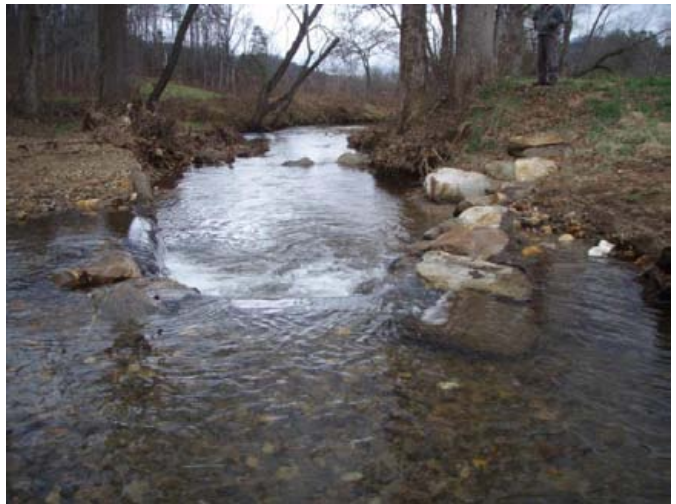
Mid channel aggradation, sta. 1+50 to 2+50, facing downstream.
22 January 2009.

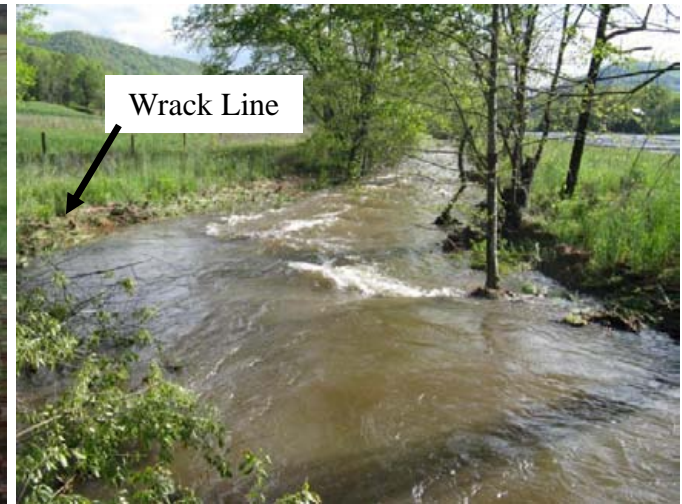
Photo 6 bankfull event on SHC, Davis property, sta. 0+50
06 May 2013.

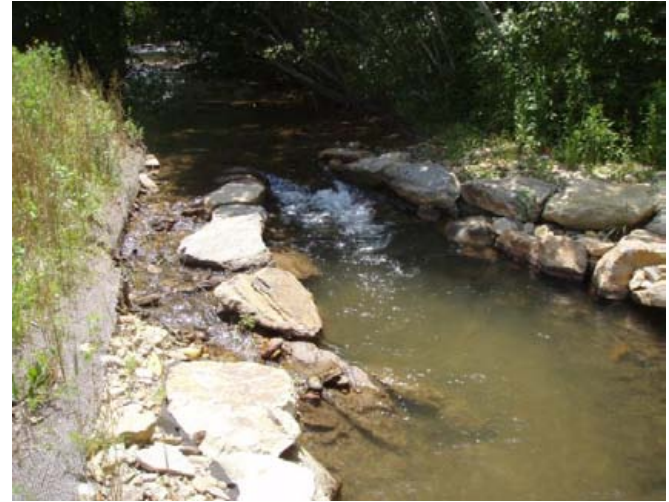
Rock vane after flood damage, sta. 1+50, facing upstream, 14 June 2012.

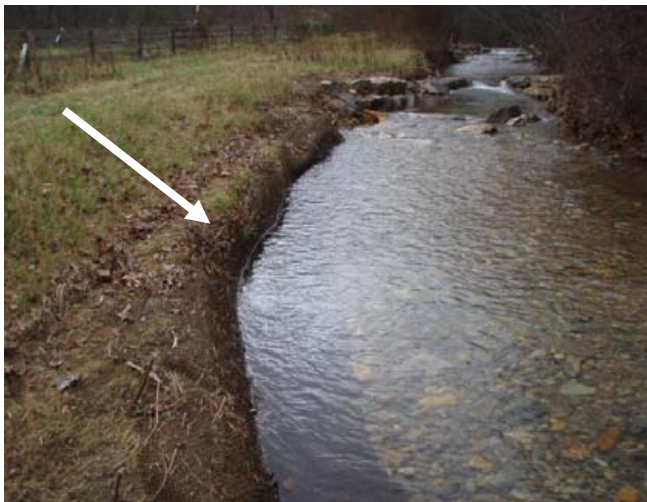
Right channel bank instability after flood damage, sta. 1+75 to 2+25, facing upstream, 5 December 2011.

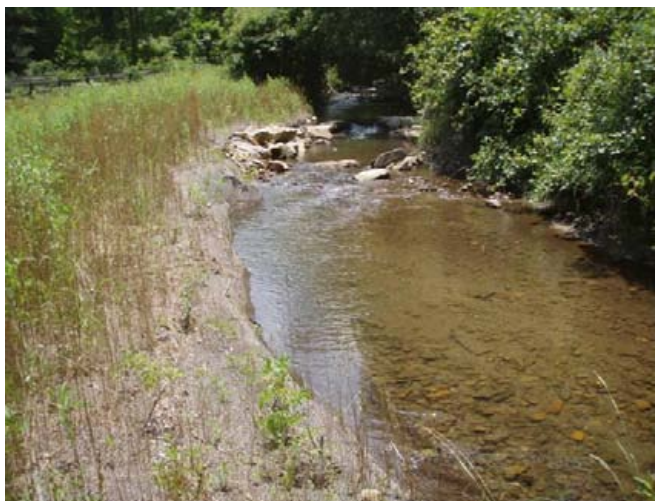
Right channel bank instability after flood, sta. 1+75 to 2+25, facing upstream, 14 June 2012.

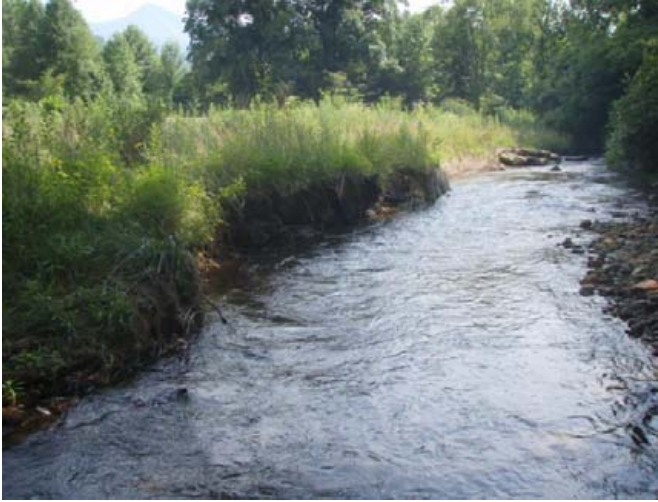
Problem Area 2

Right channel bank condition after 5 May 2013 flood, sta. 1+75 to 2+25 facing upstream, 18 July 2013.

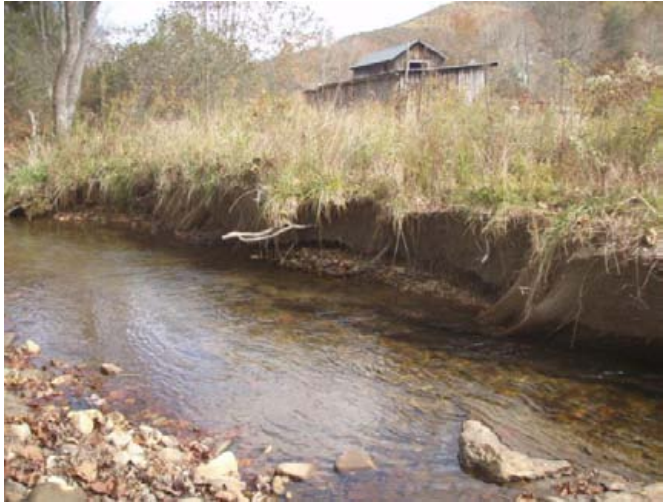
Right channel bank condition after 5 May 2013 flood, sta. 1+75 to 2+25, facing downstream, 29 October 2013.

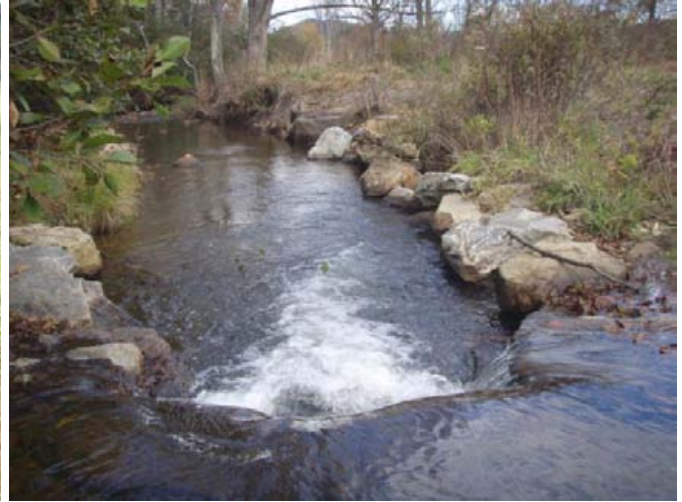
J-hook arm collapse during 5 May 2013 flood event, sta. 5+75, facing downstream, 29 October 2013.

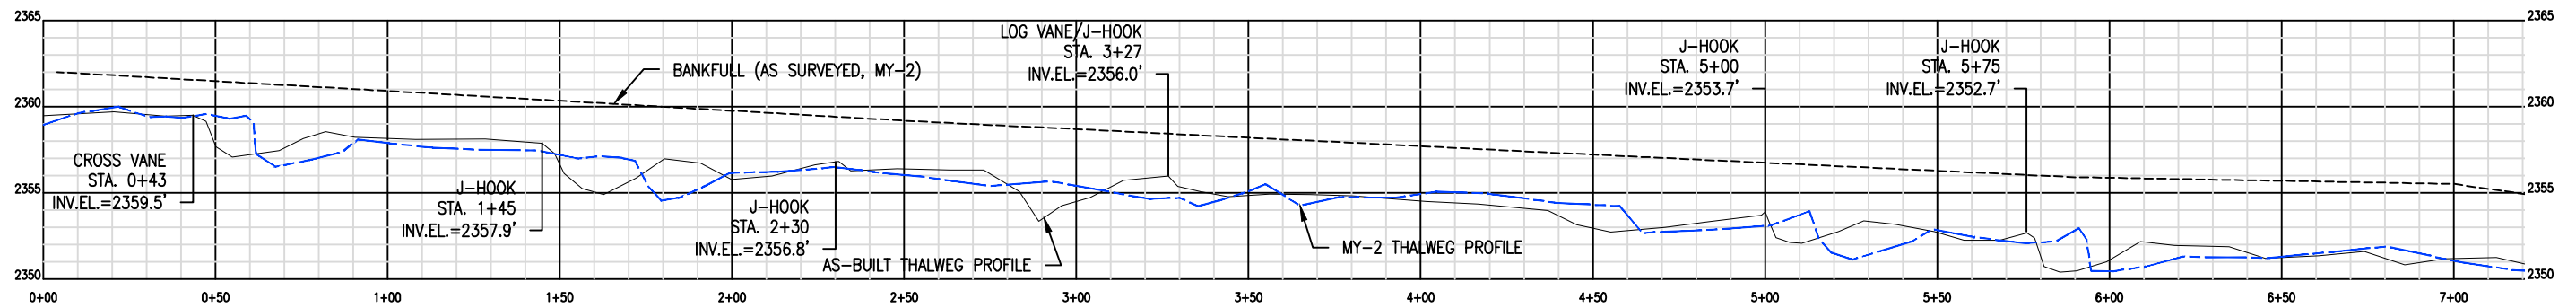
SOUTH HOMINY CREEK (BIANCULLI SECTION) MY-2 PLAN VIEW
Scale: 1"=50'

NOTE: THE CUMULATIVE EFFECT OF DEVIATIONS IN THE SURVEYED MY-2 THALWEG FROM THE BASE LINE (AS-BUILT) THALWEG BETWEEN STA 0+00 & 0+30 AND STA 2+00 & 4+50 HAVE INCREASED THE LENGTH OF THE MY2 LONG PROFILE BY APPROXIMATELY 15'. THIS IS REFLECTED IN THE APPARENT DOWNSTREAM SHIFT OF THE FIXED NICK POINTS BEGINNING AT STA. 0+30 ON THE MY-2 PROFILE.
