Monitoring Year 3 Report

Upper South Hominy Mitigation Site, South Hominy Creek, French Broad River Basin, Buncombe County, North Carolina

EEP Project Number: 92632
Contract Number: D06082; Task Order: 08 FB05-1b-d

Data Collected: October 2014-November 2014
Submitted: February 2015

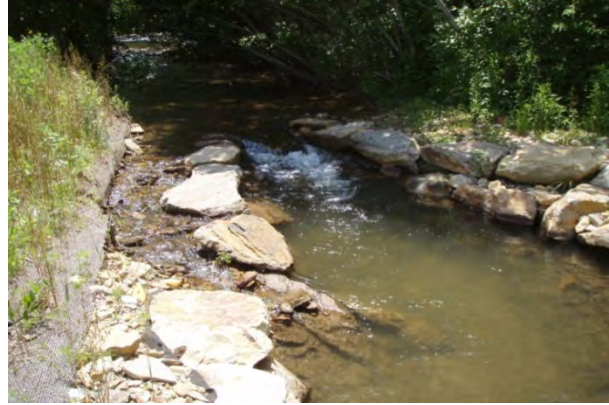
Rock vane after flood damage, sta. 1+50, facing upstream, 14 June 2012.

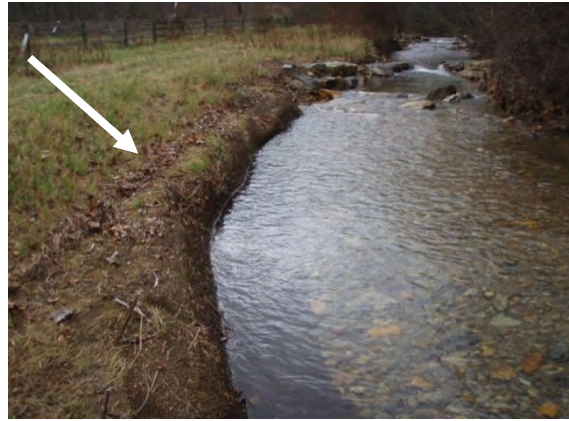
Problem Area 2

Right channel bank instability after flood damage, sta. 1+75 to 2+25, facing upstream, 5 December 2011.

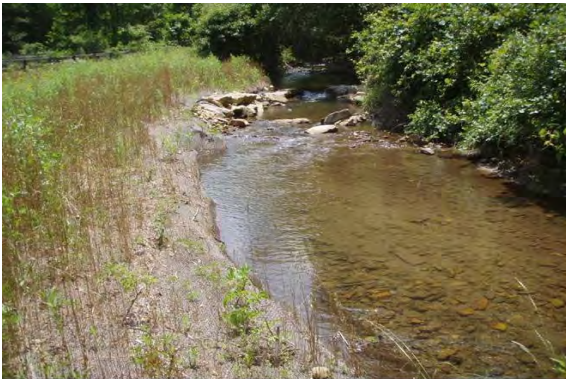
Right channel bank instability after flood, sta. 1+75 to 2+25, facing upstream, 14 June 2012.

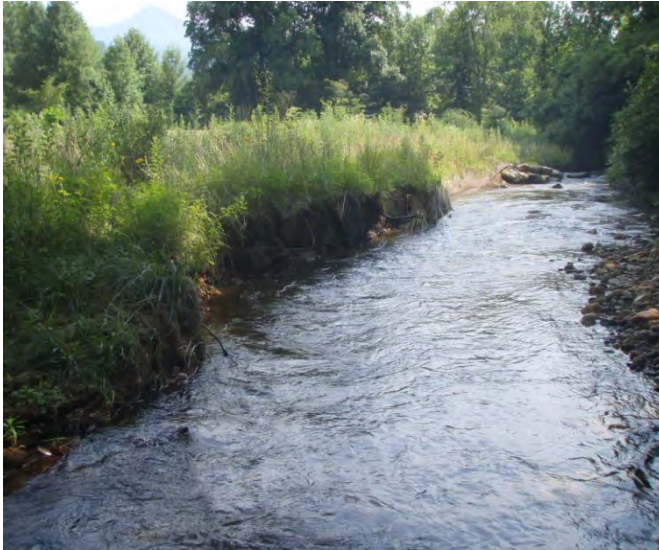
Problem Area 2

Right channel bank condition after 5 May 2013 flood, sta. 1+75 to 2+25 facing upstream, 18 July 2013.

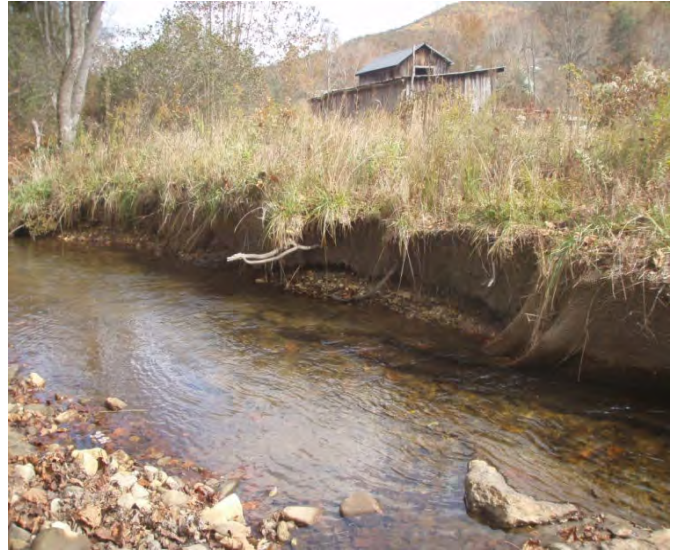
Right channel bank condition after 5 May 2013 flood, sta. 1+75 to 2+25, facing downstream, 29 October 2013.

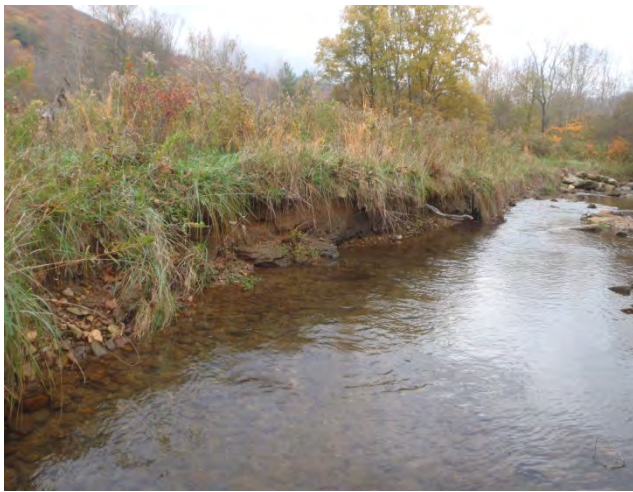
Right channel bank condition sta. 1+75 to 2+25 facing upstream, 20 October 2014.

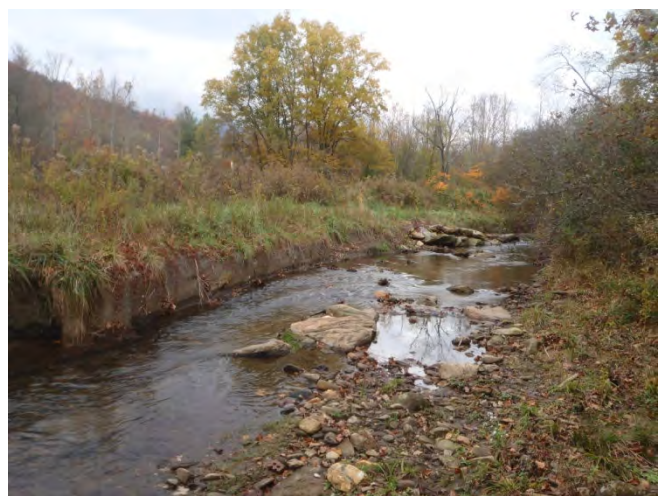
Right channel bank condition sta. 1+45 to 2+75, facing upstream, 28 October 2014.

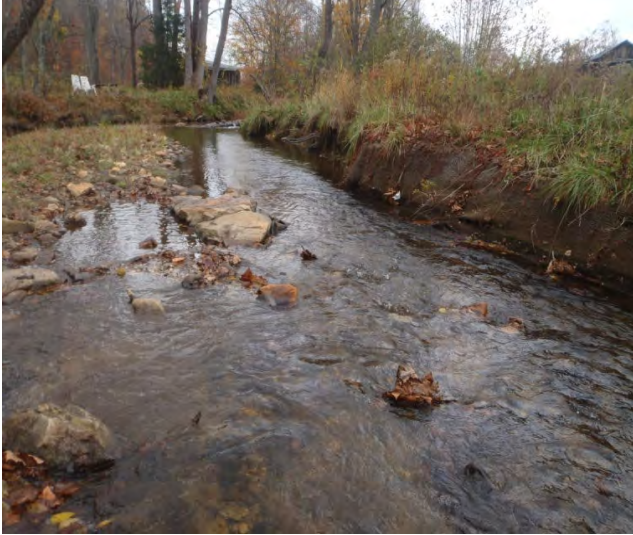
Problem Area 3

Aggradation below J-hook sta 2+50 facing
Downstream 28 October 2014

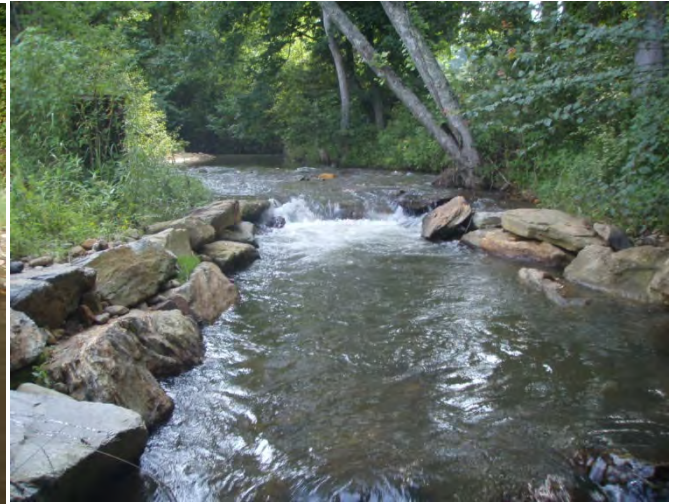
Cross vane after 5 May 2013 flood event, facing upstream,
sta. 0+50, 18 July 2013.

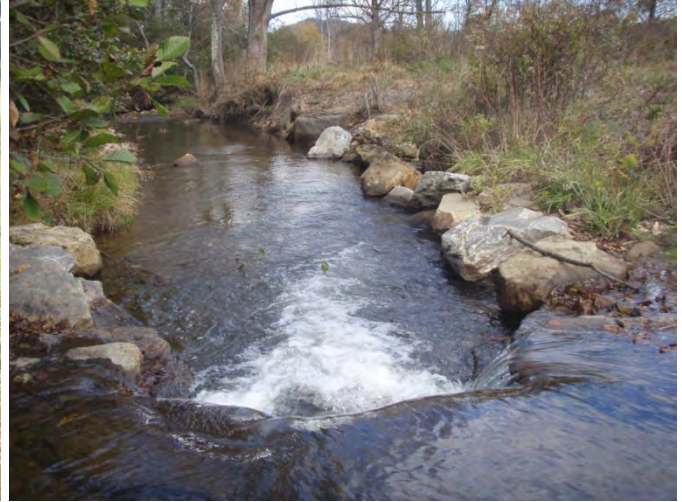
J-hook arm collapse during 5 May 2013 flood event, sta. 5+75, facing downstream, 29 October 2013.

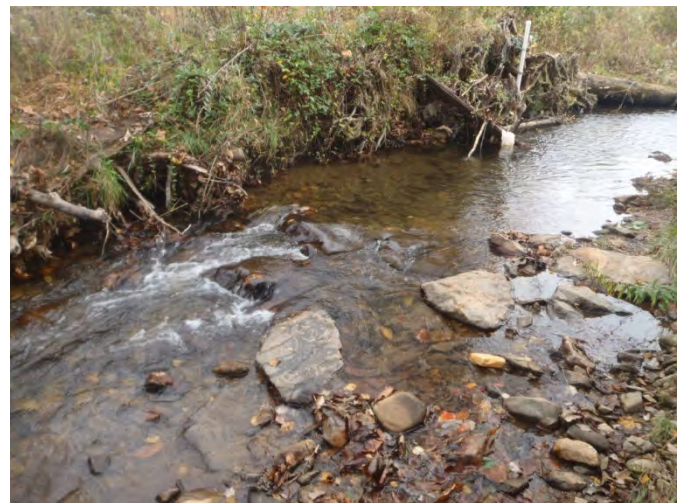
Right bank scour and erosion, sta 6+25 to 6+50 facing upstream, 28 October 2014

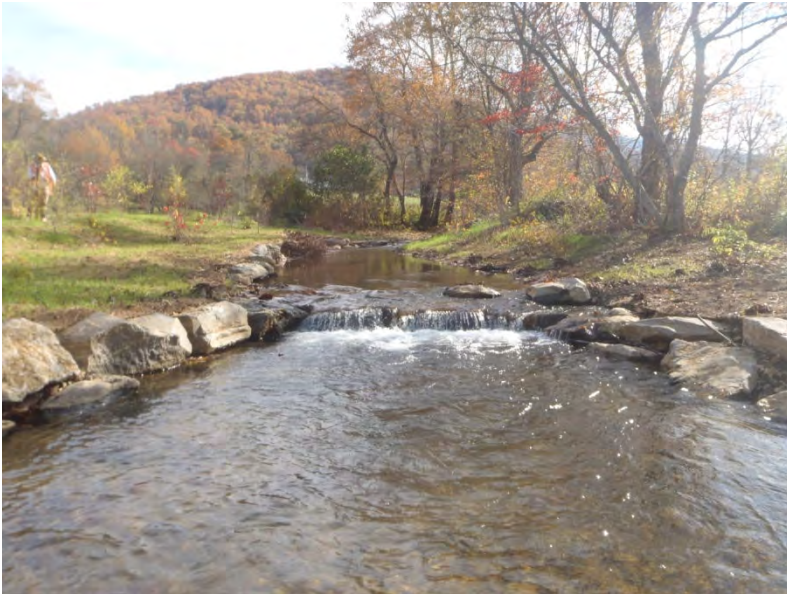
Problem Area 7

PA-7 station 12+75 facing upstream was repaired and is no longer considered a problem 28 October 2014

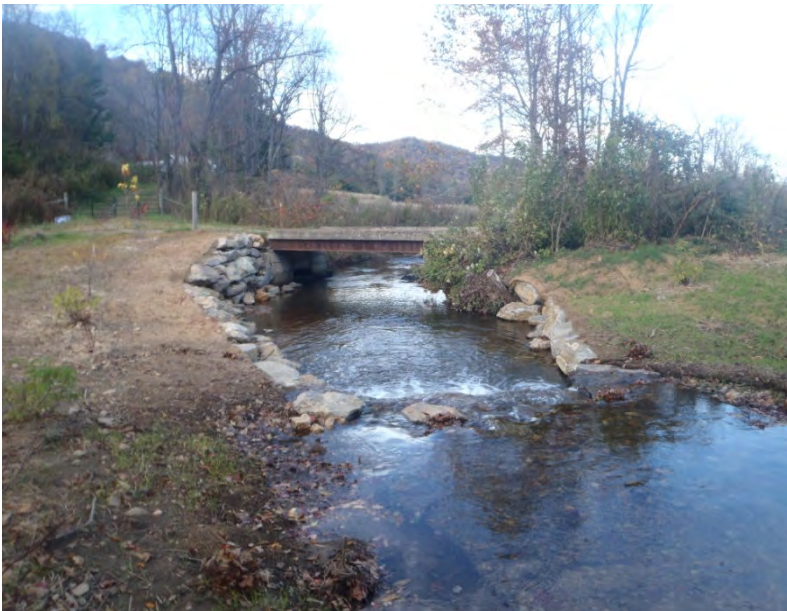
PA-7 station 12+75 facing downstream was repaired and is no longer considered a problem 28 October 2014

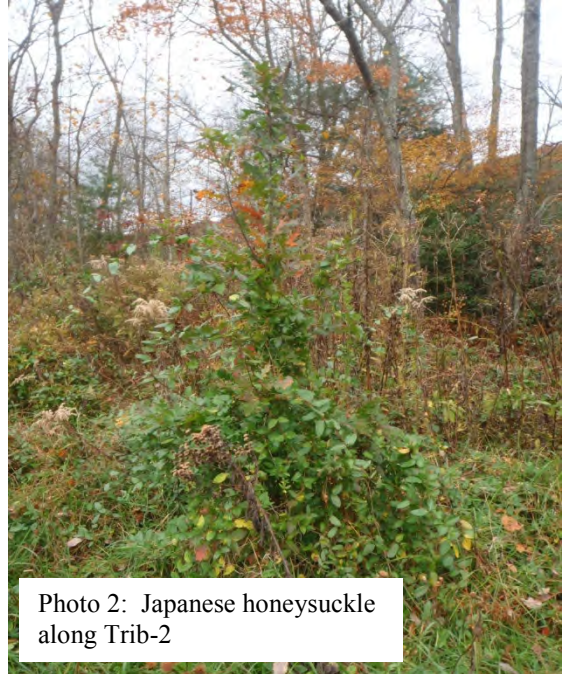
Photo 2: Japanese honeysuckle along Trib-2

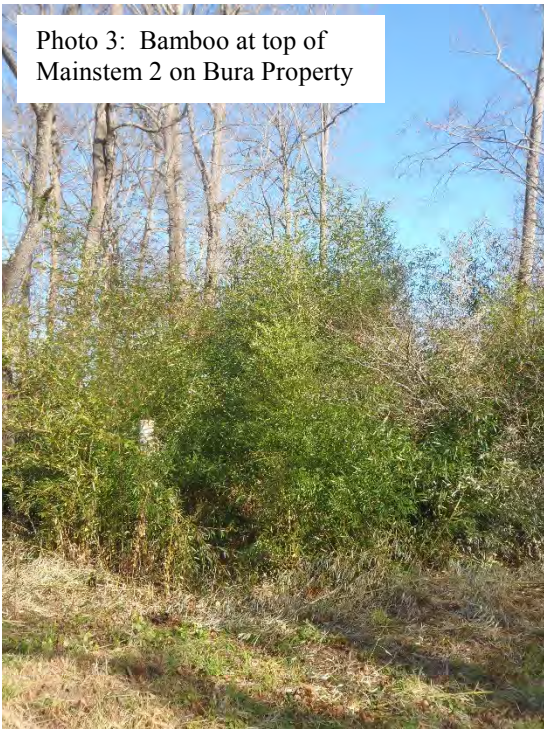
Photo 3: Bamboo at top of Mainstem 2 on Bura Property
