Monitoring Year 4 (2015) Report

Upper South Hominy Mitigation Site, South Hominy Creek, French Broad River Basin, Buncombe County, North Carolina

DMS Project Number: 92632
Contract Number: D06082; Task Order: 08 FB05-1b-d

Data Collected: April - November 2015
Submitted: December 2015

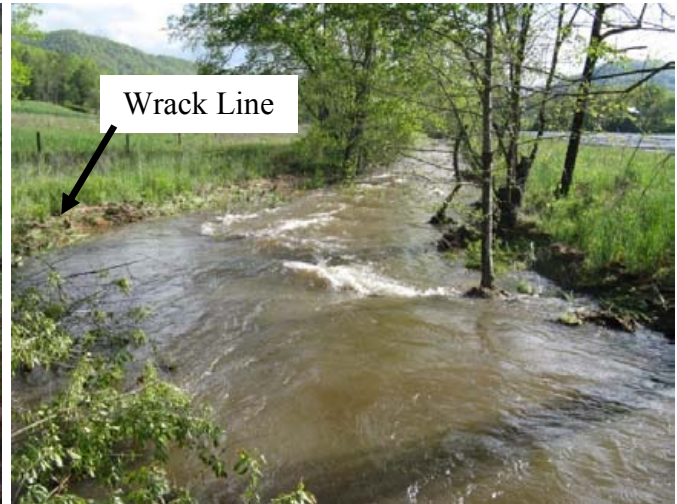
Photo 3 bankfull event on SHC, Davis property, sta. 0+50
28 November 2011.

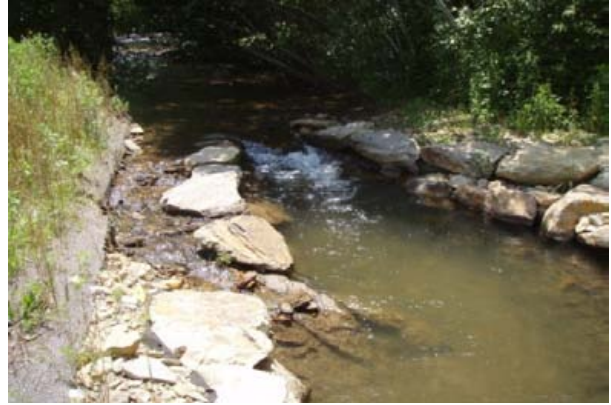
Rock vane after construction, sta. 1+50, facing upstream, 5 September 2011.

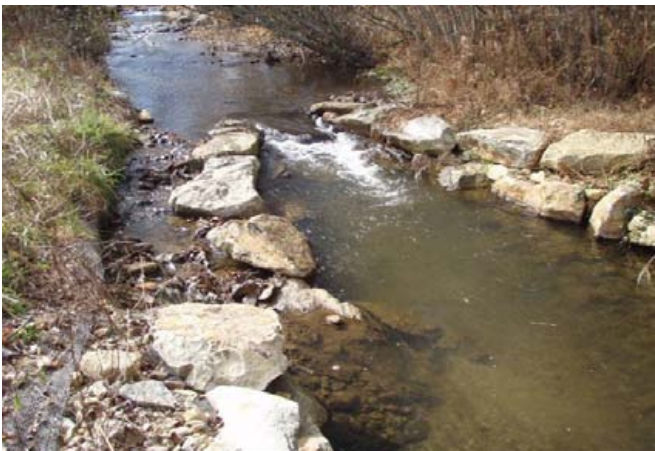
Rock vane after flood damage, sta. 1+50, facing upstream, 14 June 2012.

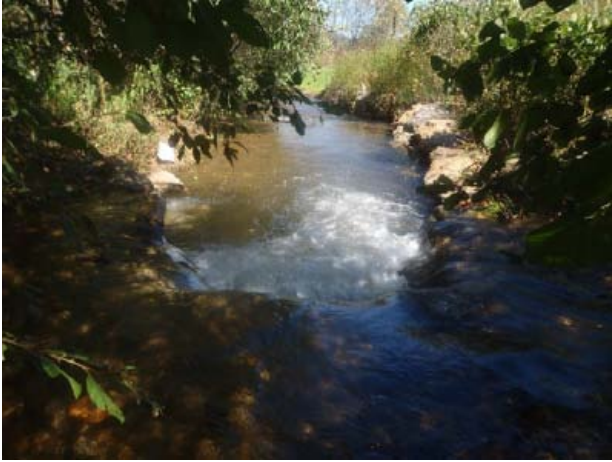
Problem Area 1

Repaired rock vane, sta 1+50 facing downstream 14 October 2015
No longer considered a problem during MY4 (2015) field surveys.

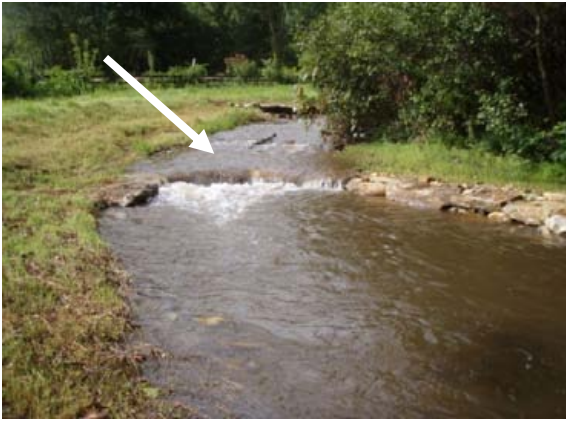
Right channel bank in stable condition, sta. 2+00, facing upstream, 5 September 2011.

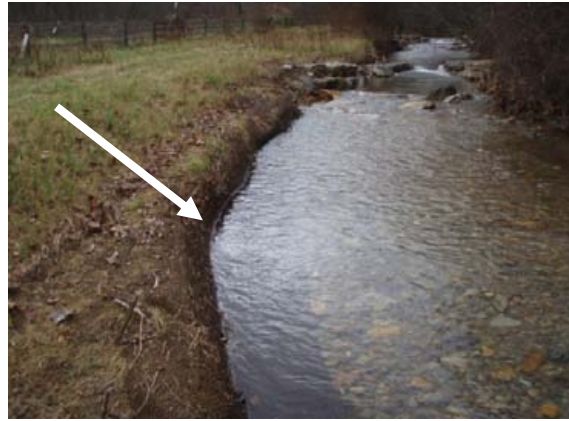
Right channel bank instability after flood damage, sta. 1+75 to 2+25, facing upstream, 5 December 2011.

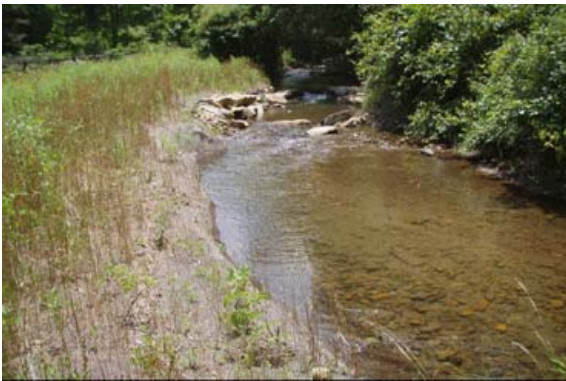
Right channel bank instability after flood, sta. 1+75 to 2+25, facing upstream, 14 June 2012.

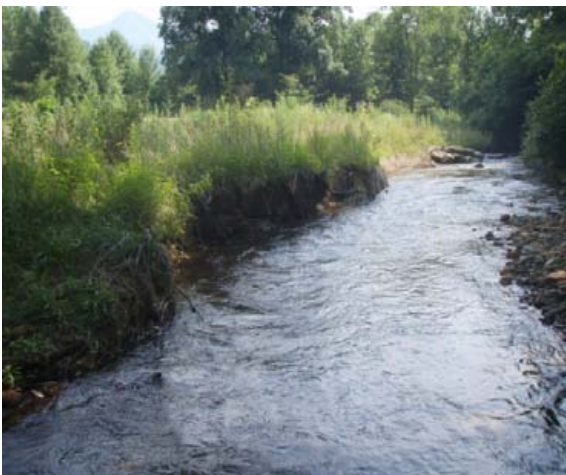
Right channel bank condition after 5 May 2013 flood, sta. 1+75 to 2+25 facing upstream, 18 July 2013.

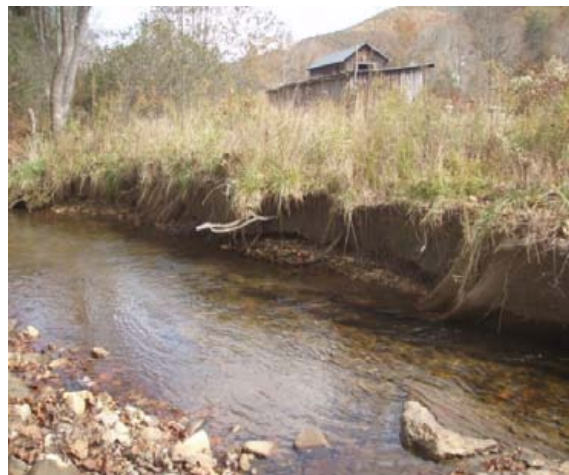
Right channel bank condition after 5 May 2013 flood, sta. 1+75 to 2+25, facing downstream, 29 October 2013.

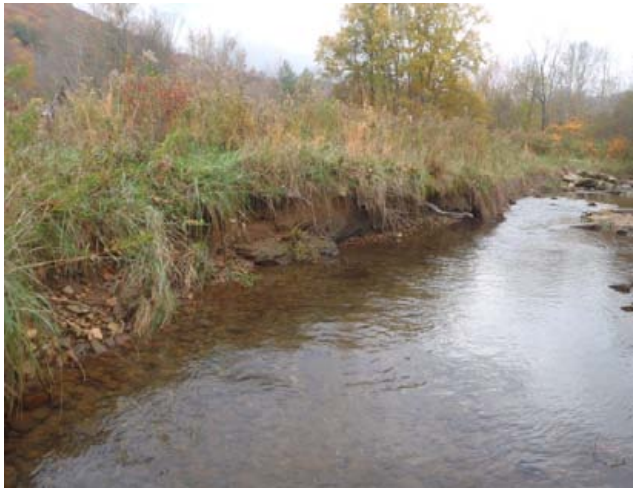
Problem Area 2

Right channel bank condition
sta. 1+75 to 2+25 facing upstream, 20 October 2014.

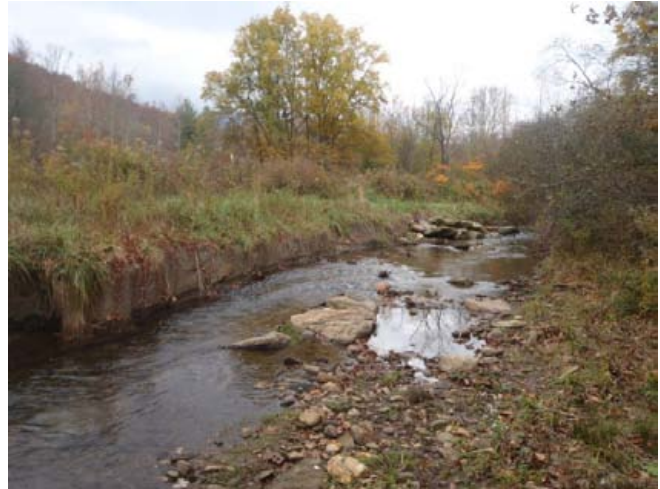
Right channel bank condition
sta. 1+45 to 2+75, facing upstream, 28 October 2014.

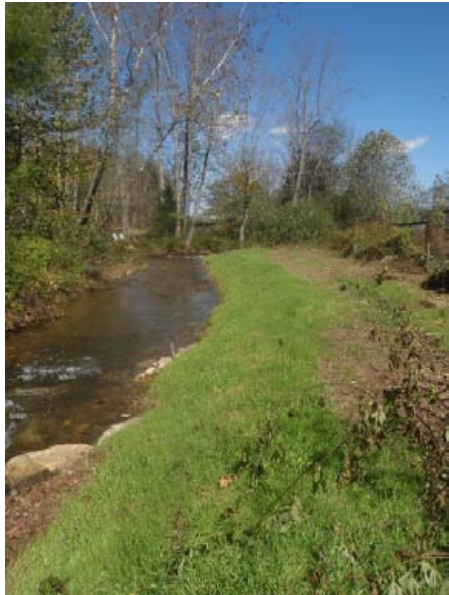
Right channel bank condition after 2015 repairs
sta. 1+75 to 2+25 facing upstream, 14 October 2015.
No longer considered a problem during MY4 (2015) field surveys.

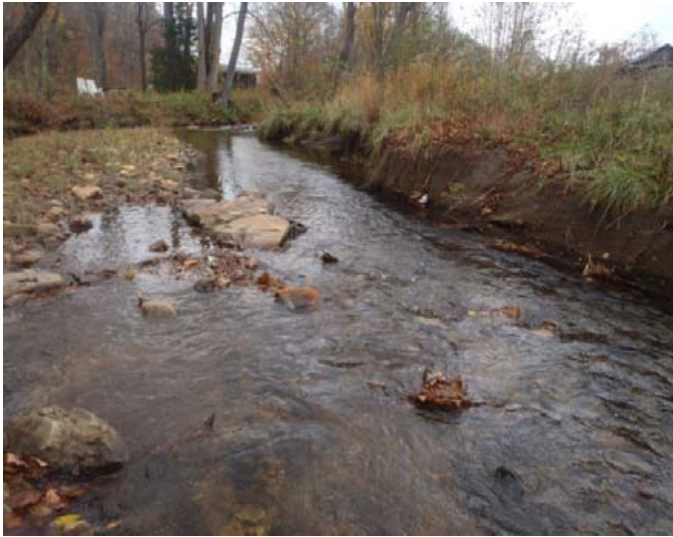
Problem Area 3

Aggradation below J-hook sta 2+50 facing downstream 28 October 2014

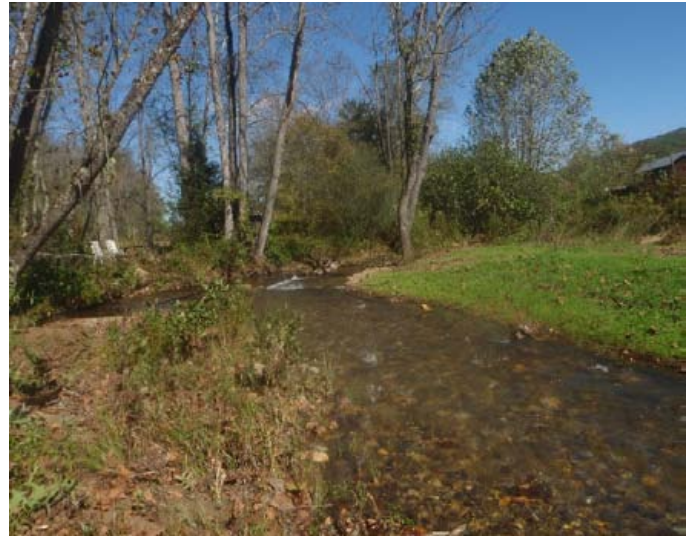
Meander below J-hook sta 2+50 after summer 2015 repairs facing downstream 14 October 2015
No longer considered a problem during MY4 (2015) field surveys.

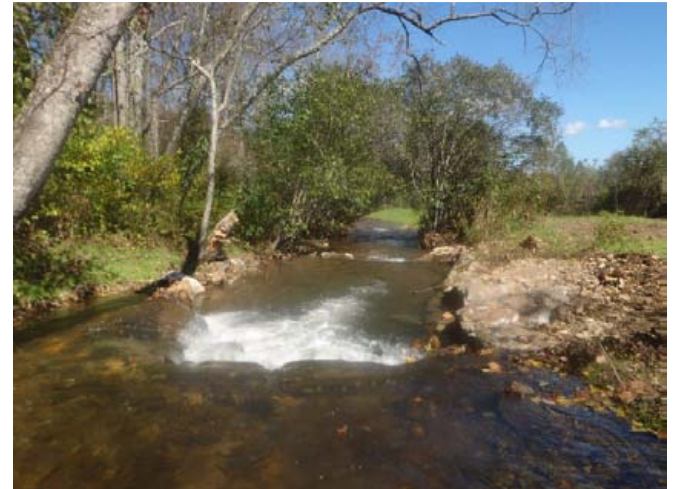
Crossvane after summer 2015 repairs, facing downstream, sta.
0+50, 14 October 2015

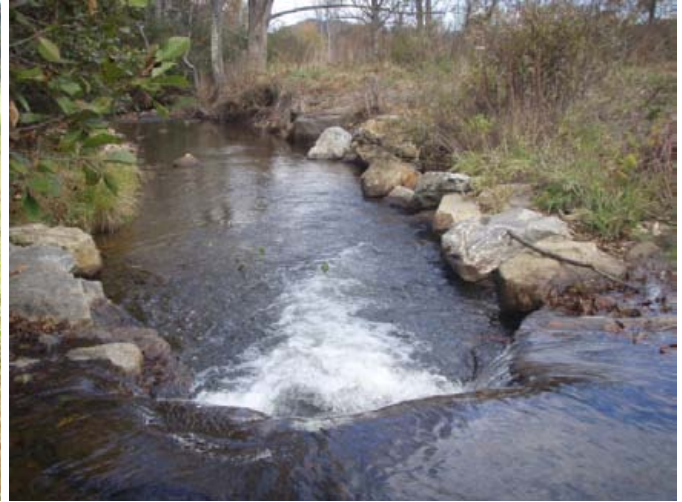
J-hook arm collapse during 5 May 2013 flood event, sta. 5+75, facing downstream, 29 October 2013.

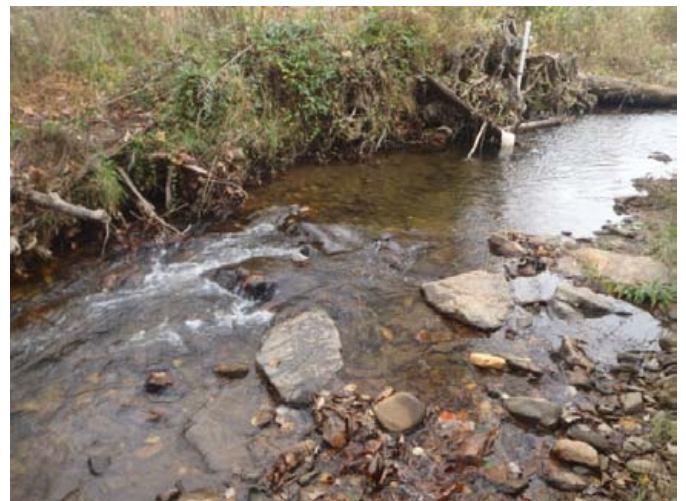
Right bank scour and erosion, sta 6+25 to 6+50 facing upstream, 28 October 2014

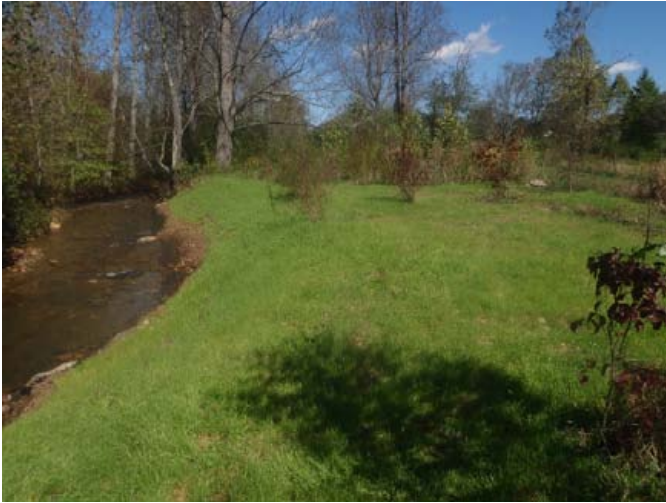
Problem Area 6

Right bank repairs performed summer 2015, sta. 6+25, facing downstream, 14 October 2015. No longer considered a problem during MY4 (2015) field surveys.

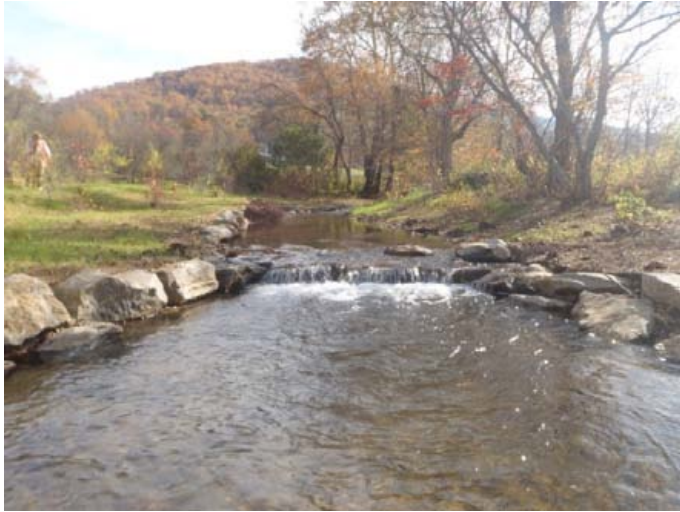
Problem Area 7

PA-7 station 12+75 facing upstream was repaired and is no longer considered a problem 28 October 2014

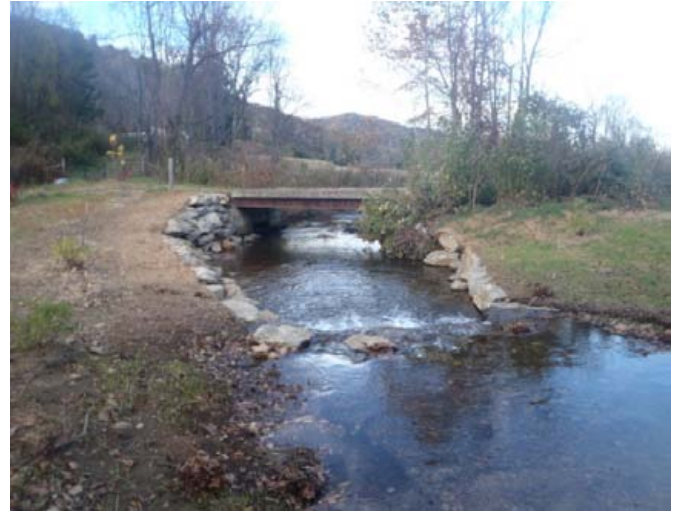
PA-7 station 12+75 facing downstream was repaired and is no longer considered a problem 28 October 2014

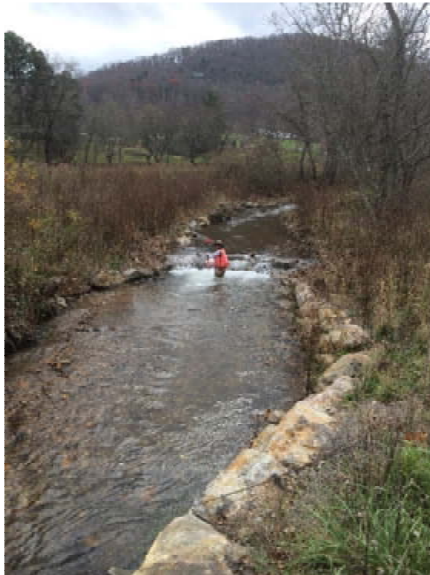
Repaired J-hook, sta. 12+75, facing upstream, 15 October 2015

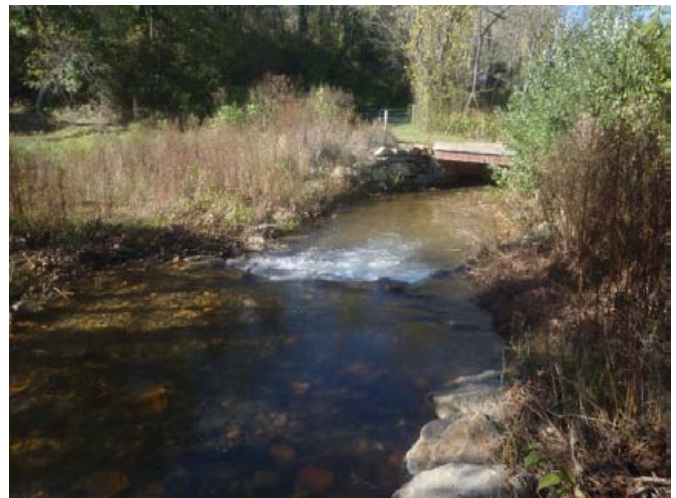
Repaired J-hook, sta. 12+75, facing upstream, 14 October 2015
